SUBJECT: NRC INSPECTION REPORT 050-00312/04-001; 072-00011/04-001

Facility: Rancho Seco Nuclear Generating Station

Rancho Seco Nuclear Generating Station
NRC Inspection Report 050-00312/04-001; 072-00011/04-001

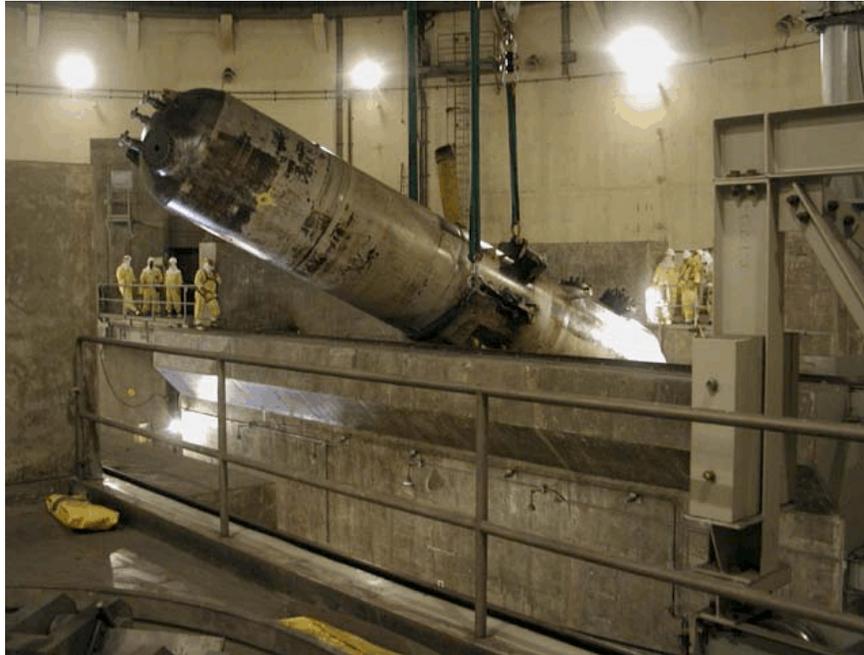
polar crane. In order to maintain control of the approximate 150-ton load, the location of the center of gravity and maintaining an amount of tilt was necessary. Since the design of the crane did not permit the operation of both hooks simultaneously, the lift required the crane operator to shift control from one hook to the other while remaining within the limits of tilt. Close proximity to remaining structural steel and the concrete biological shield further limited the permissible range of motion as the pressurizer was lifted or lowered first with one hook then the other. Figures 1-8 show portions of the pressurizer movement.

Figure 1
Rancho Seco Pressurizer
Lifted out of South Biological Shield "D" Ring

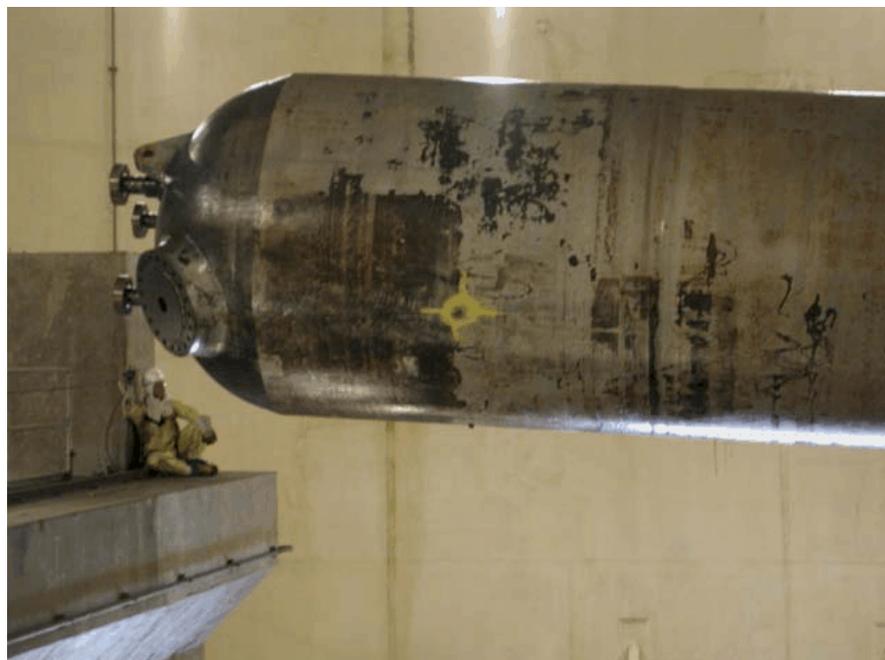
Figure 2
Rancho Seco Pressurizer
Approaching North Biological Shield "D" Ring

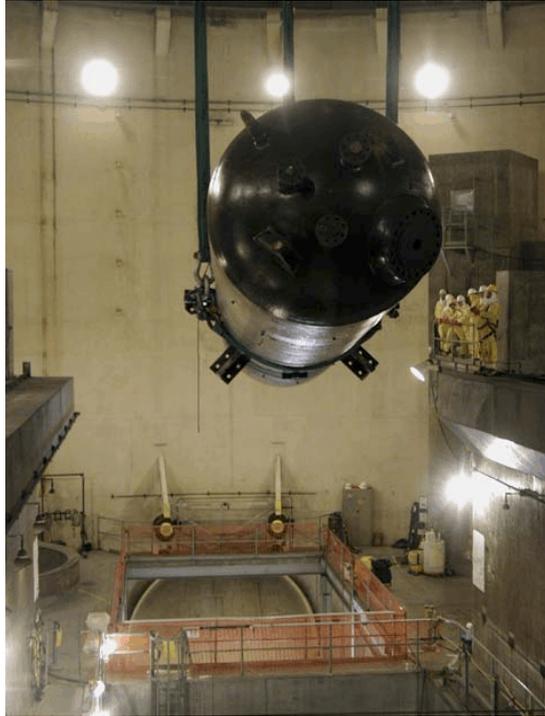
Figure 3
Rancho Seco Pressurizer
Moving toward Reactor Building Equipment Hatch

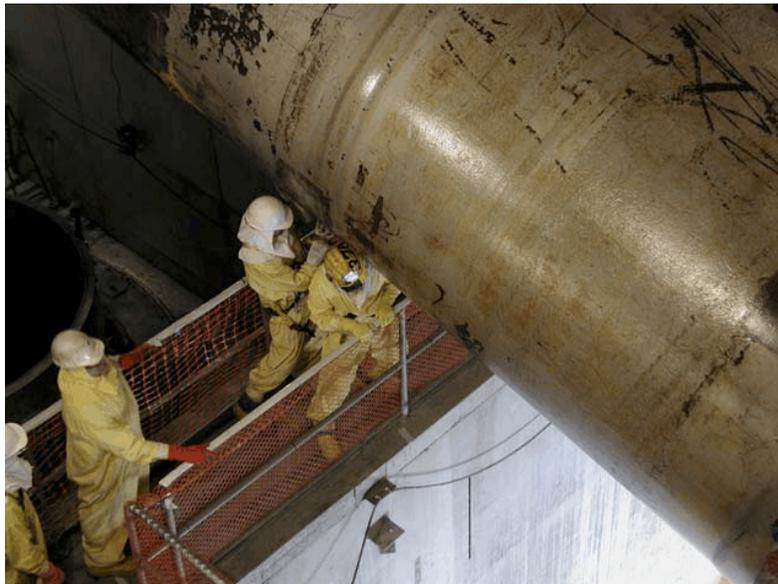
Figure 4
Rancho Seco Pressurizer
Tilted by Workers toward Equipment Hatch Bay

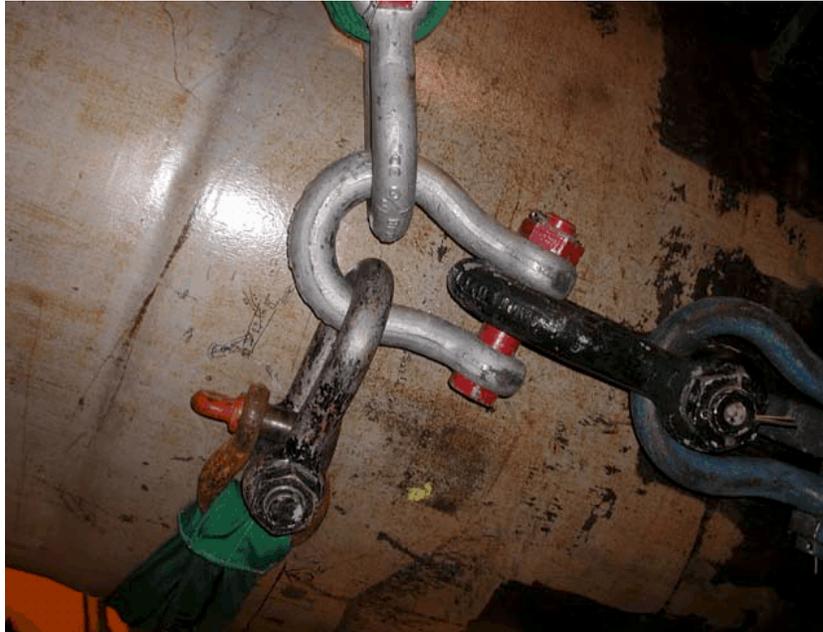
Figure 5
Rancho Seco Pressurizer
Rigging Shackle Details

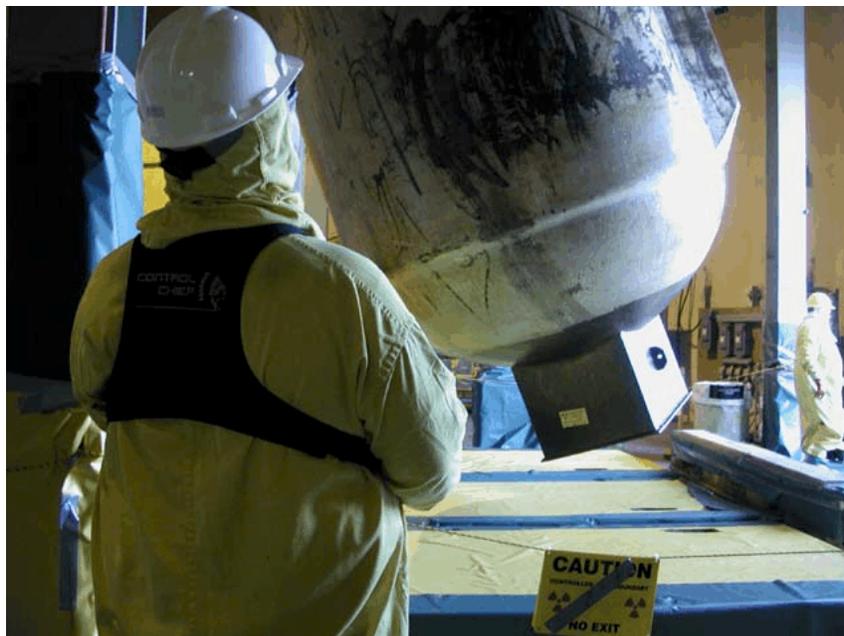
Figure 6
Rancho Seco Pressurizer
Crane Operator Using Remote Controls

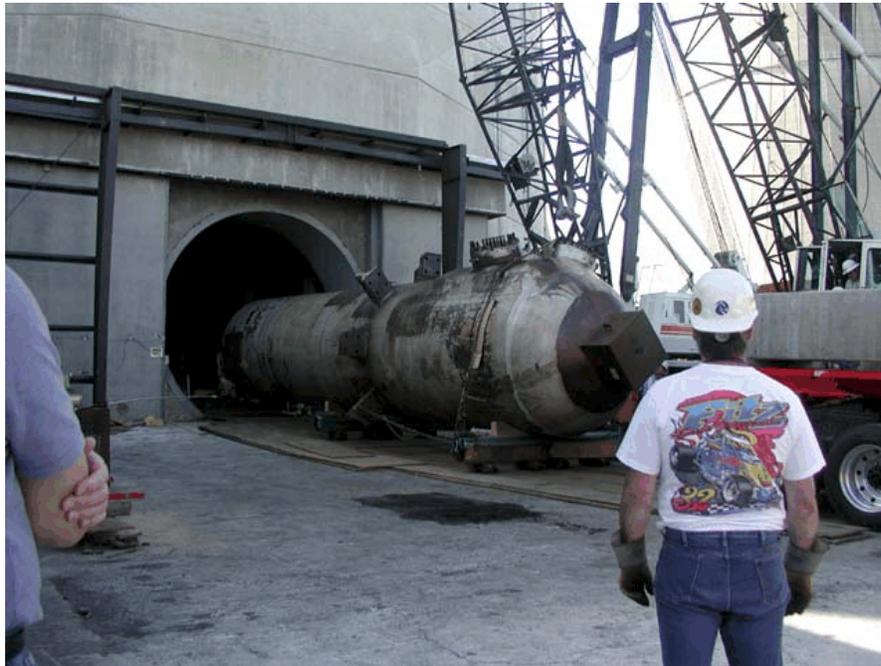
Figure 7
Rancho Seco Pressurizer
Pulled Outside Reactor Building Equipment Hatch

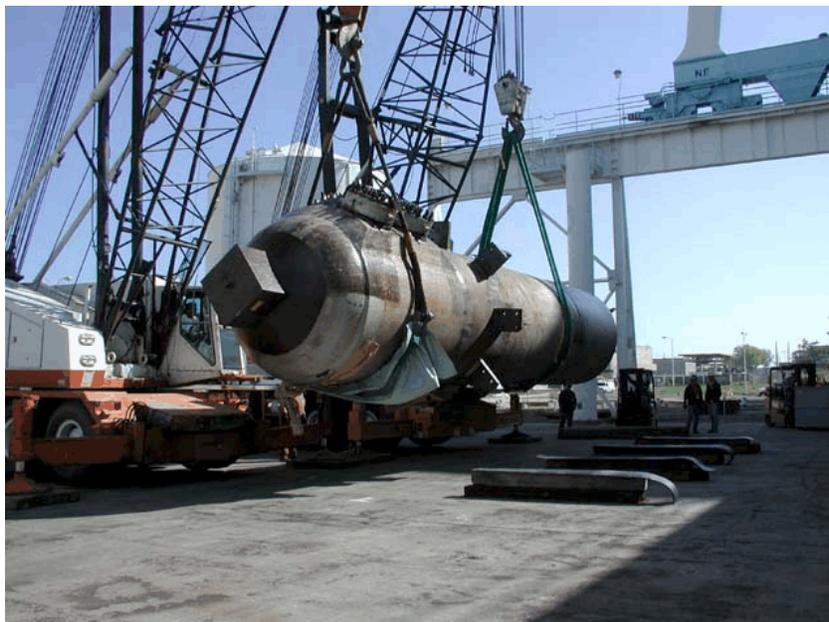
Figure 8
Rancho Seco Pressurizer
Lowered by Two Cranes at Shipping Staging Area
