NL-04-0652

Edwin I. Hatch Nuclear Plant  
Licensee Event Report  
Air Actuator for Vacuum Breaker Failed LLRT due to Inadequate Design

Enclosure: LER 50-321/2004-002

4. TITLE  
**Air Actuator for Vacuum Breaker failed LLRT because of an inadequate design**

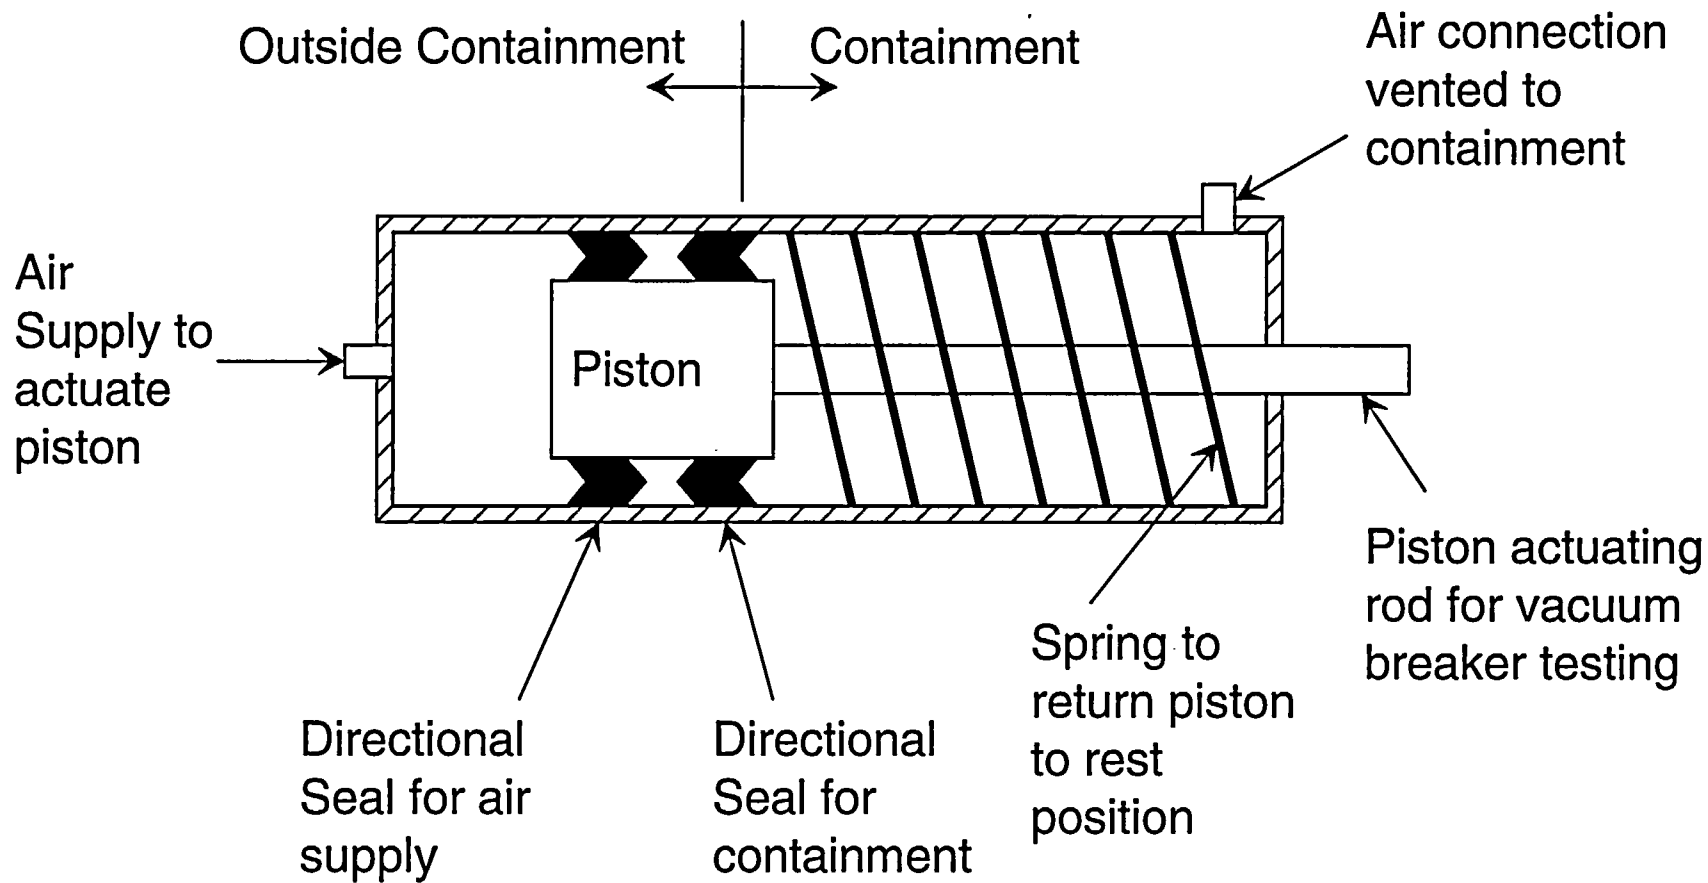
**LER 2004-002, rev. 0, Figure, pg. 1 of 2**

During the spring 2002 refueling outage, all twelve of the Unit 1 suppression chamber to drywell vacuum breakers air actuators (manufactured by Hiller) were replaced with new actuators. The actuators being replaced were dual acting actuators which had two internal seals located on the piston enabling the piston to be driven in either direction depending on the location of the air supply (see attached figure). The actual installation of these actuators at the plant relied on air for moving the piston in only one direction. The air supply moved the piston in a direction that would open the vacuum breaker. The plant installation relied on an internal spring in the actuator to return the piston after the air was isolated thereby allowing the vacuum breaker to close. The unused air supply connection is vented to the primary containment atmosphere inside the torus. Therefore, although the plant did not rely on one of the seals for moving the piston within the actuator, the plant did rely on this seal for a primary containment isolation barrier. Because of previous problems with the vacuum breaker closed position indication not picking up when cycling the vacuum breakers for the required 31 day functional test, these new actuators were being changed to use a heavier return spring. During the change process to install the heavier springs, the vendor increased the length of the actuator. The lengthening of the actuator created an interference with other plant equipment and the new actuators were returned to the vendor to be shortened. In order to shorten the actuators, the vendor reworked the piston seal arrangement and eliminated the seal being relied upon for a primary containment isolation barrier.

**Sectional view of vacuum breaker actuator**

**Required configuration**

All of the twelve suppression chamber to drywell vacuum breakers air actuators were rebuilt during the spring 2004 refueling outage to install the two internal seals restoring the inboard primary containment isolation barrier. These rebuilt actuators all successfully passed LLRT.

Following discussions between the vendor and the plant staff, a detailed design drawing was obtained from the vendor depicting the configuration of the replacement actuator and actuator seals. This drawing has been associated with the plant equipment via the plant's configuration control procedures.

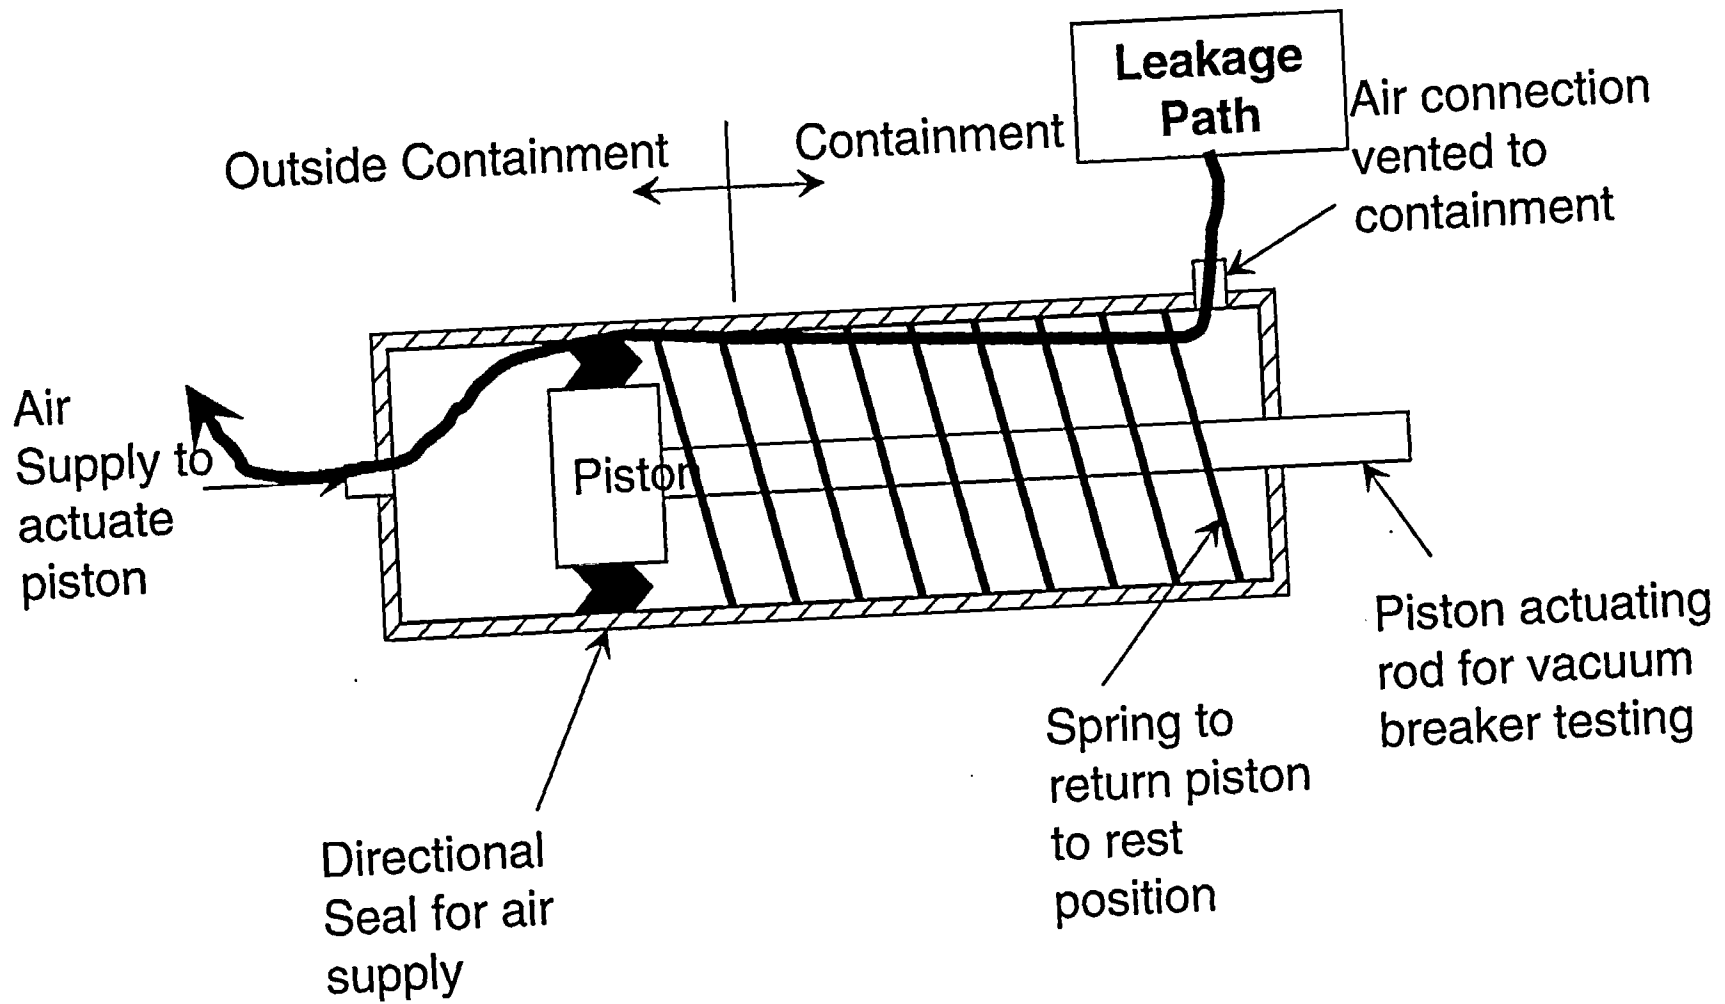
The cause of the event was that design records did not clearly specify the dual seal arrangement of the component being purchased. The focus of the change was therefore on the need for a heavier spring and, consequently, there was insufficient information for the vendor to understand that the second seal was a required design feature for these actuators. Thus, the vendor eliminated the second seal and, as a consequence, the primary containment isolation barrier.

**Sectional view of vacuum breaker actuator**  
**Shorter Piston and Containment Seal Missing**  
**LER 2004-002, rev. 0, Figure, pg. 2 of 2**
