UNITED STATES
NUCLEAR REGULATORY COMMISSION
OFFICE OF NUCLEAR REACTOR REGULATION
WASHINGTON, D.C. 20555

May 6, 2004

NRC INFORMATION NOTICE 2004-11: CRACKING IN PRESSURIZER SAFETY AND RELIEF NOZZLES AND IN SURGE LINE NOZZLE

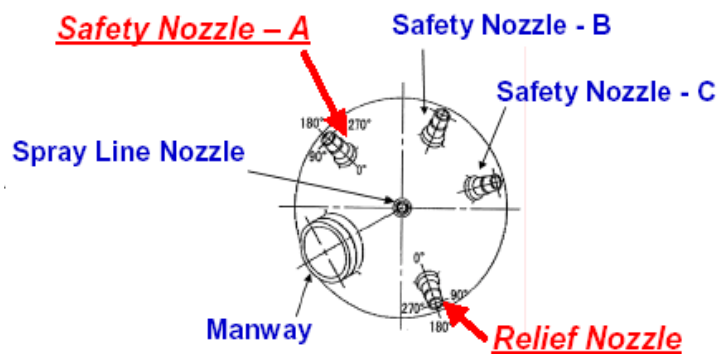
Figure 1. Top View of Reactor Pressurizer (Courtesy of Japan Atomic Power)

Tsuruga 2 was in its 13th annual inspection, which started in September of 2003. During a visual inspection of the pressurizer safety and relief nozzles with insulation removed, boric acid deposits were found on the pressurizer relief nozzle. Subsequent ultrasonic testing performed on the pressurizer safety and relief nozzles revealed linear indications in the nozzle-to-safe-end weld metal on the relief nozzle and on safety nozzle A, one of the three safety nozzles (Figure 1).

All of the flaws found were axially oriented and located in the welds, that is, the flaws did not extend into the base metal. The 0° location of each nozzle is the point of the nozzle closest to the centerline axis of the pressurizer cylinder, marked by the spray line nozzle in Figure 1. On safety nozzle A, two indications with a maximum length of 24 mm (0.9 inches) were found at the 35° - 45° location. On the relief nozzle, two indications with a maximum length of 35 mm (1.4 inches) were found at the 90° location, and one indication with a maximum length of 34 mm (1.3 inches) was found at the 315° location.

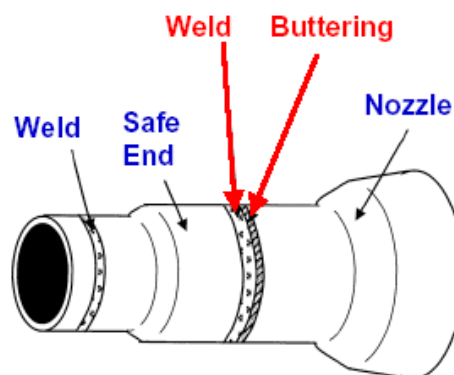
Figure 2. Nozzle Configuration (Courtesy of Japan Atomic Power)

Each nozzle consists of a safe end made of Type 316 stainless steel and a nozzle end made of a low-alloy steel, similar to Type 508 ferritic steel typically used in the same nozzles for U. S. plants (Figures 2 and 3). The safety and relief nozzles are the same size, about 190 mm (7.5 inches) outside diameter and about 130 mm (5.1 inches) inside diameter. Weld butter with Alloy 132 (which has properties similar to Alloy 182) was initially applied to each of the nozzles. The component was stress-relieved. Then a safe end was welded to each nozzle with Alloy 132. The weld is approximately 40 mm (1.6 inches) in width.

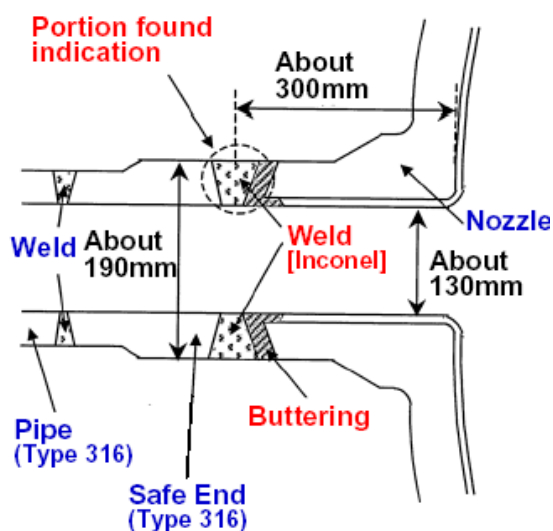
Figure 3. Nozzle Materials (Courtesy of Japan Atomic Power)

Radiography was performed on the severed pieces, confirming the linear flaws. Metallurgical failure analysis was performed on these samples. The results showed that the cracks initiated from the inside diameter surface, were axially oriented and were intergranular or interdendritic in nature. A through-wall crack was confirmed at the 90° location in the weld on the relief nozzle. The conclusion of the metallurgical analysis was that the nozzle failures were caused by primary water stress corrosion cracking (PWSCC) in the nozzle weld.
