NUREG/CR-4939
BNL-NUREG-52031
VOLUME 3

IMPROVING MOTOR RELIABILITY IN NUCLEAR POWER PLANTS

VOLUME 3: FAILURE ANALYSIS AND DIAGNOSTIC TESTS
ON A NATURALLY AGED LARGE ELECTRIC MOTOR

ENGINEERING TECHNOLOGY DIVISION
DEPARTMENT OF NUCLEAR ENERGY, BROOKHAVEN NATIONAL LABORATORY
UPTON, LONG ISLAND, NEW YORK 11973

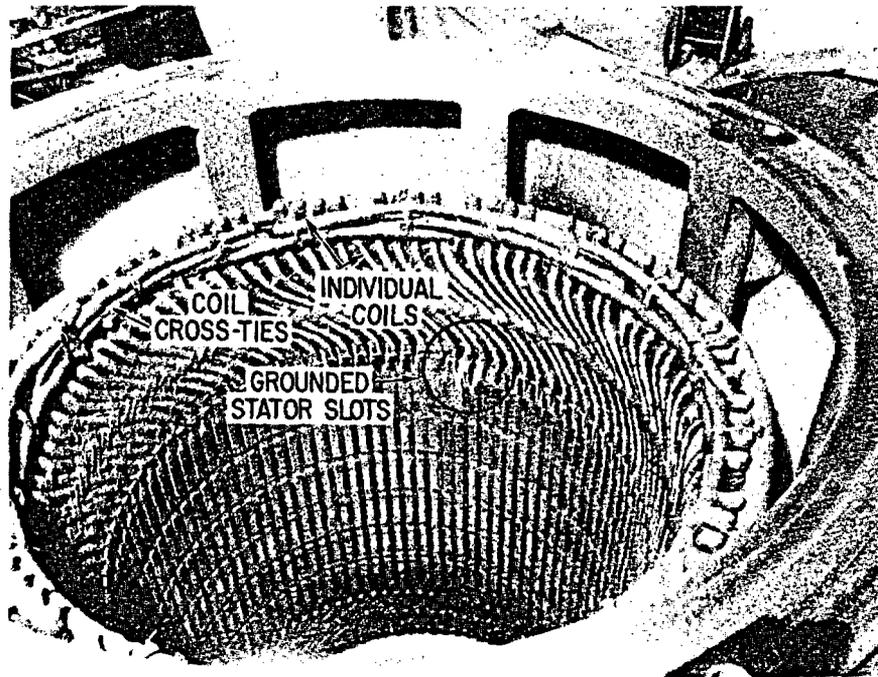
Figure 1.1 - Failed HFBR 400 hp motor stator.

Prior to performing this study, it was not clear whether the motor failed first due to a turn to ground short, creating a current surge which failed the transformer cable, or the transformer cable failed first, resulting in an overload on the two phases in the motor winding which subsequently failed, or both motor and transformer failed simultaneously. However, the motor had been in service at this facility for over 20 years with minimal maintenance activities and without any appreciable problems. Figure 1.1 shows the failed motor stator winding and the burned out area.

At the time this study was started, the motor had been disassembled and the stator had been put aside inside the reactor facilities at BNL for testing. Figure 1.1 shows the failed stator with the damaged winding slots.

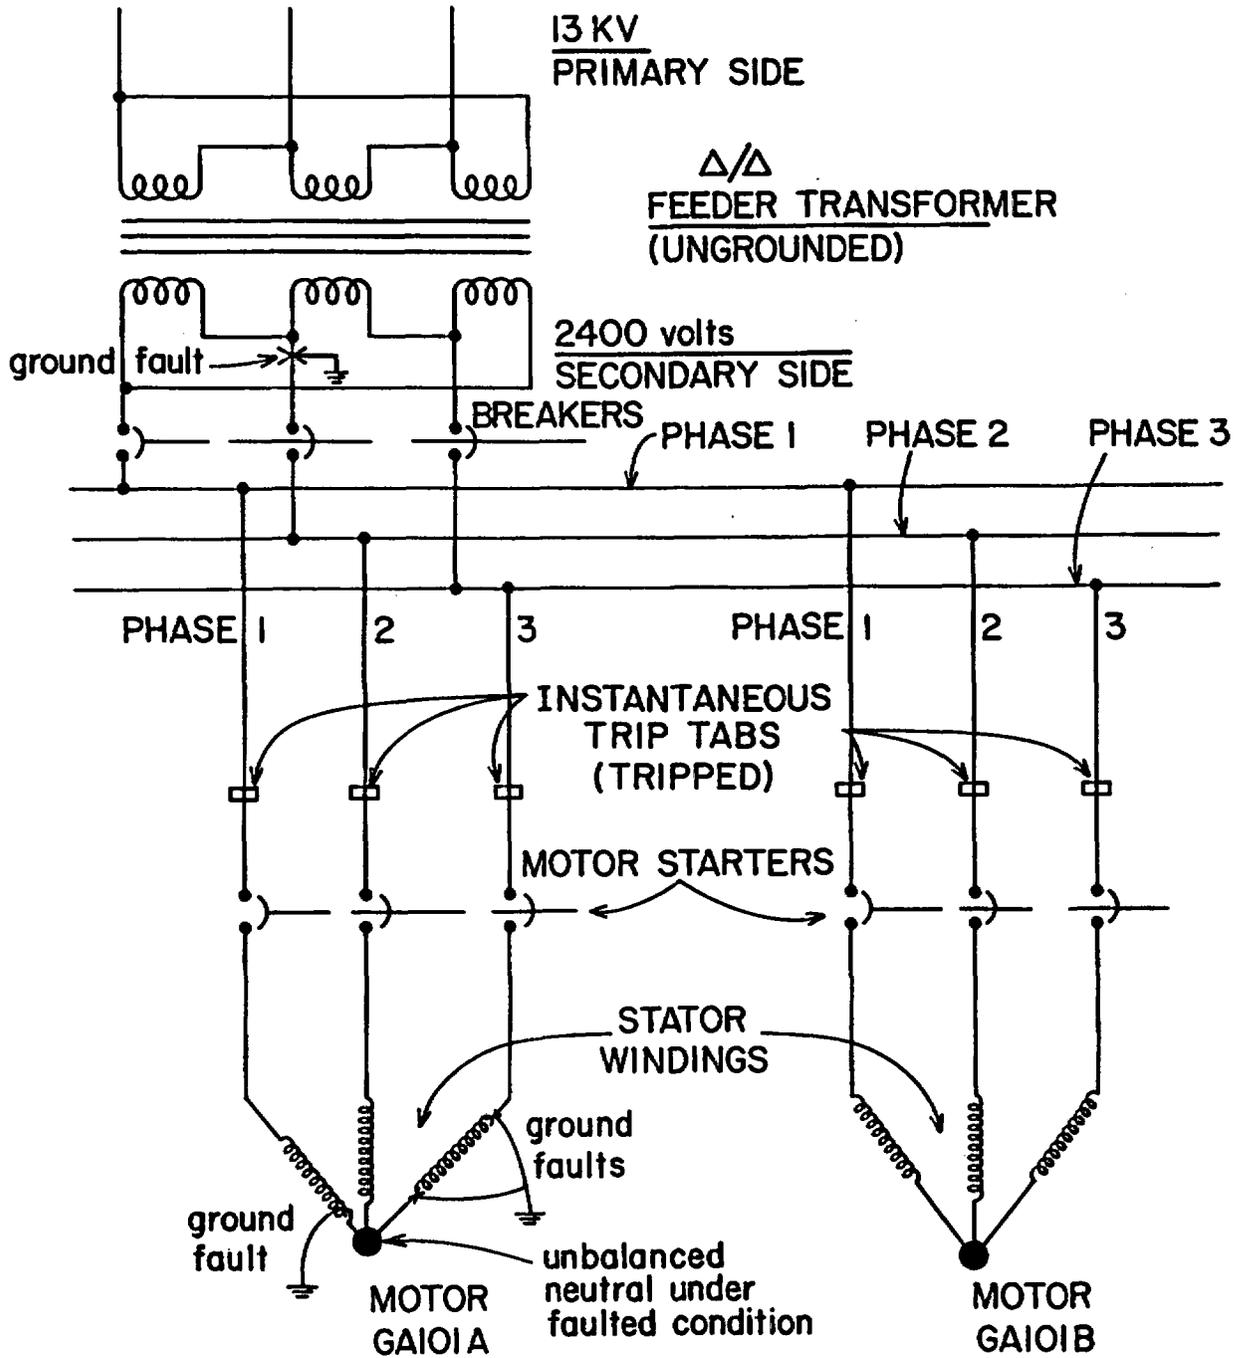
Figure 3.1 - Power supply to RCP motors from feeder transformer.

Figure 3.1 shows a schematic of the circuit between the feeder transformer and the two recirculating pump motors. The 2,400 volt side of the Δ/Δ transformer and the two Y connected motors are ungrounded. Each phase from the transformer secondary consists of two cables in parallel to provide the required current carrying capacity. In such an arrangement, each phase line current is shared by the two cables. As indicated earlier, one of the two cables from the phase 2 of the transformer was found to have an open circuit and probably grounded as indicated in Figure 3.1. The post-failure tests also found that the Y-connected stator windings of motor GA101A had grounded coils in phases 1 and 3.

Based on the above post-failure grounded conditions in the ungrounded transformer-motor system arrangement, as shown in Figure 3.1, it is evident that there exist three possible scenarios the system might have experienced prior to its failure. These are:

The above explanations lead to the conclusion that the oil saturated transformer cable grounded first and produced an arcing to ground which in turn failed the motor (mode 3). The following discussions justify this mode of system failure. Before the Phase 2 secondary transformer lead grounded, the voltage to ground on all phases was zero volts for the ungrounded system. Once one of the two cables from the Phase 2 transformer secondary grounded the voltage to ground on that phase remained at zero. This caused the corresponding phase terminal on the motor winding to be at zero potential to ground, whereas the voltage to ground at the motor terminals for phases 1 and 3 was raised to 2400 volts. The increase in potential resulted in overstressing the aged insulation in these two phases which caused them to fail. Usually the insulation between each line to ground is adequate to withstand full line-to-line voltage (i.e., 2,400 volts). However, if this voltage is applied to age-degraded insulation, it can result in failure. Insulation tests performed on the stator windings revealed weak and degraded conditions existed in a number of coils.

Based on the analysis presented, it is believed that the ground fault in the transformer cable was the initiating event leading to motor failure. The cable ground fault caused an over-voltage condition in the motor windings which resulted in failure of the age-degraded winding insulation. Since the same transformer supplies a second identical motor, it could also have experienced an over-voltage condition. The second motor is the same age as the failed motor and the high voltage could have further degraded the winding insulation. It is therefore recommended that replacement of the second motor (GA-101B) be considered in the near future.

To avoid future occurrences of this type of failure, it is additionally recommended that the motor-transformer system design be modified to include a ground. If a system ground cannot be provided, ground fault detectors should be installed.

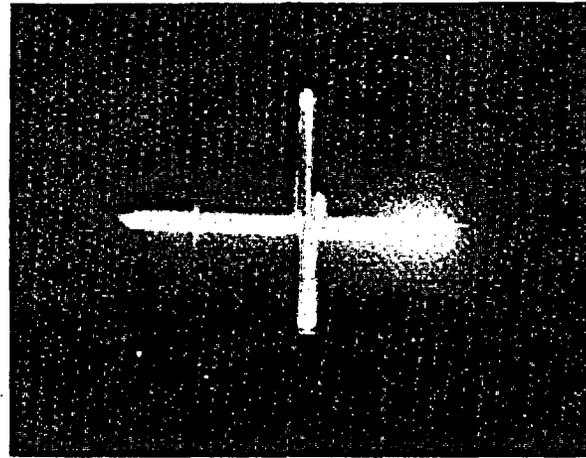
Figure 4.2 illustrates the superposition of standing voltage wave traces on the oscilloscope for four different coils tested. Coils 1 and 46 were first determined to be good coils. These coils were then used as a baseline to compare against other coils for evaluating their condition. Figure 4.2(a) indicates a perfect match between coils 1 and 46. A perfect match indicates that both coils are good since it is extremely unlikely that two coils would degrade to exactly the same degree, which is what would be required to produce the same wave pattern. Therefore, it is concluded that the insulation on

(a) COILS 1 & 46: PERFECT MATCH

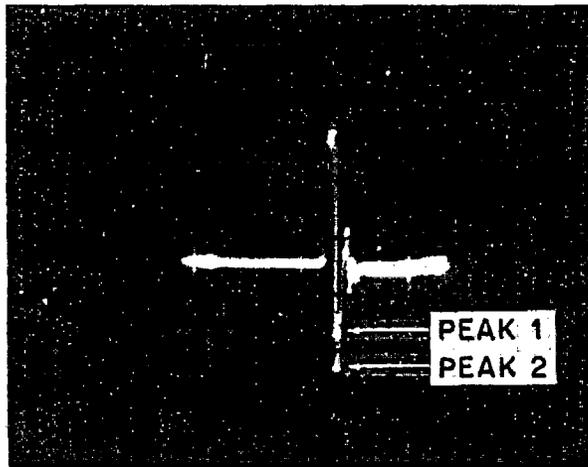
All coils in the motor were surge tested at 2,500 volts after the series connections were cut. This particular test indicated the obviously grounded coils and a turn short in coil 14.

(b) COILS 14 & 1 : SIGNAL MISMATCH (SHORT)

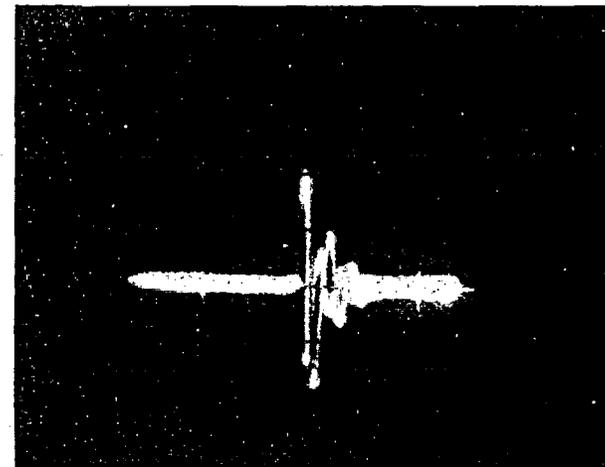
(c) COILS 1 & 67: SIGNAL MISMATCH (GROUND)

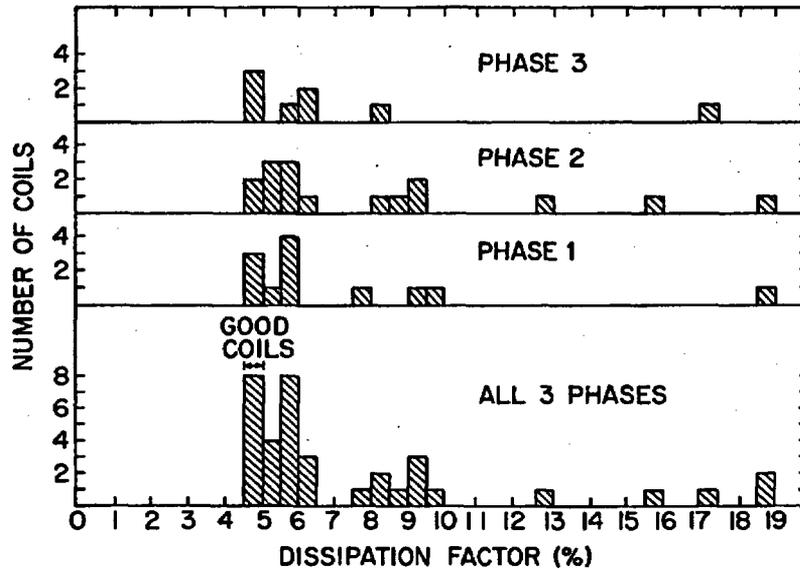
Figure 4.3 - Dissipation factor at 2000 volts.

Figure 4.3 shows the distribution of the 36 coils tested at 2000 volts. Eight (8) coils were found to be good coils with dissipation factors less than 5%. Another fifteen (15) coils were found to have a dissipation factor of less than 7% and were considered to be in acceptable condition. The remaining thirteen (13) coils exhibited aging in their insulating materials. These coils (70-79, 84, 87, and 88) are presumed to have developed cracks and voids in their insulation resulting in the higher dissipation factors.

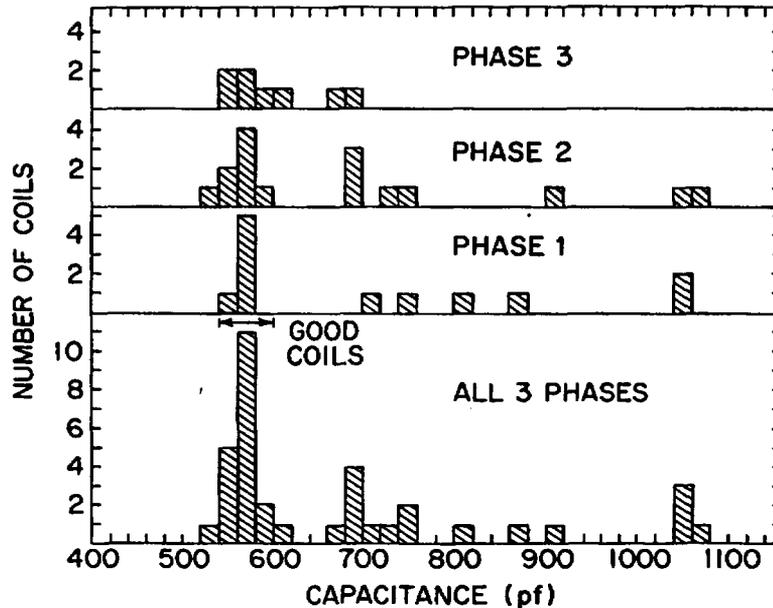
Figure 4.4 - Capacitance at 2000 volts.

The distribution of capacitance values among the 36 tested coils is shown in Figure 4.4. As shown, twenty (20) of the coils indicated normal values while the remaining sixteen (16) coils exhibited higher capacitance in their insulating materials. From the above discussion, it can be concluded that

these 16 coils have probably experienced thinning in their insulation materials due to their age and environmental conditions. Of the 16 coils with high capacitance, coils 46, 47, 70-79, 84, 87, 88, and 89 are definitely showing signs of insulation thinning.

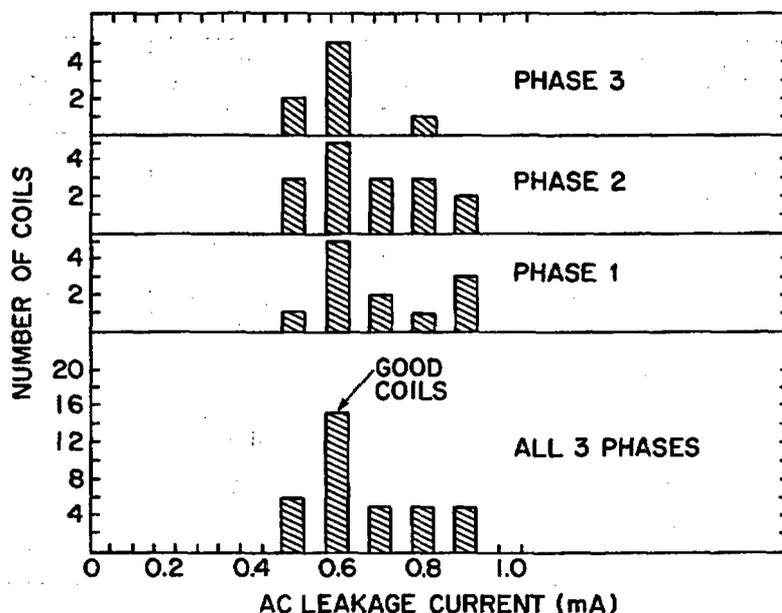
Figure 4.5 - Ac leakage current at 2000 volts.

Figure 4.5 shows the distribution of leakage current for the 36 coils tested. As shown, fifteen (15) of the coils indicated a higher leakage current at an impressed voltage of 2,000 volts than the baseline data presented in Table 4.3 (0.6 mA @ 2000 v). Comparing the data from Table 4.1 with Table 4.2, it is seen that all of these coils have also indicated higher dissipation factors and/or capacitance values. This is consistent with expected results since increased dissipation factor or capacitance would indicate the insulation is in a degraded condition. The degraded insulation should show an increased leakage current. The ac leakage current test, therefore, verified the findings of the dissipation factor and capacitance tests.
