Aging and Qualification Research on Solenoid Operated Valves

Prepared by V. P. Bacanskas, G. J. Toman, S. P. Carfagno

Franklin Research Center

Prepared for
U.S. Nuclear Regulatory
Commission

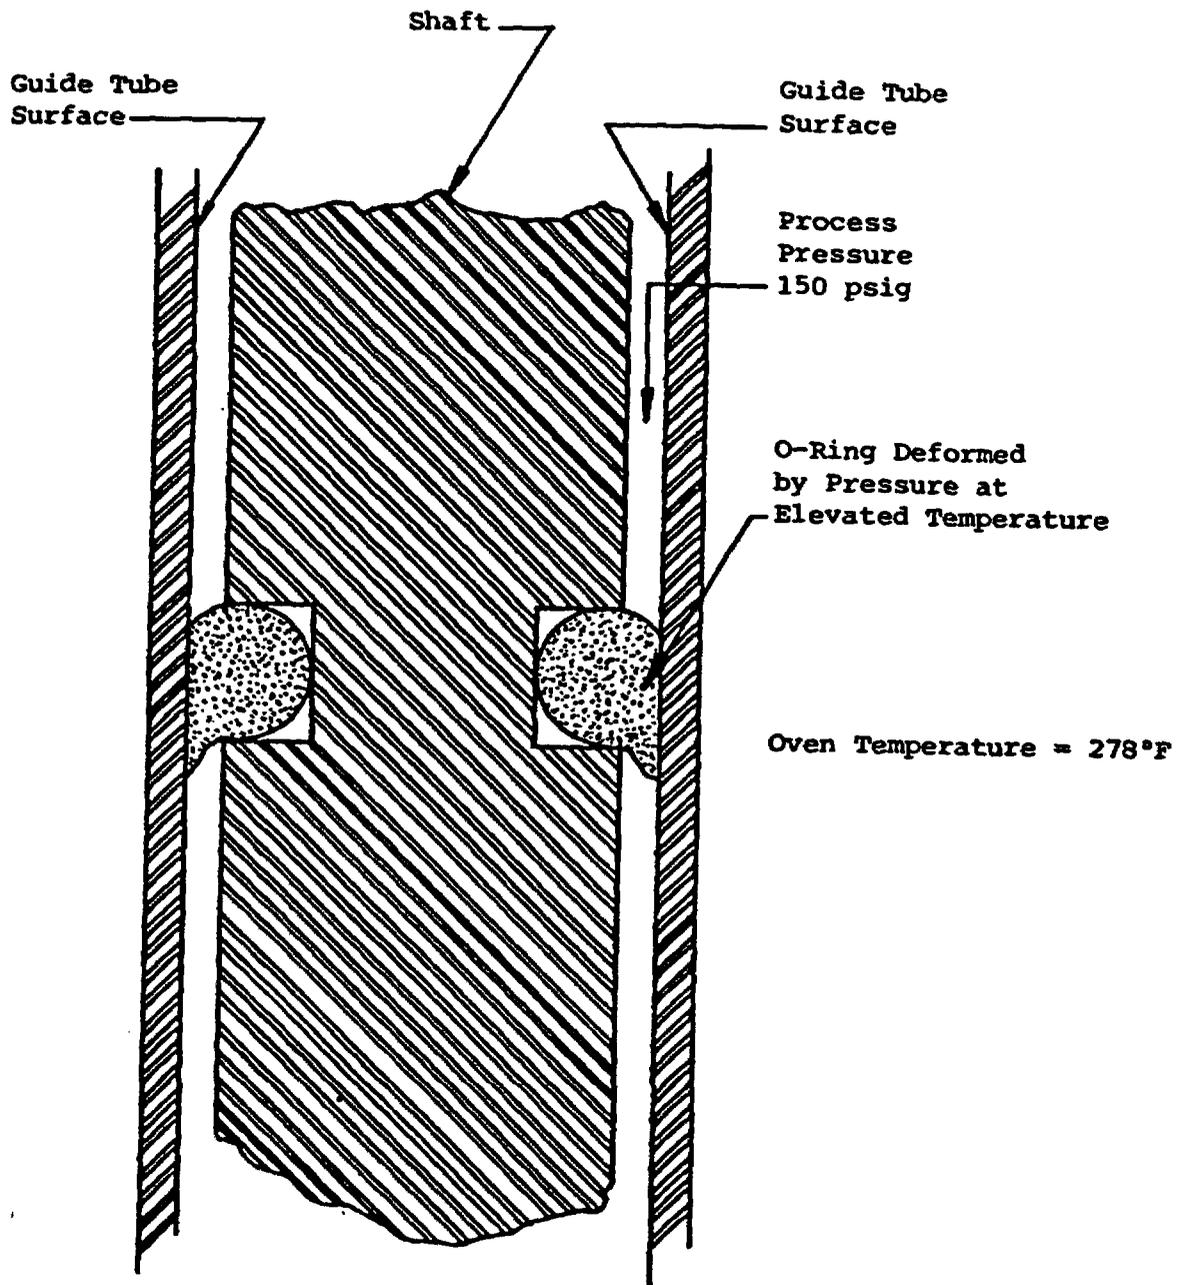
Figure 7. Hypothesized Deformation of Valcor Shaft Seal O-Ring During Accelerated Thermal Aging

Accelerated aging of the Valcor SOVs was intended to simulate 5 years of energized service at 140°F (60°C). However, the SOVs failed to operate early during the accelerated aging exposure. Failure analysis indicated that the shaft seal O-ring is more critical than the lower seal O-ring, which had previously been assumed to be the most critical component. The thermal aging procedure was modified accordingly, and additional changes in test procedures were made with the intention of eliminating any possible unrepresentative overstressing of Valcor SOVs while retaining the equivalence of 5 years of thermal aging. In spite of such changes in the procedures, the Valcor SOVs failed to operate during two additional attempts at artificial thermal aging. Due to limitations of funding and time the program was continued with Valcor SOV specimens that had not been through accelerated thermal aging. Disassembly and inspection of the failed SOVs revealed that the shaft seal O-rings were hard and had started to become powdery and were disintegrating. The upper O-ring on the seal assembly was severely deteriorated and adhered to the seat.

The pressure normally assists in unseating the SOV seats and starts the shaft in its downward direction when the SOV is deenergized. The second stress acting on the O-ring is related to a combination of mechanical and thermal stresses acting on it and is a possible explanation of the observed failure. At elevated temperatures, such as those used during the thermal aging simulation, the EDPM O-ring material has a tendency to soften and become more pliable, as with most rubber products. The differential pressure across the O-ring (150 psig) causes the O-ring to deform by wedging between the shaft and guide tube, such that a larger portion of the O-ring is in contact with the guide tube. If the SOV is cooled while remaining in the energized state, the deformed O-ring becomes harder and binds the shaft in its energized position.
