NUREG/CR-5762
WYLE 60101

Comprehensive Aging Assessment of Circuit Breakers and Relays

Prepared by
J. F. Gleason

Wyle Laboratories

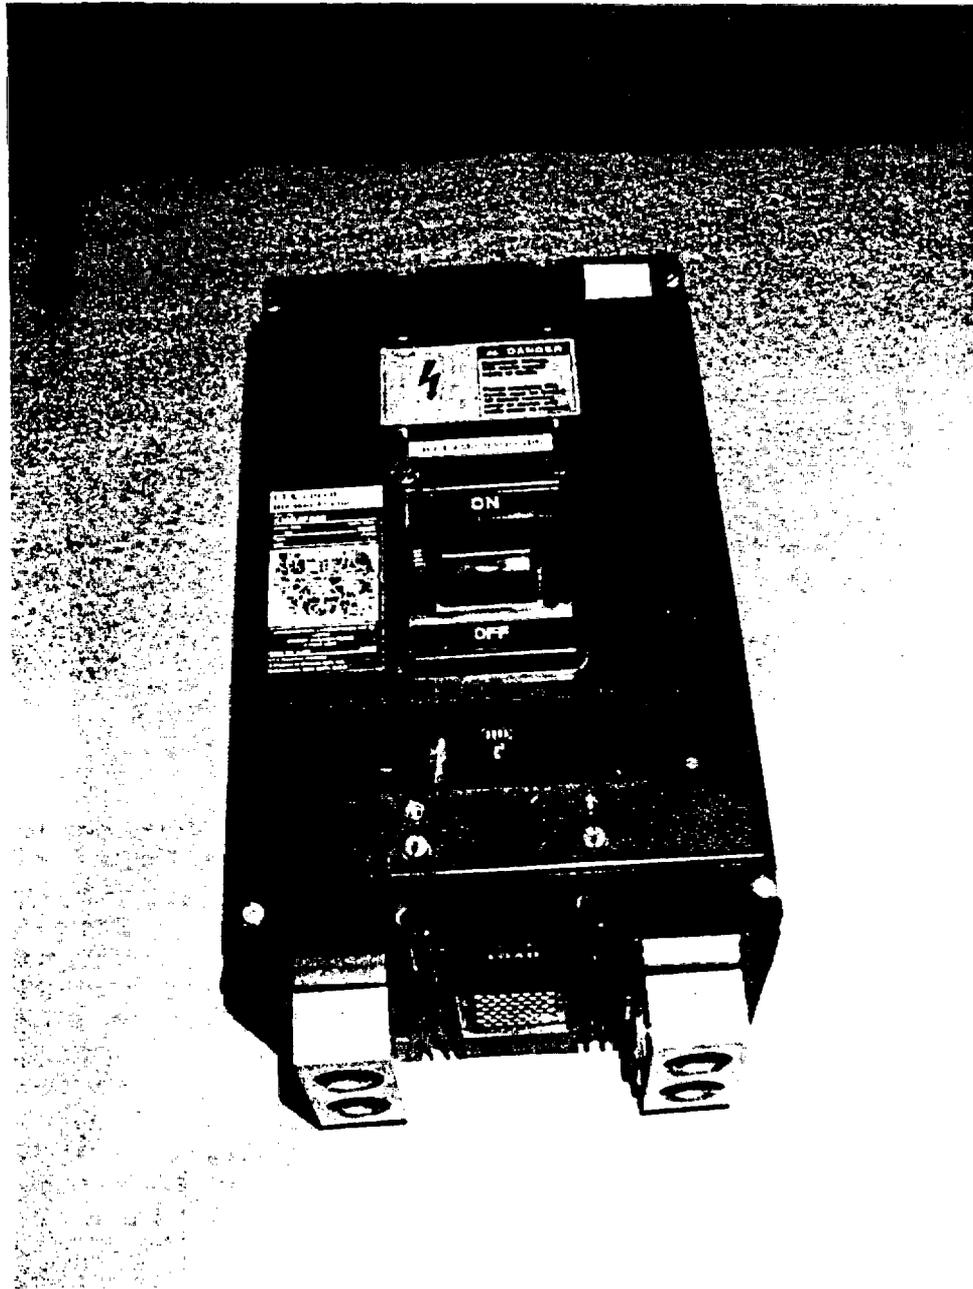
The pole resistance was measured in the as received condition for each specimen and after testing the other ISM methods. The highest resistances measured for the poles of each circuit breaker were summarized in Figure 3-58 for the as received initial condition and for the post test condition. The pole resistance of one of the HFB breakers was 139 mohms and one of the poles of a 30 year breaker was 537 mohms. The pole resistance showed a trend towards increased resistance with age. Lack of operation appears to contribute to this increase in pole resistance since the initial values were higher than the value obtained after the ISM methods had been performed. Pole resistance in general did not correlate with problems noted in the other ISM techniques except for the temperatures noted on the 30 year breaker with high resistance.

**Figure 3-56. ITE KMB2F800, 800 Amp
Molded Case Circuit Breaker**

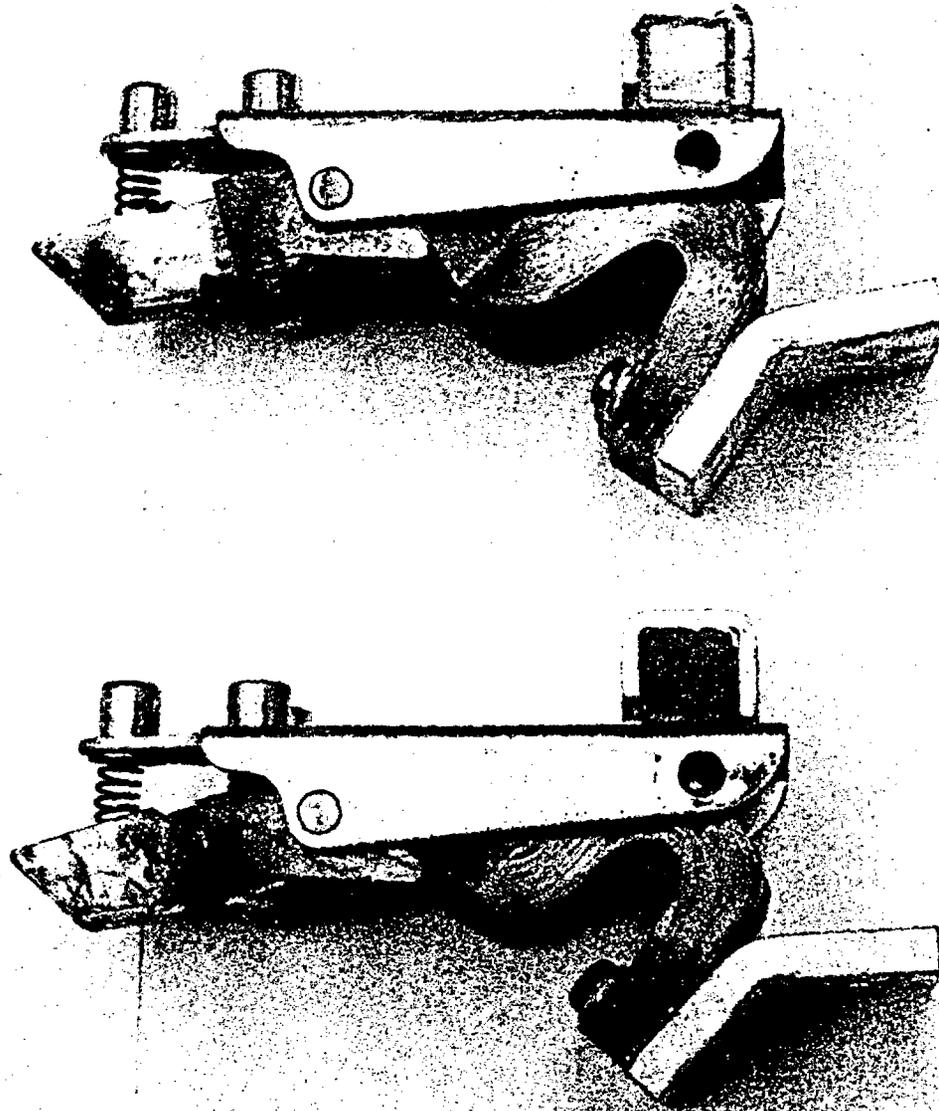
Figure 3-60. Thermal Trip Elements
of ITE KMB2F800 Molded Case Circuit Breaker
(Pole 1 on Bottom, Pole 2 on Top)

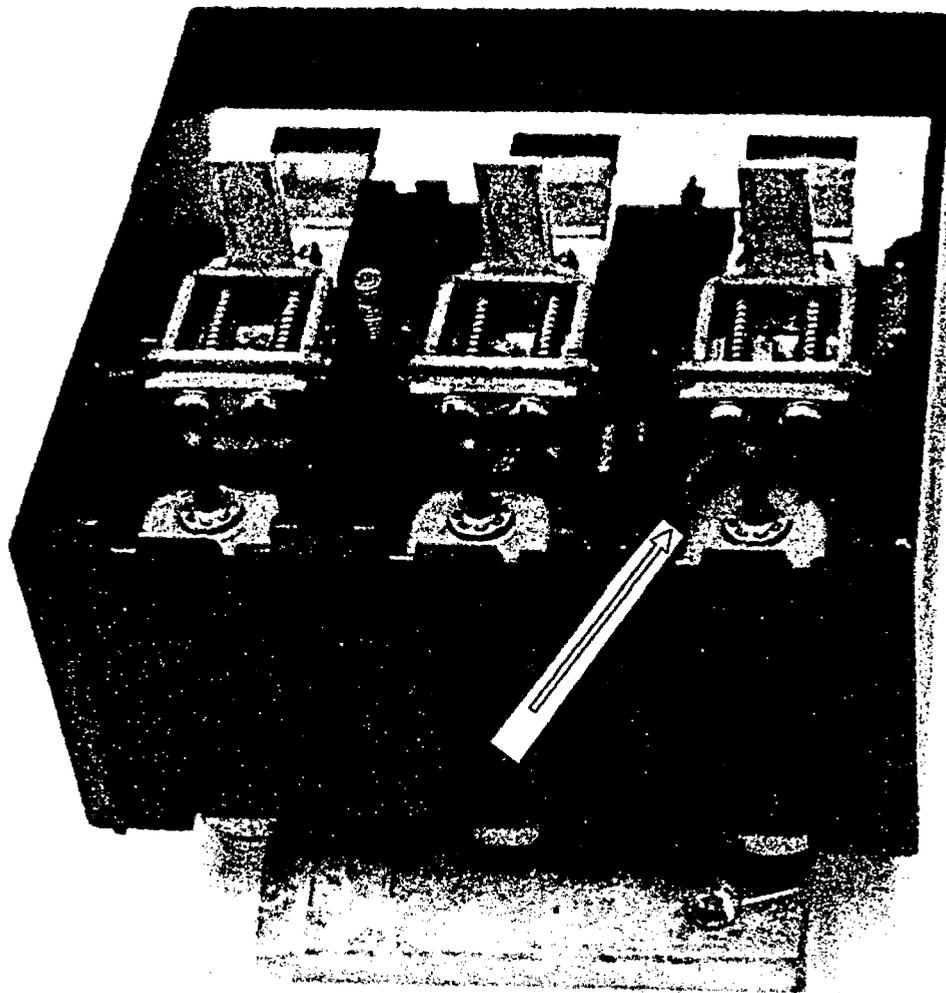
A root cause failure analysis of the Klockner-Moeller NZMH6-100 was performed. The root cause was also overheating. The overheating caused shrink tubing on all three poles to shrink further and interfere with the thermal element. The shrink tubing was located in the thermal and magnetic trip assembly in the base of the molded case circuit breaker. On pole number 1, the shrink

Figure 3-61. Root Cause Failure Analysis
of Thermal and Magnetic Trip Assembly of
Klockner-Moeller NZMH6-100 Molded Case Circuit Breaker,
Showing Heat Shrink Tubing

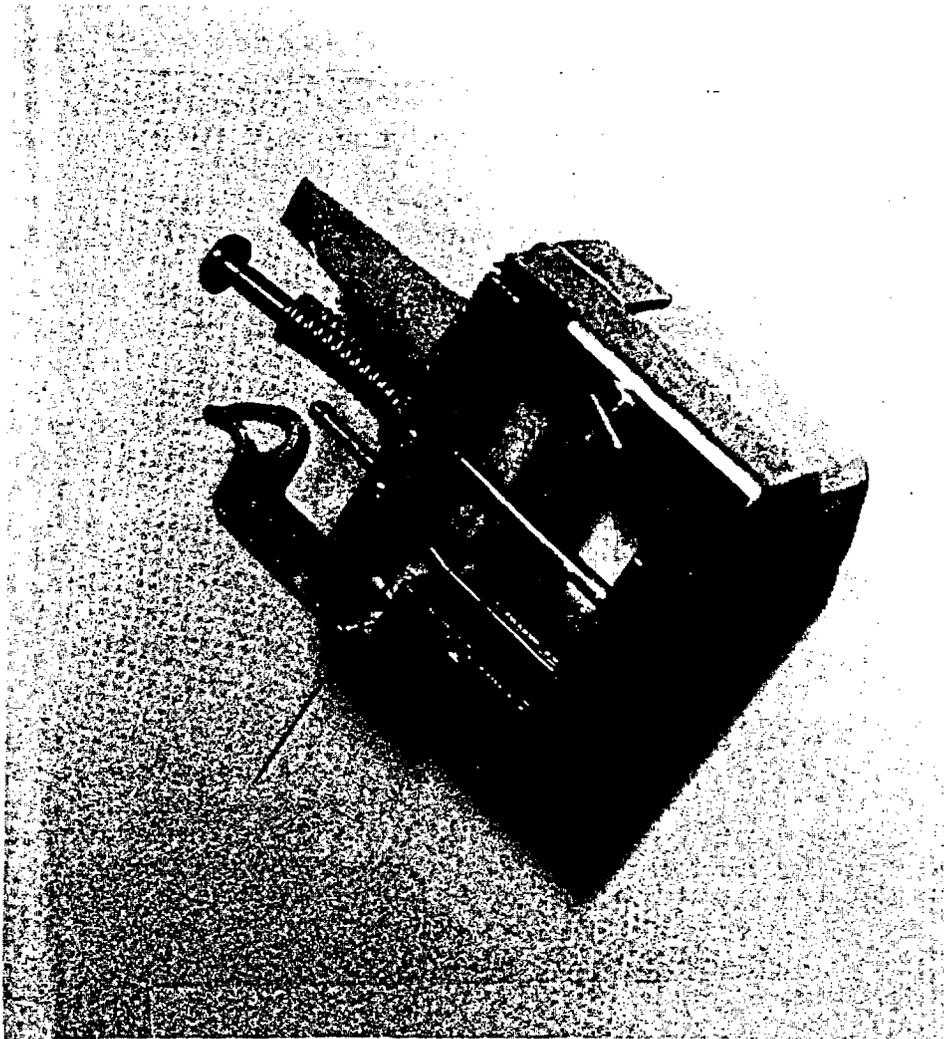
Figure 3-64. Root Cause Failure Analysis of Instantaneous Trip Plunger Assembly on Pole 2 of ITE KMB2F800 Molded Case Circuit Breaker, Showing Solidified Grease

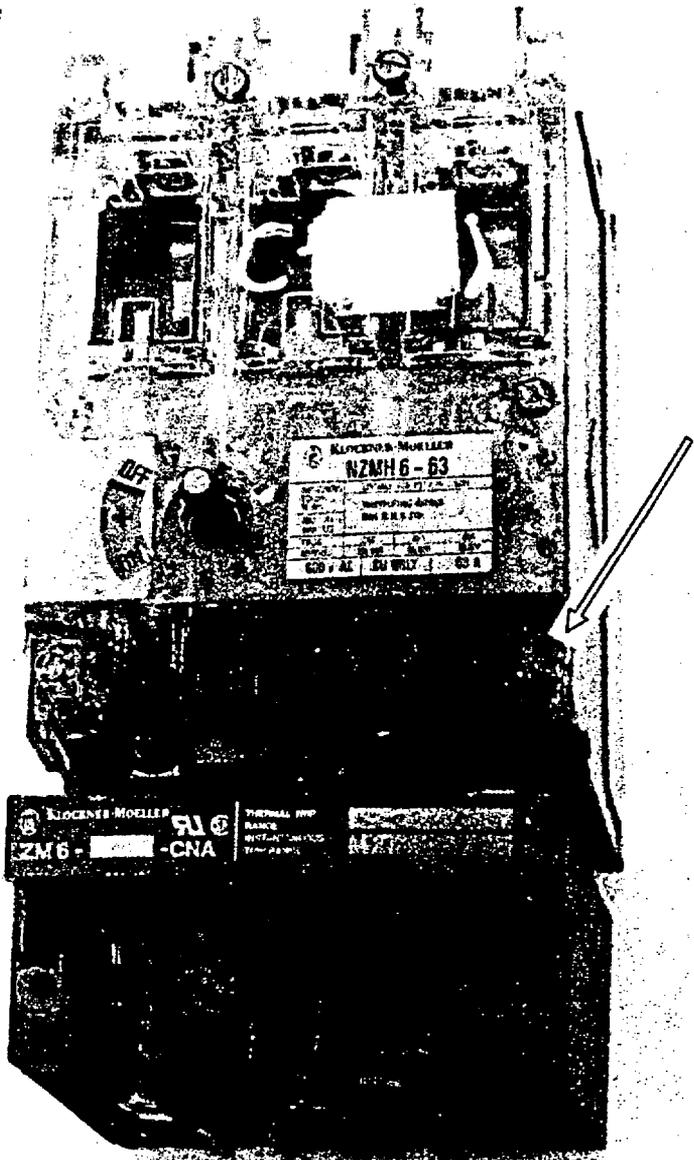
Figure 3-65. Melted Pole 3 of Klockner-Moeller NZMH6-40 Molded Case Circuit Breaker

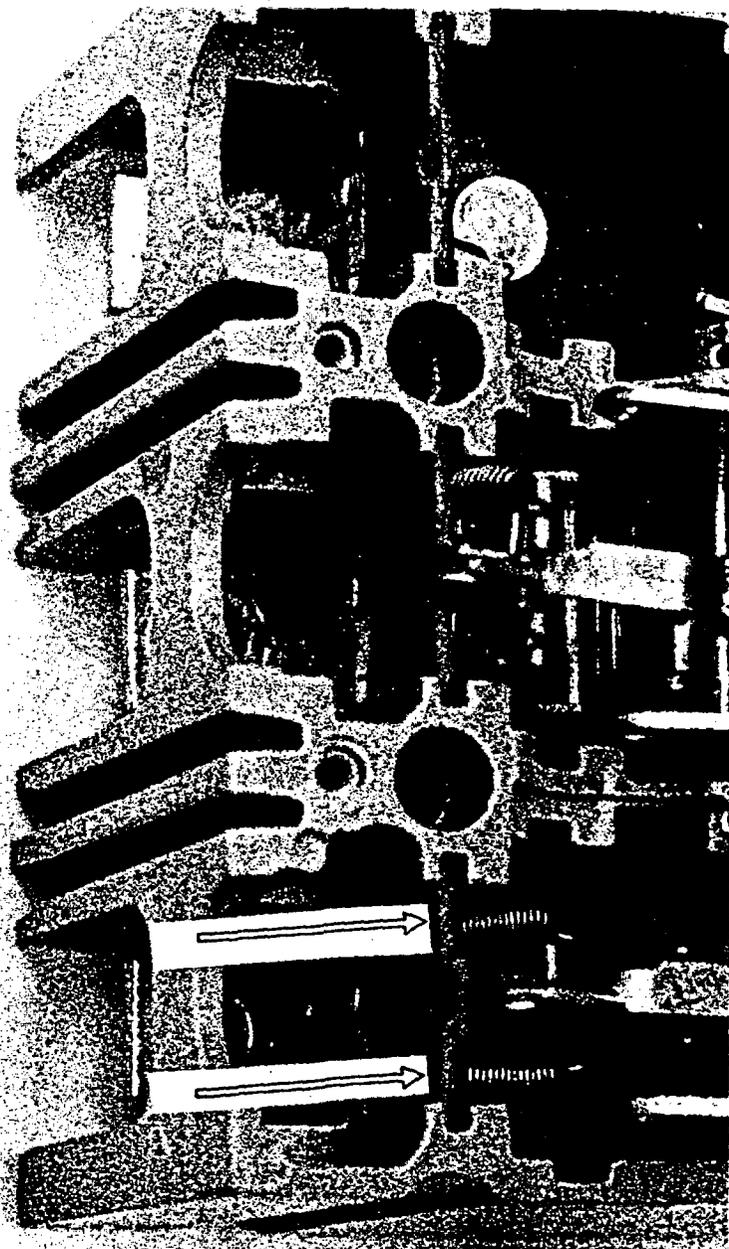
A root cause failure analysis of molded case circuit breaker Westinghouse HFB31550 was performed. The root cause was determined to be a missing spring on pole 1 of the instantaneous trip mechanism. The armature in the instantaneous trip assembly for each pole normally contains two springs, Figure 3-67. Only one spring was found on the armature of pole 1. With only one spring, the armature assembly was twisted and higher current was required to trip the breaker. The root cause for the other breaker's out of specification condition was indeterminate.

Figure 3-67. Typical Two Springs on Pole 1 of a Westinghouse HFB 31550 Molded Case Circuit Breaker

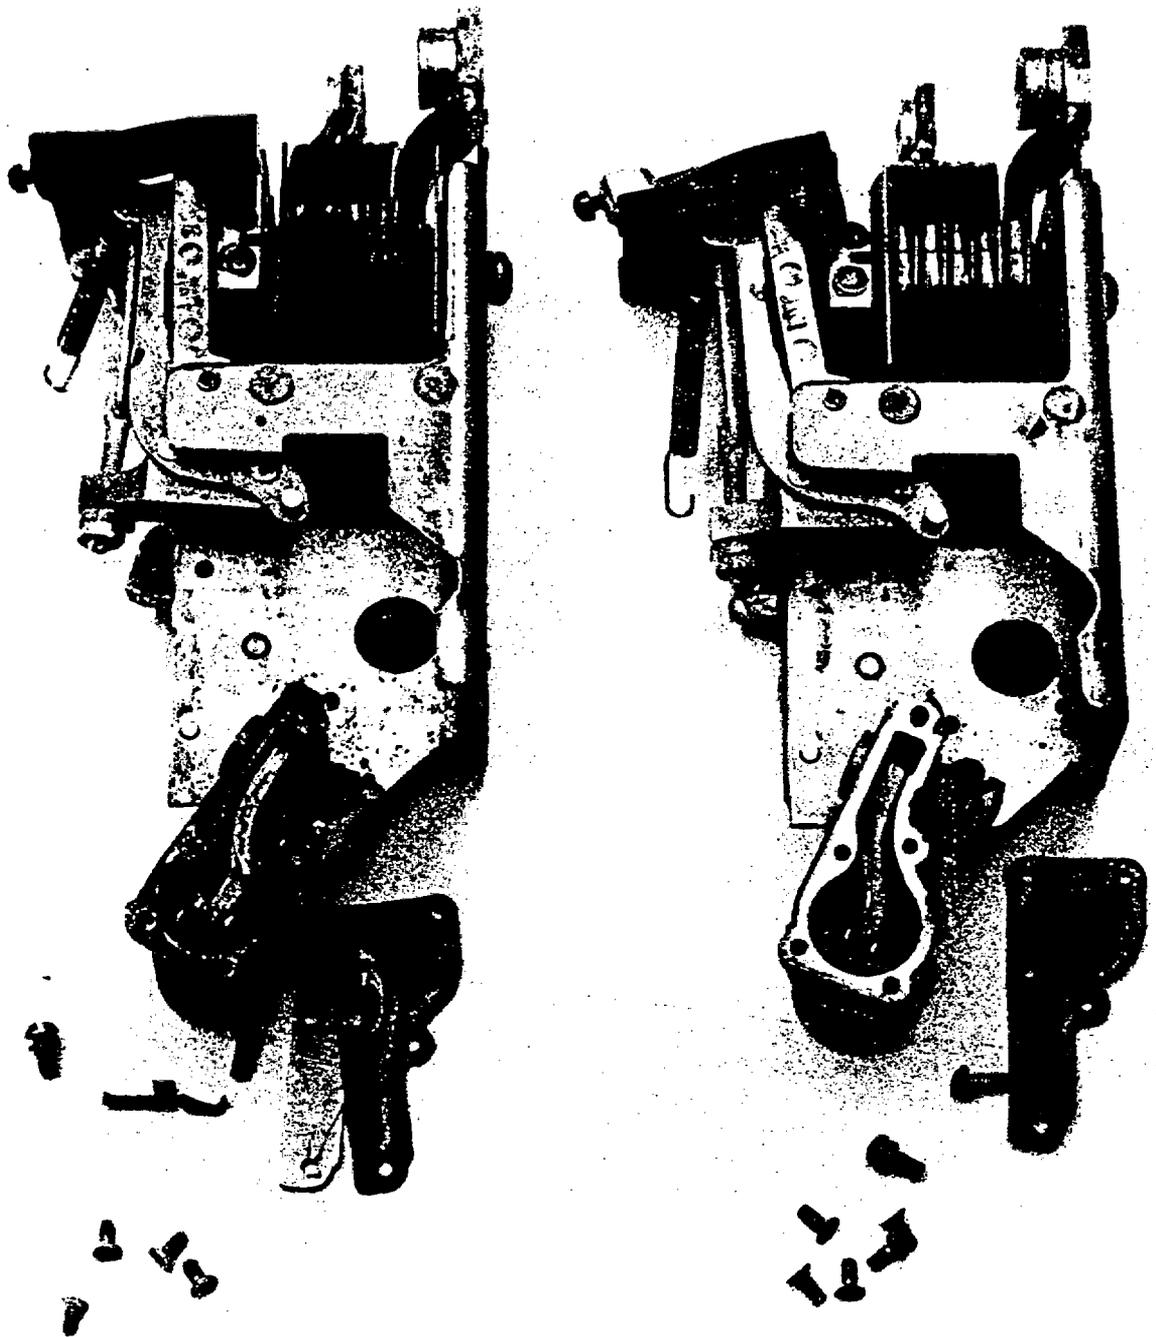
For the AK-2S-25-M breaker, one pole was tested for over 426 seconds and never tripped. Smoke was visible from the area around the arc chutes. The other pole tripped in 5.69 seconds while at rated current and therefore three times the setting was not attempted. The long time delay overcurrent function was accomplished by the EC-1 Series Overcurrent Tripping Device. Root cause failure analyses of the EC-1 tripping devices were performed to determine the cause for the significant differences in trip characteristics. The root cause of the failure to trip on long time delay was caused by binding in the dash pot. The dash pot was bound and the dash pot arm would not move. The dash pot was full of oil and appeared to have been overheated since the metal in contact with the gasket had discolored the seal area, Figure 3-69. Additionally, the coil insulation had been overheated as noted by its black color.

**Figure 3-69. General Electric EC-1 Series
Overcurrent Tripping Devices
(Left Device Failed to Trip;
Right Device had No Long Time Delay)**

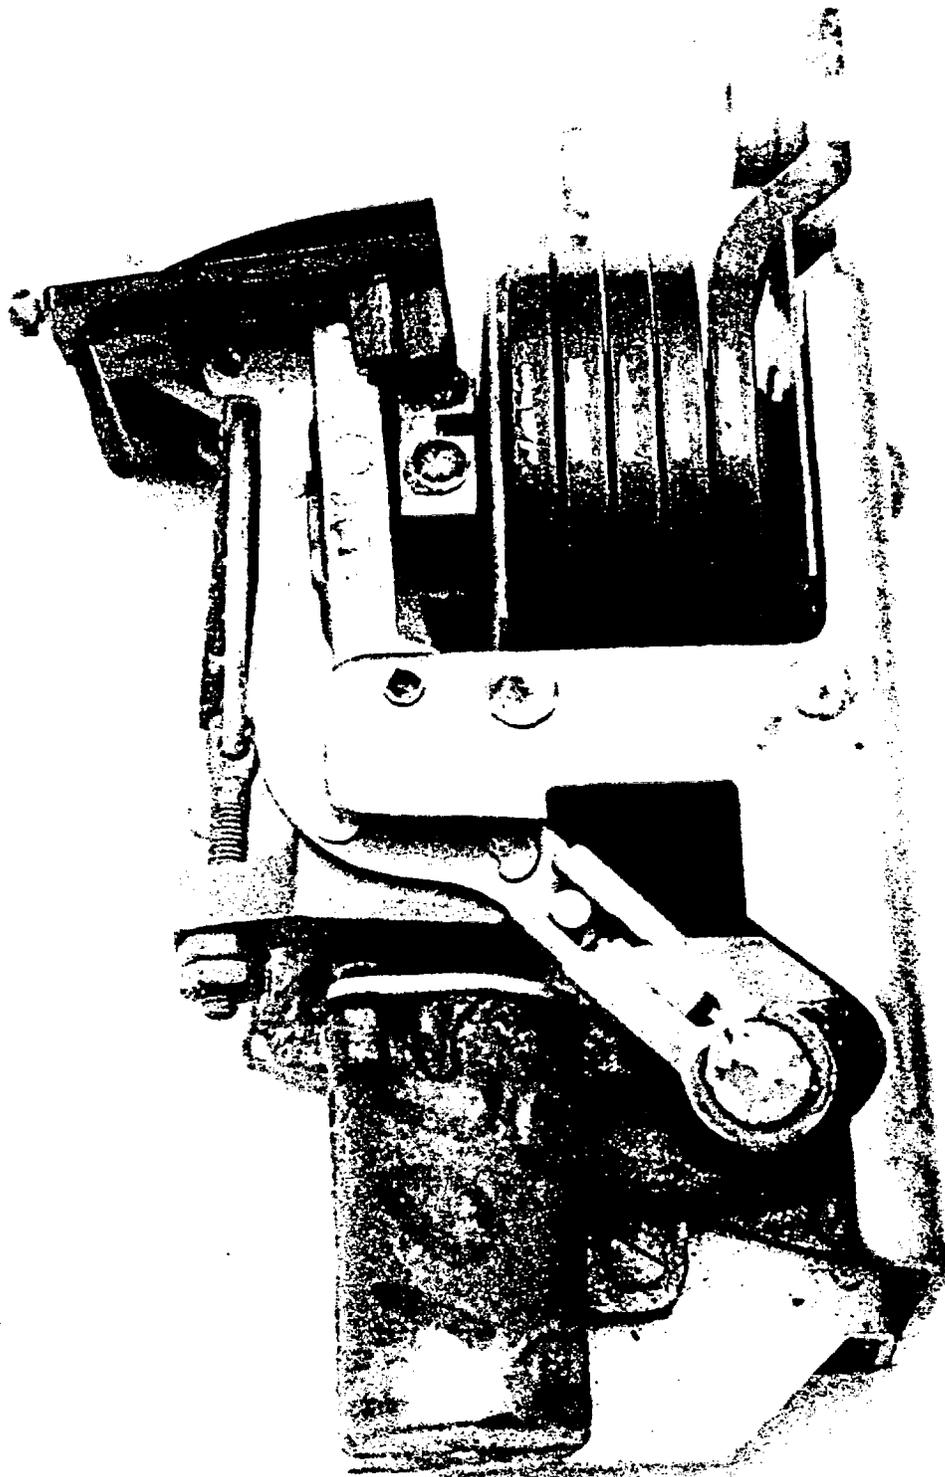
**Figure 3-70. General Electric EC-1 Series
Overcurrent Tripping Device
Note Evidence of Oil Leakage and Dirt on Side of Dashpot**

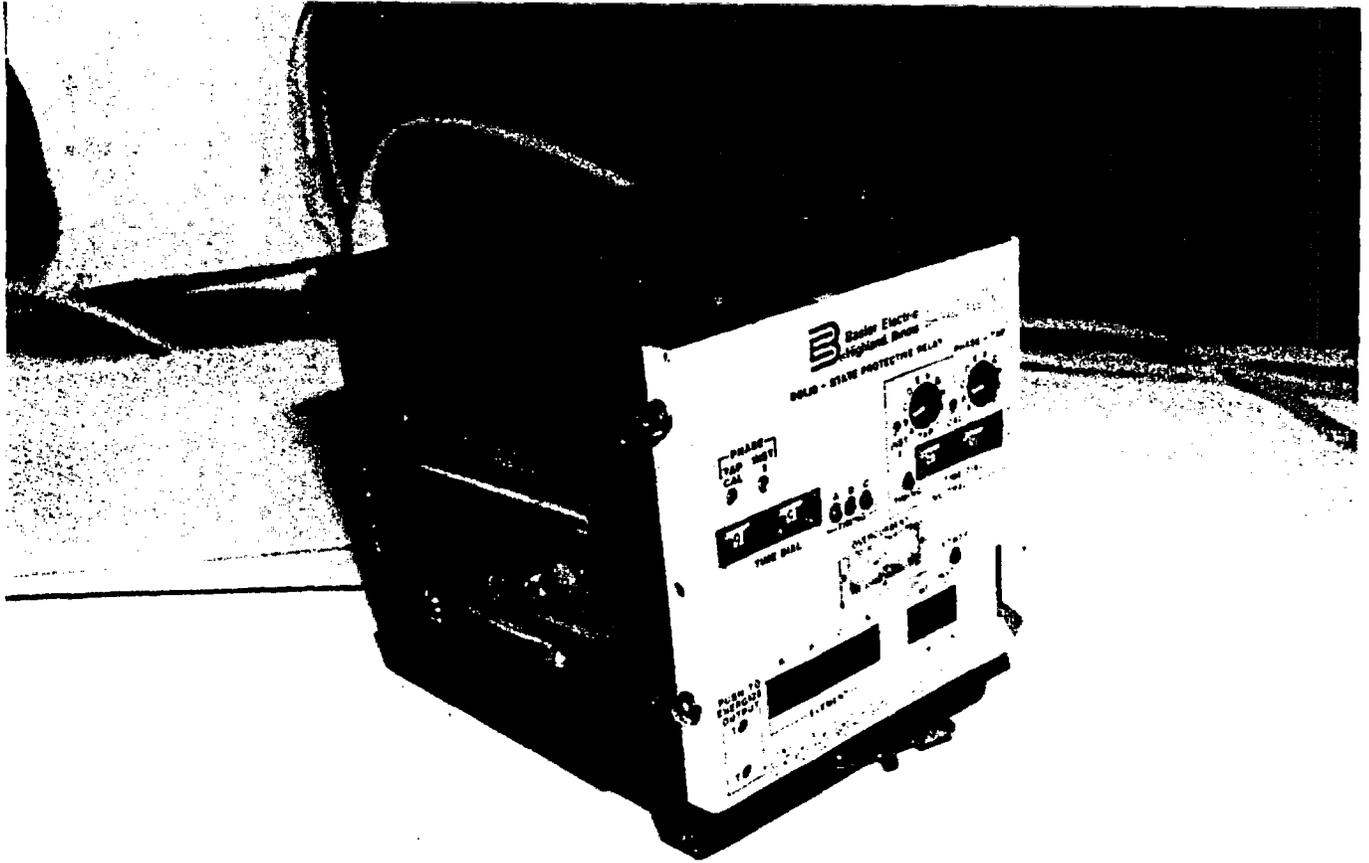
Figure 4-32. Basler Electronic Relay after Degraded Condition of Dirt Accumulation

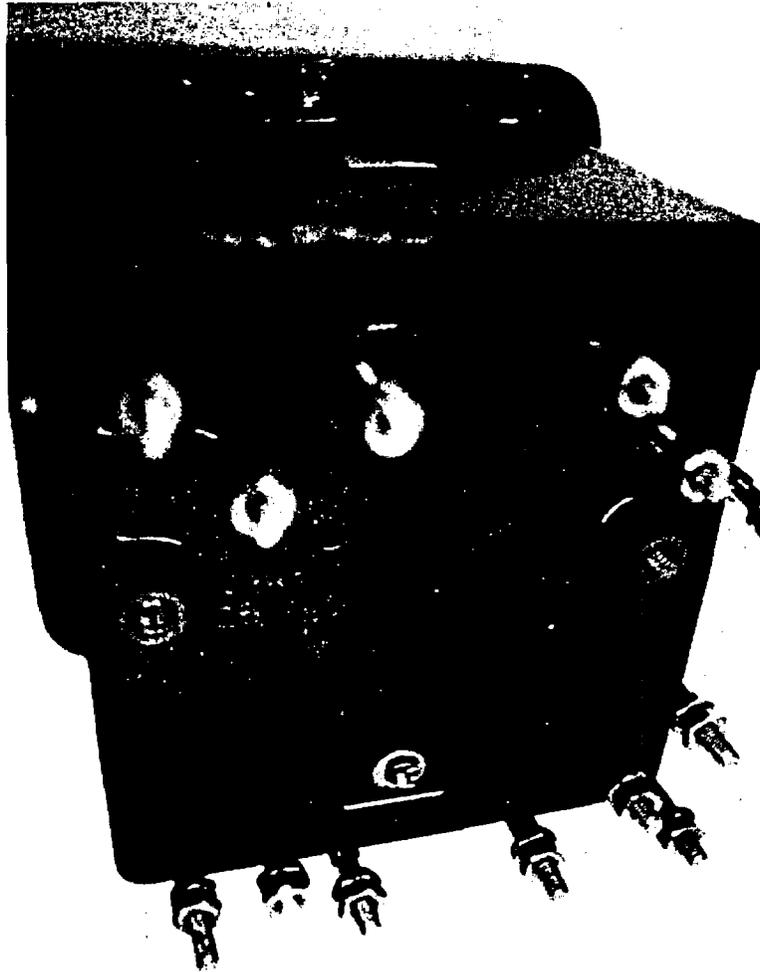
**Figure 4-36. Blistered Surface on
GE HFA Auxiliary Relay in
Overheated Degraded Condition**

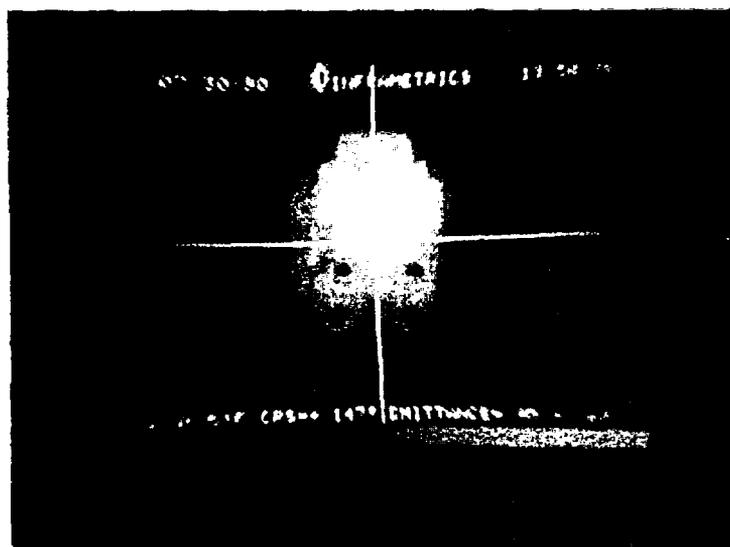
Figure 4-72. Infrared Scanning Thermograph of Timing Relay Showing Hot Spot During Overheated Degraded Condition
