**UNITED STATES
NUCLEAR REGULATORY COMMISSION
REGION II
SAM NUNN ATLANTA FEDERAL CENTER
61 FORSYTH STREET SW SUITE 23T85
ATLANTA, GEORGIA 30303-8931**

SUBJECT: NRC INSPECTION REPORT NO. 70-1151/2004-001

This refers to the inspection conducted on April 12-16, 2004, at the Columbia Nuclear Fuel Plant. The purpose of this inspection was to determine whether activities authorized by the licensee were conducted safely and in accordance with NRC requirements. At the conclusion of this inspection, the findings were discussed with those members of your staff identified in the enclosed report.

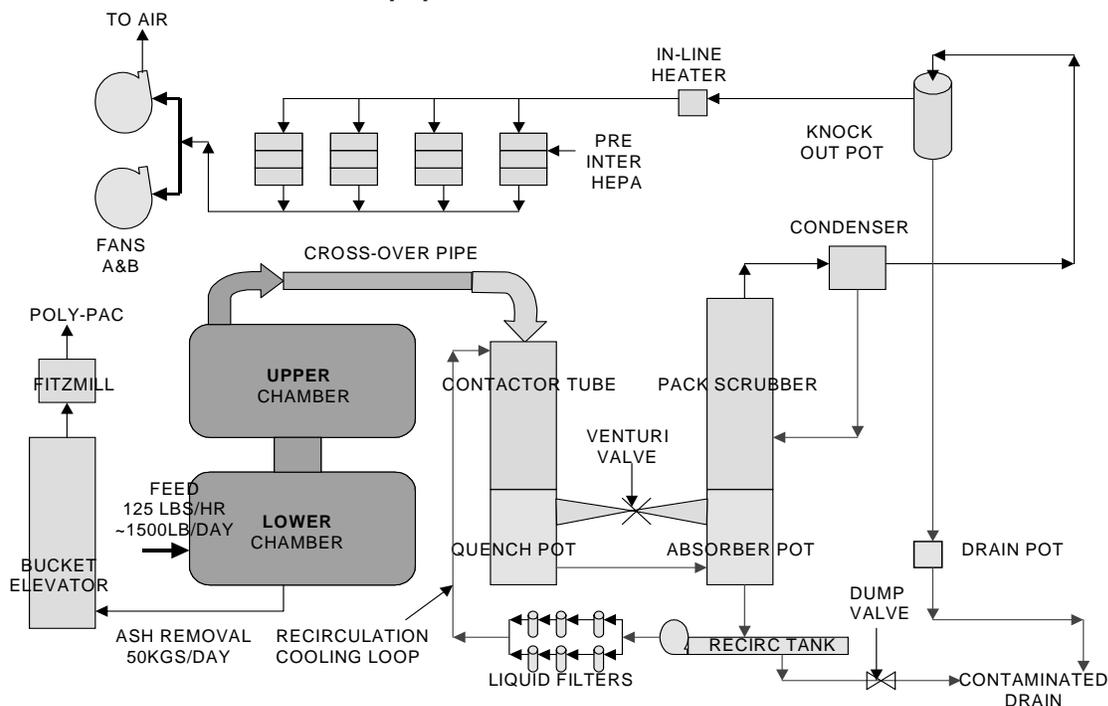
Figure 1

The incinerator lower combustion chamber operates at approximately 1000 degrees F and the upper combustion chamber operates at approximately 1300 degrees F. Off-gas cools several hundred degrees in the cross-over pipe and approaches the quench column at approximately 1000 degrees F where it is reduced to approximately 150 degrees F in the upper quench column contactor tube. Off-gas is directed through a condenser and knock-out pot to the final HEPA filter. Quench water is circulated through a filter and cooling loop and returned to the quench column contactor tube spray nozzles. Quench water is pH adjusted in the recirculation tank. City water at normal pressure is connected to the quench column to provide emergency cooling capacity to protect off-gas system components.

Westinghouse Incinerator Equipment and Process Flow
