RE: Permit to Mine No. 603
In Situ Uranium Wellfield Release Report

**Power Resources, Inc
Smith Ranch-Highland Uranium Project
URANIUM IN SITU WELLFIELD FLUID RELEASE REPORT**

PIPELINE FITTING FAILURE HEADERHOUSE 4-9 VALVE STATION

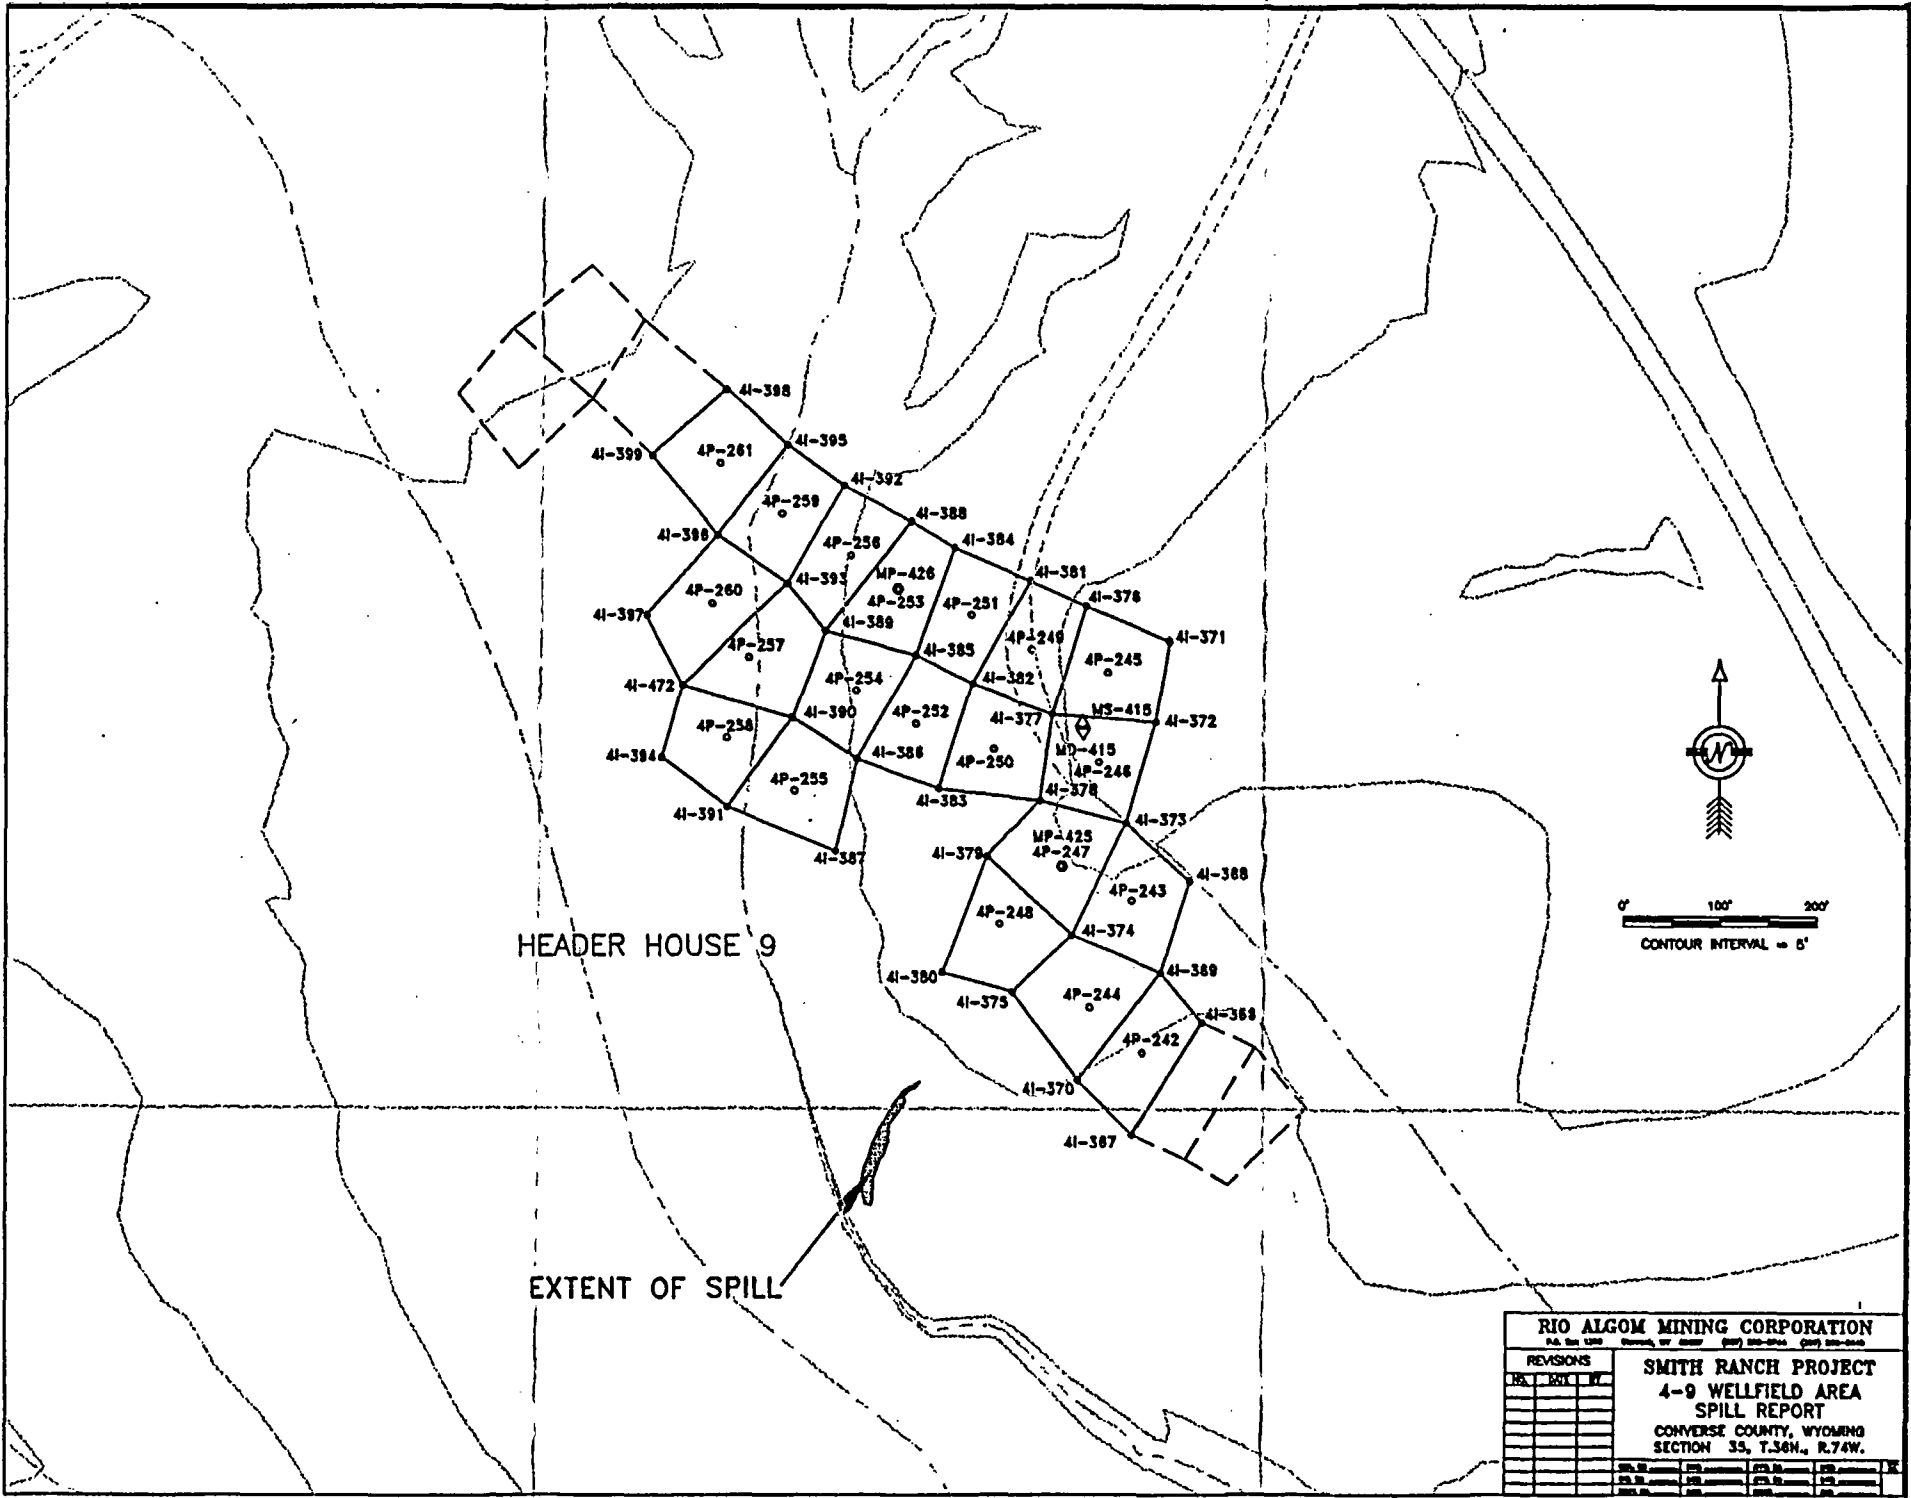
**4-9 WELLFIELD AREA
SPILL REPORT**
CONVERSE COUNTY, WYOMING
SECTION 35, T.56N., R.74W.

The release occurred in the SE ¼, SW ¼, Section 35, T36N, R74W and affected approximately 0.01 acres. The exact location and extent of the spill is shown on the attached map.

EXTENT OF SPILL
