Event # 40783

PART 21 NOTIFICATION - VALVE ACTUATOR SWITCH MECHANISMS

Re: Revised part 21 report

10CFR21 REPORT

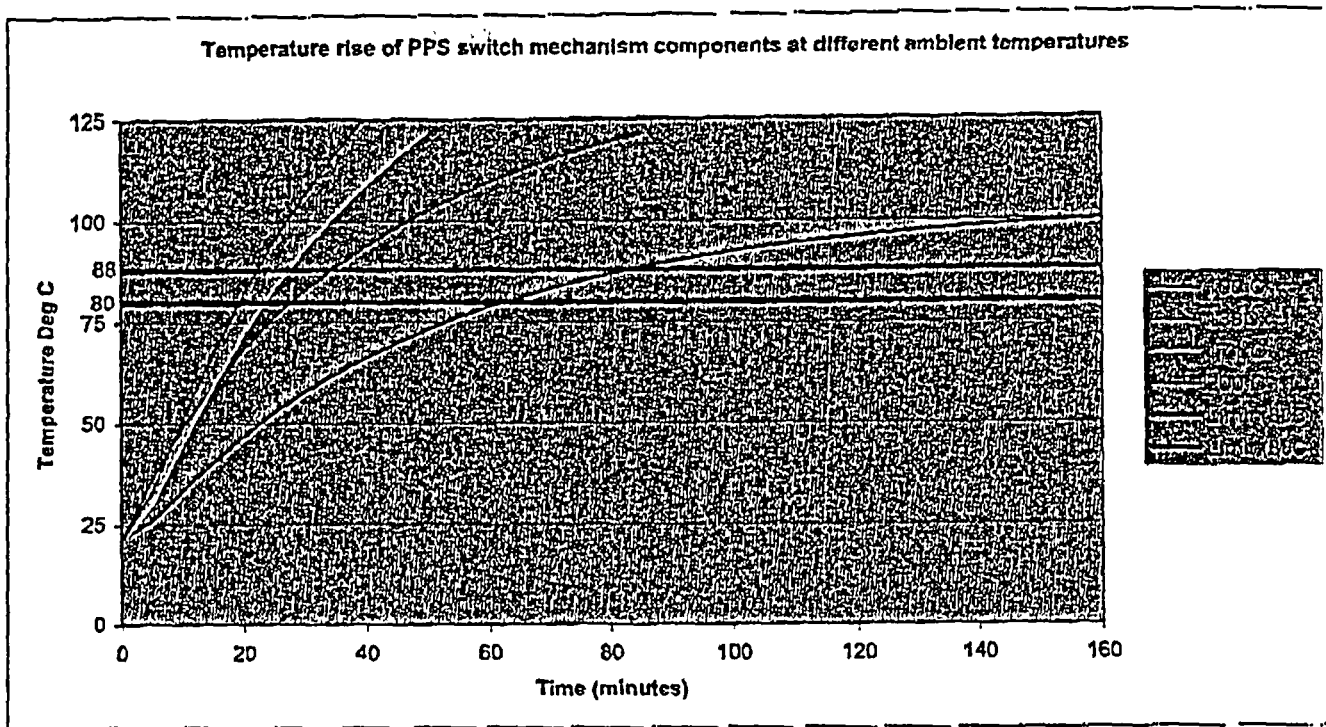
ATTACHMENT B

Attachment B provides a chart showing the approximate time delay from when the actuator is exposed to different ambient temperatures and the switchmechanism components exceeding 80°C (176°F). This should enable assessment of the temperature-time limits for individual site conditions.

The manufacturer's datasheet states that the critical temperature for PPS is *about* 88°C (190°F). This temperature is shown on the chart and in the table below for reference purposes.

As a result of extensive testing, Rotork can guarantee functionality providing the *switchmechanism components* do not exceed 80°C (176°F).

Ambient Temperature	Time to reach 80°C (176°F) in minutes	Time to reach 88°C (190°F) in minutes
100°C (212°F)	60	80
138°C (280°F)	23	30
171°C (340°F)	19	23
200°C (392°F)	14	17
