Event # 40783

## PART 21 NOTIFICATION - VALVE ACTUATOR SWITCH MECHANISMS

**PART 21 NOTIFICATION OF FAILURE OF SPRING CHARGING FUNCTION IN CIRCUIT BREAKER**

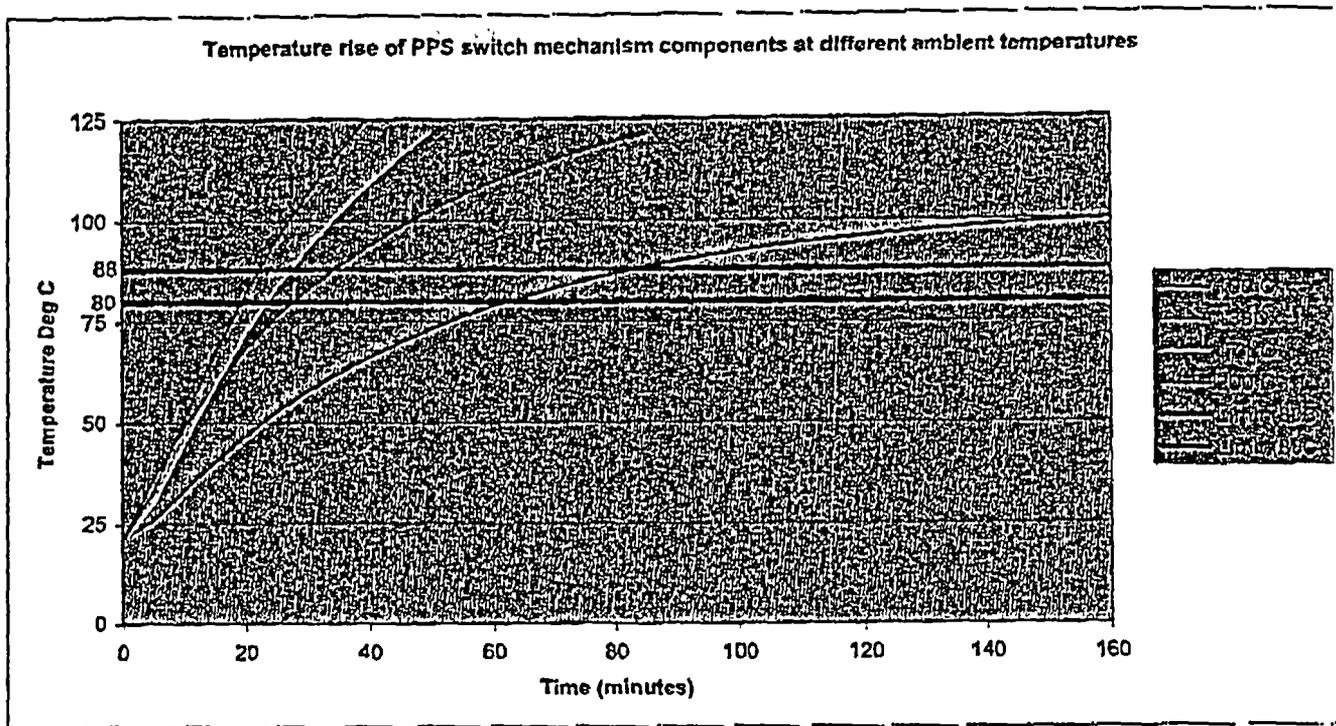
## ATTACHMENT B

*Attachment B provides a chart showing the approximate time delay from when the actuator is exposed to different ambient temperatures and the switchmechanism components exceeding 80°C (176°F). This should enable assessment of the temperature-time limits for individual site conditions.*

The manufacturer's datasheet states that the critical temperature for PPS is *about* 88°C (190°F). This temperature is shown on the chart and in the table below for reference purposes.

As a result of extensive testing, Rotork can guarantee functionality providing the *switchmechanism components* do not exceed 80°C (176°F).

Ambient Temperature	Time to reach 80°C (176°F) in minutes	Time to reach 88°C (190°F) in minutes
100°C (212°F)	60	80
138°C (280°F)	23	30
171°C (340°F)	19	23
200°C (392°F)	14	17
