STEAM GENERATOR PULLED TUBE EXAMINATION
Watts Bar Unit 1 – Cycle 5 RFO

FINAL REPORT

Prepared by
Westinghouse Electric Company LLC

Prepared for
Tennessee Valley Authority

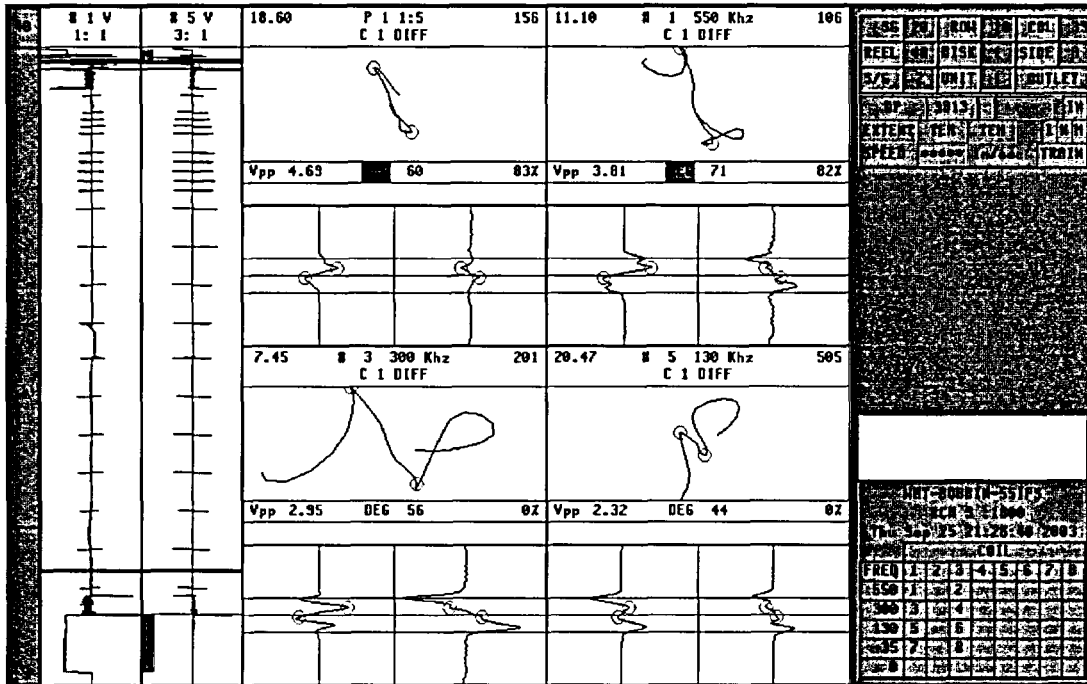
The eddy current response of the tube support crevice regions of R10C39 HL and R11C41 HL showed indications at H02 and H03, respectively. No other indications were identified in either the field or laboratory examinations. During the laboratory examination the locations of some of the support regions could be identified with the pancake coil through the presence of deposits and/or subtle material property variations; however, none of these responses indicated degradation. The TSP indications found in the field remained essentially unchanged in the laboratory. What differences exist may reflect differences in the calibration standards used or the details of the probe location within the tube, rather than a significant change in the degradation morphology. Circumferential indications were noted at the TTS of R11C41 HL in the field data analysis. In the laboratory data for tube R11C41 HL the TTS region was distorted by the tube removal process, increasing the amplitude of the indications.

Figure 4-1 Field bobbin coil response for the H02 tube support intersection of Watts Bar Unit 1 steam generator 2 tube R10 C39 HL, Piece 3. A distorted support indication was identified at this location

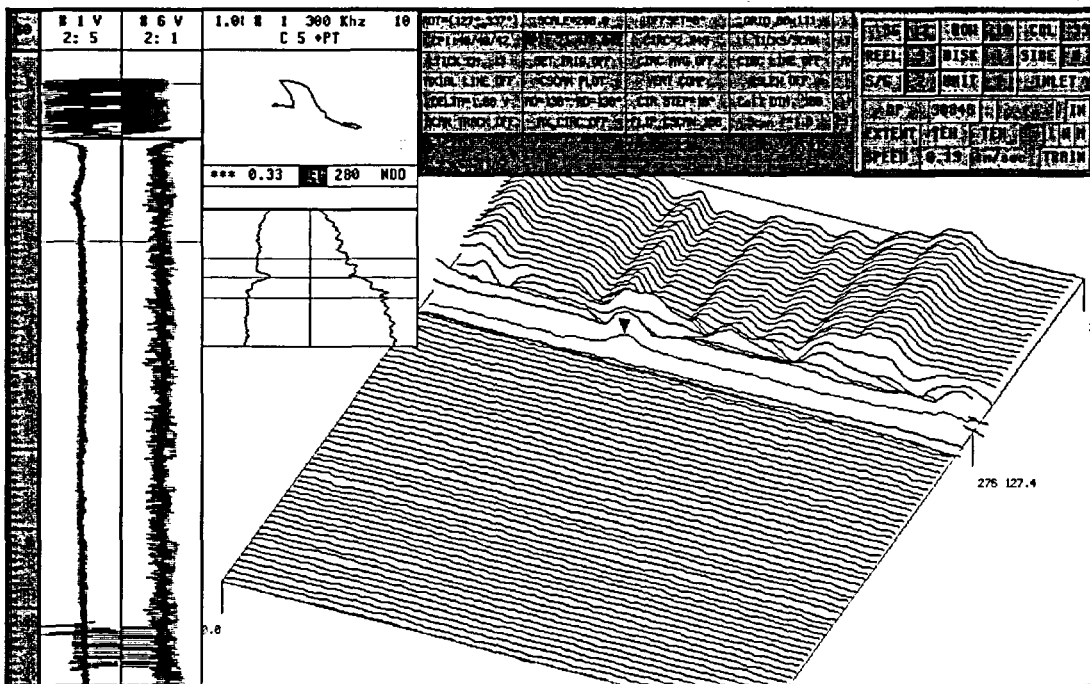
No indications were noted for the TTS region of tube R10C39 HL in the field inspections. Signal distortion likely caused by the tube removal operation was noted in the laboratory examination.

Figure 4-6 Laboratory +Pt response for the top of tube sheet (TTS) of Watts Bar Unit 1 steam generator 2 tube R10 C39 HL, Piece 2. No indication noted. The region was distorted by the tube removal operation.

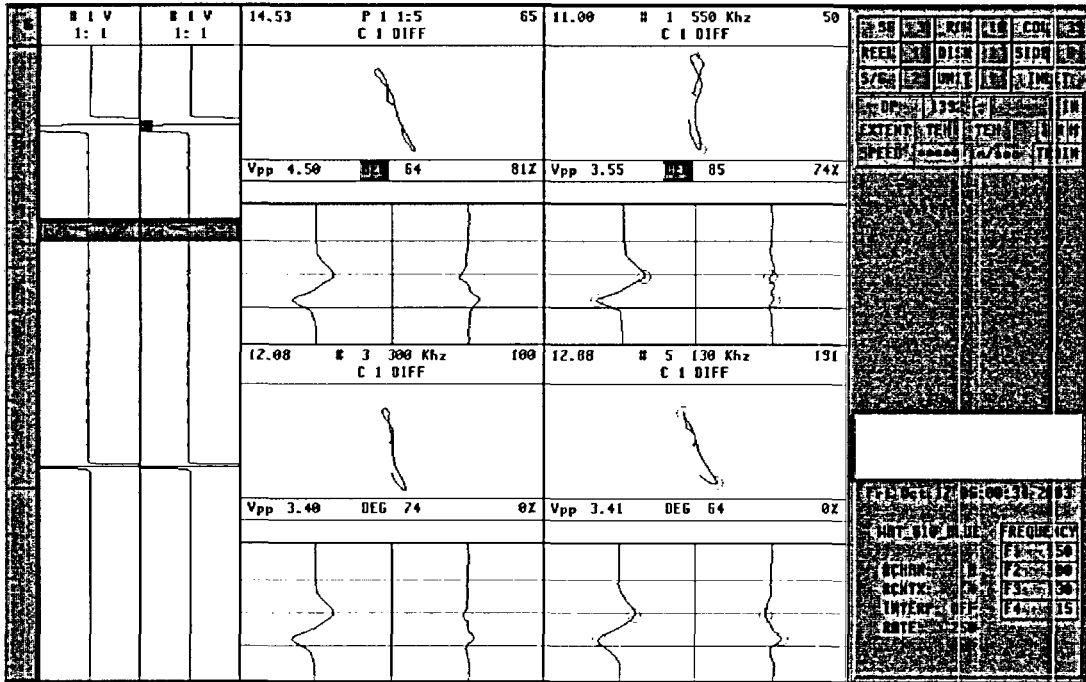
In the laboratory, both bobbin and +Pt probe examinations of the tube section were conducted. One bobbin coil indication (Figure 4-7) was found corresponding to the one found in the field located at H02. The amplitude was 4.5 volts with an apparent depth of 81%. Both these measurements are consistent with the field data.

Figure 4-7 Laboratory bobbin coil response for the H2O tube support intersection of Watts Bar Unit 1 steam generator 2 tube R10 C39 HL, Piece 3. A distorted support indication was identified at this location.

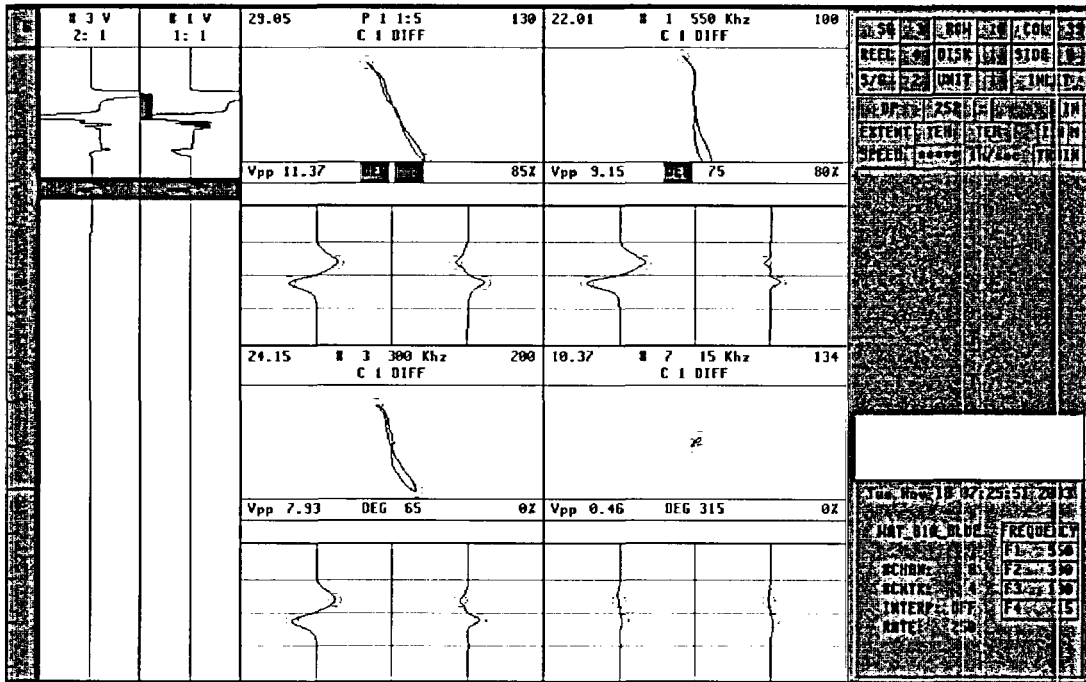
Two of the tube pieces containing the support intersection with indications, R10C39 HL Piece 3 and R11C41 HL Piece 4 were eddy current inspected after leak testing. In both cases the amplitude of the degradation response grew by more than a factor of 2 for the bobbin and +Pt coils. This indicates the rupture of ligaments during the test.

Figures 4-15 and 4-16 show the bobbin and +Pt coil response for the H02 region of R10C39 HL (Piece 3B). No secondary indications appeared due to the deformation associated with the test conditions. Figures 4-17 and 4-18 show the bobbin and +Pt coil response for the H03 region of R11C41 HI (Piece 4B). The small indication adjacent to the main indication was less discernible as a separate indication after leak testing. This suggests that ligaments separating the degraded regions had been ruptured, causing the indications to blend together.

Figure 4-15 Laboratory bobbin coil response for the H02 tube support intersection of Watts Bar Unit 1 steam generator 2 tube R10 C39 Piece 3B after elevated temperature leak testing.

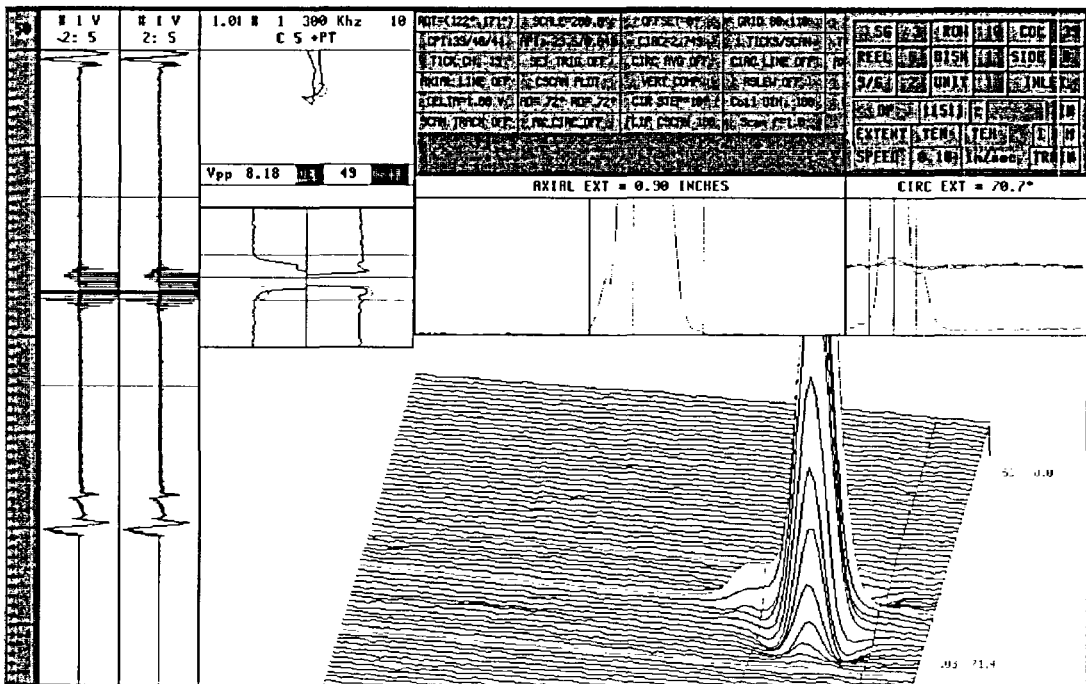
Figure 4-16 +Pt coil response for the H02 tube support intersection of Watts Bar Unit 1 steam generator 2 tube R10 C39 Piece 3B after elevated temperature leak testing.

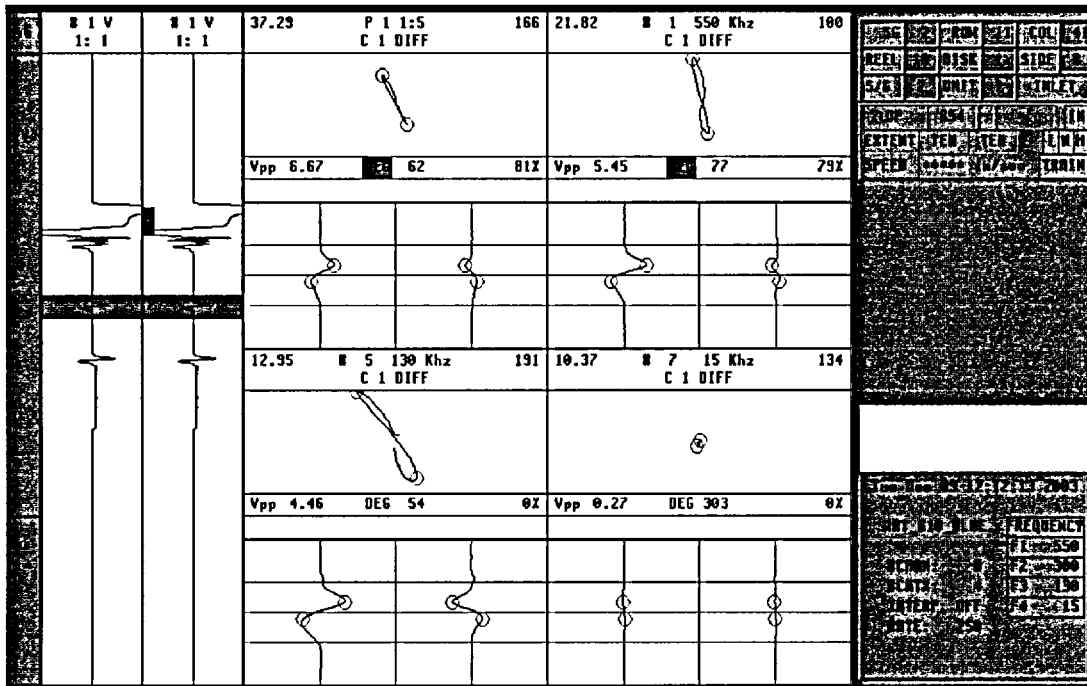
Figure 4-17 Laboratory bobbin coil response for the H03 tube support intersection of Watts Bar Unit 1 steam generator 2 tube R11C41 HL Piece 4B after elevated temperature leak testing.

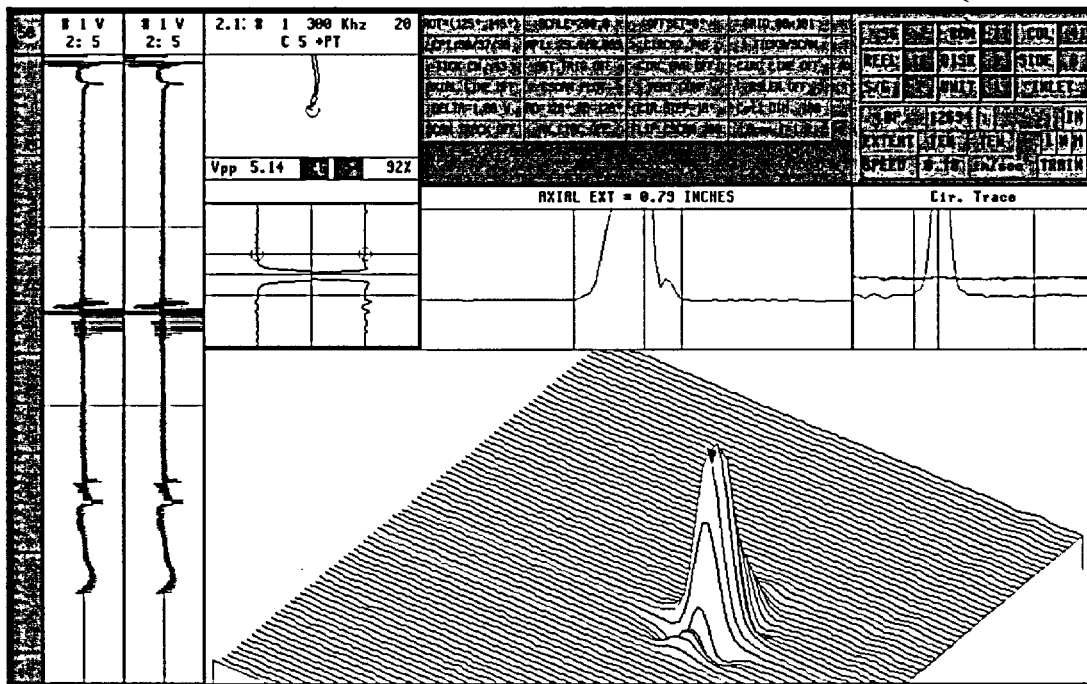
Figure 4-18 Laboratory +Pt coil response for the H03 tube support intersection of Watts Bar Unit 1 steam generator 2 tube R11C41 HL Piece 4B after elevated temperature leak testing.
