**UNITED STATES
NUCLEAR REGULATORY
COMMISSION**

**MATERIALS DEGRADATION
DUE TO POWER UPRATE**

ANTHONY MCMURTRAY

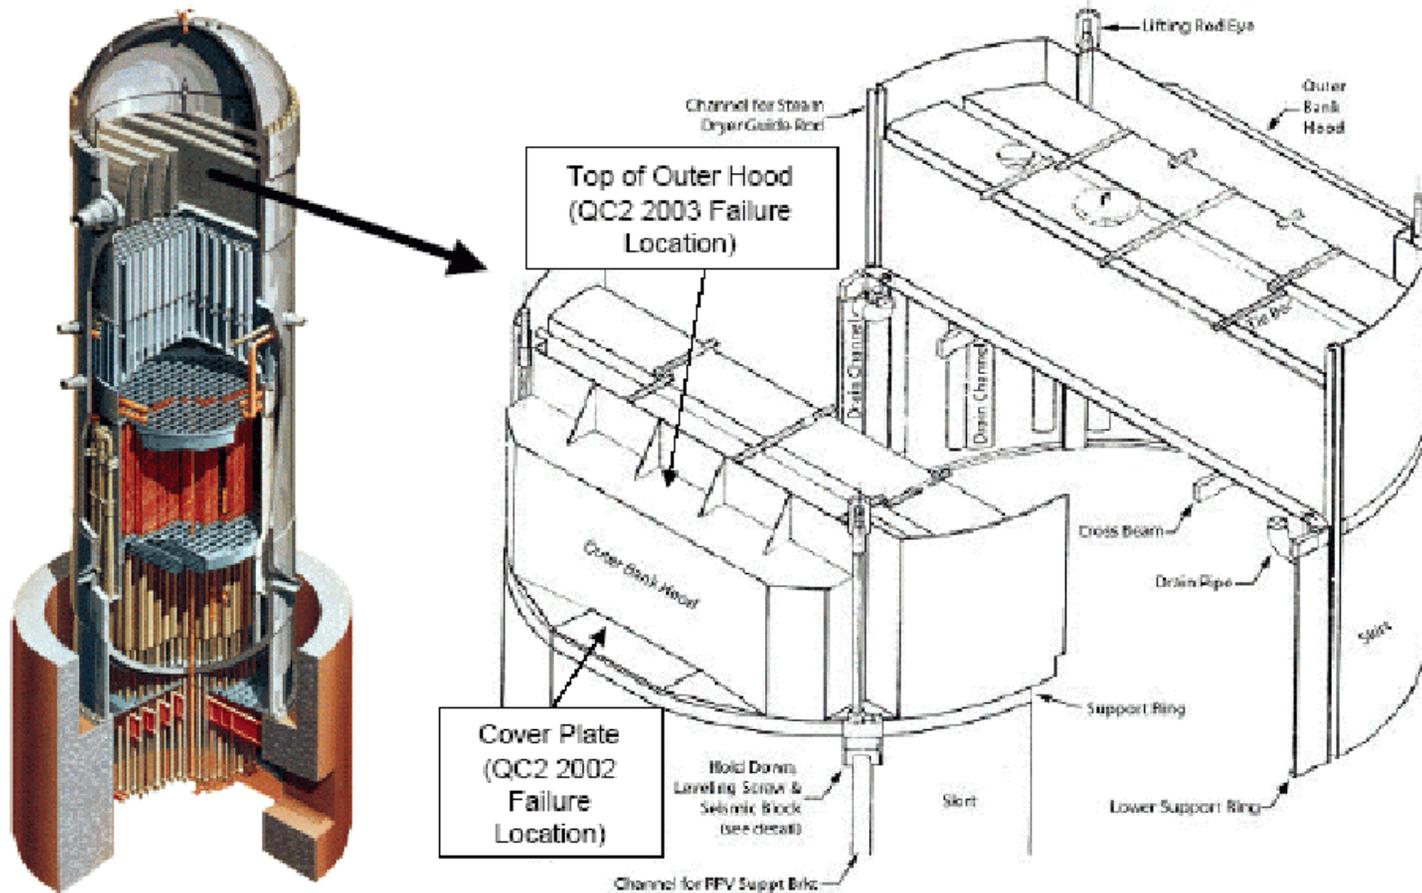
Quad Cities 2 Steam Dryer Failures 2002 and 2003

- **Quad Cities Unit 2 – June 2002:**
 - **After 90 days of extended power uprate (EPU) operation, steam dryer cover plate fails with pieces found on steam separators and in main steamline**

- **Quad Cities Unit 2 – June 2003:**
 - **After additional 300 days of EPU operation, steam dryer experiences failure of hood, internal braces, and tie bars**

- **July 2002 Quad Cities Unit 2 steam dryer cover plate:**
 - **High cycle fatigue due to high frequency resonance (180 Hz) as a result of alignment of cover plate natural frequency, standing acoustic wave frequency, and vortex shedding frequency**

- **July 2003 Quad Cities Unit 2 steam dryer hood:**
 - **High cycle fatigue due to low frequency pressure loading (0 – 50 Hz)**

- **July 2002:**
 - **Quad Cities Unit 2 steam dryer cover plate thickness increased from 0.64 cm. to 1.27 cm.**

- **July 2003:**
 - **Quad Cities Unit 2 steam dryer outer hood plates thickness increased from 1.27 cm. to 2.54 cm. with gussets installed and braces removed**

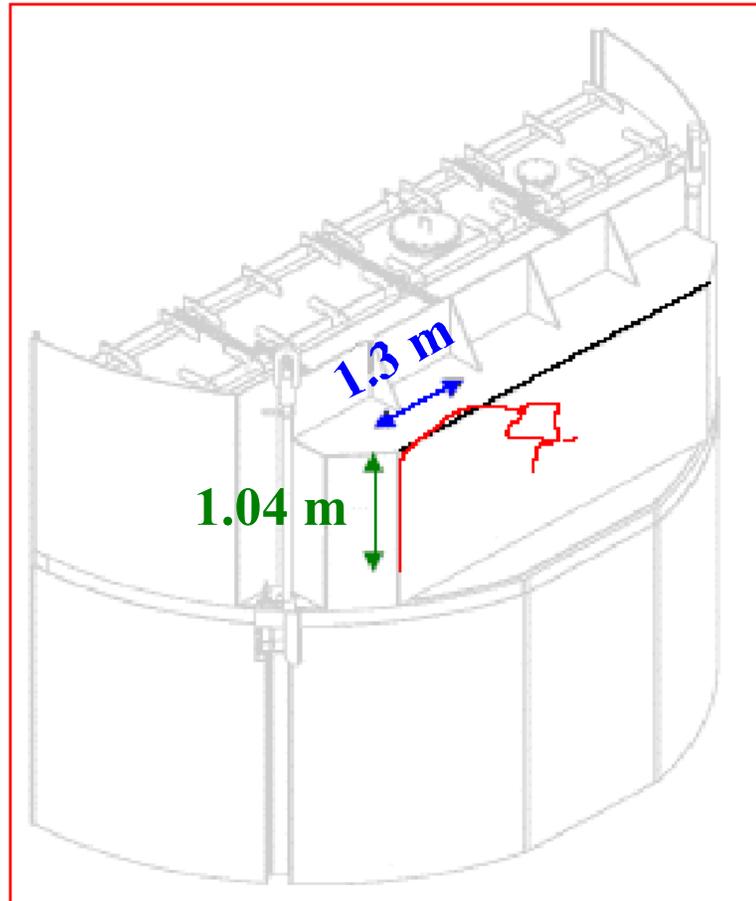
Quad Cities Unit 1 Steam Dryer Failure November 2003

- **Quad Cities Unit 1 - November 2003:**
 - **After approximately one year of EPU operation, significant cracking had occurred on the steam dryer hood and a 16.5X23 centimeter piece of the outer bank vertical plate was missing**
 - **The pilot vent line on a main steam electromatic relief valve (ERV) was sheared off from the pilot assembly and the solenoid actuator for the ERV was significantly damaged. Damage was also discovered on the main steam line supports**

- **November 2003 Quad Cities Unit 1 steam dryer:**
 - **High cycle fatigue from fluctuating pressure loading with acoustics**

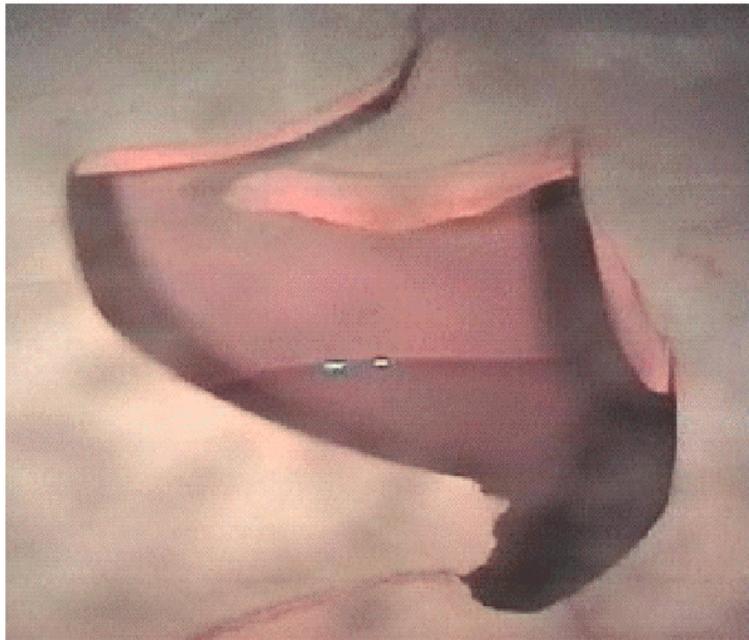
Quad Cities Unit 1 Steam Dryer Failure November 2003

**Missing portion of outer bank vertical plate,
approximately 16.5 cm. X 23 cm.**

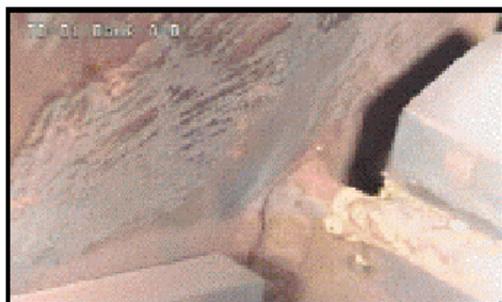
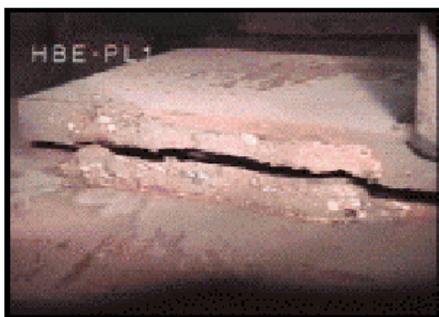
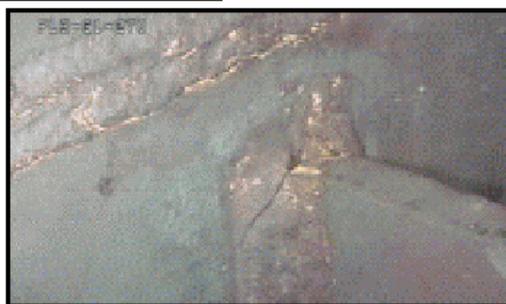
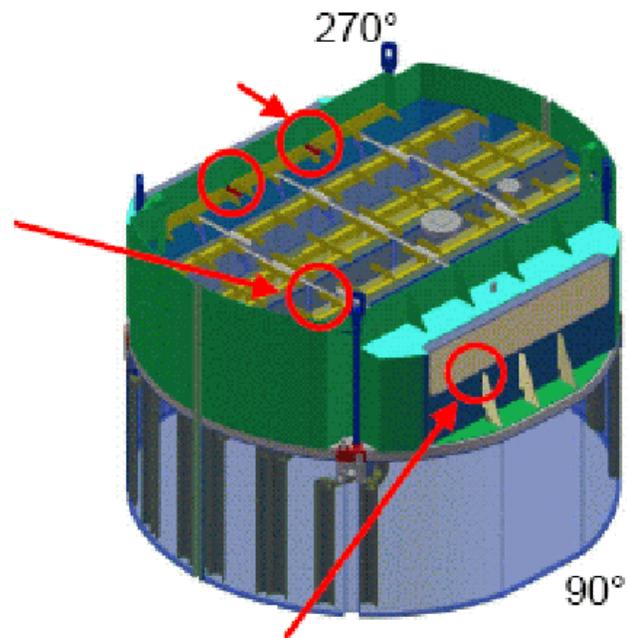
Quad Cities Unit 2 Steam Dryer Failure March 2004

- **Quad Cities Unit 2 – March 2004:**
 - **After approximately 8 months of EPU operation, numerous steam dryer indications were identified during a refueling outage inspection including:**
 - **Cracking near gussets installed in 2003,**
 - **Broken tie bar welds, and a**
 - **Damaged stiffener plate weld**
 - **Damage was identified in areas that had previously been repaired**
 - **A Target Rock safety relief valve tested 6.8% above the nominal safety lift setpoint**

- **March 2004 Quad Cities Unit 2 steam dryer:**
 - **Inadequate design of previous gusset repair, movement of high stress point during tie bar repair, and poor installation practice for stiffener plate**
