L-2004-125

Re: Turkey Point Units 3 and 4
Docket Nos. 50-250 and 50-251
Request for Additional Information -
Triennial Fire Protection Inspection

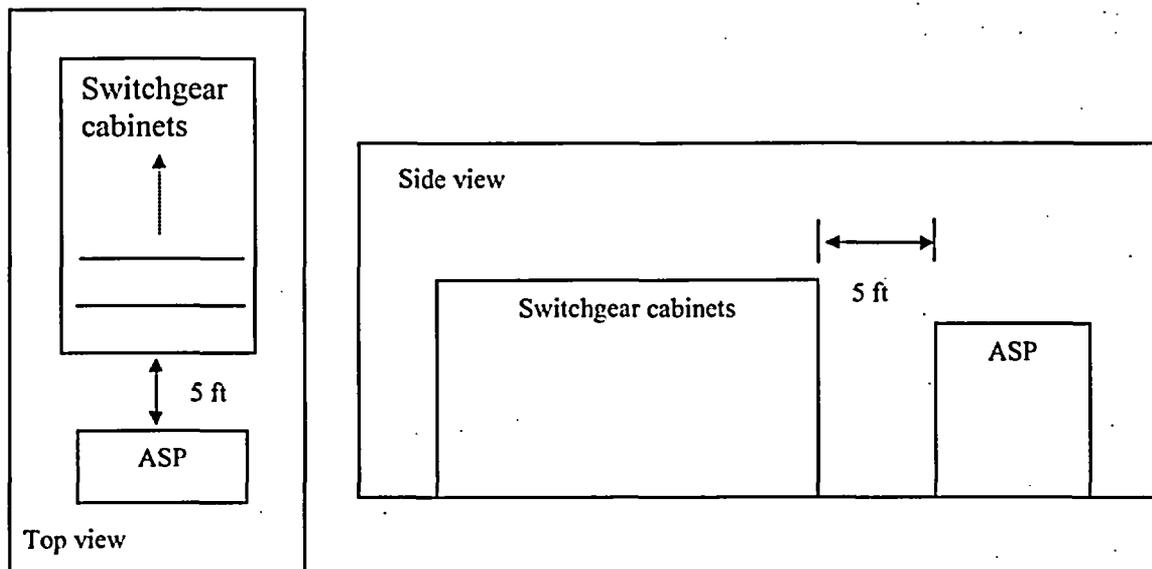
This section describes the thermal insult from a 4160 V switchgear fire to the auxiliary shutdown panel (ASP) located in the same switchgear room. The ASP faces the side-wall of the switchgear cabinet. Figure 1 illustrates the relative location of the ASP to the switchgear cabinet. The switchgear room is 73 ft x 18 ft x 23 ft high.

Figure 1: Relative location of the emergency switchgear room to auxiliary shutdown panel in the switchgear room.

A switchgear cabinet fire in the 4B switchgear room will not generate damaging conditions to the ASP. Specifically, two fire generated conditions could potentially damage the ASP. Those conditions are flame radiation, and smoke layer temperature. The fire modeling analysis described in this letter report indicates that no damage is expected.

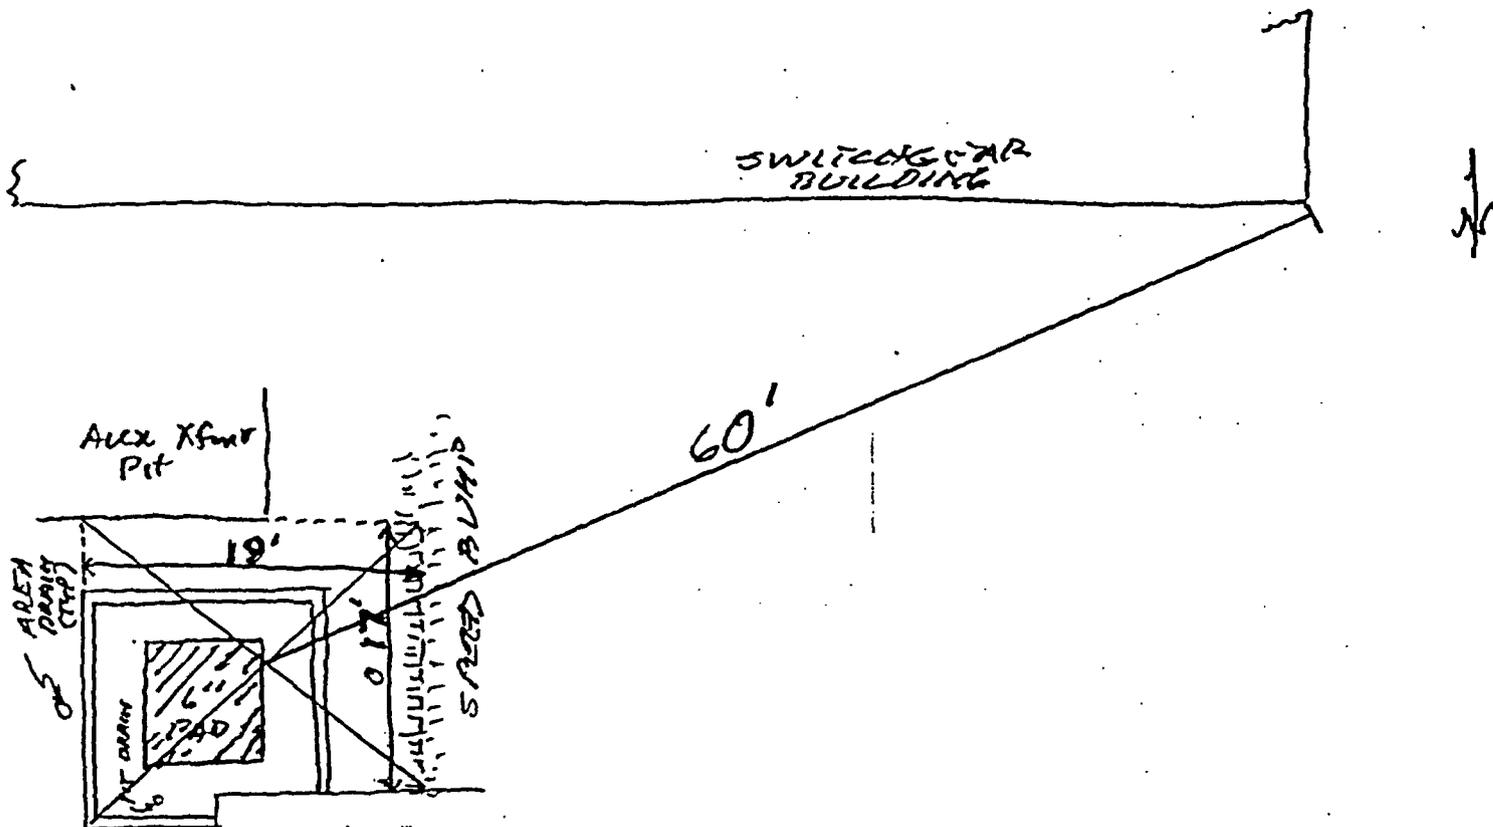
H₂ Seal Oil Units

A Night Order was issued for increased awareness, by Operators, of unusual heat sources in the areas of the hydrogen seal oil units. Also, a preliminary risk-significance assessment was performed assuming spillage from the hydrogen seal oil units is not contained by the curbs but overflows to the turbine building floor. An illustration of assumed oil pool spreading limits and relative distance to a vulnerable target (Train A cable) are illustrated. The NUREG-1805 spreadsheet for this condition is also provided and indicates screens below cable qualification limits prior to reaching the vulnerable cable. This assessment will be finalized via CR 04-0477.

Spread limits to Aux Xfour Pit and spread bump peak.
