**INTEROFFICE MEMORANDUM  
REGULATORY COMPLIANCE  
POTENTIALLY REPORTABLE OCCURRENCE REPORT**

**TO:** MIKE DESILETS, TECHNICAL SUPPORT MANAGER  
**FROM:** JIM DEVINCENTIS, MANAGER LICENSING *JM Devincenis*  
**SUBJECT:** CR-VTY-2004-0981 A PIECE OF SHOOT-OUT STEEL NOT INSTALLED  
**DATE:** APRIL 19, 2004  
**PRO NUMBER:** PRO-040981

**EVENT DESCRIPTION:**

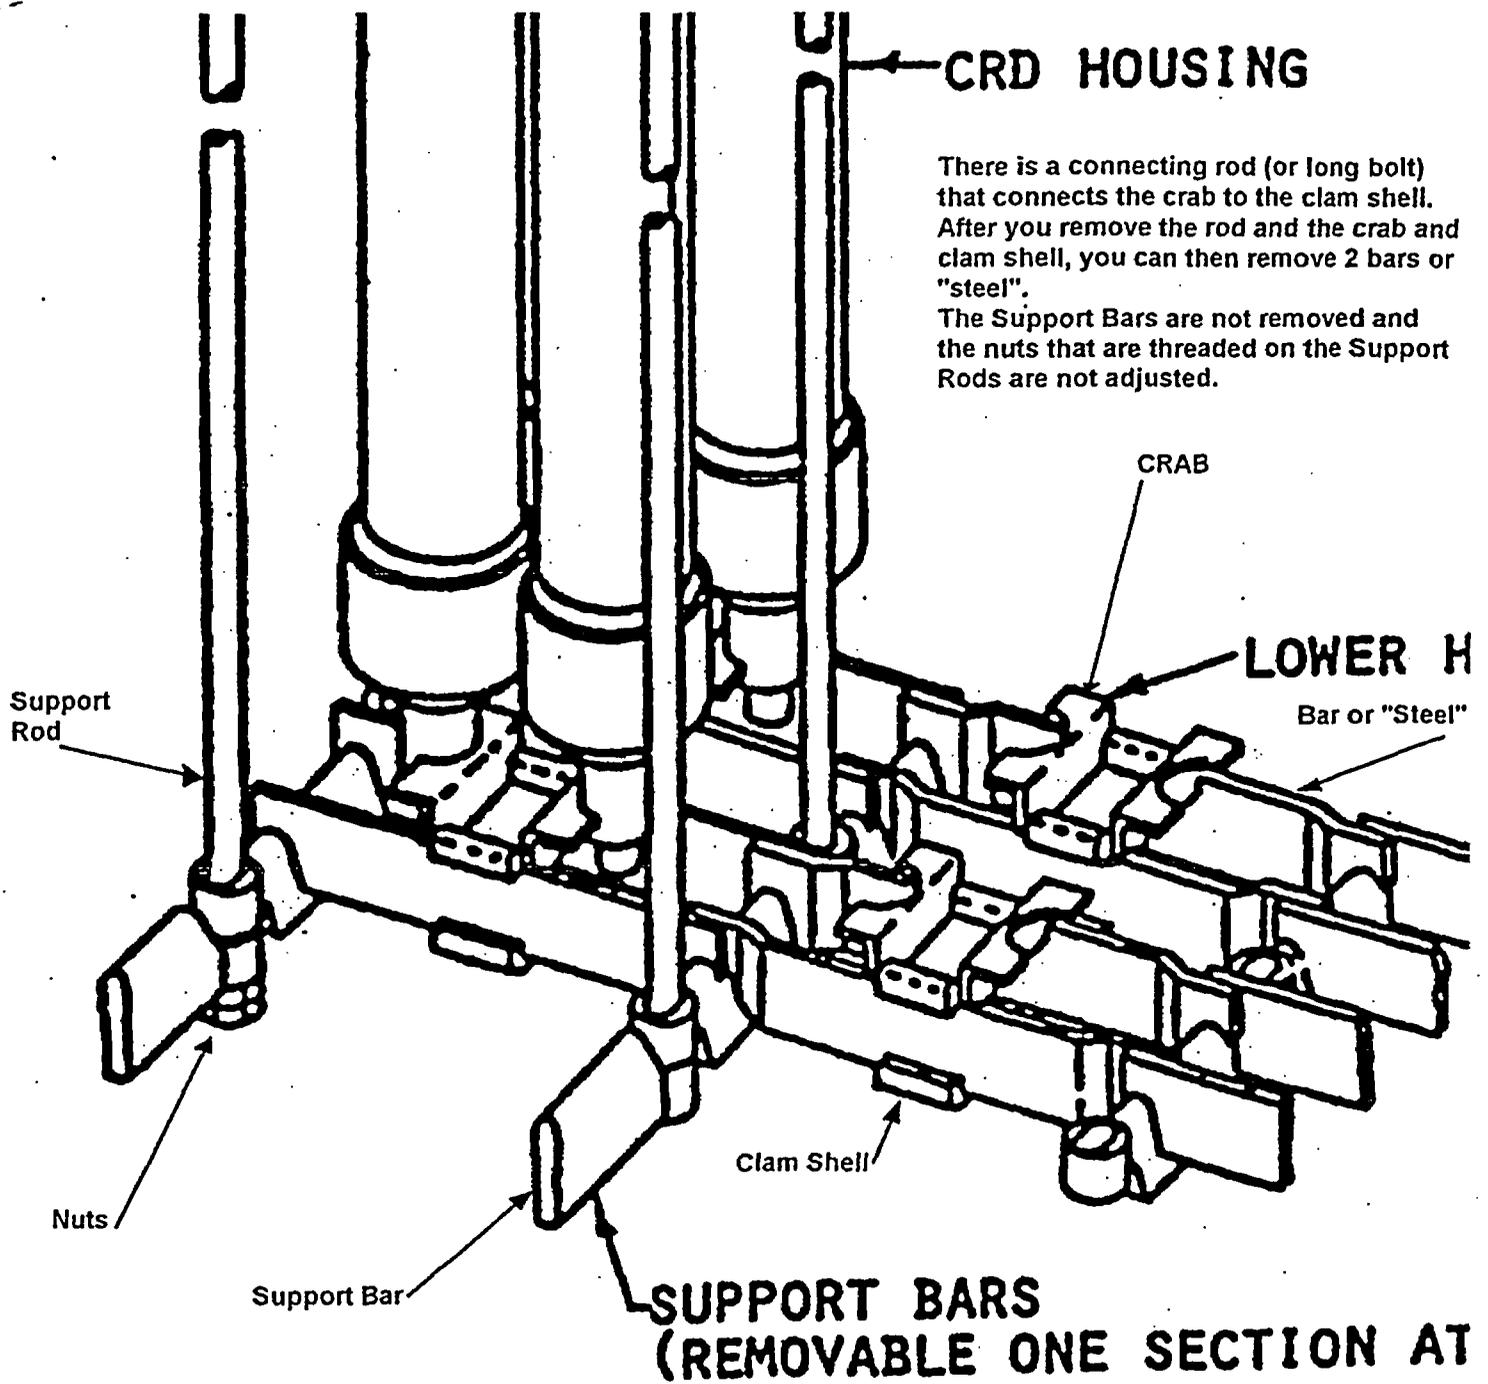
Figure 1-5. Lower Control Rod Drive Housing

Spoke with Jon Todd today regarding extent of condition related to this issue. Jon said that it is limited to one Clamshell piece associated with a CRD housing that was not worked this outage. Therefore, the missing piece has been missing for some indeterminate period.

See enclosed figure depicting configuration. The shootout steel is a latticed assembly supported by rods that have incorporated stacked disc springs into them. The assembly functions to resist the downward loads generated as a result of a postulated full circumferential break of a CRD Housing at full power operations. The Clamshell is centered beneath the Crab on the short Steel Bars that run between the Support Bars and Rods. The Clamshell includes a single bolt that protrudes through it from the underside and engages the Crab. Both the Clamshell and the Crab are configured with a notch, or recess, to fit snug across adjacent pieces of the Steel Bars to align the shootout steel as a lattice and to vertically align the CRD Housings. Based on the input received from Jon, the Clamshell was missing but the Crab was in place, engaged across the adjacent Steel Bars and performing its alignment function for the lattice assembly and CRD Housing positioning. Since the forces resultant of a postulated rupture of a CRD Housing are transferred directly to the structural framing (Steel bars, Support bars and Rods) making up the lattice/rod assembly and since that load transfer is not affected with the Clamshell alone being found missing, the prior function of the shootout steel remains assured.

Jon has discussed his intent for obtaining a replacement Clamshell and has initiated discussion with Procurement to buy or fabricate a replacement piece to re-install where the missing one was found.
