**From:** Teras, Markus  
**Sent:** Monday, August 25, 2003 4:44 PM  
**To:** Siemel, Beth  
**Cc:** Leach, Don; Bronson, Kevin; Wamser, Chris; Wanczyk, Robert; Boivin, Joe; Dreyfuss, John; Amidon, Doug; Pelton, David  
**Subject:** NRC Request - Aug 14 Grid Disturbance

## **Information Request to Support the Working Group on Nuclear Generator Issues. (Entergy Vermont Yankee Station)**

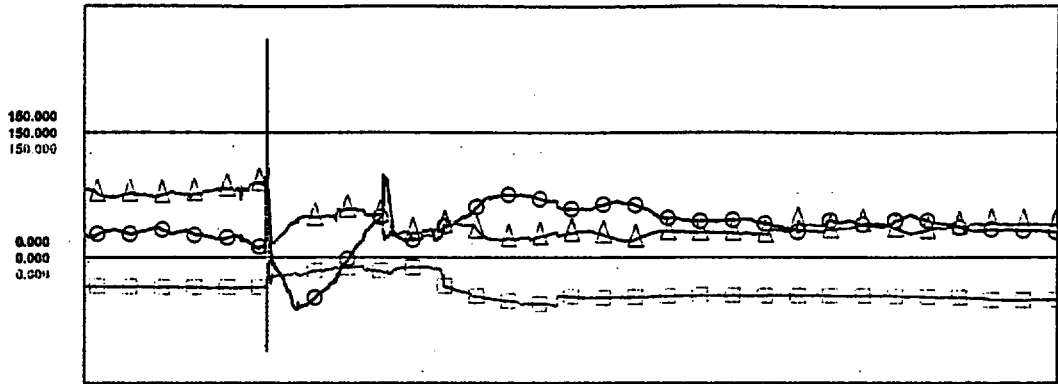
TREND\_3 9/25/2003  
11:55:52

017	NORTHFIELD-381 LINE MVAR	-14.160	MVAR	○
016	SCOBIE-379 LINE MVAR	98.877	MVAR	△
017	SCOLLIDGE 340 LINE MVAR	-21.747	MVAR	□
