**FIRST REVISED NRC ORDER EA-03-009:
REACTOR PRESSURE VESSEL HEAD AND VESSEL HEAD
PENETRATION NOZZLE POST OUTAGE INSPECTION RESULTS
SALEM GENERATING STATION UNIT 1
FACILITY OPERATING LICENSE NO. DPR-70
DOCKET NO. 50-272**

Salem Unit 1-1R16 Reactor Vessel Head Penetration Examination

WDI-PJF-1302611-FSR-001

Report of the Bare-Metal Visual Examination of the Salem Unit 1 Reactor Pressure Vessel Head

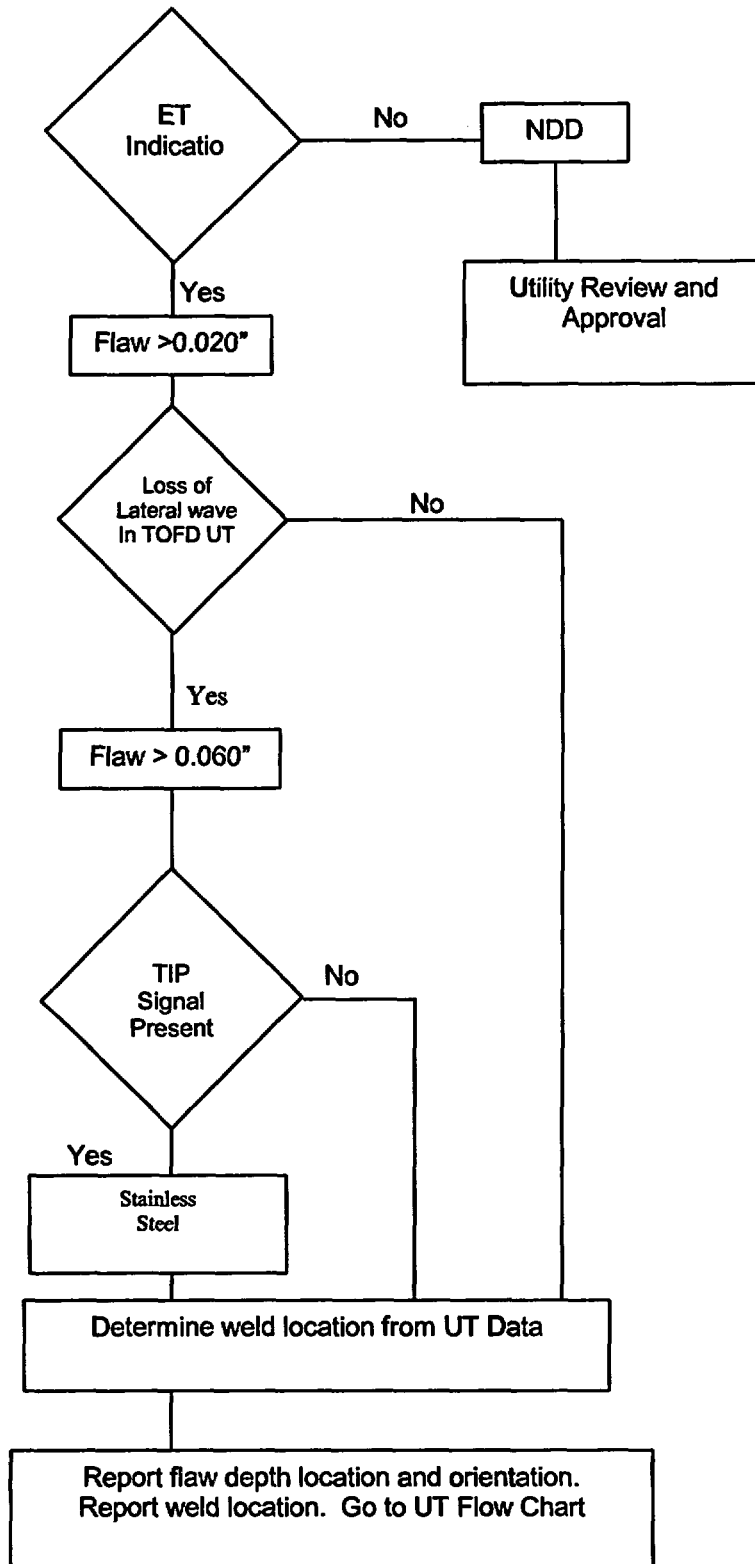
Figure 5-1 - Penetration Tube ID Flaw Evaluation

Eddy Current results from tube ID surface examinations showed 15 penetration tubes with indications characteristic of axial cluster cracking. With the exception of penetration #19 these indications were determined with the TOFD inspection to have a depth less than 0.040". Penetration #19 had indications characteristic of axial cluster cracking as described above. One indication in the cluster area had a reflector which produced a measurement of 0.047" with the TOFD inspection channel.

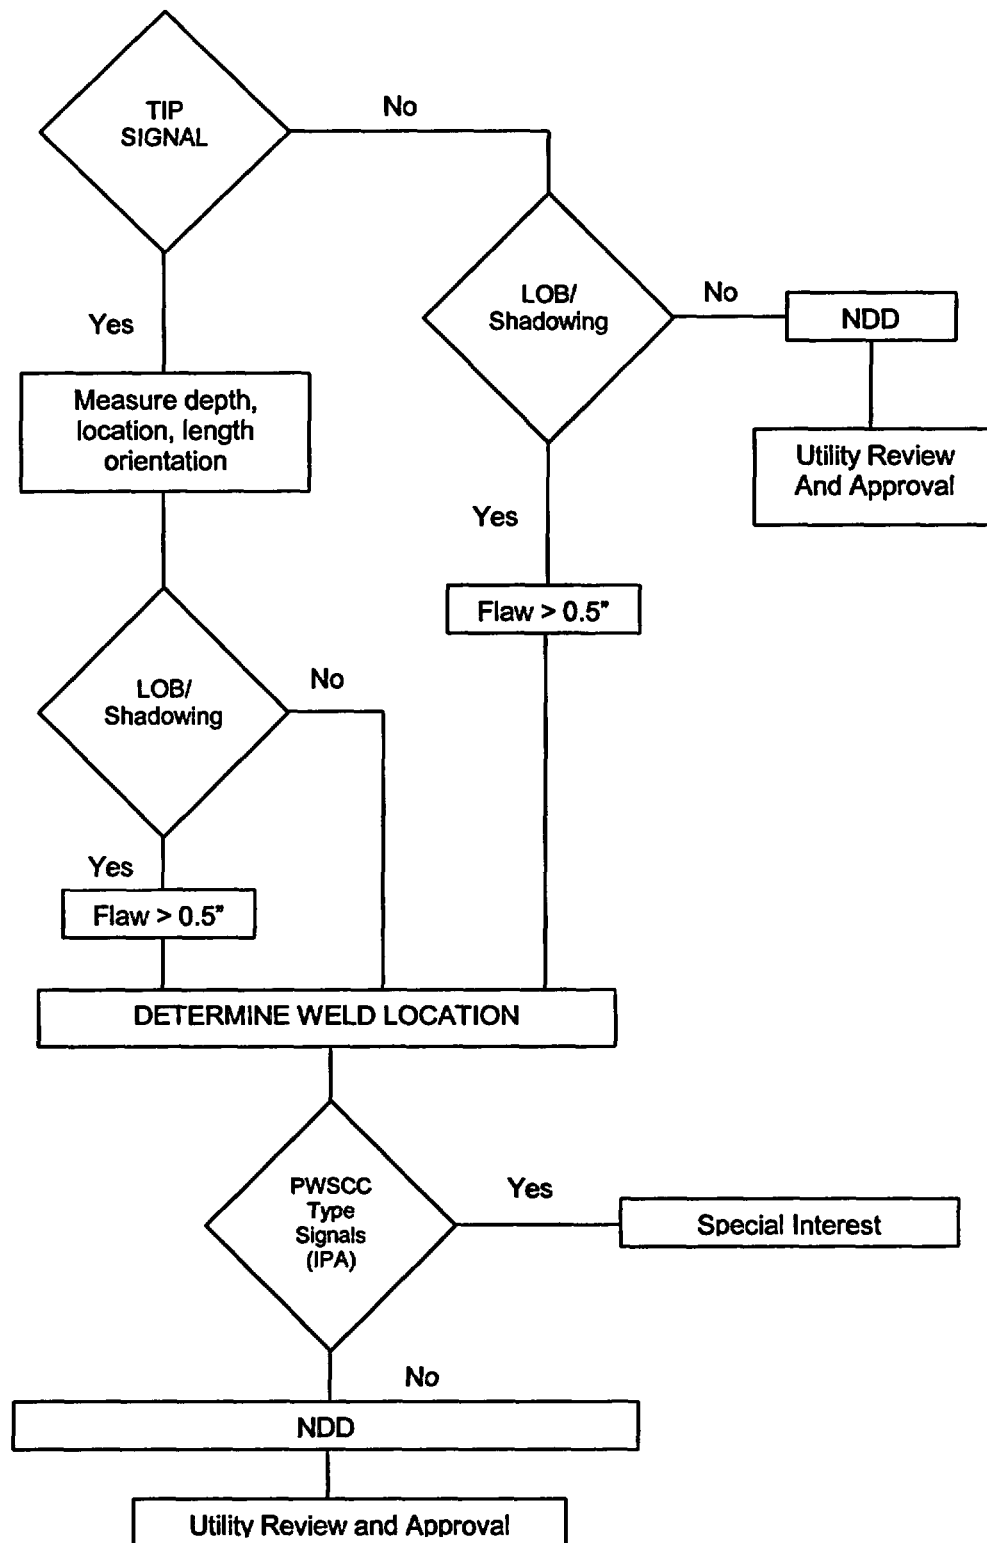
Figure 5-2 - Penetration Tube OD Flaw Evaluation

Results from the TOFD ultrasonic and eddy current examinations of the sixty-nine reactor vessel head penetrations identified no indications characteristic of PWSCC. The straight beam ultrasonic examinations of the shrink-fit regions of the seventy nine penetration tubes showed no evidence of leak paths.
