Entergy Vermont Yankee

Root Cause Analysis Report

CR-VTY-2004-2015

Electrical Fault / Fire

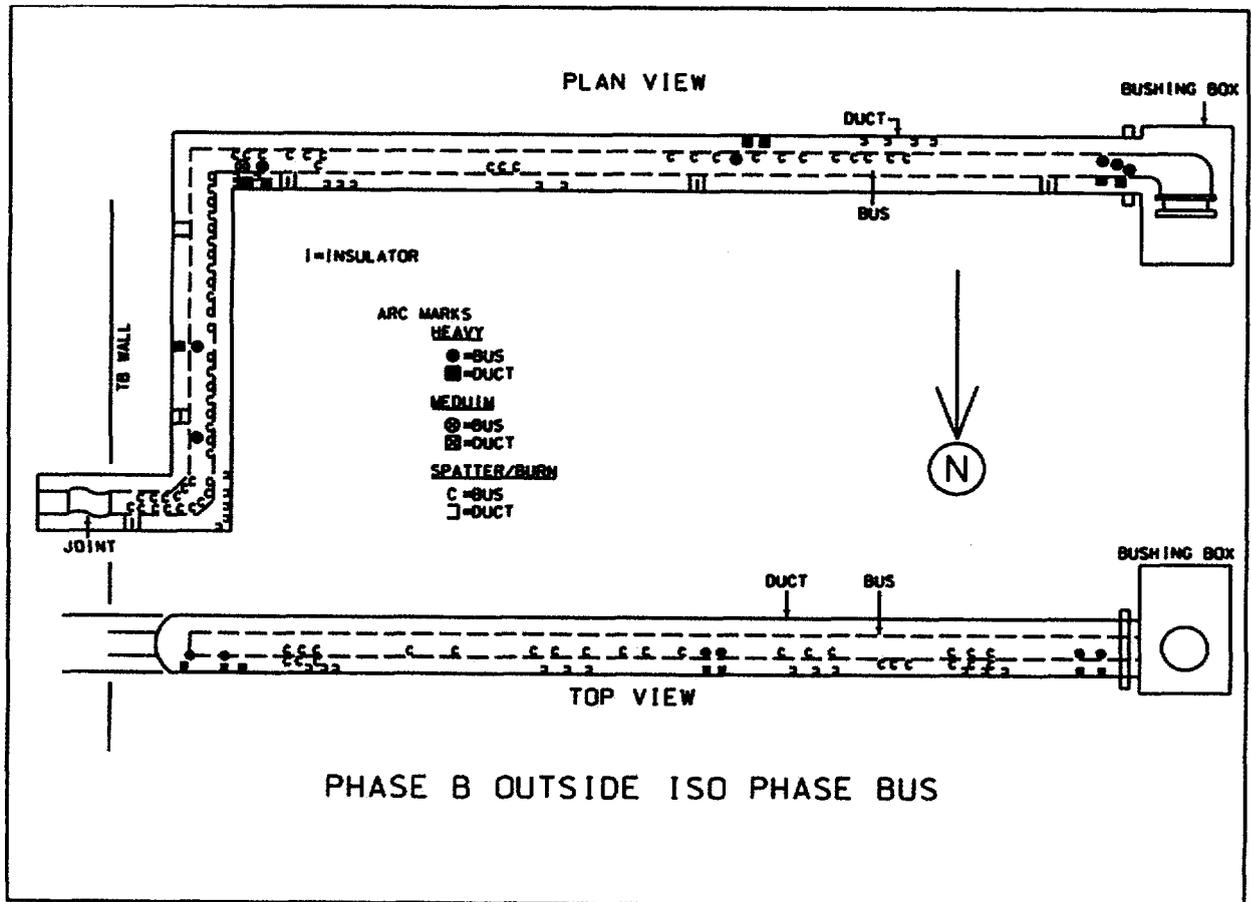
Figure 2

- ? Sometime after bus energization following RFO24, a piece (or pieces) of the failed laminate and/or other material, now located in or at the bottom of the vertical section of the "B" isophase bus duct, was (were) moved by the air stream upward and outward toward the "B" low voltage bushing. Numerous arc strikes occurred en route (see Figure 2), each arc strike representing a momentary ground of the "B" phase bus.

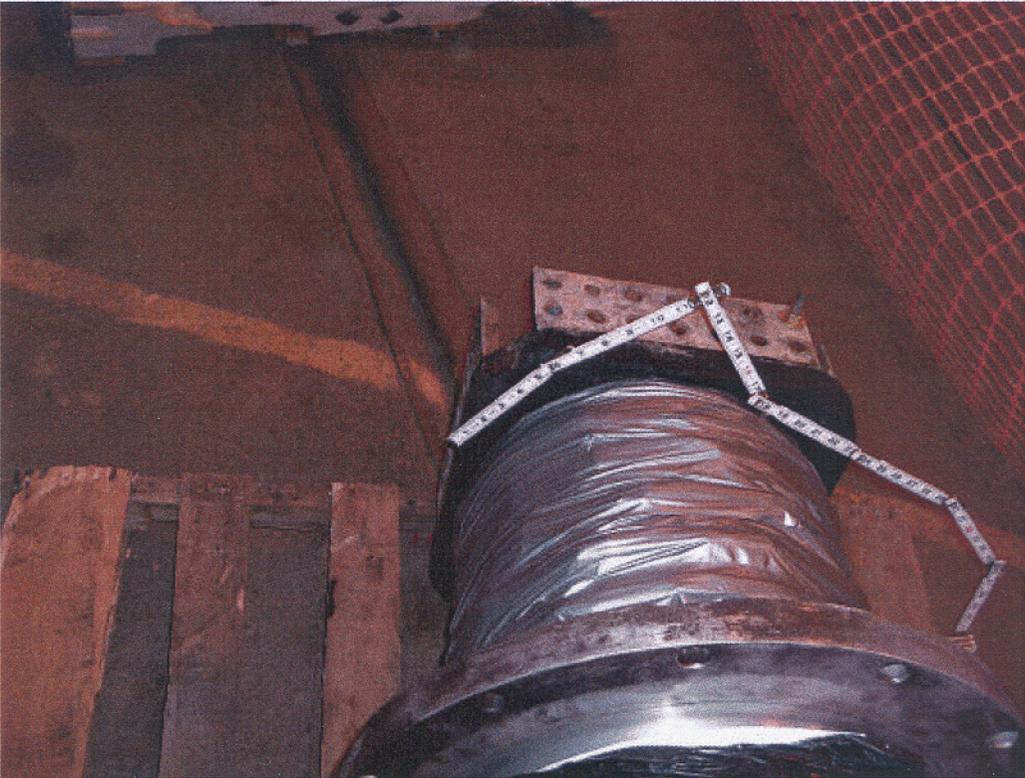
B Phase Bushing Arc Mark

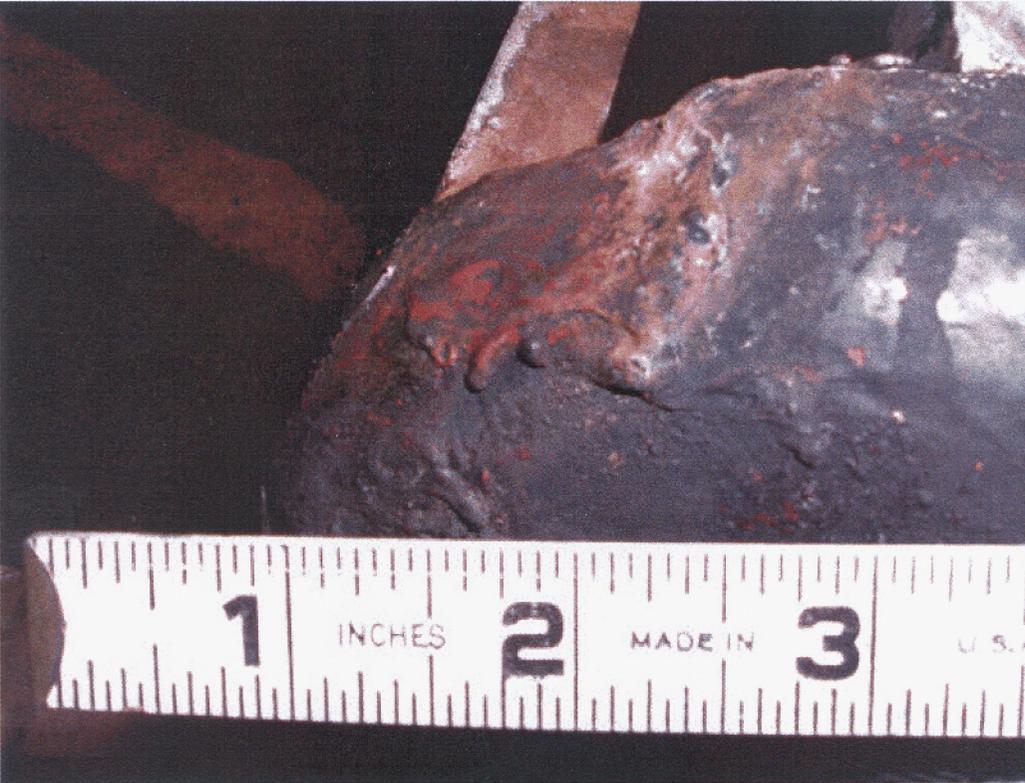
B Phase Bushing Arc Mark Close-up

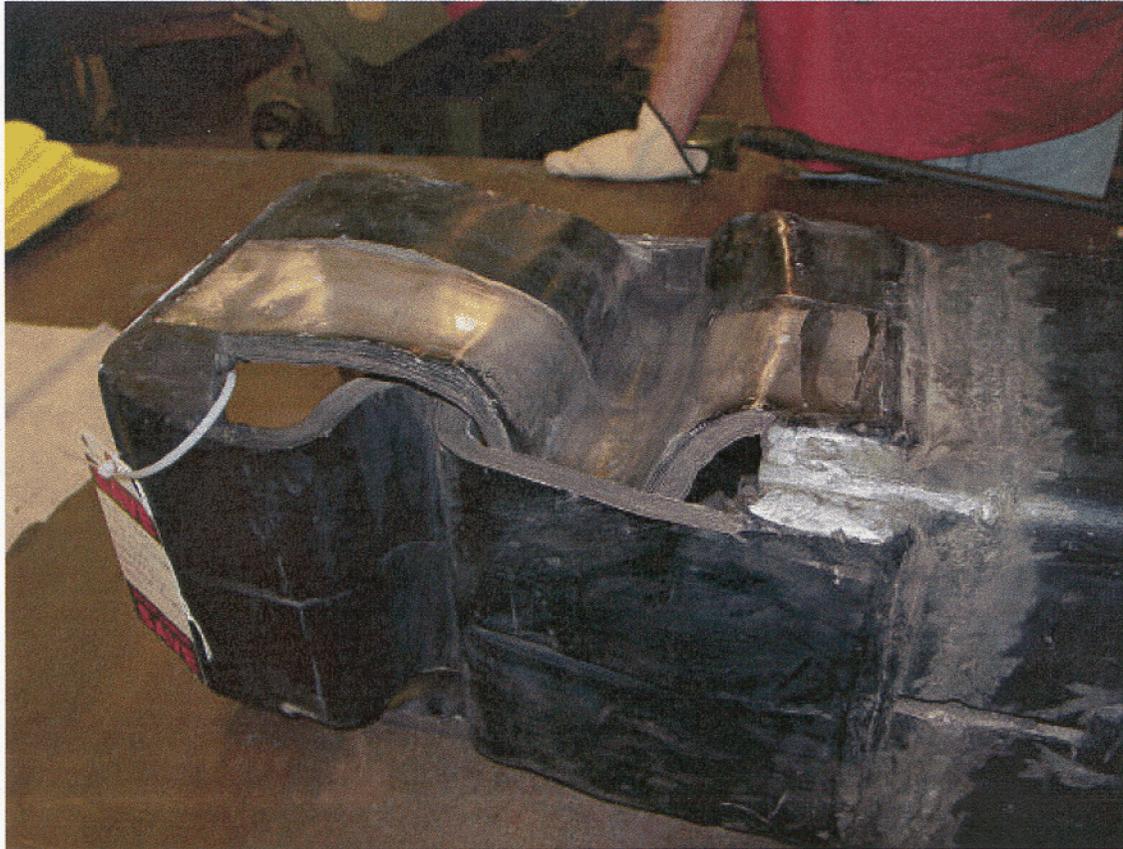
- ? The laminate layer of the flexible connector suffered failure due to low cycle fatigue on the leading (upstream) edge of the laminate. With the isophase bus cooling system in operation, the laminate was lifted and protruded upward into the air stream.

- ? Caught by the air stream, the trailing edge of the laminate failed, and the laminate became detached from the flexible connector. The air stream within the duct caused the detached laminate to tumble downstream until it reached the vertical section of bus external to the Turbine Building. It is fairly clear that this occurred during the period the isophase bus was not energized during the most recent refueling outage (RFO24), as evidenced by a lack of arc strikes on the horizontal section of "B" bus internal to the Turbine Building.

Flexible Connector from the “B” Isophase Bus Cooling Unit end (Missing Lamination)

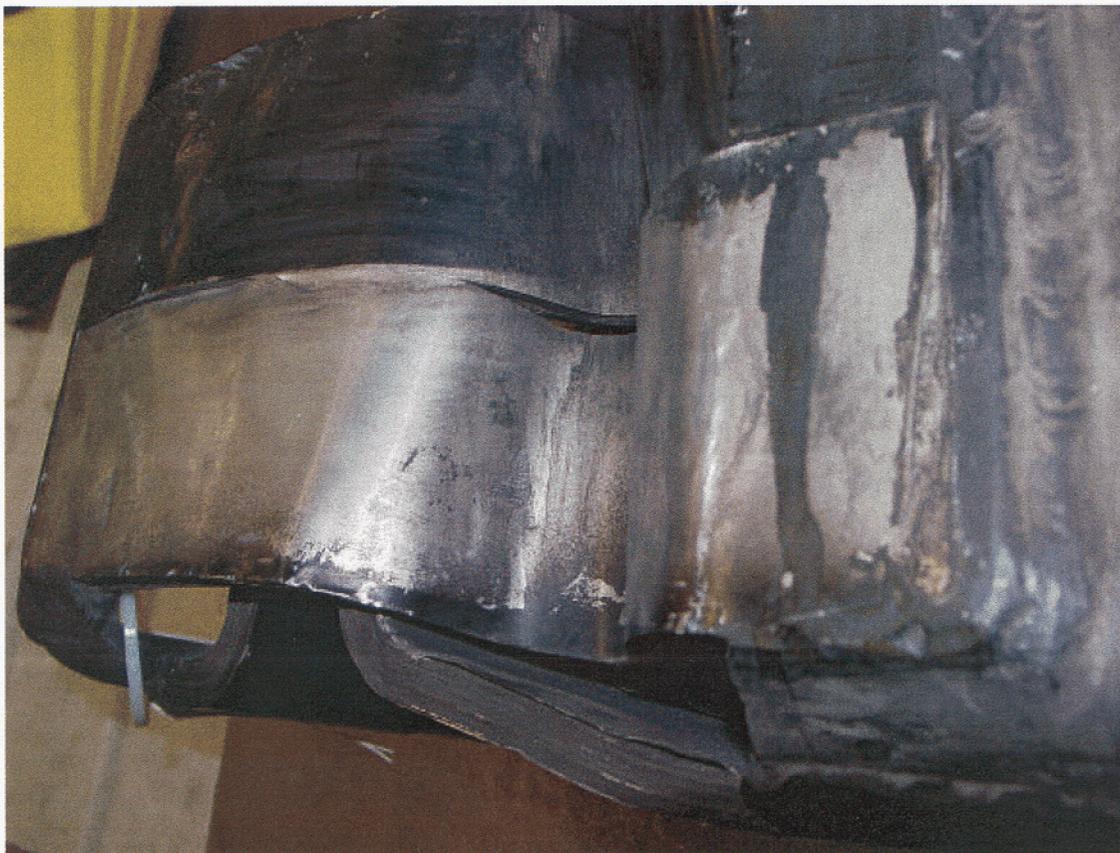
Close-up of Missing Lamination

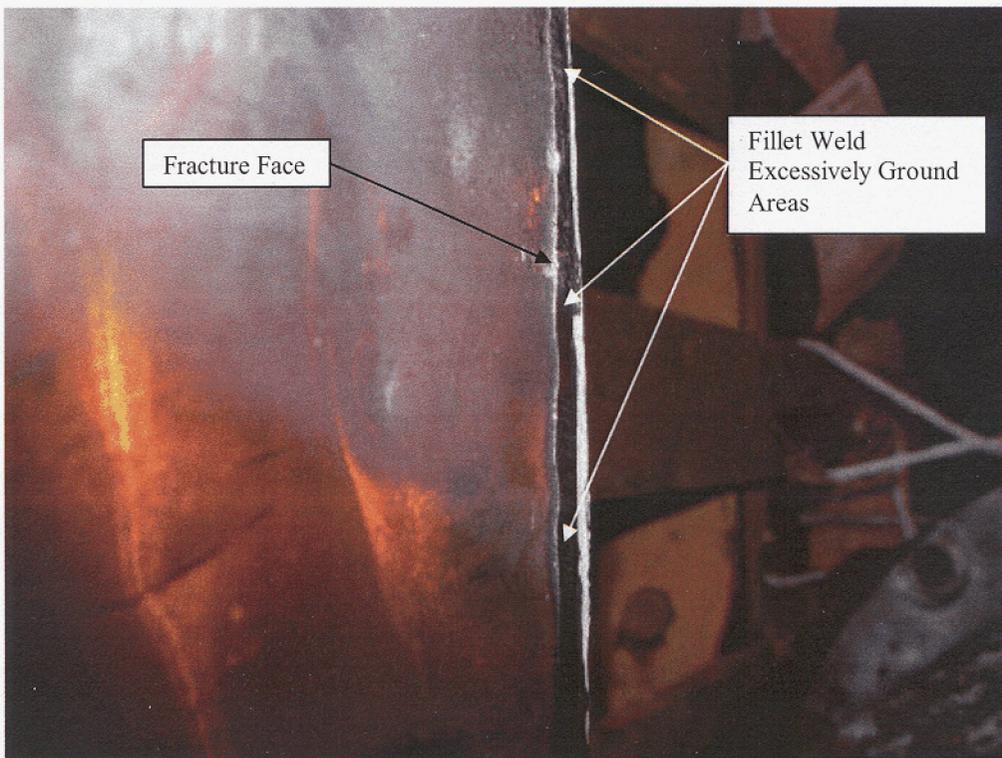
B Phase Flexible Connector Showing Transformer End Fracture Face (note shiny appearance)

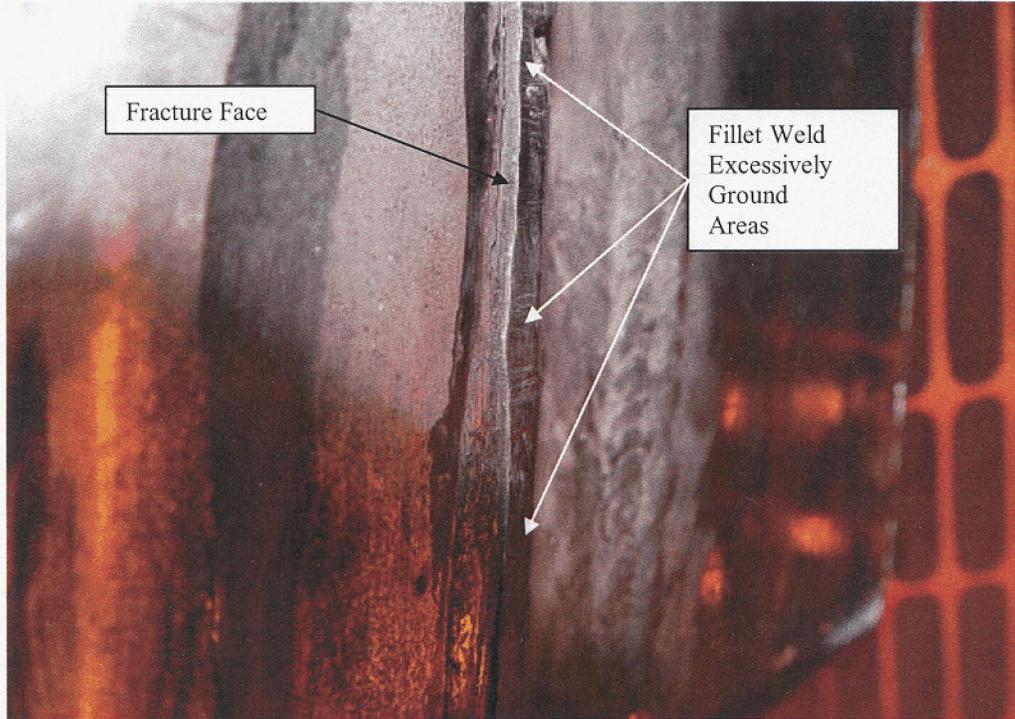
B Phase Flexible Connector Showing Generator End Fracture Face (note dull appearance)

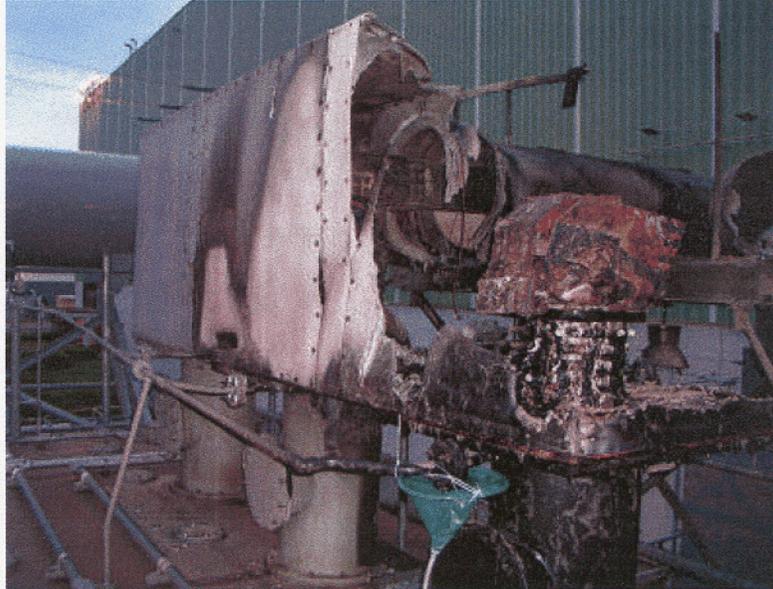
Photograph : T-1-1A ABB 31

A close examination of the fire area witnessed at the Main Transformer was conducted. The fire damage appeared to be at the top area of the Main Transformer in proximity to the secondary "C" phase area.

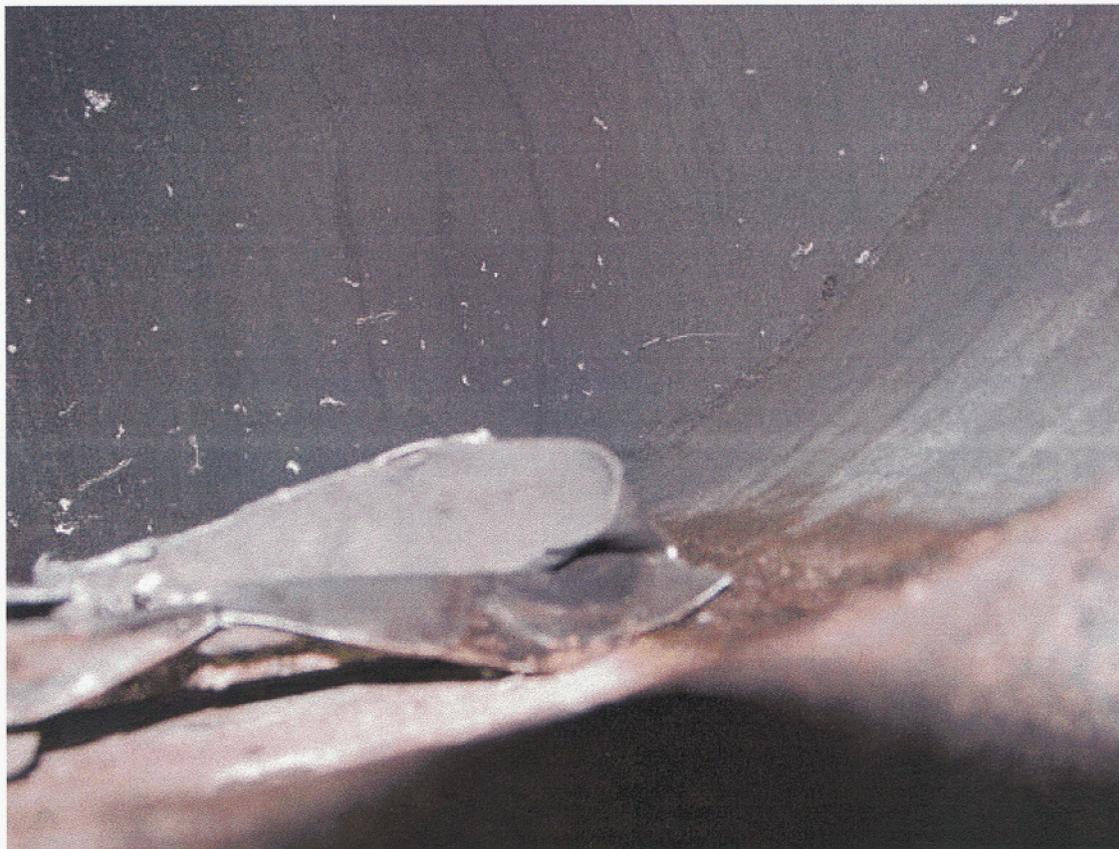
The laminate was found at the bottom of the "B" isolated phase bus duct riser elbow, just outside the Turbine Building where the duct transitions from horizontal to vertical. The laminate was severely twisted and deformed. In the as-found condition, it weighed 38.64 grams which, compared to an undamaged laminate weight of 64.27 grams, represents a weight loss of 25.63 grams or approximately 40% of its original weight. Further evaluation will be performed to determine the parts of the laminate that are missing.

Figure 1
As-Found Condition of Failed Laminate in Isophase Bus Duct

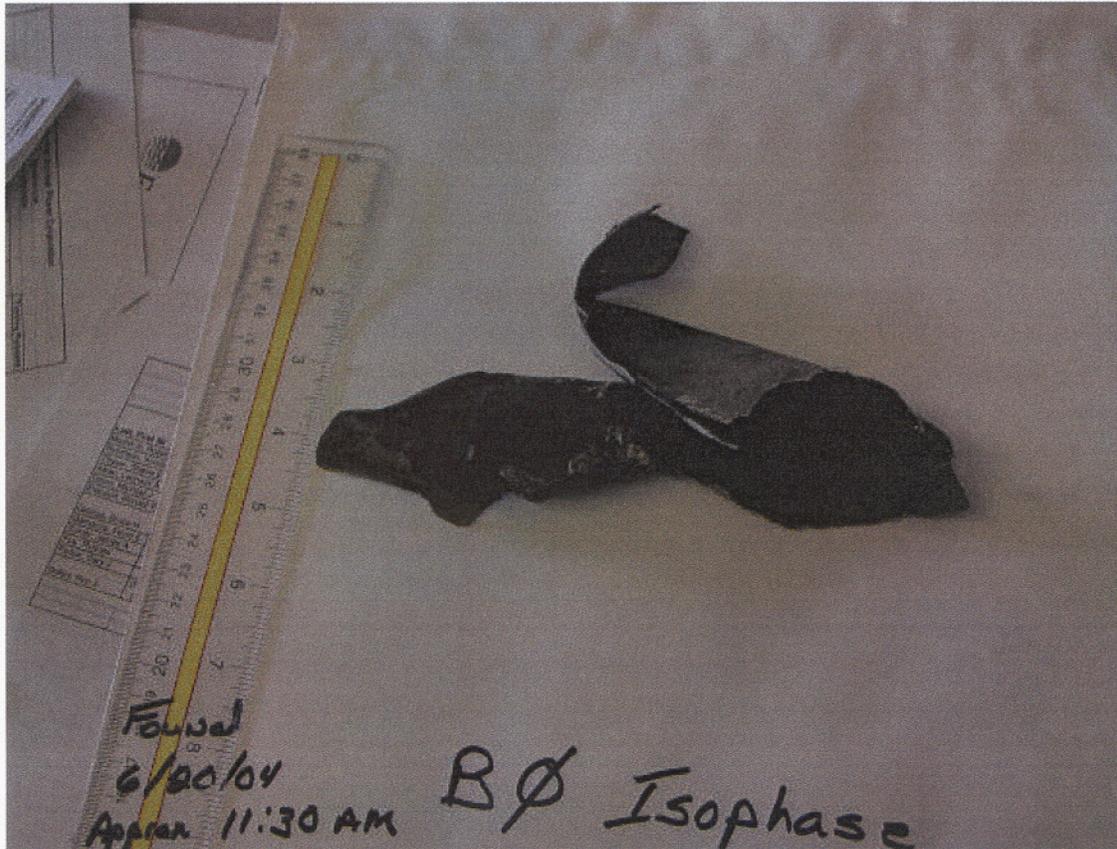
Figure 2
Failed Laminate after Removal from Isophase Bus Duct

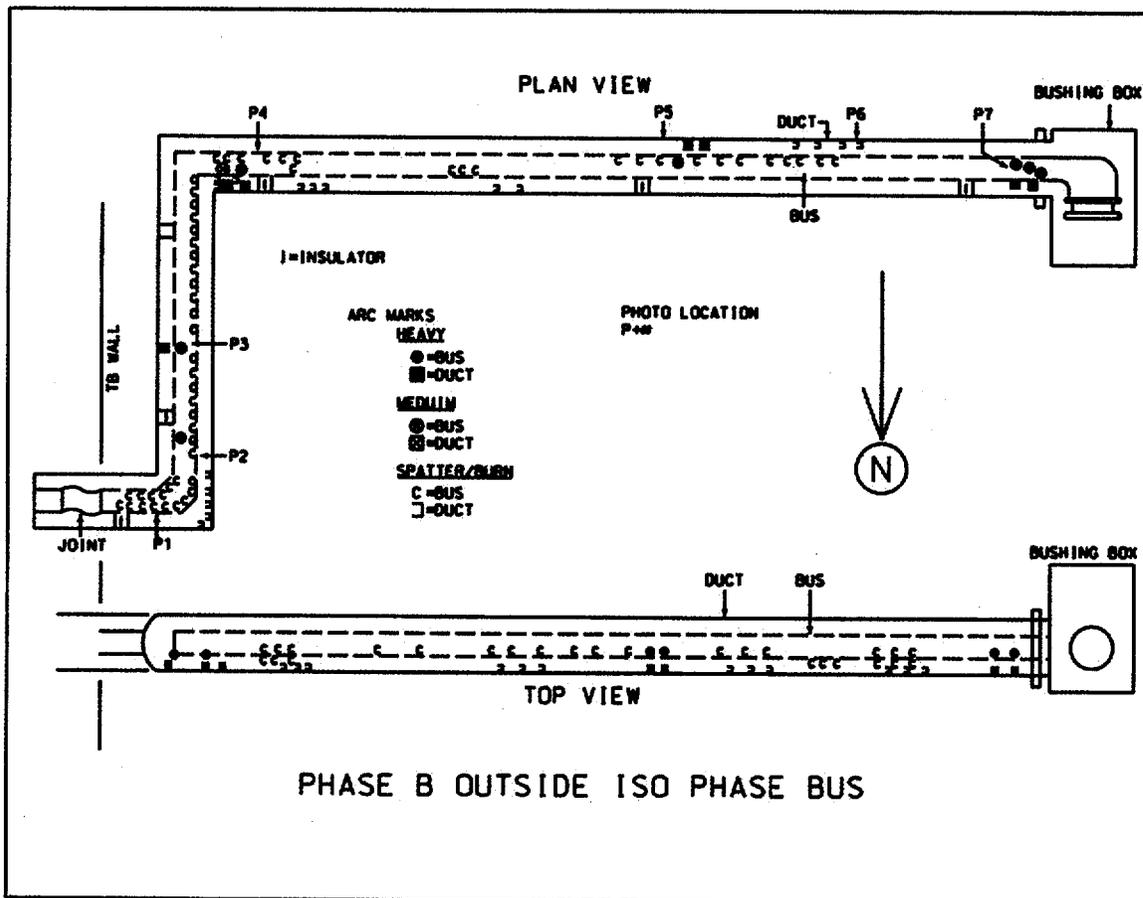
Figure 3
 Diagram Showing Density of Arc Strikes Along "B" Isophase Bus Duct From
 Turbine Building Wall to Low Voltage Bushing Box at Main Transformer

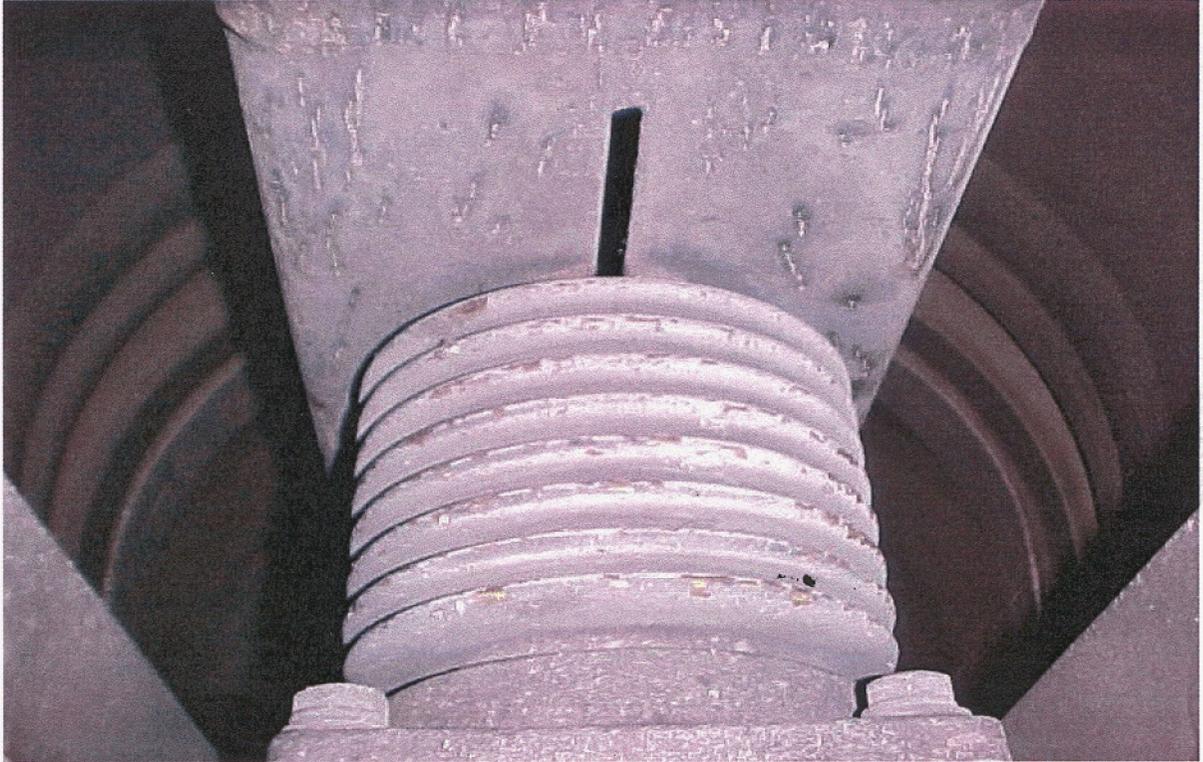
Figure 1
Arc Strikes at Location P1 on Figure 3 of Attachment 16

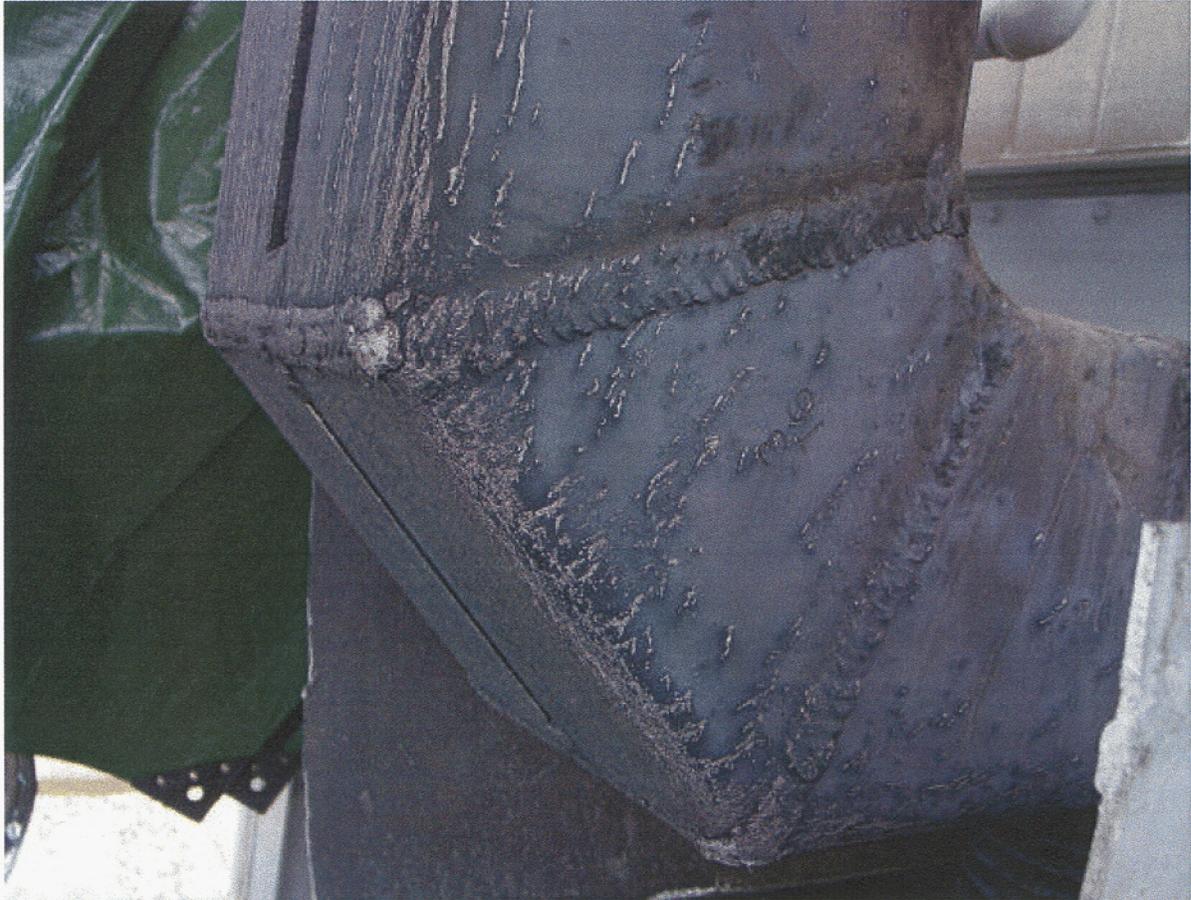
Figure 2
Arc Strikes at Location P2 on Figure 3 of Attachment 16

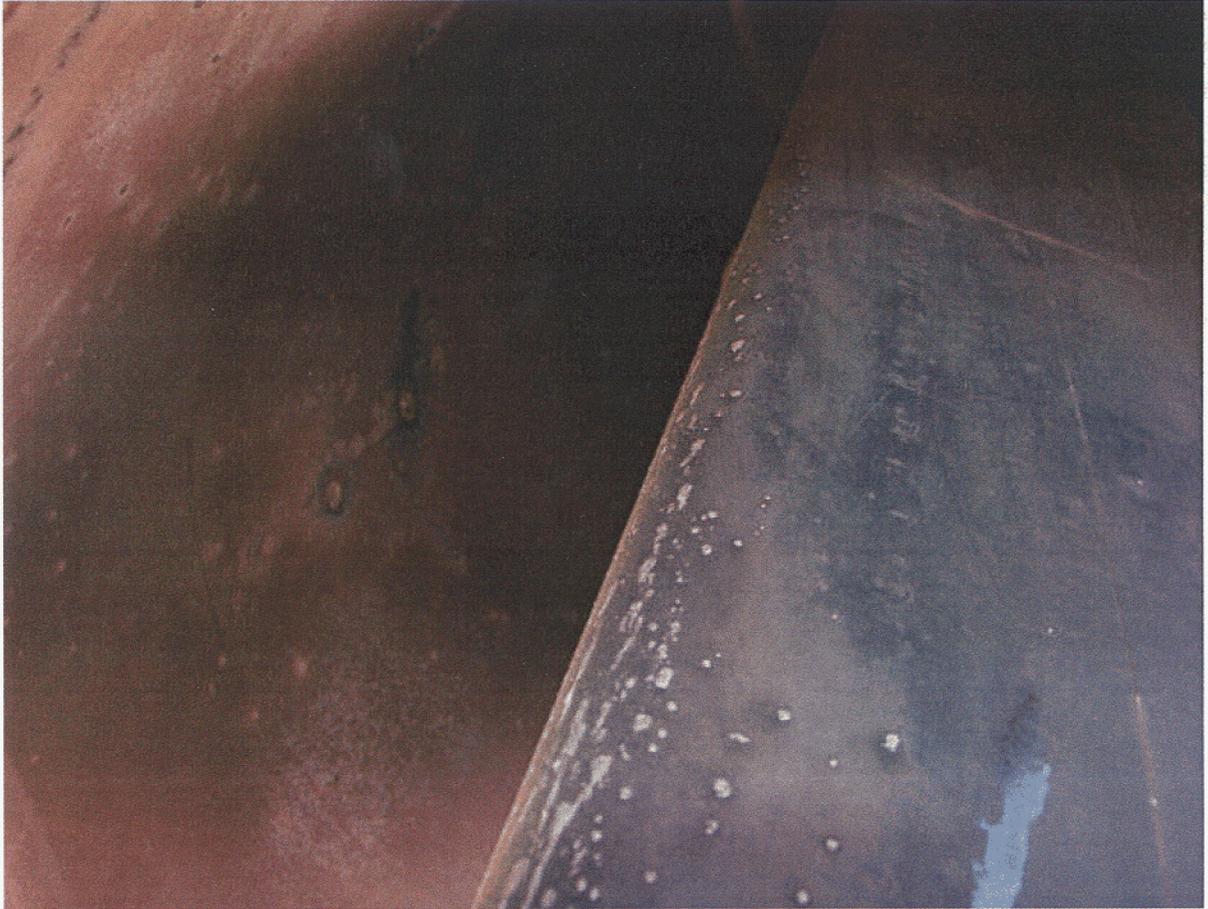
Figure 3
Arc Strikes at Location P3 on Figure 3 of Attachment 16

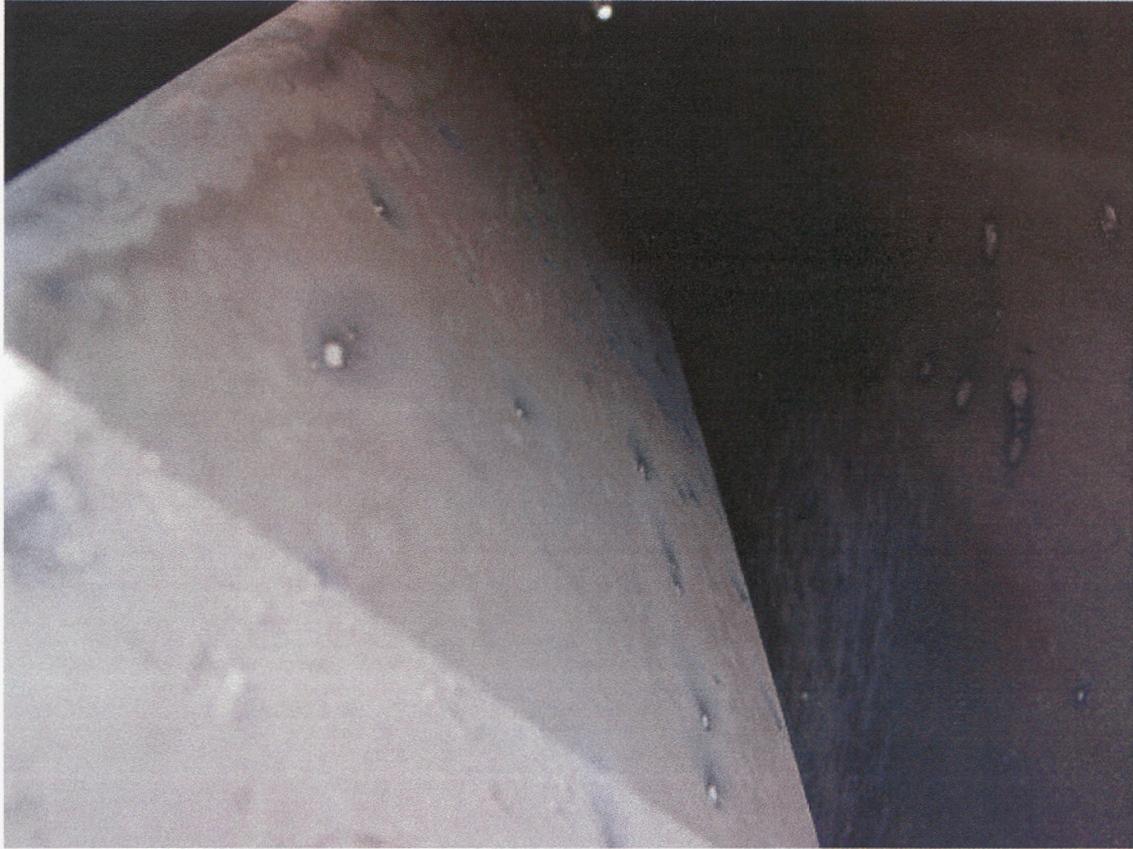
Figure 4
Arc Strikes at Location P4 on Figure 3 of Attachment 16

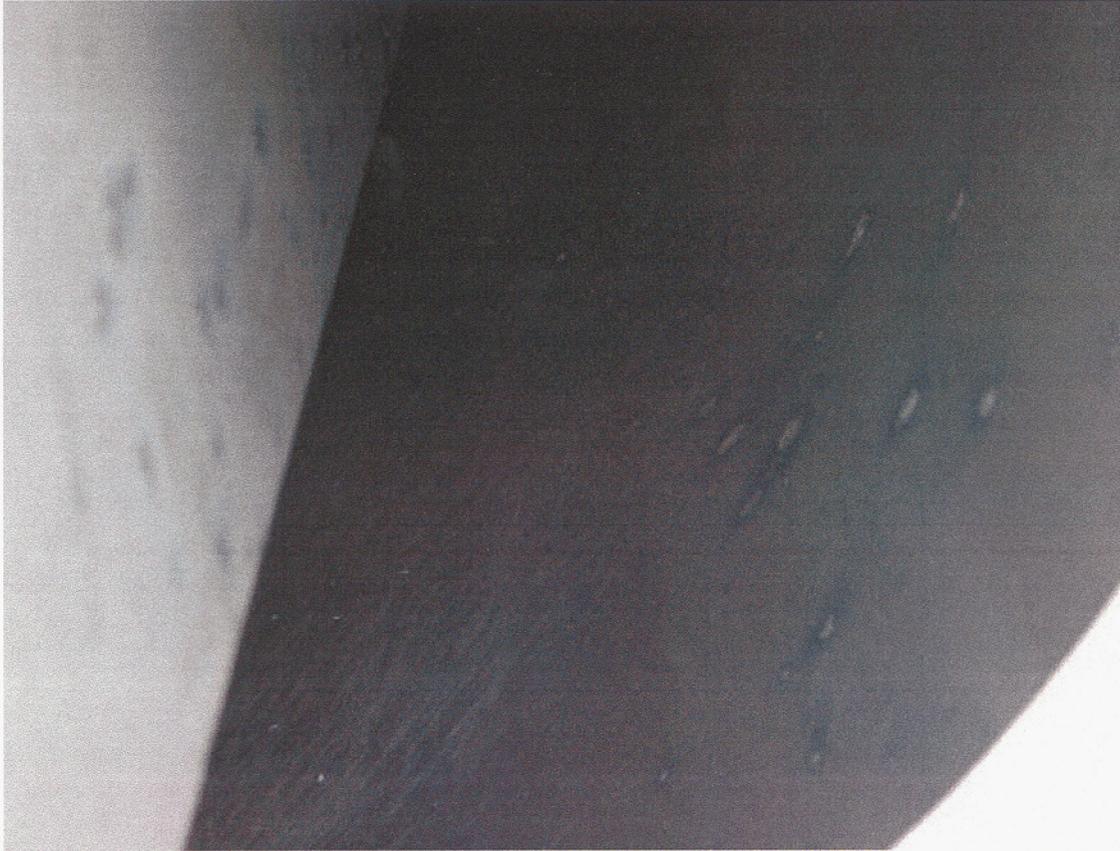
Figure 5
Arc Strikes at Location P5 on Figure 3 of Attachment 16

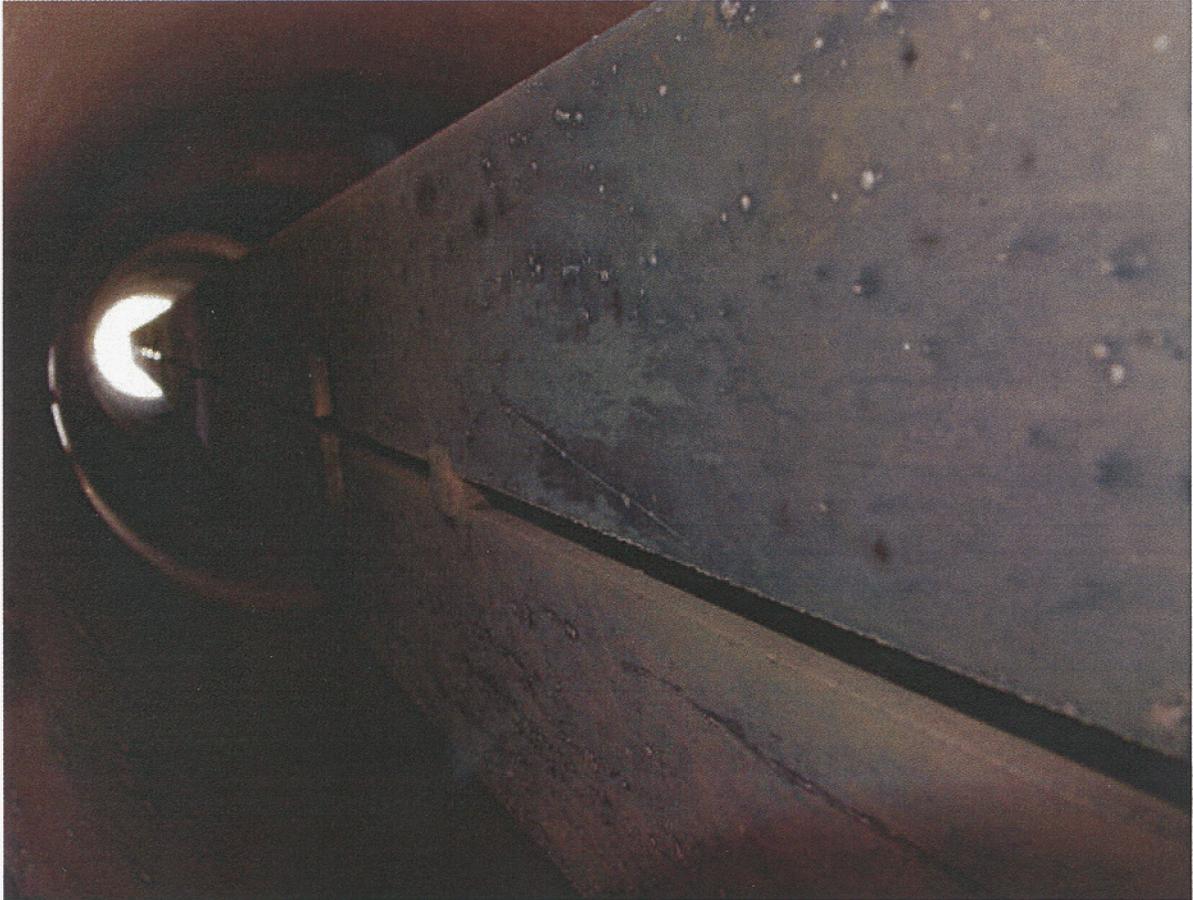
Figure 6
Arc Strikes at Location P6 on Figure 3 of Attachment 16

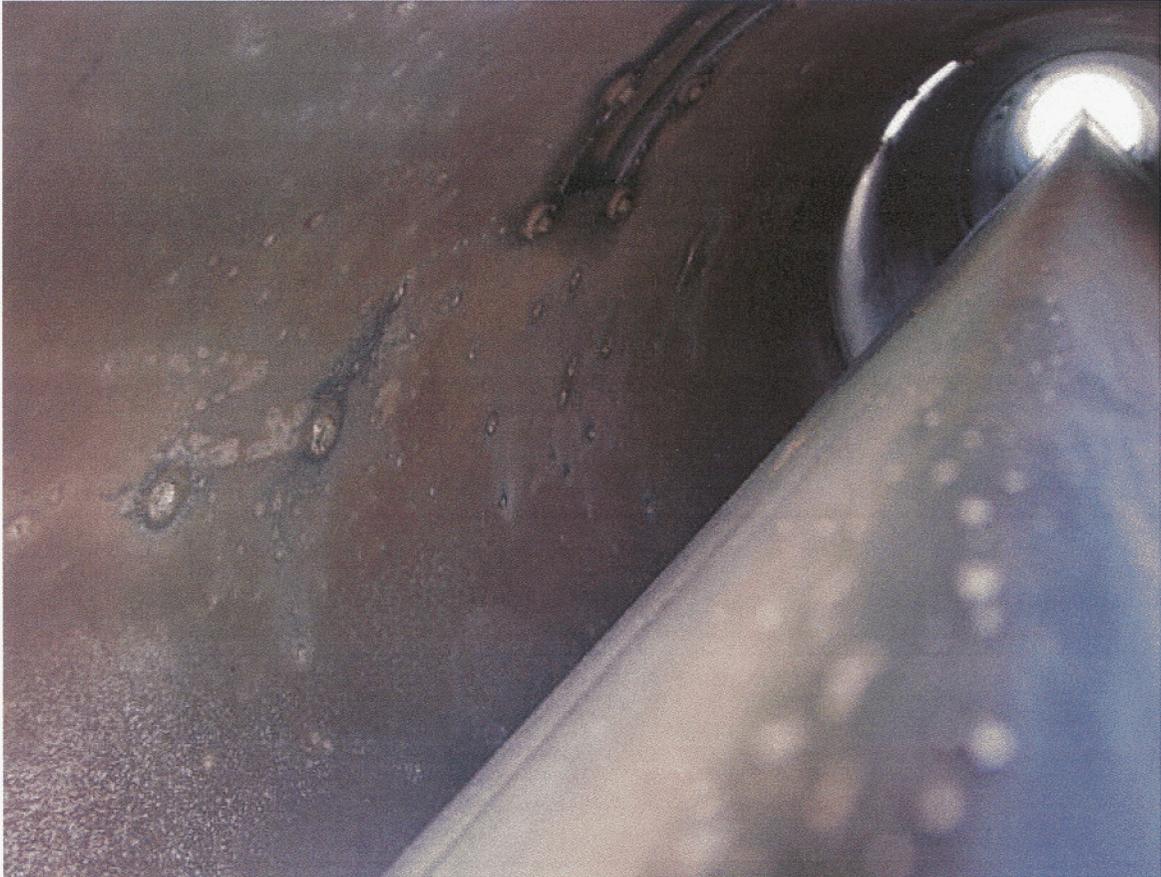
Figure 7
Arc Strikes at Location P7 on Figure 3 of Attachment 16
