UNITED STATES
NUCLEAR REGULATORY COMMISSION
OFFICE OF NUCLEAR REACTOR REGULATION
WASHINGTON, D.C. 20555

December 18, 1991

NRC INFORMATION NOTICE 91-18, SUPPLEMENT 1: HIGH-ENERGY PIPING FAILURES CAUSED BY WALL THINNING

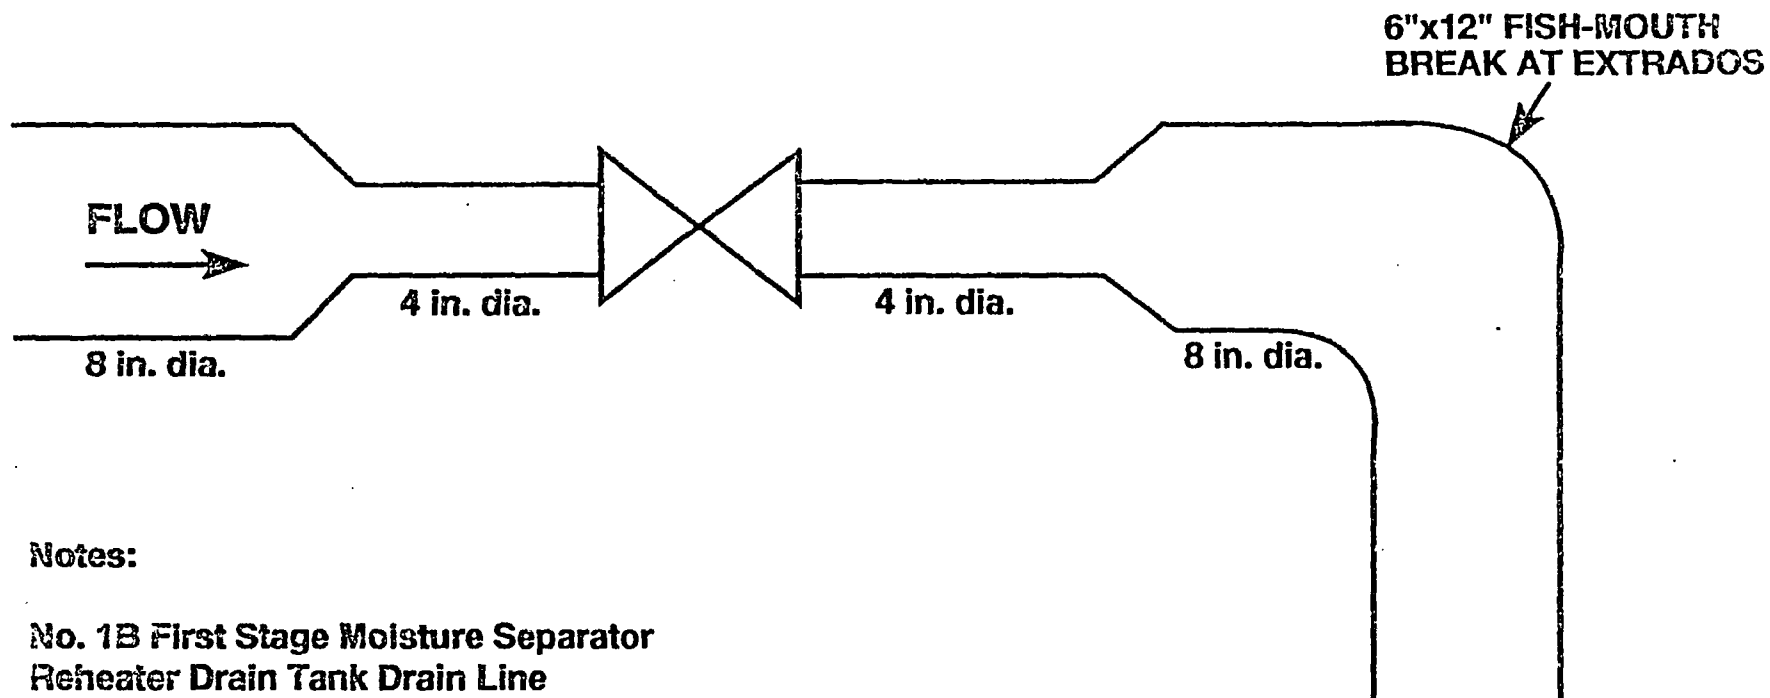
Figure 1. Rupture of Elbow in Secondary System at Millstone Unit 2 on November 6, 1991

At Millstone Unit 2, on November 6, 1991, while the licensee, the Northeast Nuclear Energy Company (NNECo), was operating the plant at 100 percent of full power, a rupture occurred in train B of the moisture separator reheater (MSR) system. An 8-inch elbow, located between the first stage MSR drain tank and the feedwater heater, ruptured at its extrados (Figure 1). The elbow was located downstream from a 4-inch flow control valve and a 4- to 8-inch expander. The high energy water in the pipe (approximately 463 F, 470 psig) flashed to steam, actuating portions of the turbine fire protection deluge system. The water level in the steam generator decreased slightly. The licensee had not selected the ruptured elbow for ultrasonic testing (UT) in its erosion/corrosion monitoring program.

The ruptured elbow was made of carbon steel with nominal wall thickness of 0.322 inch. Wall thickness at the failed area was eroded to 95 percent of the initial nominal value. Other areas, away from the failed area, showed a loss of 22 percent of the wall thickness. The identical elbow in the A train had a maximum wall loss of 34 percent of the initial nominal value.

In its response to GL 89-08, NNECo indicated that its Engineering Procedure EN-21153, "Thickness Testing of Secondary Piping," describes its monitoring program, established in accordance with EPRI guidelines and using the CHEC program to select for testing those areas of the piping systems with highest probabilities for wall thinning. The licensee also selects areas on the basis of plant experience. However, although the pipe wall thickness testing program was included in the licensee's procedures, the licensee had not implemented the methodology using the EPRI computer codes at Unit 2. This omission may account for the licensee not having tested previously the piping that ruptured on November 6, 1991.

The licensee did use an earlier version of the CHEC computer code in limited analyses at its other nuclear units. The licensee's program did not reflect the use of current versions of EPRI codes (either CHEC or CHECMATE). The Unit 3 rupture described in the March 12, 1991, issuance of this information notice prompted NNECo to commit to perform CHEC or CHECMATE analyses at all its units by December 31, 1991. However, at the time of the second rupture on November 6, 1991, the licensee was implementing this program at its corporate engineering office and not at Unit 2. The Unit 2 personnel were consequently relying on inspection procedures that did not possess the benefit of the EPRI's methodology for selecting areas of piping for UT inspection. After November 6, 1991, NNECo performed a CHECMATE analysis that did identify this portion of the MSR system as highly susceptible to erosion or corrosion and thus as a candidate for UT inspection.

**No. 1B First Stage Moisture Separator
Reheater Drain Tank Drain Line**

**Pipe: Carbon Steel
No Chromium Content**

**Fluid: H₂O @ 470 psig, 463°F
pH: 8.2 → 8.7
O₂: <2ppb**
