**ROOT CAUSE ANALYSIS REPORT**

CR Number: CR-VTY-2004-00955

Investigation following a failed As-found leak rate test during RFO24 found MSIV V2-80B to have a galled stem.

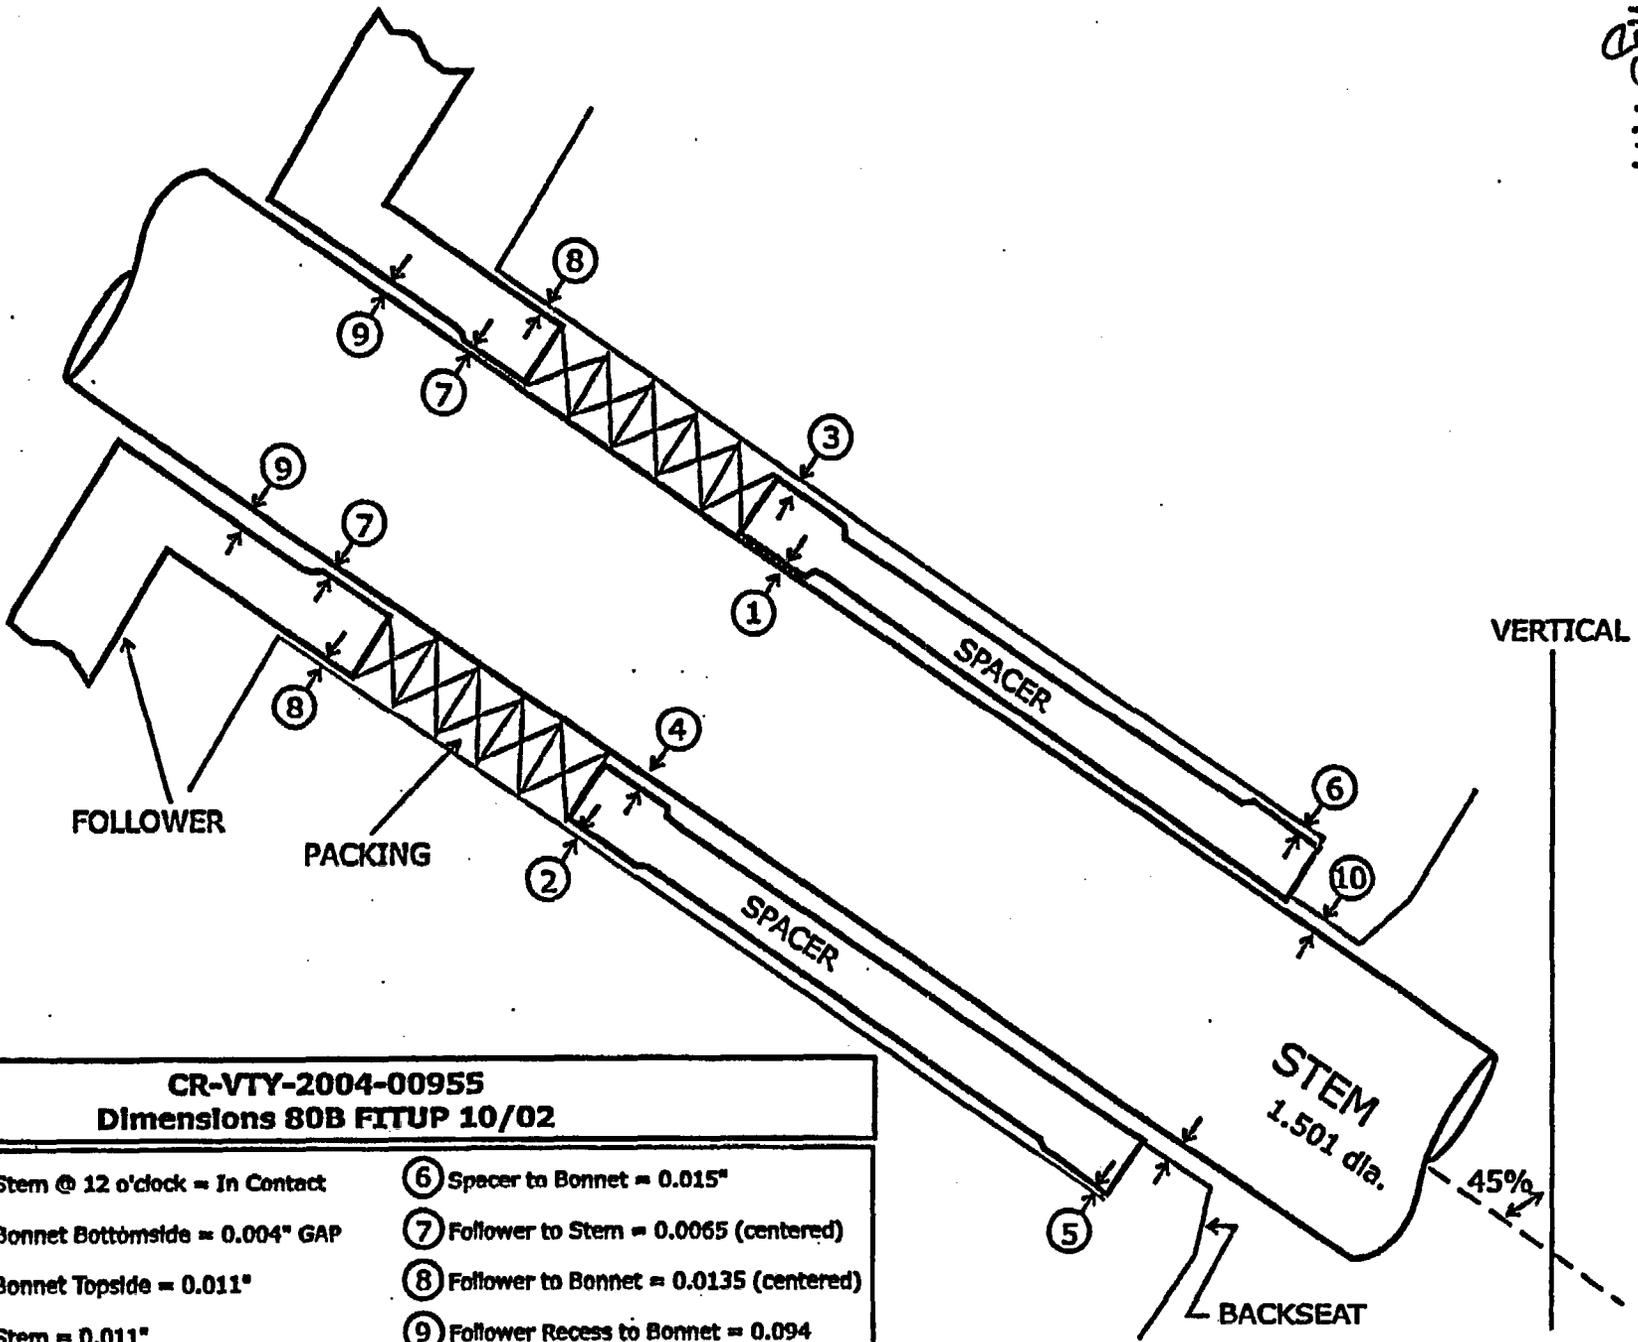
**Sketch of Stuffing Box Configuration which allowed galling**

contact at the top of stem. The stuffing box ID is oversized by (0.009 to 0.015) [2.299 as-found; 2.284-2.290 design]. This oversized condition resulted from a maintenance activity performed prior to 1999 when the stuffing box bore was "cleaned up", "honed", or "machined" without adequate control of the work activity. Prior to 1999, the significance of stuffing box clearances was not explicitly documented and may not have been recognized. The failure to recognize the significance of the clearance tolerances within the stuffing box resulted in the valve being reassembled with inadequate clearances. With the excessive clearance between the packing spacer and the stuffing box ID, the clearance between the stem and packing spacer ID is compromised, allowing metal-to-metal contact.

**CR-VTY-2004-00955**  
**Dimensions 80B FITUP 10/02**

| ① Spacer to Stem @ 12 o'clock = In Contact | ⑥ Spacer to Bonnet = 0.015" |
| ② Spacer to Bonnet Bottomside = 0.004" GAP | ⑦ Follower to Stem = 0.0065 (centered) |
| ③ Spacer to Bonnet Topside = 0.011" | ⑧ Follower to Bonnet = 0.0135 (centered) |
| ④ Spacer to Stem = 0.011" | ⑨ Follower Recess to Bonnet = 0.094 |
| ⑤ Spacer to Bonnet = In Contact | ⑩ Bonnet to Stem = 0.045 |

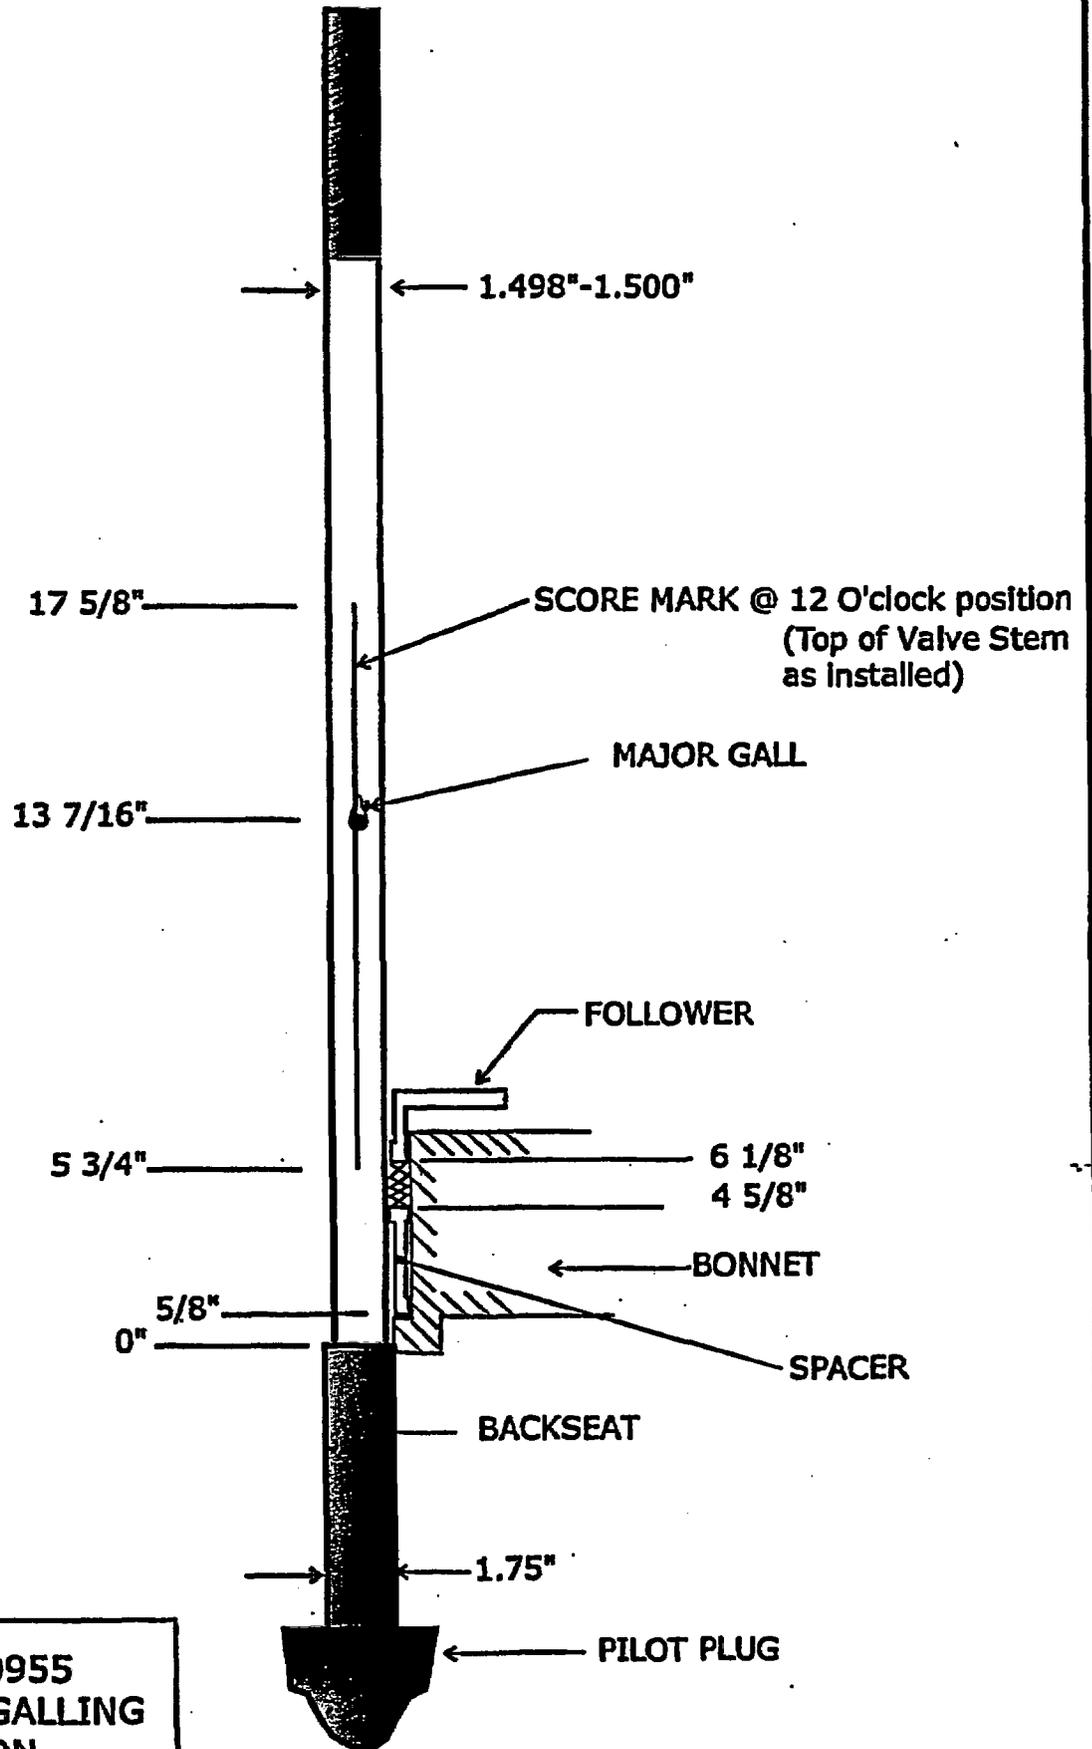
**Attachment F**  
**Sketch of As-found stem condition**

During investigation following a failed as-found LRT for MSIV V2-80B, the valve stem was found galled and bound into packing follower. Stem material was raised up due to scoring at the packing spacer and took up clearances between the stem and the packing follower, resulting in binding. There had been metal-to-metal contact between the packing spacer and the valve stem at the "12:00 position" or "top" of stem. The as-found diametrical clearances of V2-80B packing spacer/stuffing box allowed for metal-to-metal

CR-VTY-2004-0955  
V2-80B STEM GALLING  
CONFIGURATION

The 80B stem material is 17-4 PH stainless steel whose hardness value is approximately Rockwell C 34-36. The packing spacer is carbon steel A105-cadmium plated. The hardness of the packing spacer (A 105) is approximately HB 187 corresponding to a Rockwell B of 91 which is softer than the stem. The silver cadmium plating is relatively soft compared to the stem. The packing follower is made of ASTM A331 GR4140HT which is as hard or harder than the stem depending on the specific heat treatment.

During the first 6-8 strokes of the valve following the repack, the stem was rubbing off the cadmium coating and the carbon steel spacer and thus, when observed by the VY Valve Engineer at 20% power during plant startup, no galling was indicated. The 80B valve was stroked for Tech Spec Surveillances each quarter and stem scoring noted during a Oct 2003 shutdown. The rubbing and friction between the carbon steel spacer and the stainless stem resulted in an accumulation of material on the stem. This material builtup in size and by sticking to the stem was transported to the follower and when it exceeded the radial clearance (.005inch) was stopped by the follower. The hardness of the carbon steel was increased by work hardening until it resulted in the observed score

Immediate corrective actions in RFO24 included modification of the stuffing box configuration to utilize a custom fit carbon packing spacer in lieu of the cadmium plated carbon steel standard packing spacer and increased clearances in the backseat and packing follower areas.
