BATTELLE COLUMBUS LABORATORIES
USNRC
EVENT REPORT

PART I
Initial Discovery/Notification

1. Date/time the event was discovered: August 4, 2004 7:40 AM
2. Date/time the event occurred, if different than the date of discovery: Same as #1
3. Describe the event:

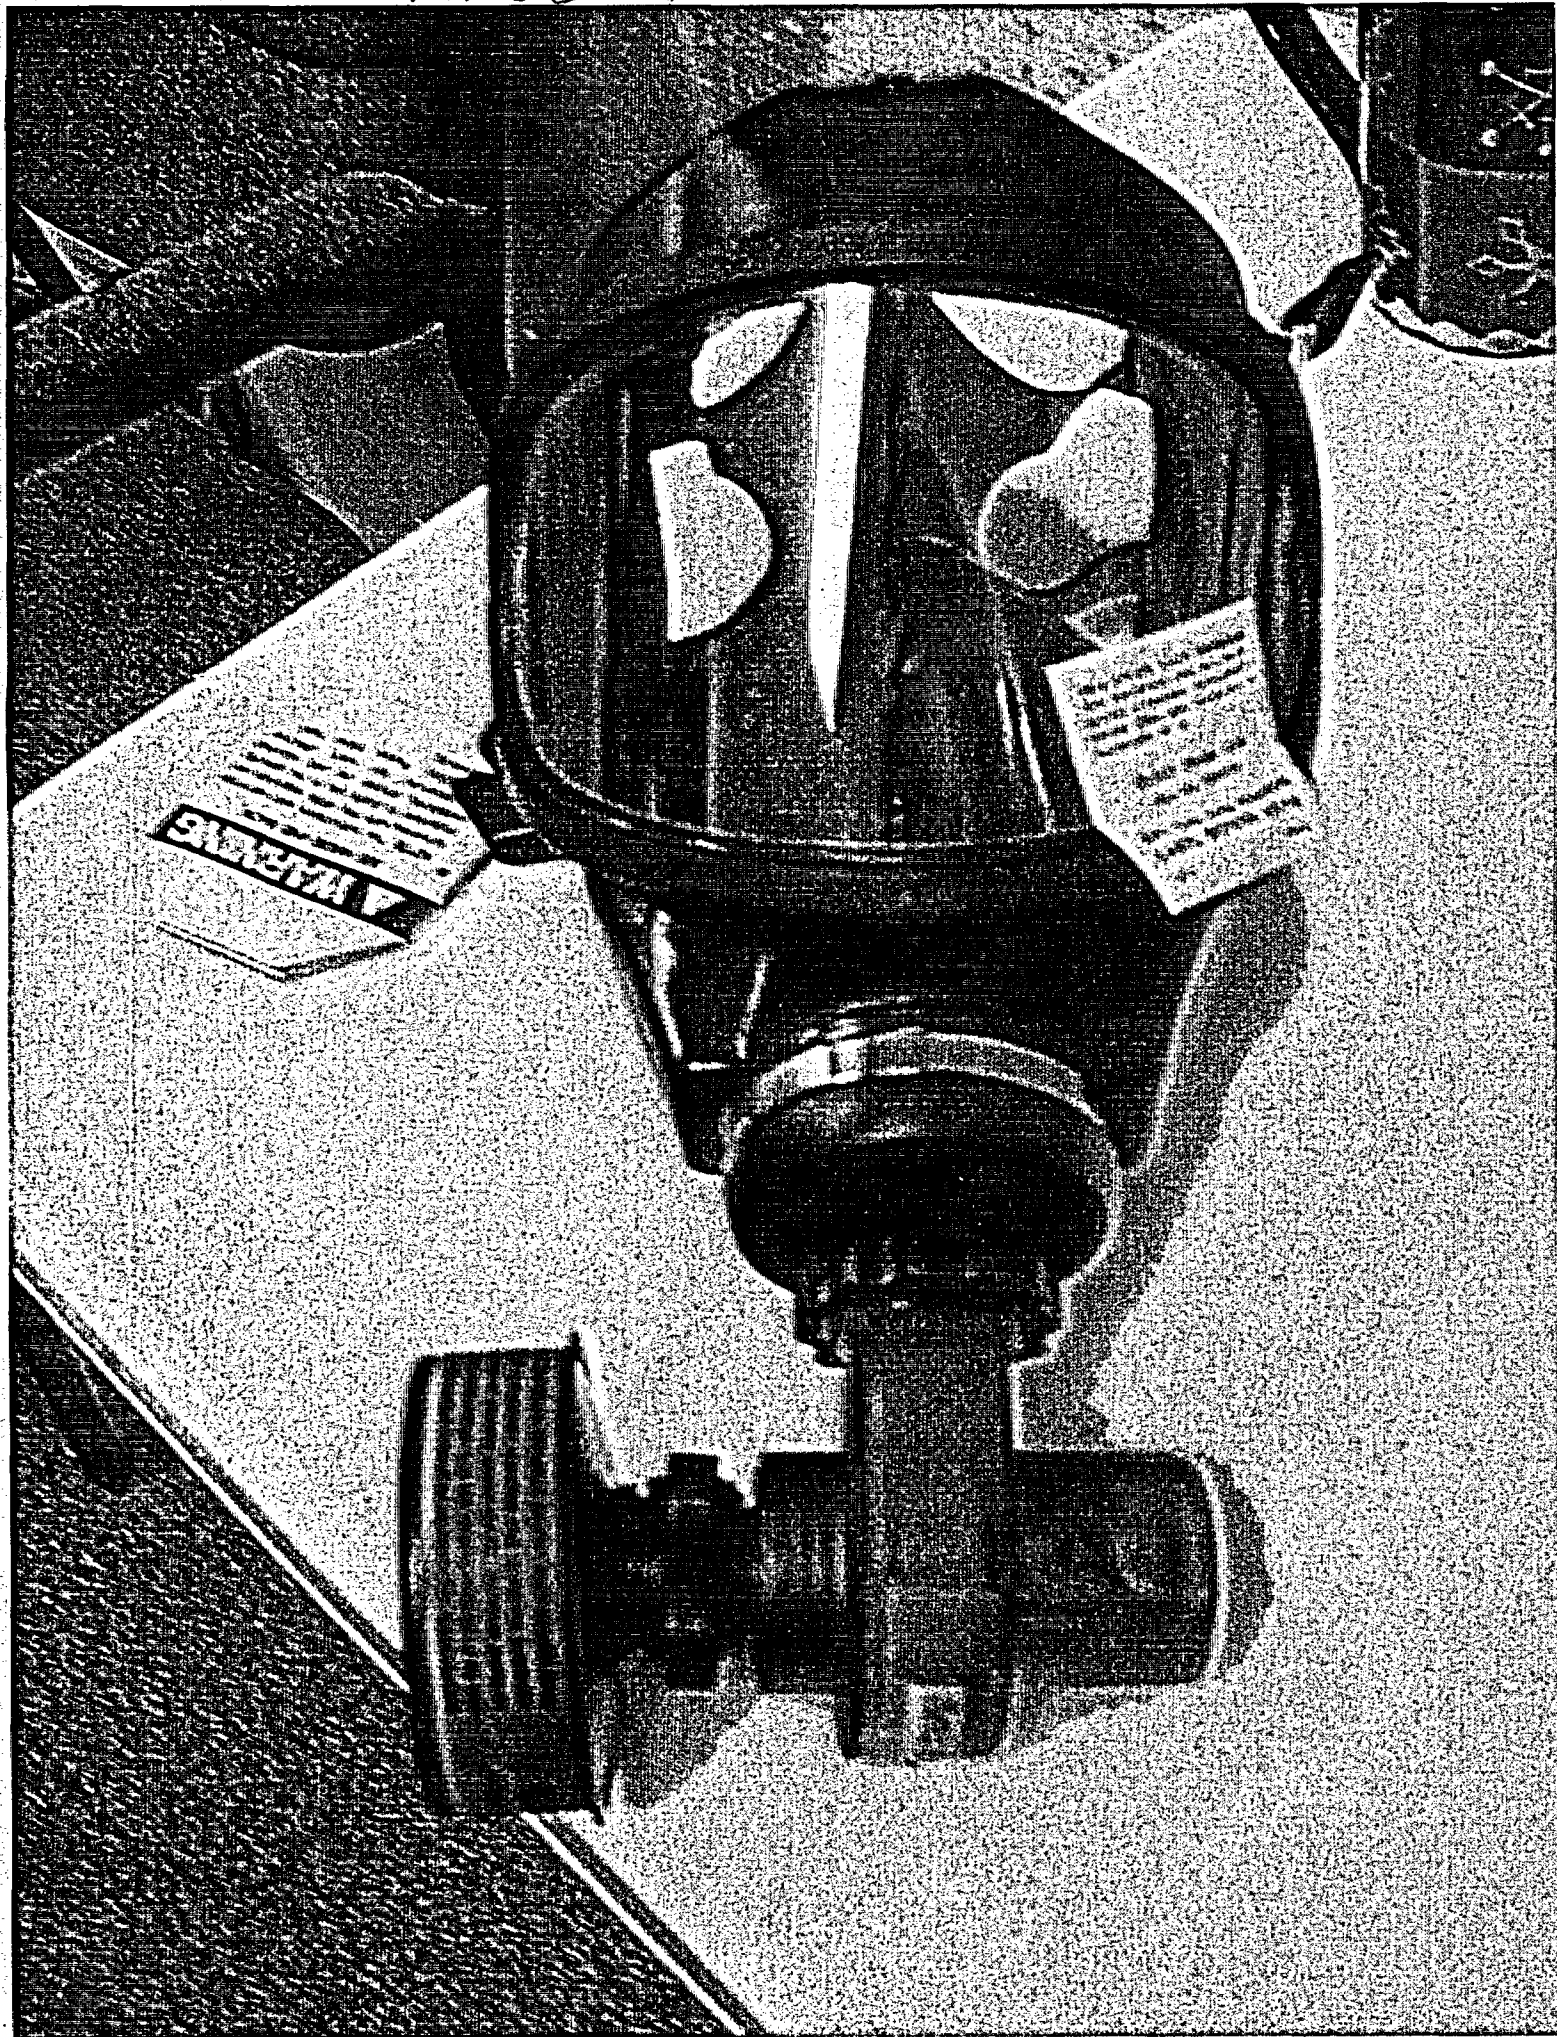
Individuals assigned to perform work activities in the High Energy Cell (HEC) were observed by the Respiratory Protection Program Administrator (RPPA) using the MSA OptimAir MM 2K Mask Mounted Powered Air Purifying Respirator (PAPR) in a configuration that is not approved by the manufacturer. The configuration that was observed to be in use was as follows: the motor- blower housing (P/N 10022695) was threaded into the MSA Ultravue face piece with a MSA P100 Ultrafilter filter (P/N 816255) attached to a coupling nut adapter assembly (P/N 96547) that was threaded into the motor-blower housing. See photograph 1, titled incorrect configuration. The assigned crew, two laborers and one Health Physics Technician, were instructed to exit the HEC by the RPPA. The crew spent approximately fifteen minutes in the HEC. During the initial fact finding assessment, it became evident that the use of the incorrect configuration of the PAPR was not limited to the observed use in the HEC. The incorrect configuration had also been used periodically for work in the High Level Cell/Low Level Cell filter box removal effort and previous work in the HEC dating back to when the PAPR was introduced for use on site on July 6, 2004. On several occasions it was observed that the correct configuration of the PAPR was used in these work locations. It is evident that both the incorrect configuration and correct configurations were used intermittently throughout the work evolutions requiring PAPR protection. In the instances where the incorrect configurations were used it was cited that the correct filters, Optifilter Type HE (P/N 495692), were not available. Individuals were questioned on the performance of prerequisite inspections and checks of the PAPR units. Individuals stated that they had performed the required face-piece negative and positive pressure fit checks prior to use and a flow test of the motor-blower had been performed. The flow test of the incorrect configuration was performed with a MSA flow check meter (P/N 487995) to verify the statements made by the laborers and the health physics technicians. In all cases, the incorrect configuration passed the pre- use tests.

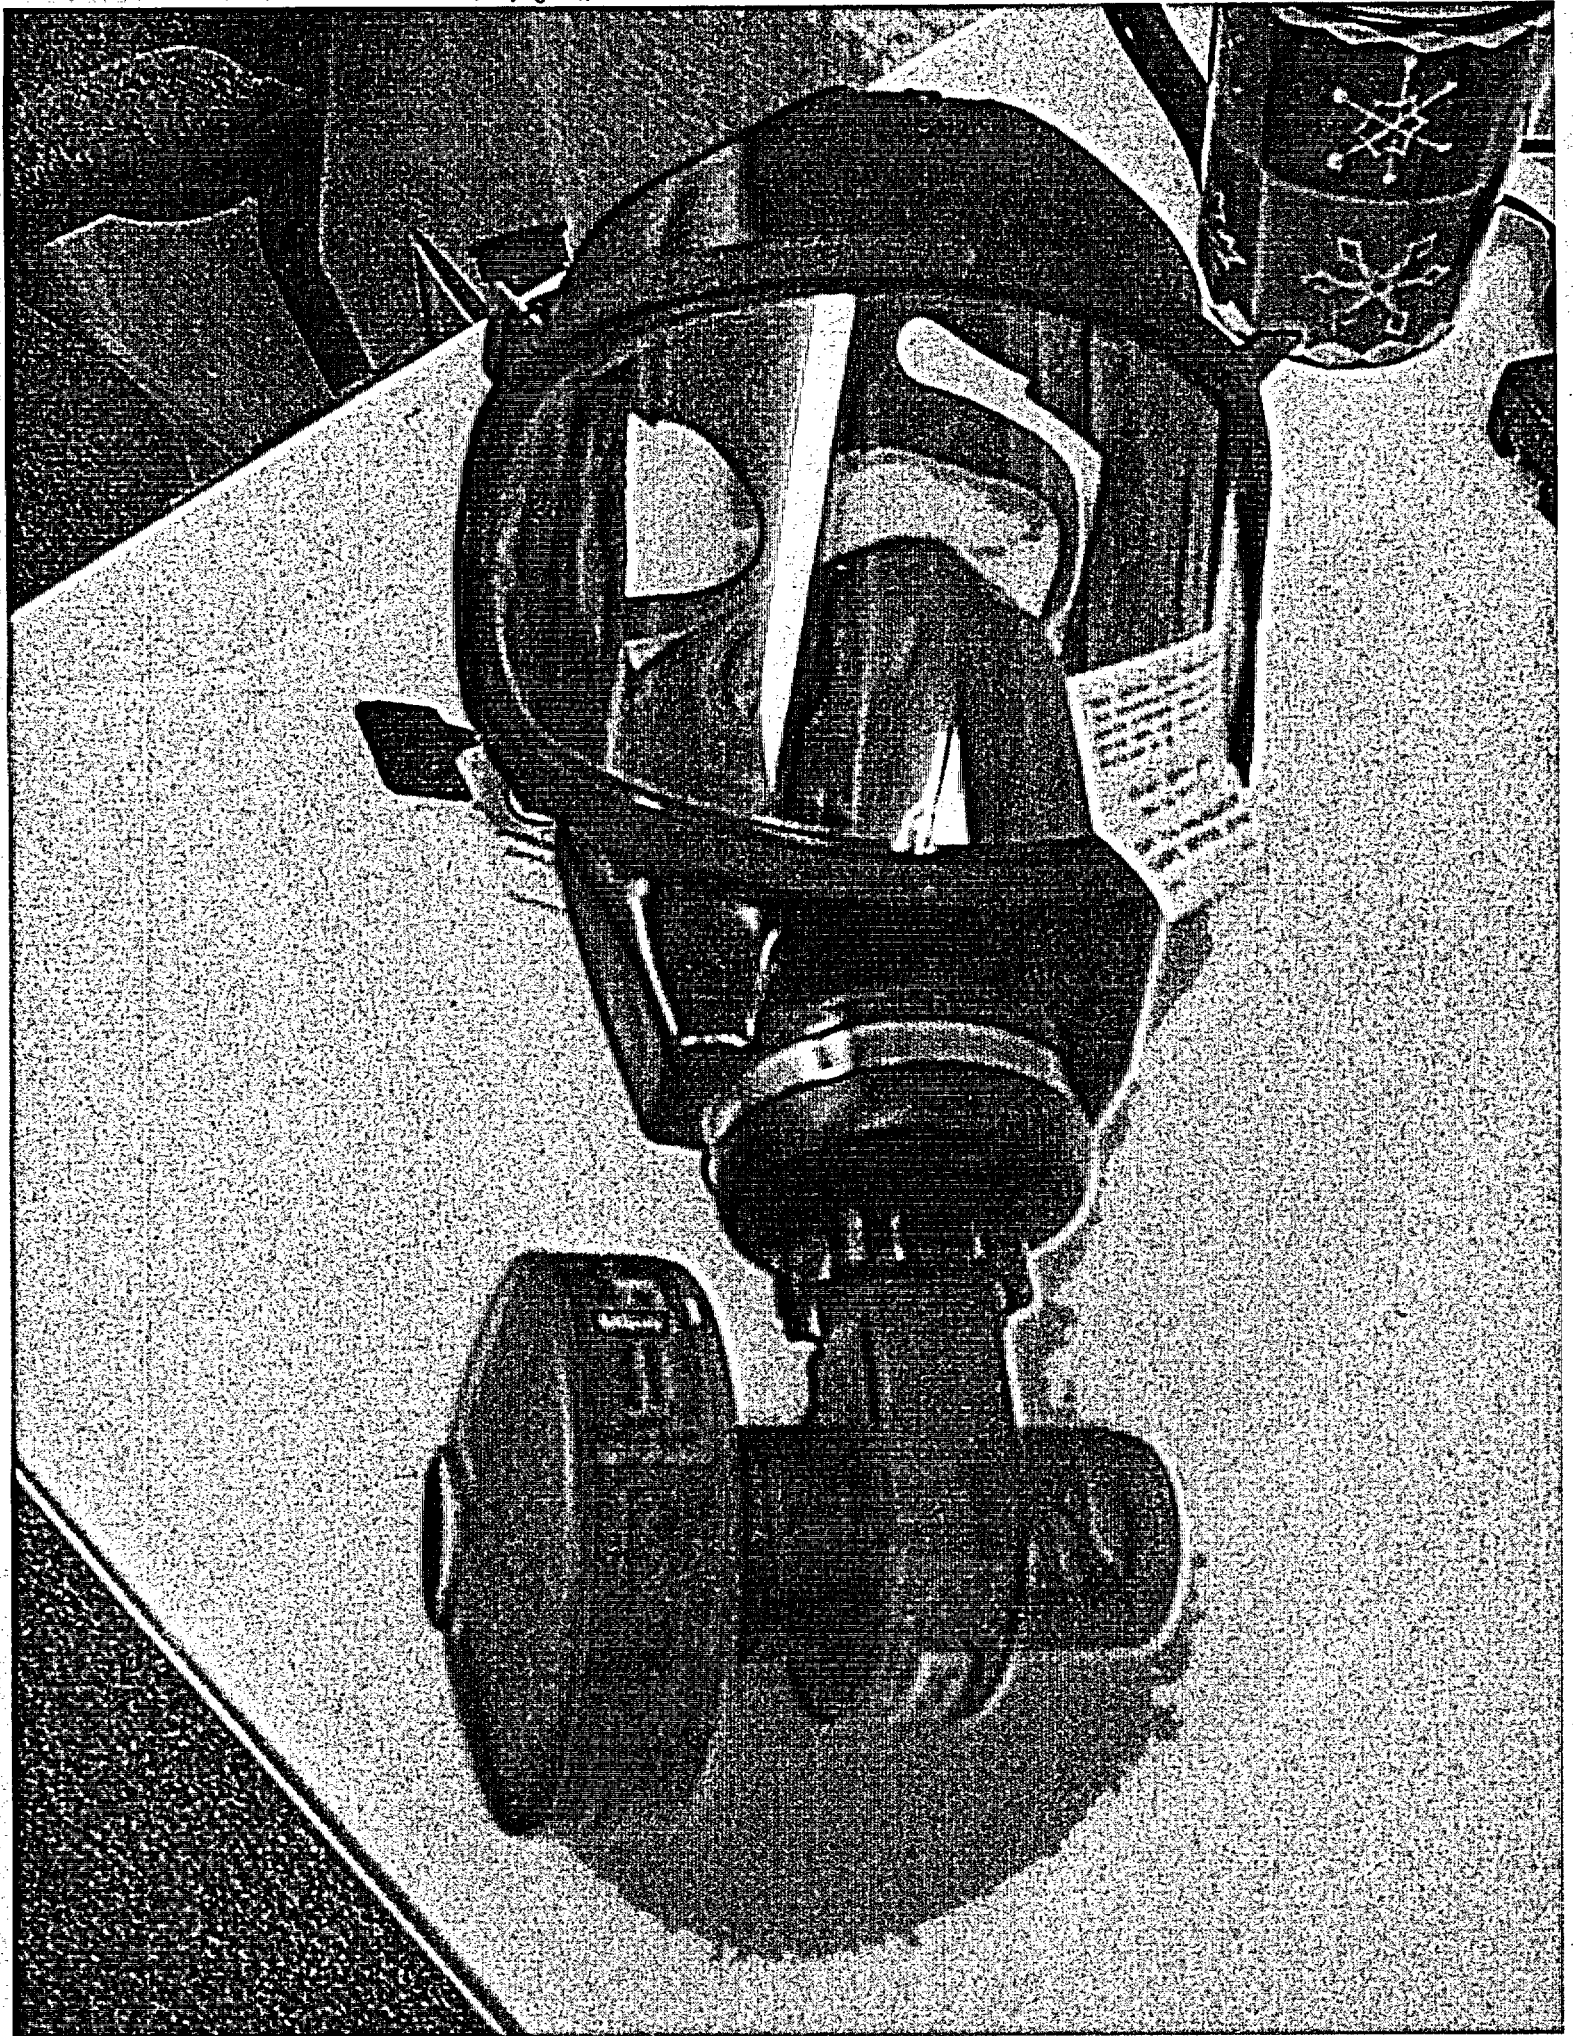
PHOTO 2

The correct configuration for the mask mounted PAPR is as follows; the motor-blower housing (P/N 10022695) threaded into the MSA Ultravue face-piece with a MSA Optifilter Type HE filter cartridge (see photograph 2), or Type HE particulate filter (P/N 48707). These are the only approved high efficiency particulate air filters for the mask mounted PAPR.
