Operational Safety Issues

Significant Events Review: Examples

S S Bajaj

Significant Events Review

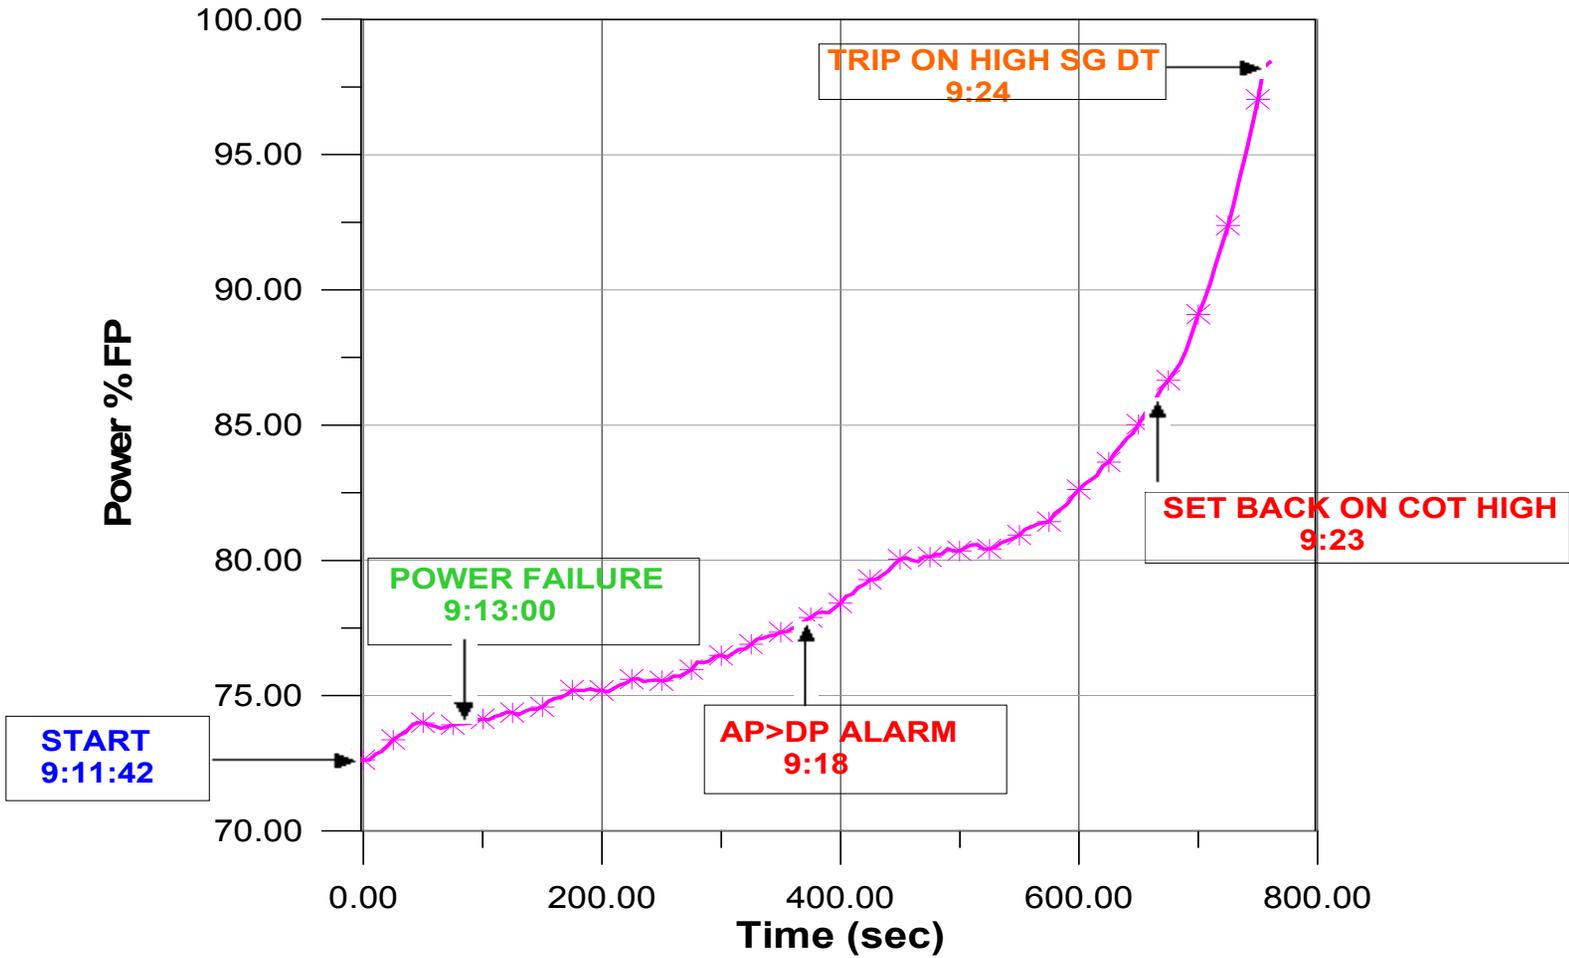
Fig-1 : Variation of Actual Reactor Power

Analysis of KAPS Incident of March 10,2004

POWER CURVE

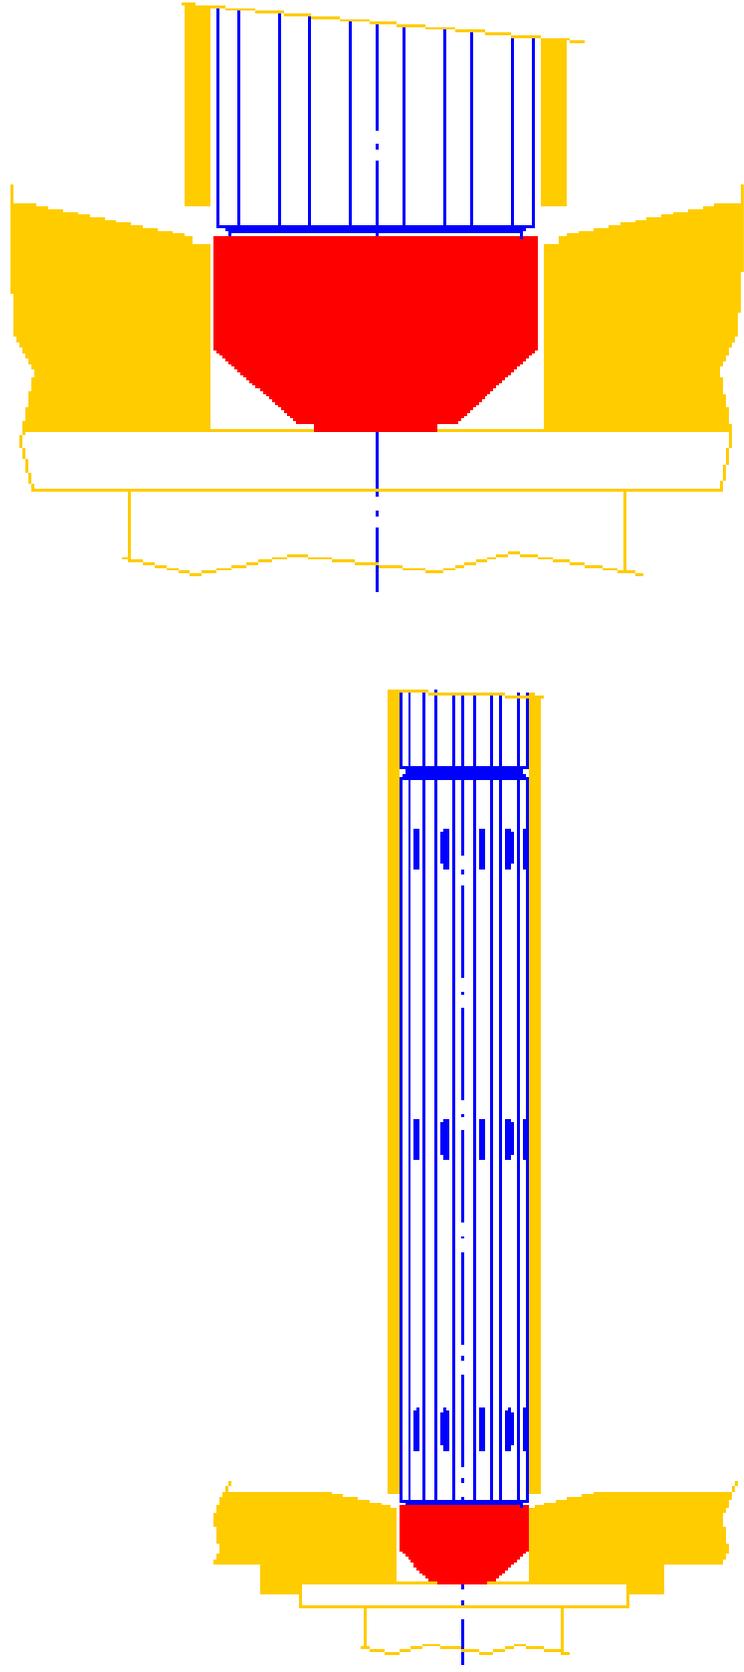
POSITION OF K-11 CHANNEL NEW BUNDLES IN TM AFTER LOADING BY RAM CJ

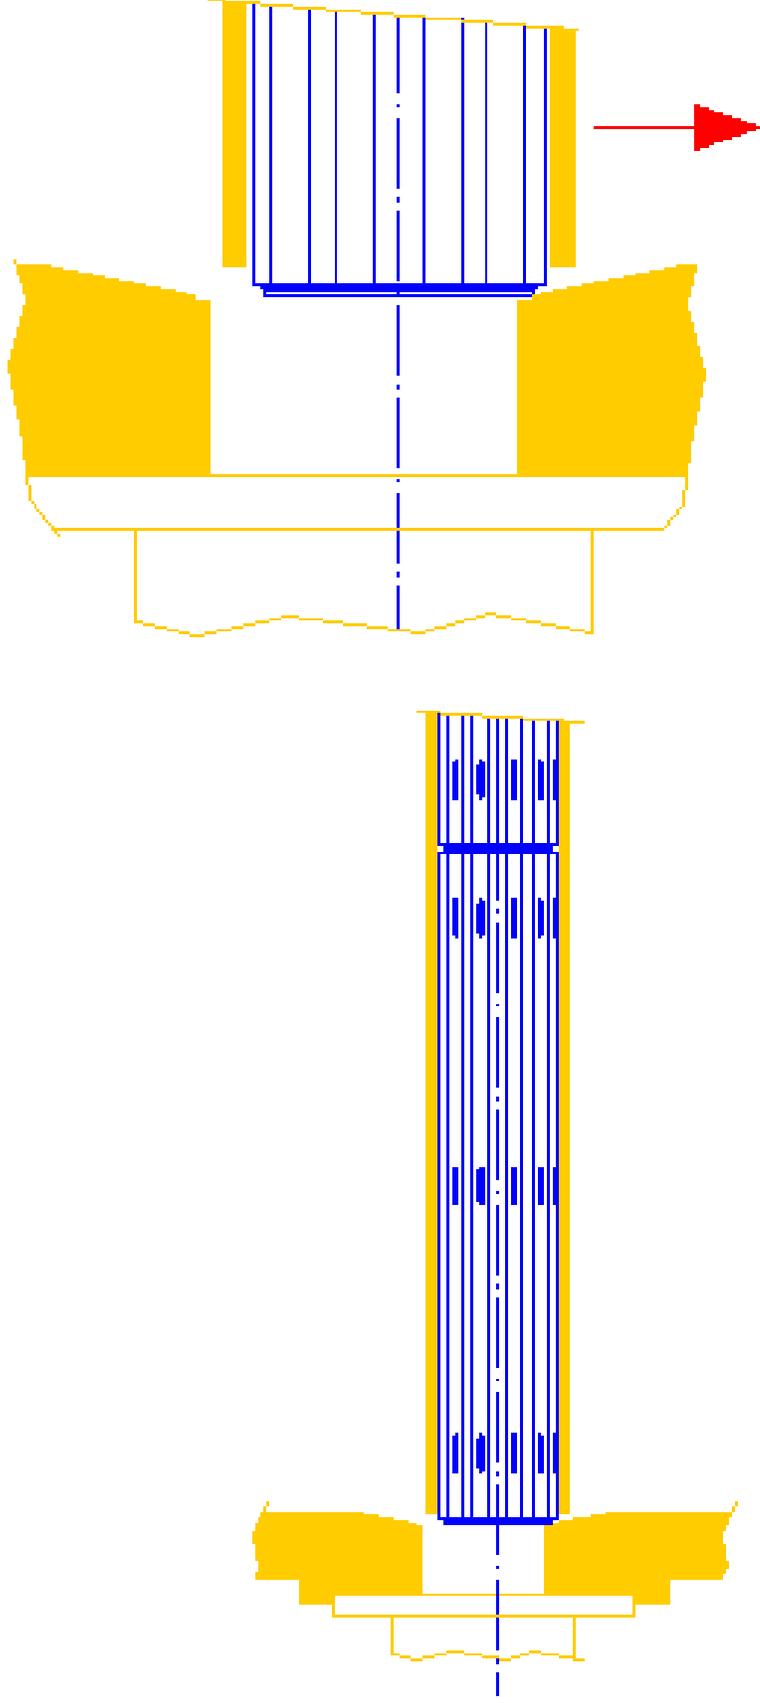
- VISUAL INSPECTION REVEALED THAT THE END PLATE OF THESE BUNDLES TOWARDS RAM CJ WAS FOUND DEFORMED.

THE END PLATE OF REAR BUNDLE HITS THE EDGE
OF TM FUEL GUIDE AS TM CARRIAGE MOVES DOWN

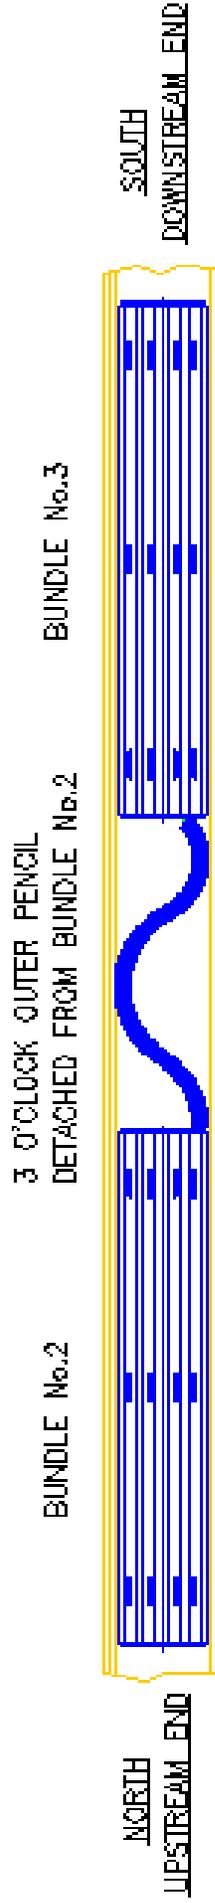
PENCIL BENT DUE TO APPLICATION OF B RAM FORCE 3
(SHAPE OF PENCIL CONSTRICTED BASED ON SITE FEED BACK)

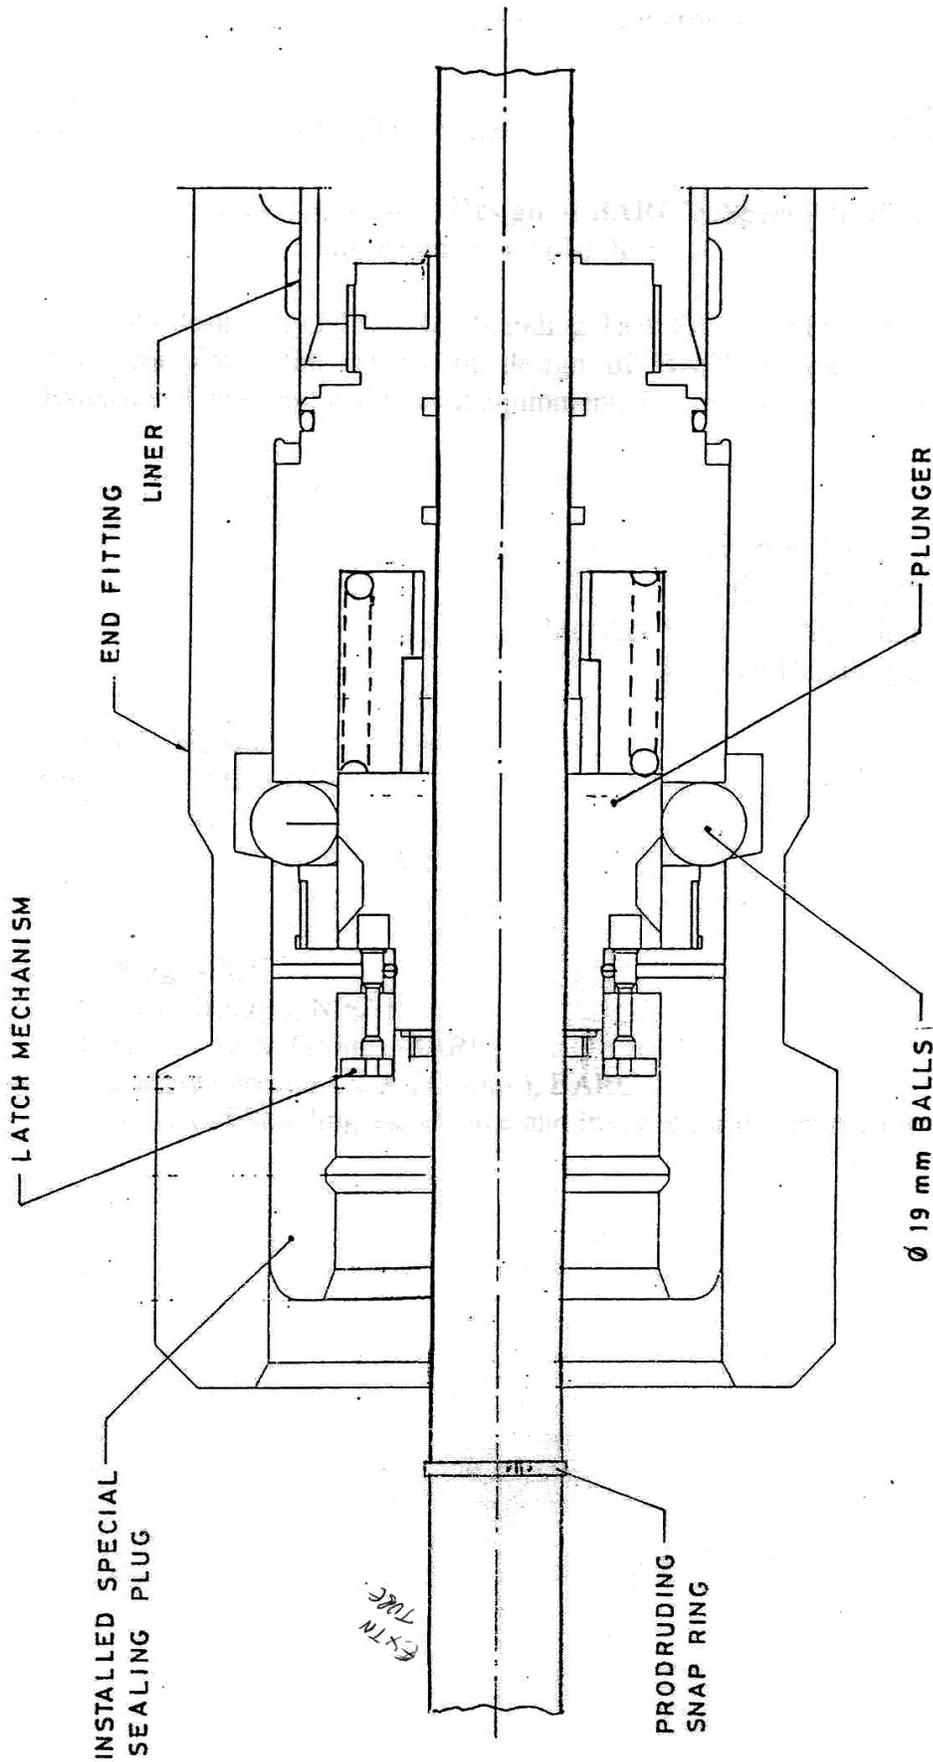
INTERACTION OF PROTRUDING SNAP RING WITH SPECIAL SEALING PLUG

- **Restart of unit permitted only after full review of incident**
- **BARCIS tool prohibited from use till its design review and necessary modifications**
- **Strengthening of formal system of qualification of components/ tools developed for use in reactor**
- **Revised requirements for re-maintenance/ testing of BARCIS between uses**
- **Unavailability of moderator circulation during work on PHT System was deviation from normal practice necessitated addition of light water to PHT D2O during incident, with consequent downgrading**

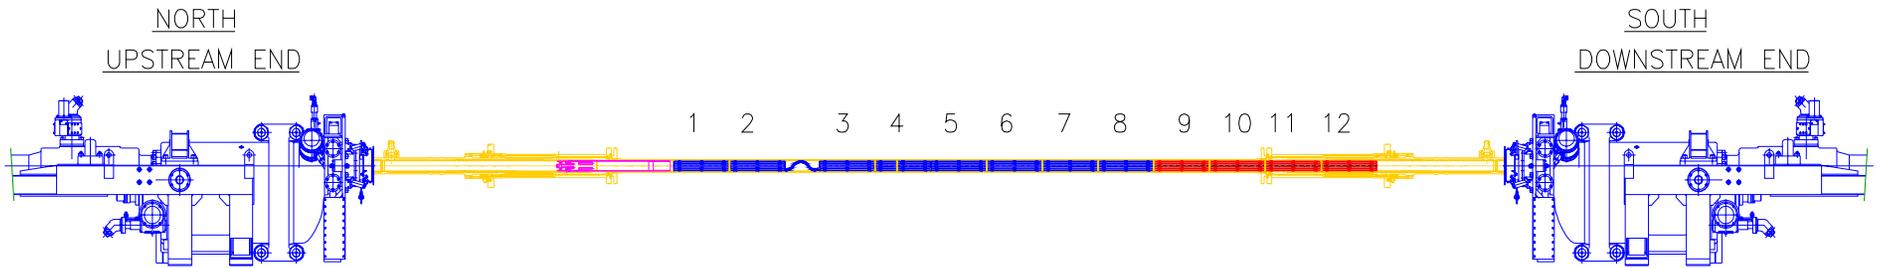
DOWN STREAM FM FAILS TO INSTALL SHIELD PLUG

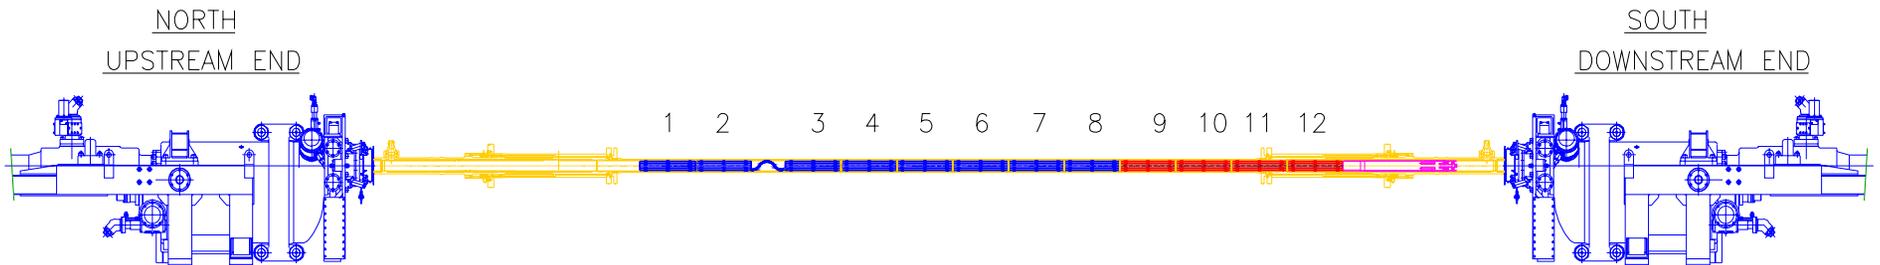
UPSTREAM SHIELD PLUG REMOVED & DOWN STREAM PLUG INSTALLED
