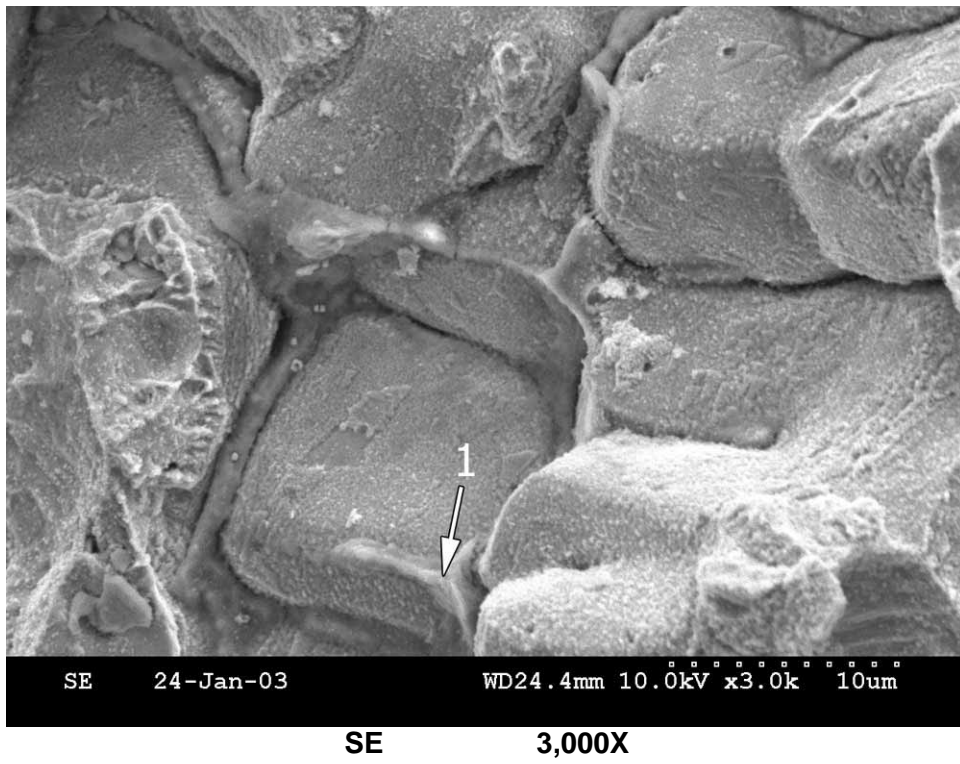
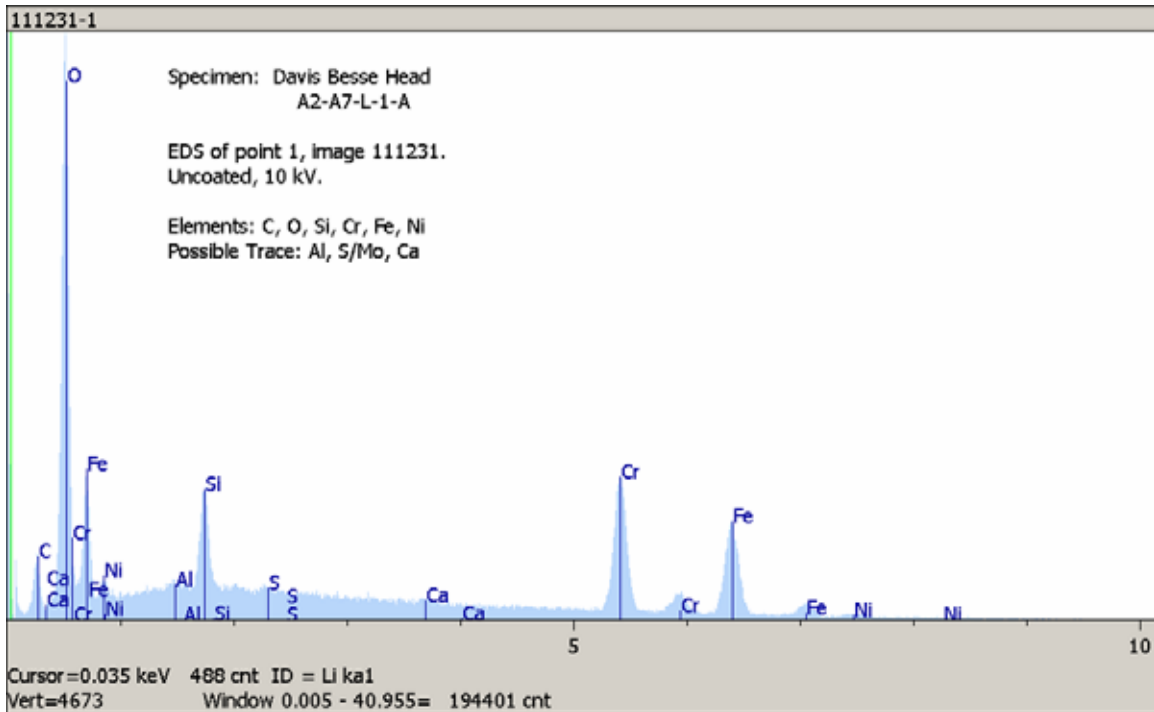
Figure 6.4.1.8: Higher magnification SE micrograph and EDS results for a grain boundary deposit near area "E". This area contained primarily carbon, oxygen, silicon, chromium, iron, and nickel. Lesser amounts of aluminum, sulfur, and calcium were also detected.

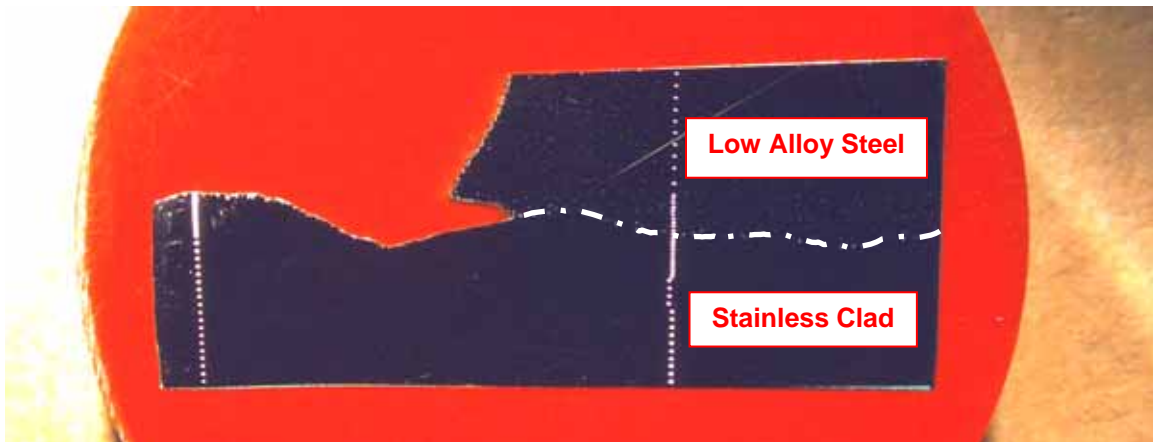
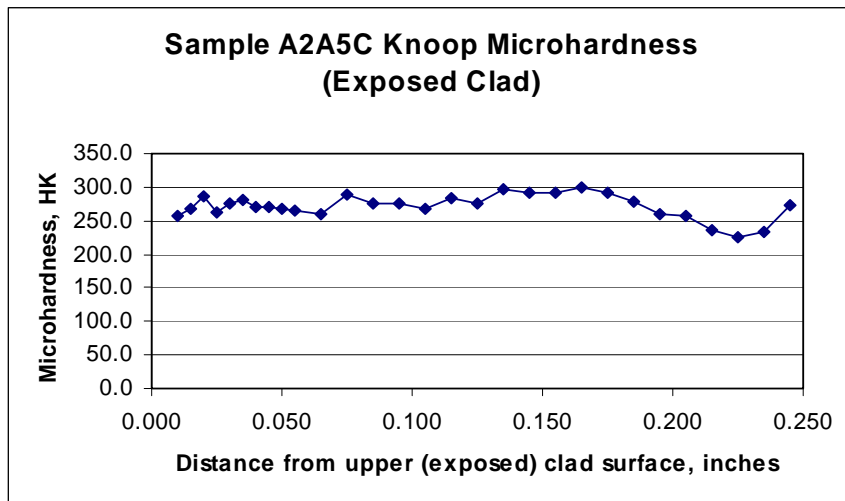
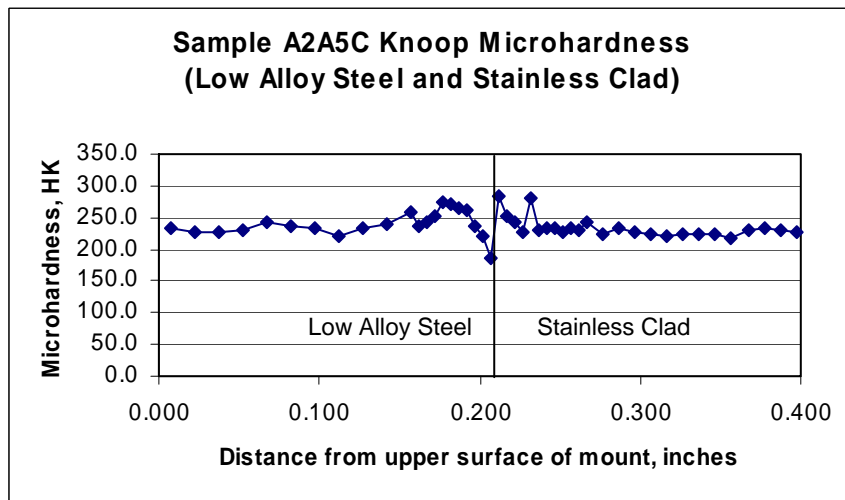
Figure 6.5.1.1: 4X macro photograph of metallographic mount A2A5C, along with Knoop microhardness data. Refer to Figure 5.13 for the sample orientation. The two Knoop microhardness traverse lines are visible in the macro photo. The significant microhardness variations occur in the heat affected zone of the low alloy steel and the cladding adjacent to the fusion line.

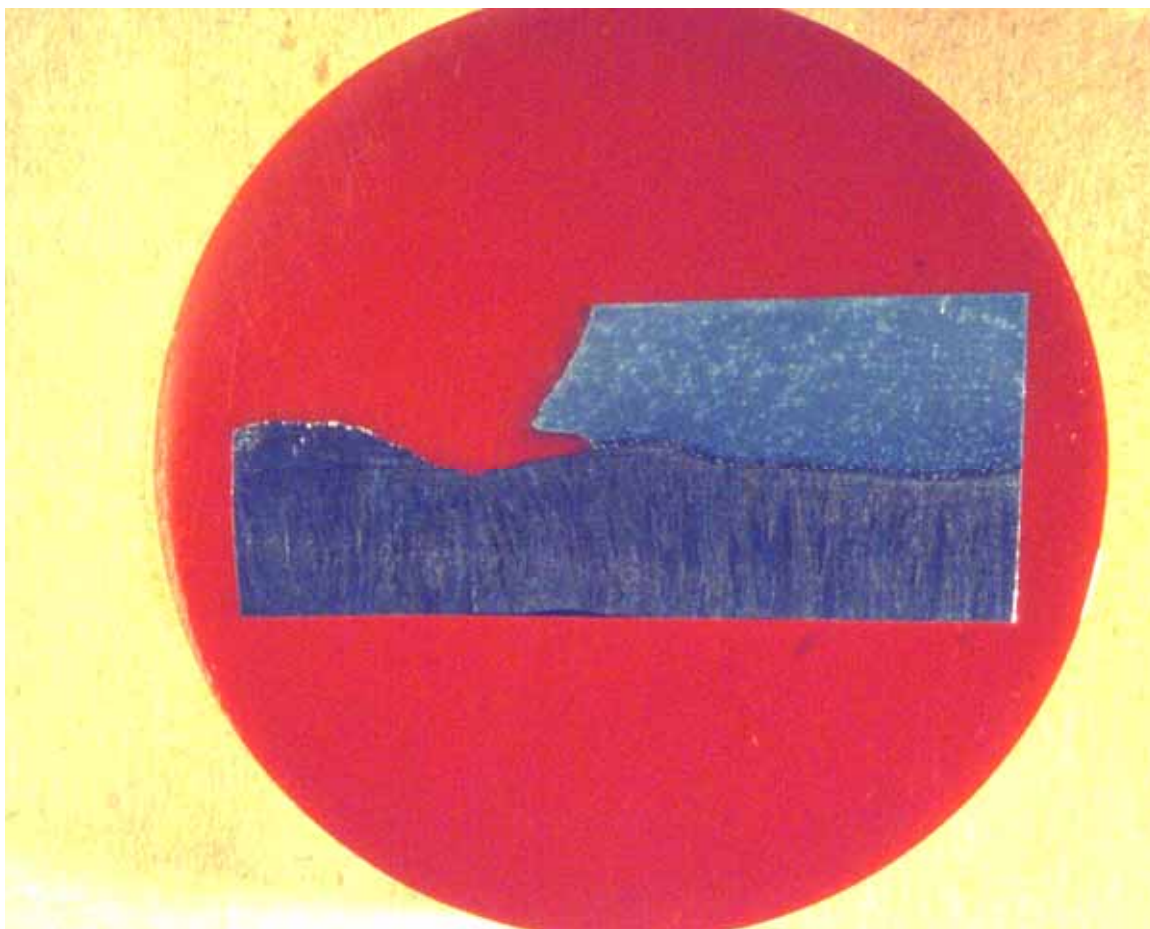
4X

Figure 6.5.1.2: Low magnification photograph of mounted sample A2A5C after chemical etching to reveal the cladding microstructure. It did not appear that a weld deposition change occurred in this region.

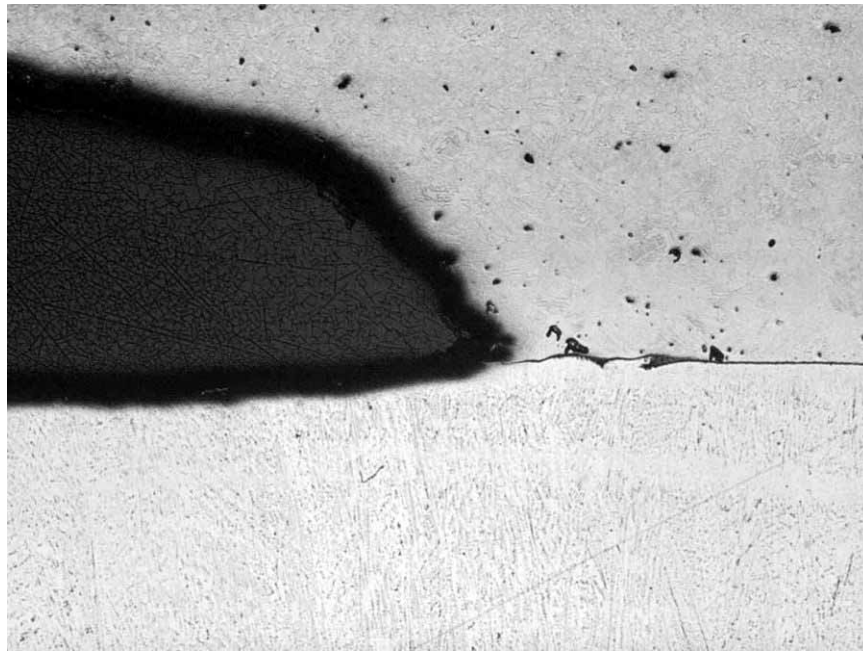
Etched 48X

Figure 6.5.1.3: Micrograph showing the undercutting due to boric acid corrosion in the RV head low alloy steel at the interface between low alloy steel (above the notch) and stainless steel cladding (below the notch).

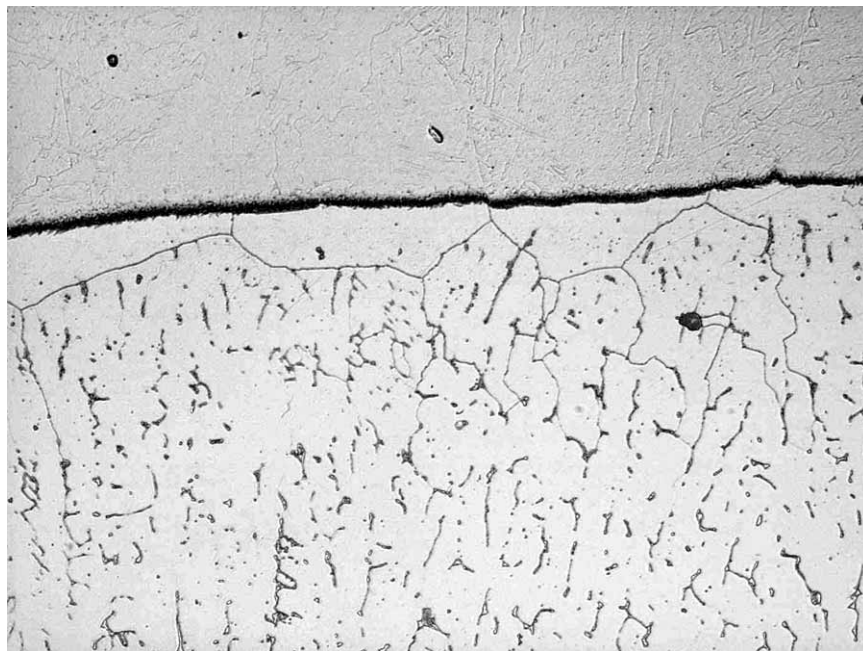
Etched 375X

Figure 6.5.1.4: Micrograph showing the interface between low alloy steel (above) and stainless steel cladding (below). The austenitic grains in the first interface layer on the stainless steel cladding side are equiaxed and growing preferentially from the ferrite grains (low alloy steel). The subsequent grain growth in the cladding is columnar.

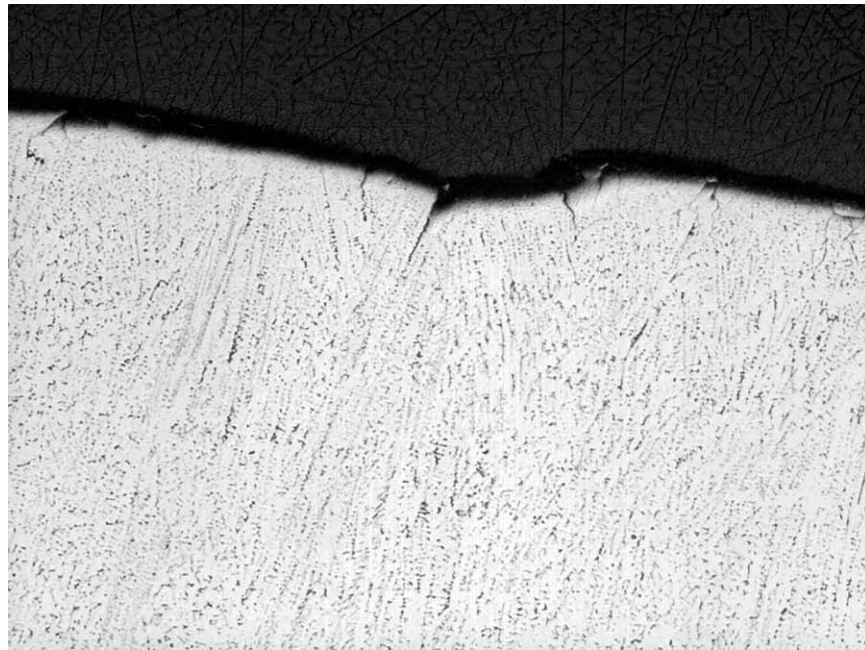
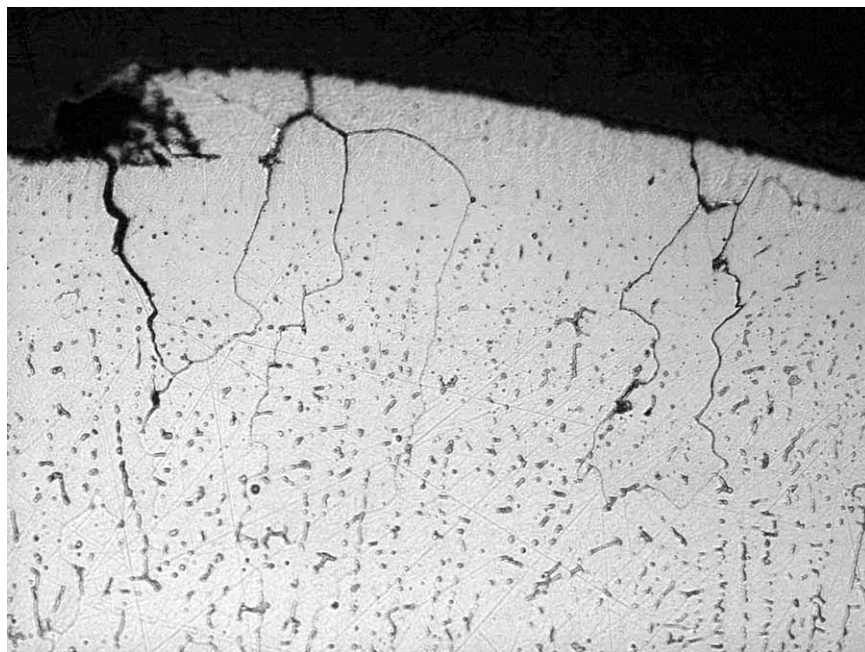
Figure 6.5.1.5: Micrographs of the cladding surface exposed due to boric acid corrosion of the RV head low alloy steel. Intergranular attack (IGA) of stainless steel cladding to a depth of the first or second layers of grains is clearly visible. The IGA is probably due to oxygenated and highly concentrated boric acid. There was no evidence of plastic deformation observed in the cladding in this area.

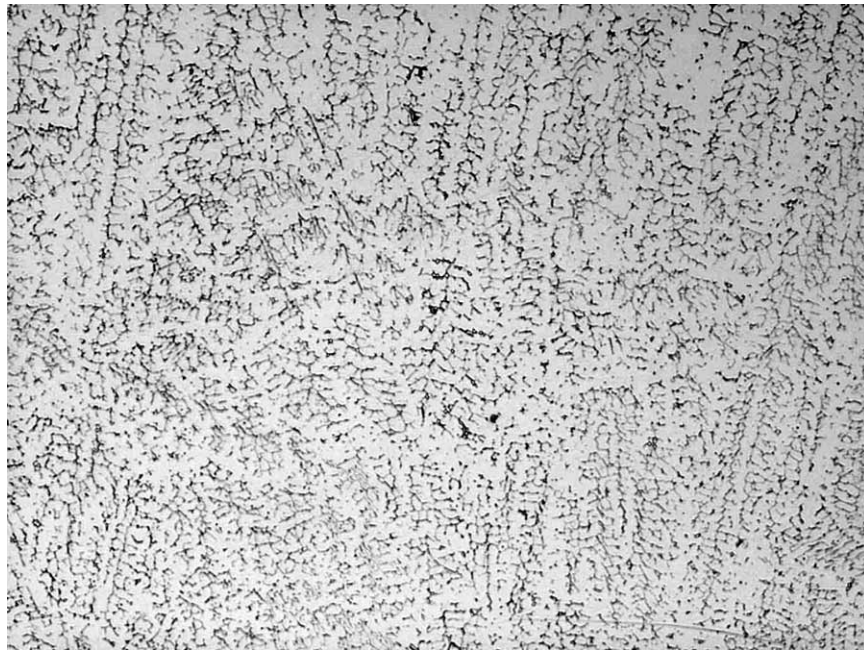
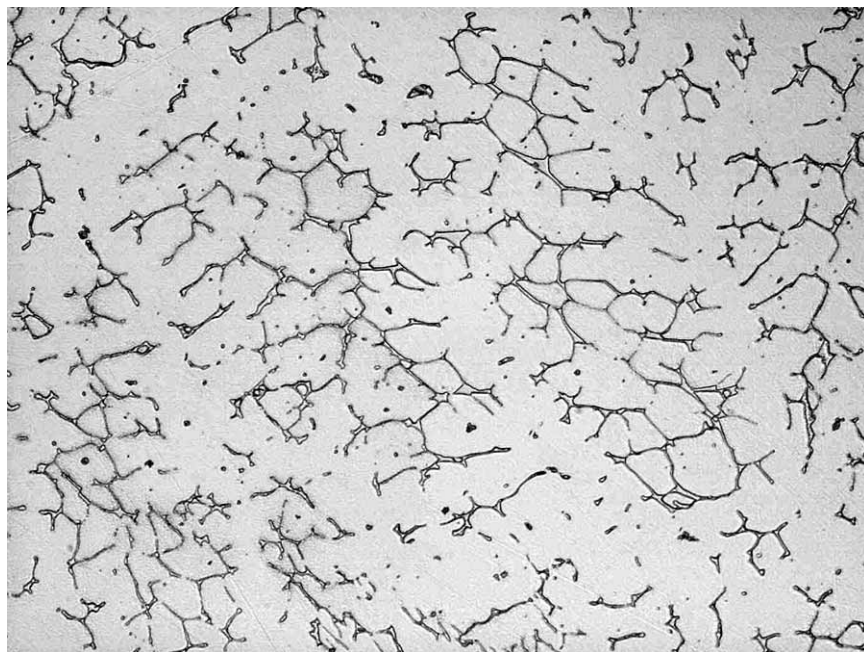
Figure 6.5.1.6: Micrographs showing typical stainless steel cladding microstructure. The dendritic solidification structure is delineated by small pools (or islands) of ferrite in an austenitic matrix.

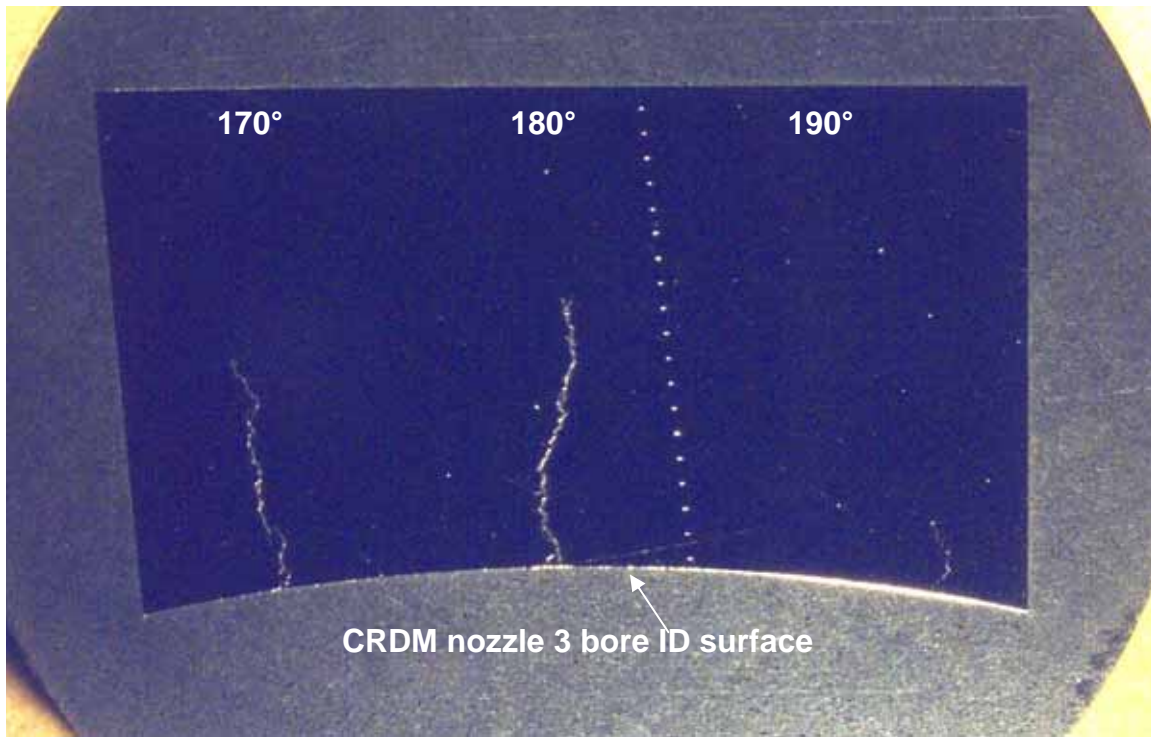
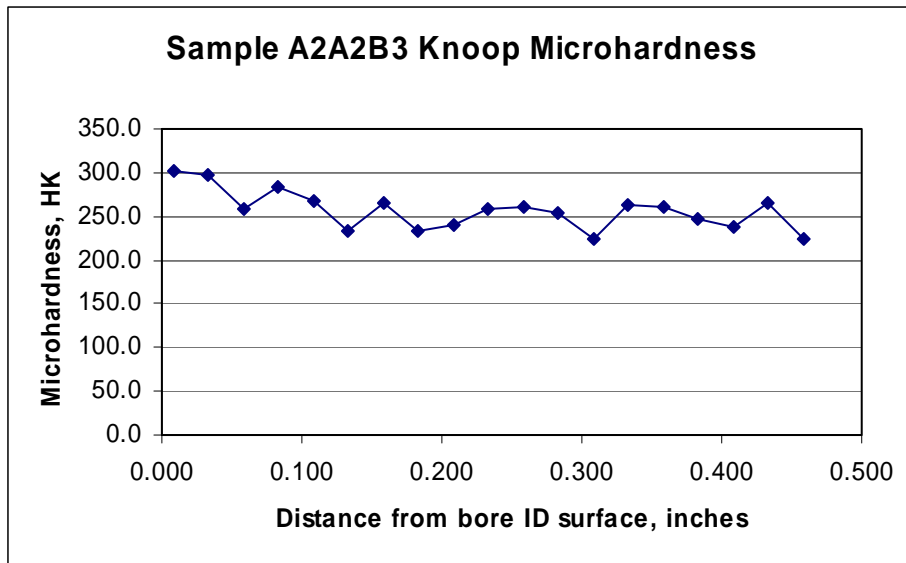
6X

Figure 7.1.1.1: Macro photograph and Knoop microhardness results for metallographic sample A2A2B3 (see Figure 5.2 for the sample orientation). The lower concave surface is the I.D. of the nozzle 3 bore from the nozzle removal process. The crack tips of the two cracks are estimated to be approximately 0.24" and 0.20" below the surface, respectively. The indentations from the microhardness traverse are visible. The elevated microhardness level near the surface is due to the surface cold work layer from the boring of nozzle 3 removal process (see Figures 5.2 and 7.1.1.5).

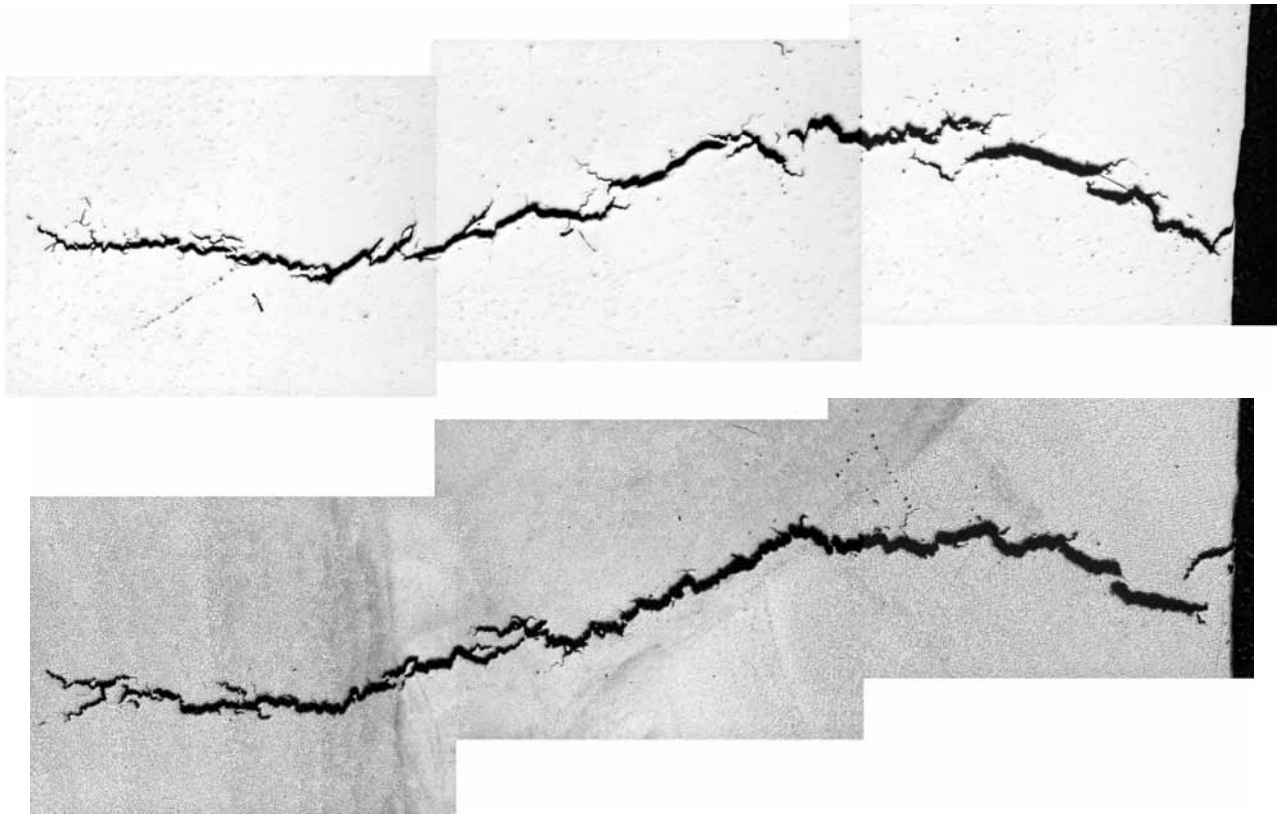
Figure 7.1.1.2: Micrographs showing the crack at ~180° in sample A2A2B3. Top as-polished, bottom etched. Both micrographs 24X.

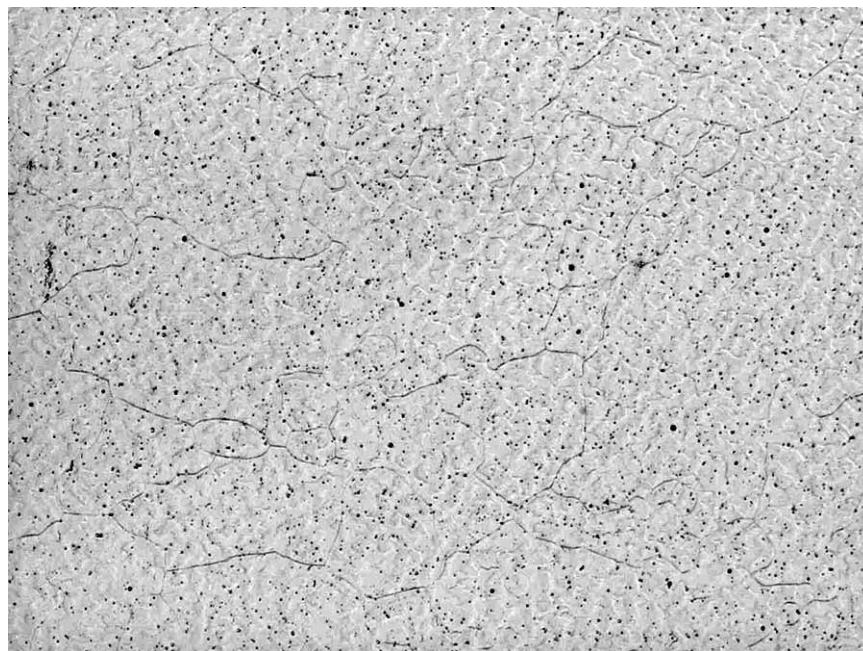
Etched 375X

Figure 7.1.1.3: Typical microstructure of sample A2A2B3. The grain size and dendritic structure within each grain are consistent with typical Alloy 182 weld.

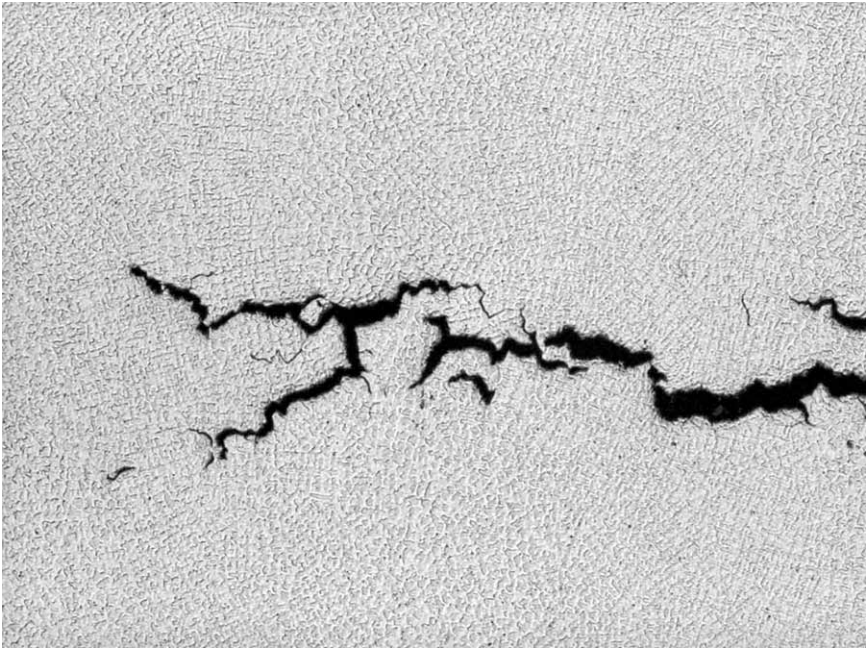
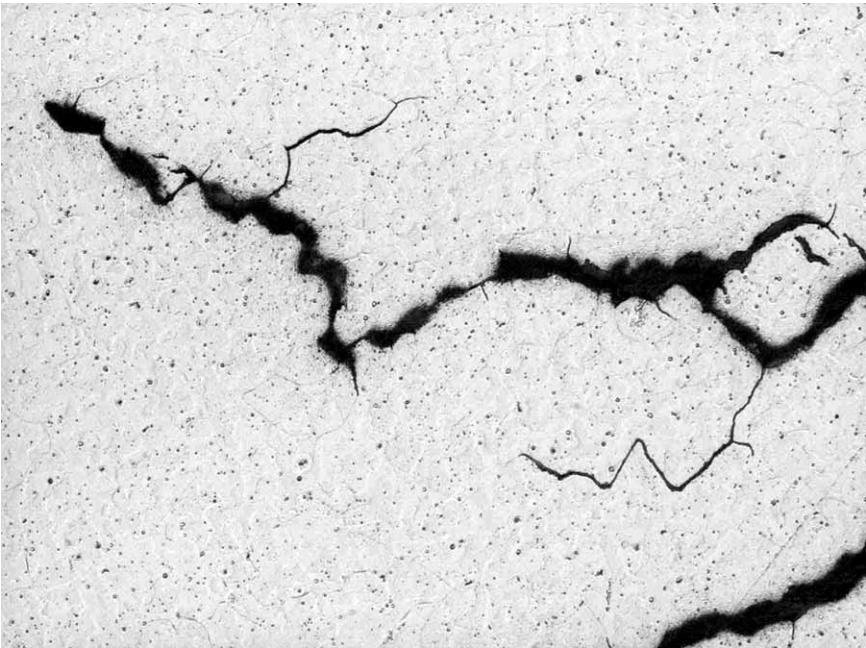
Figure 7.1.1.4: Higher magnification micrographs of the crack tips. Cracking is intergranular or interdendritic.

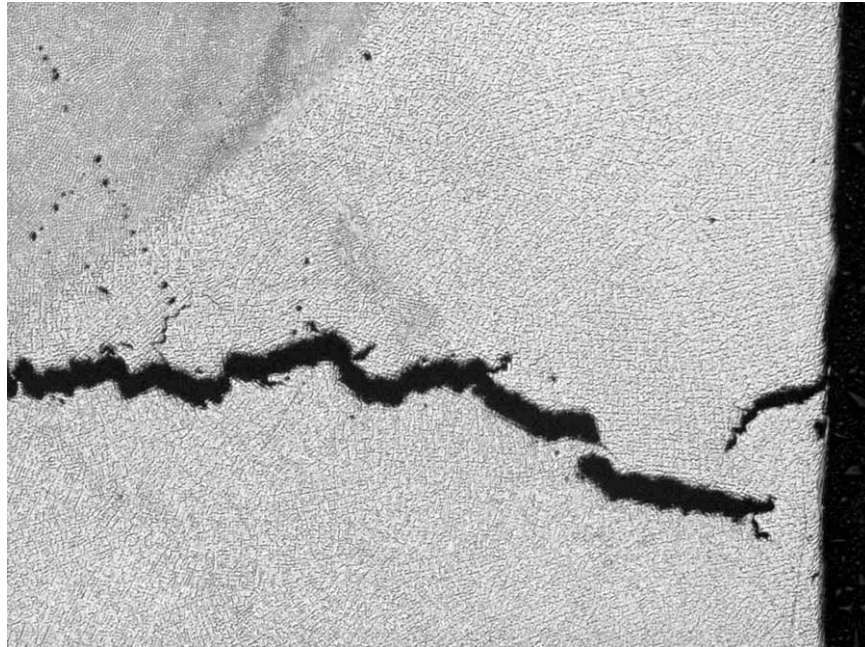
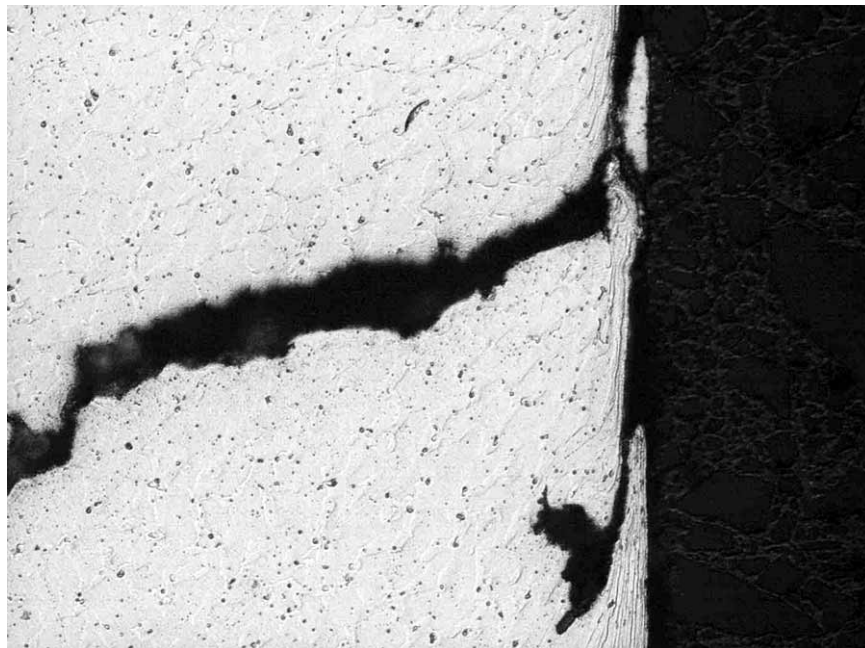
Figure 7.1.1.5: Higher magnification micrographs of the cracking at $\sim 180^\circ$ near the bored surface. The bored surface shows evidence of surface cold work. The surface cold work is due to the nozzle removal from the RV head and is not related to the J-groove weld fabrication process.

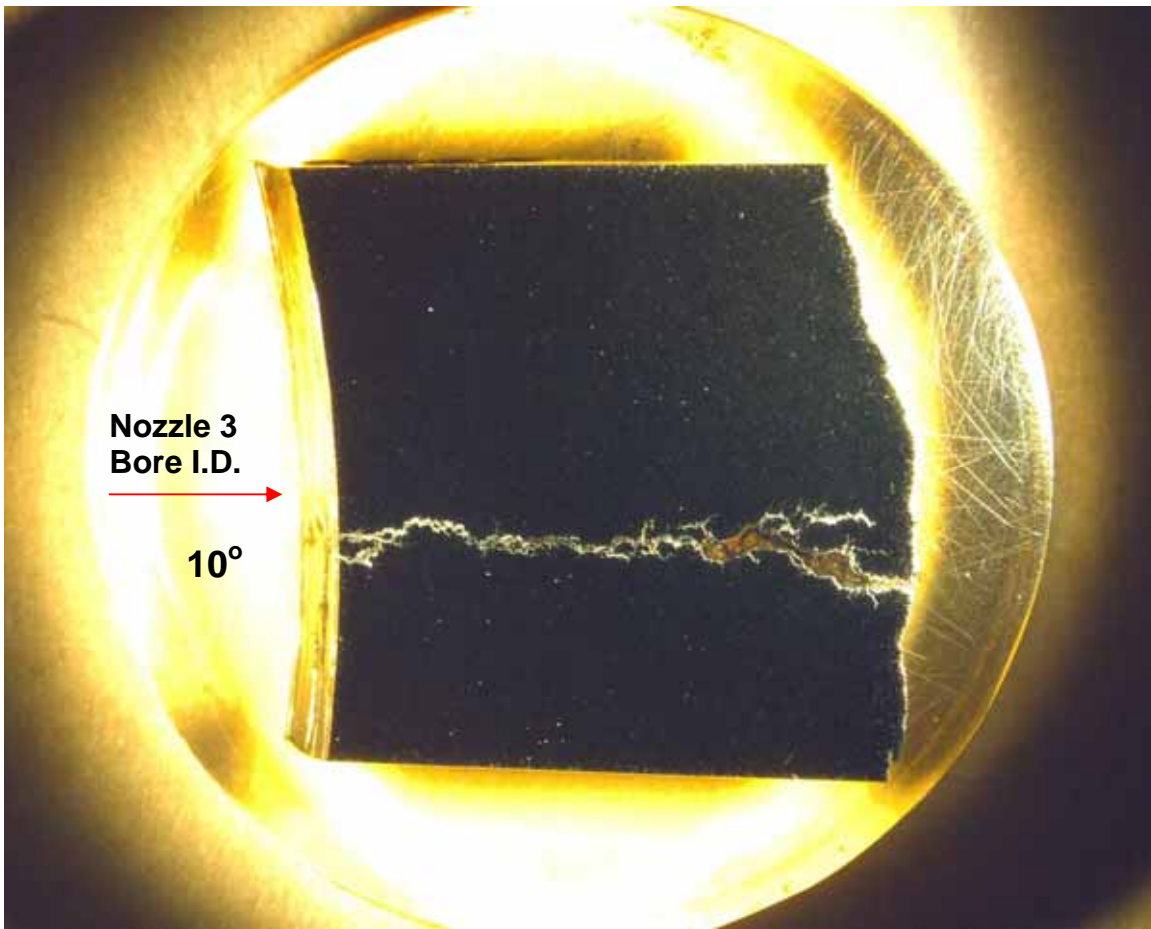
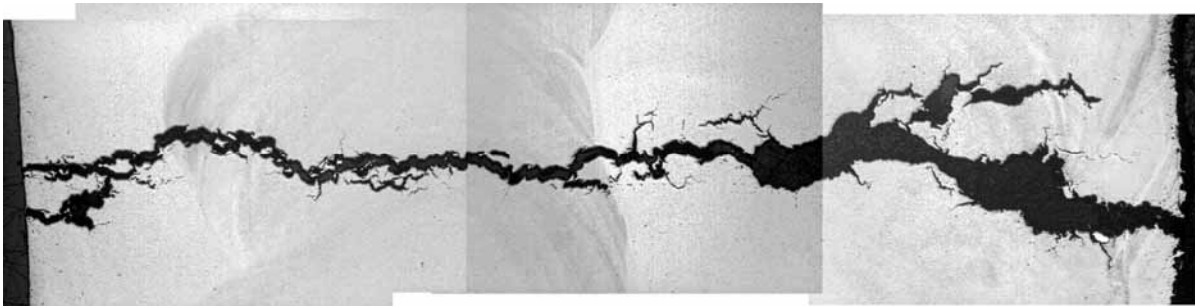
Figure 7.2.1.1: Macro photograph of metallographic mount sample A2A6B2 (see Figures 5.4 and 5.5 for the sample orientation). The axial cracking at $\sim 10^\circ$ is through the J-groove weld, in contrast to the cracking near 180° , which was partially through the weld. A slightly higher magnification micrograph is also provided.

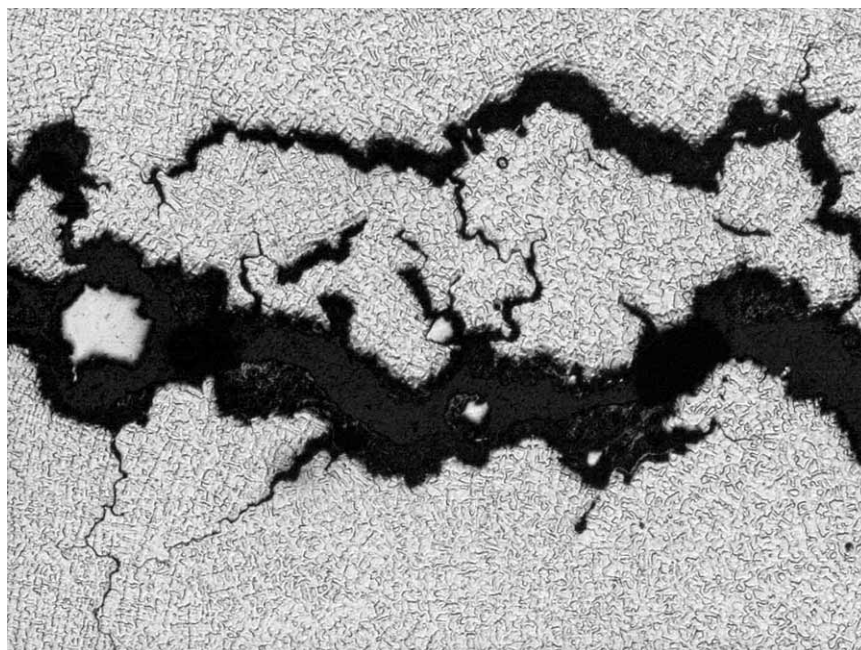
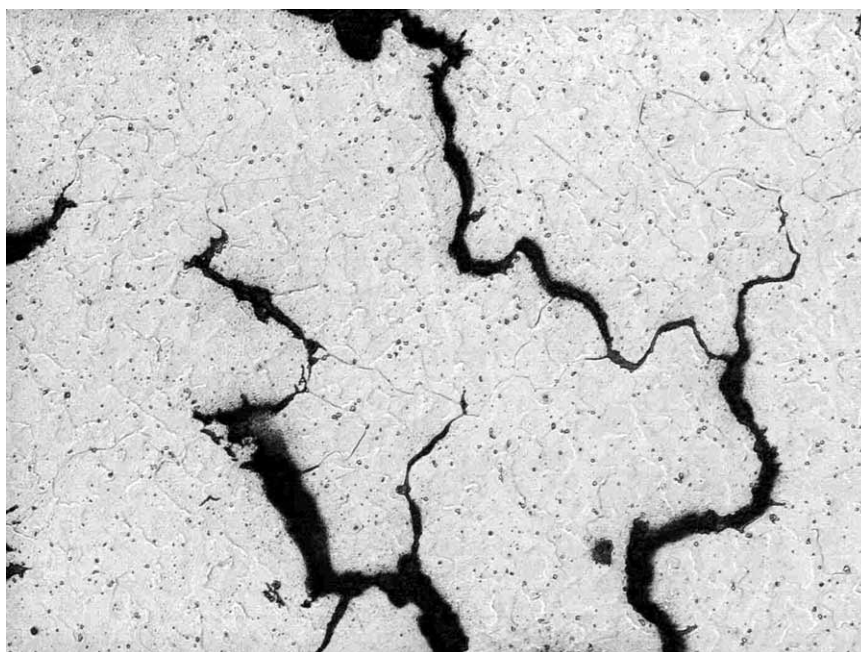
Figure 7.2.1.2: Higher magnification micrographs of the J-groove weld cracking. Cracking is intergranular or interdendritic, similar to the cracking at $\sim 180^\circ$ in Figure 7.1.1.4.

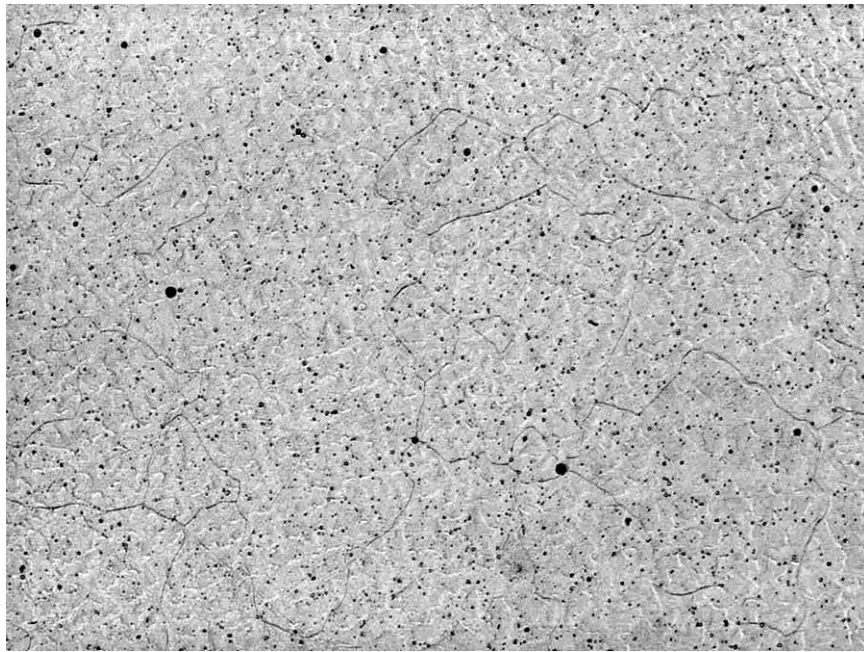
375X

Figure 7.2.1.3: Typical microstructure of sample A2A6B2, which was similar to Figure 7.1.1.3 (at $\sim 180^\circ$).

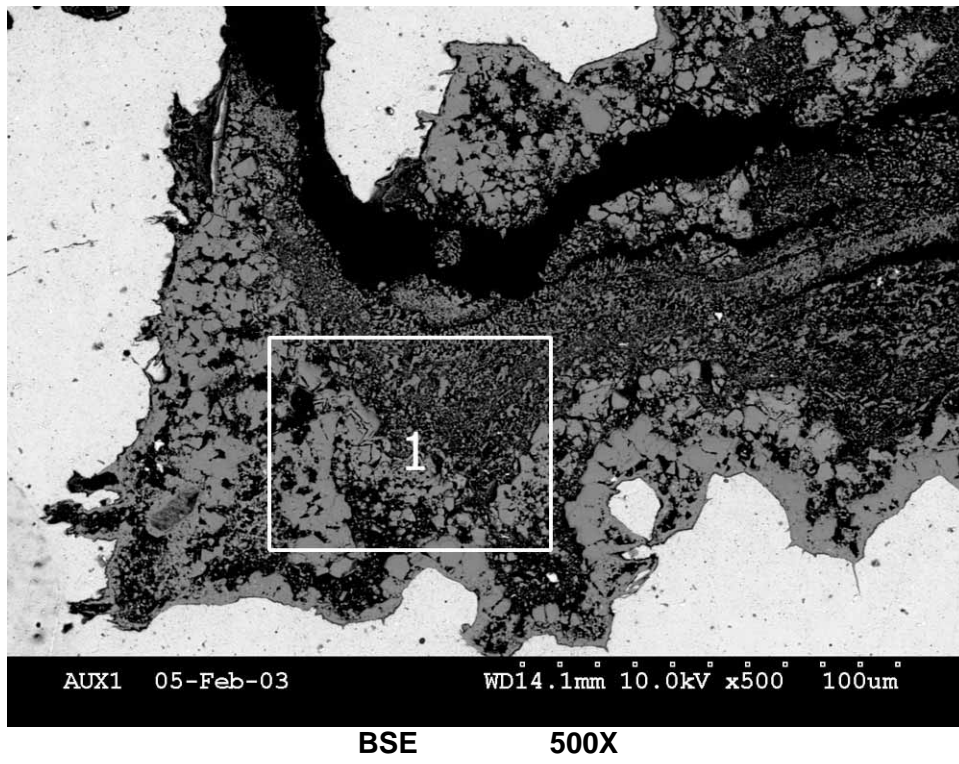
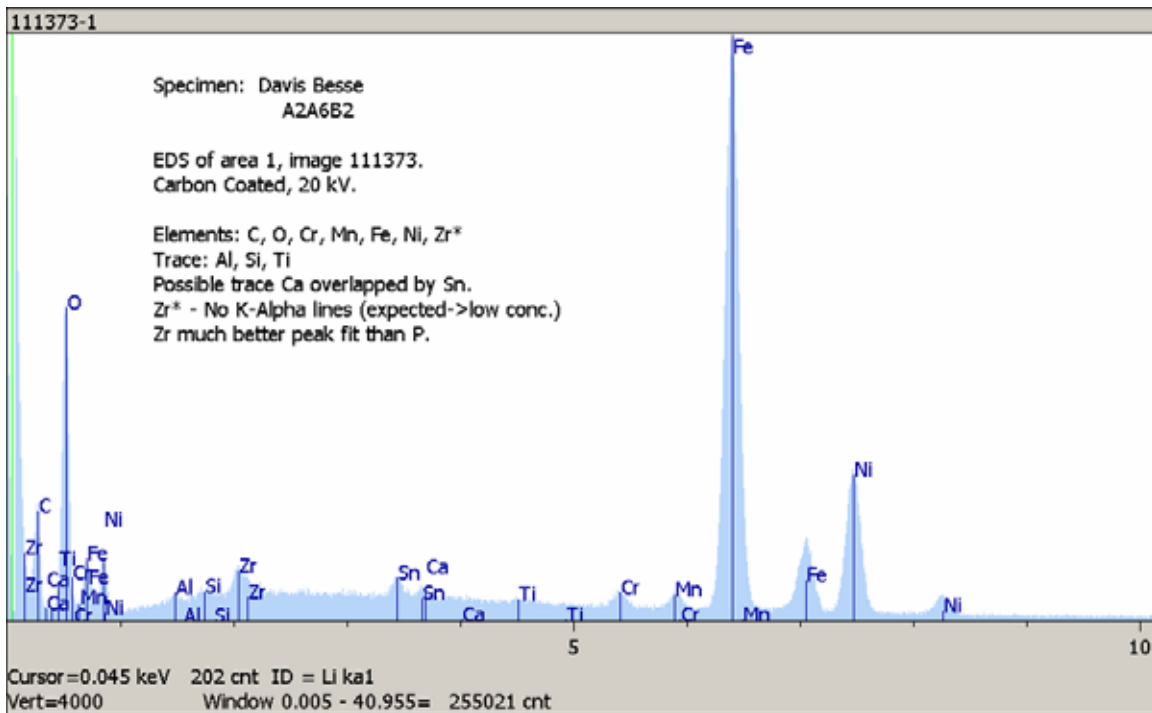
Figure 7.2.2.1: BSE micrograph showing portion of crack filled with corrosion products. The EDS results indicated high concentrations of carbon, oxygen, iron, and nickel.

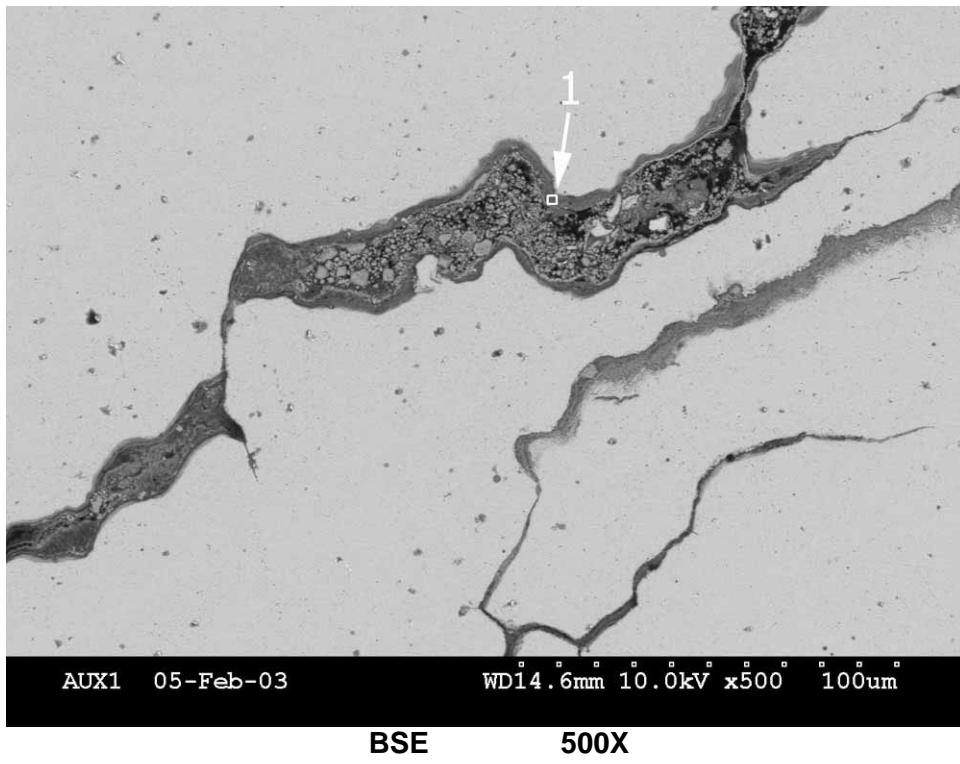
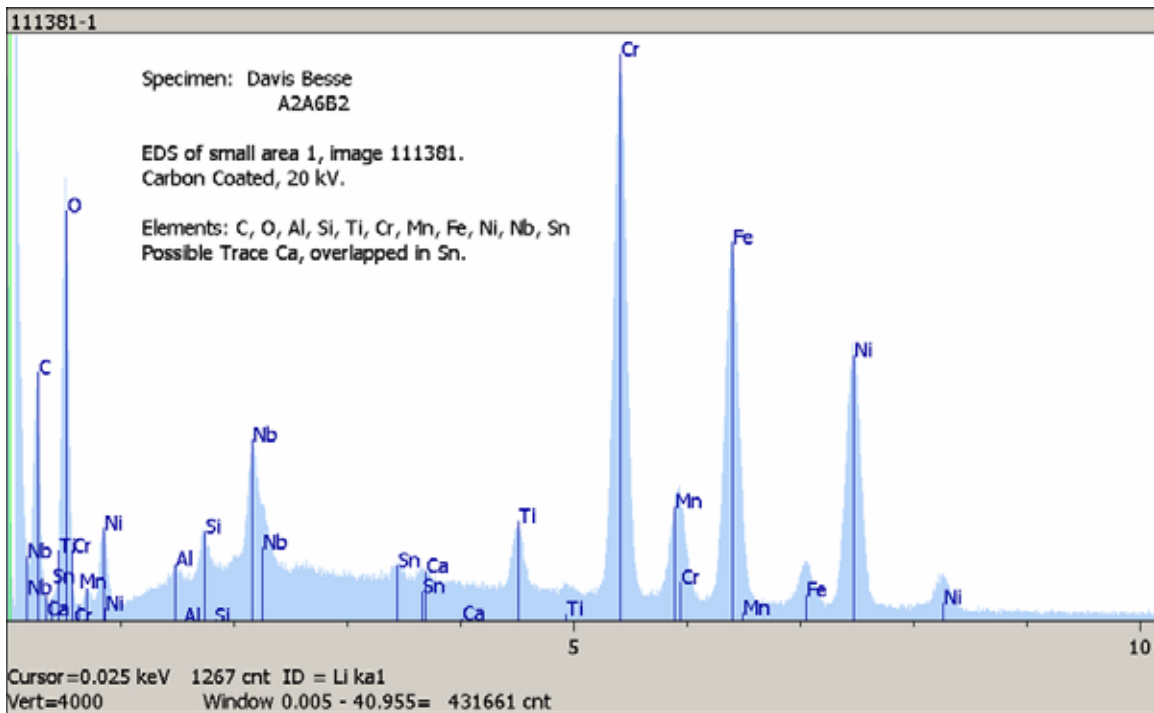
Figure 7.2.2.2: BSE micrograph showing corrosion products near crack tip. The EDS results collected from the area 1 indicated high concentrations of carbon, oxygen, niobium, titanium, chromium, manganese, iron, and nickel.

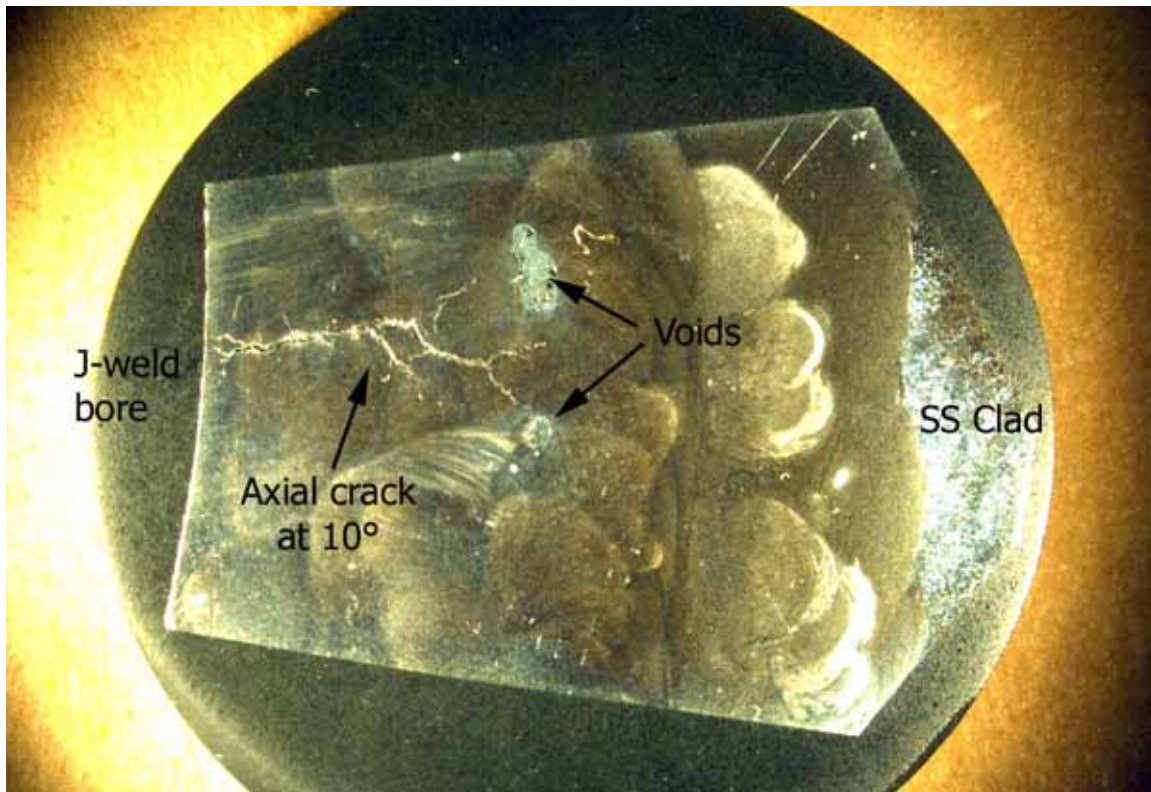
4X

Figure 7.2.3.1: Macro photograph of metallographic mount A2A6A2E1 (see Figure 5.6 and 5.10 for the sample orientation). Cracking was partially through the J-groove weld in the sample plane.

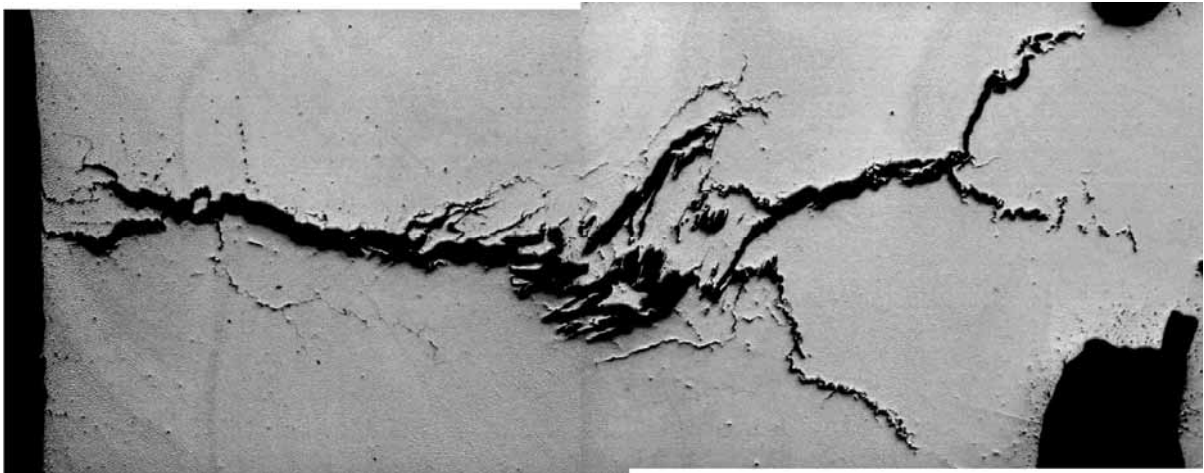
Etched 13X

Figure 7.2.3.2: Micrograph showing axial cracks in the lower portion of the J-groove weld at $\sim 10^\circ$. The crack maximum depth is approximately 0.45" beneath the bore I.D. surface.

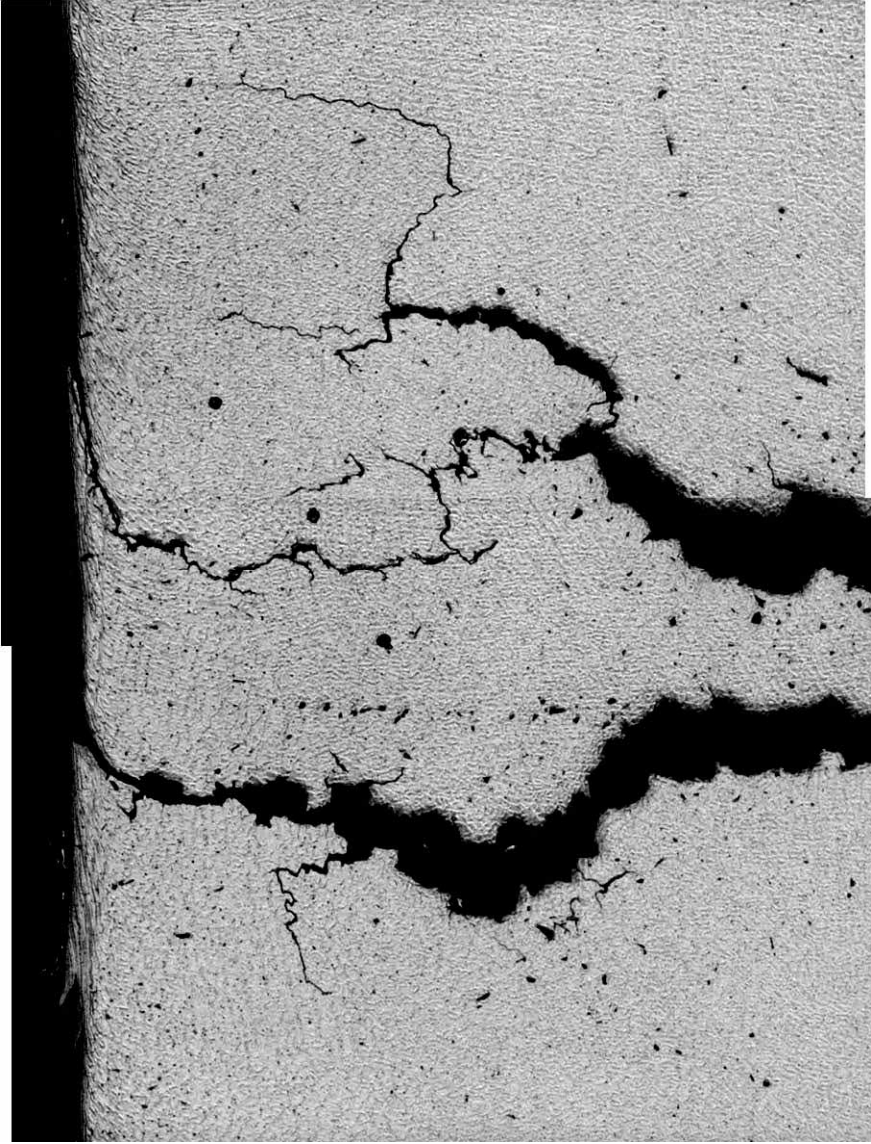
Etched 100X

Figure 7.2.3.3: Cracks located near the bored surface. Surface cold work layer is due to the boring (nozzle removal) process.
