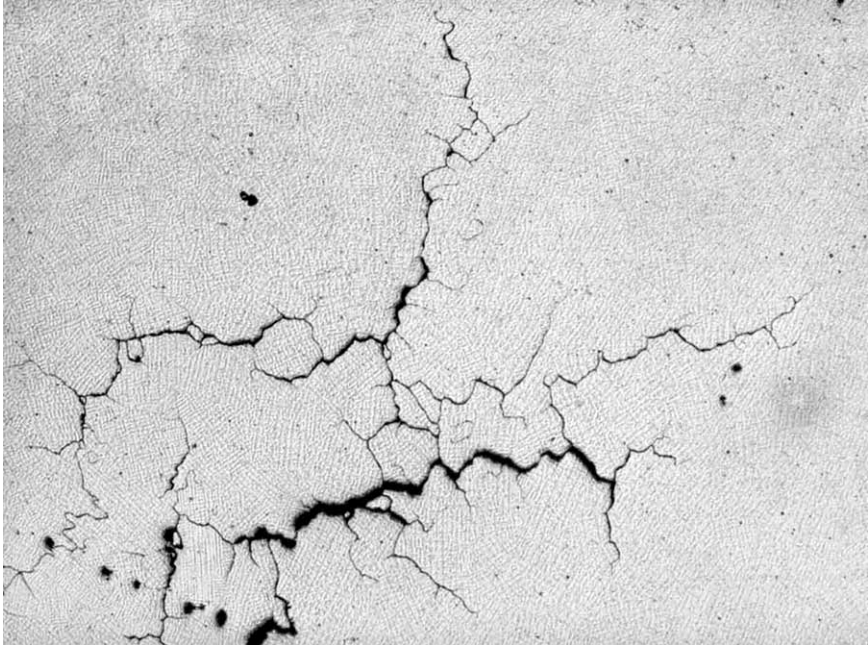
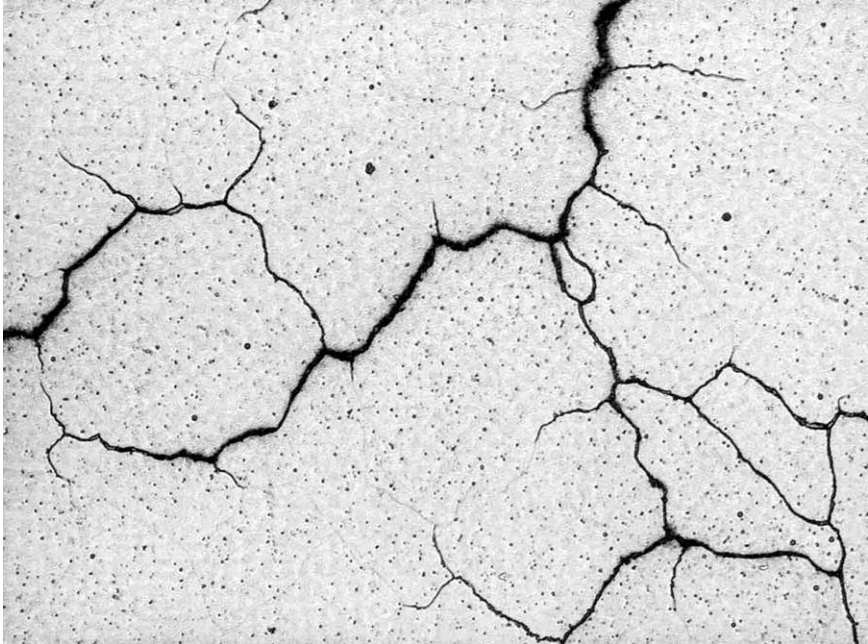
Figure 7.2.3.4: Interdendritic or intergranular cracking in the J-groove weld away from the bore I.D. surface.

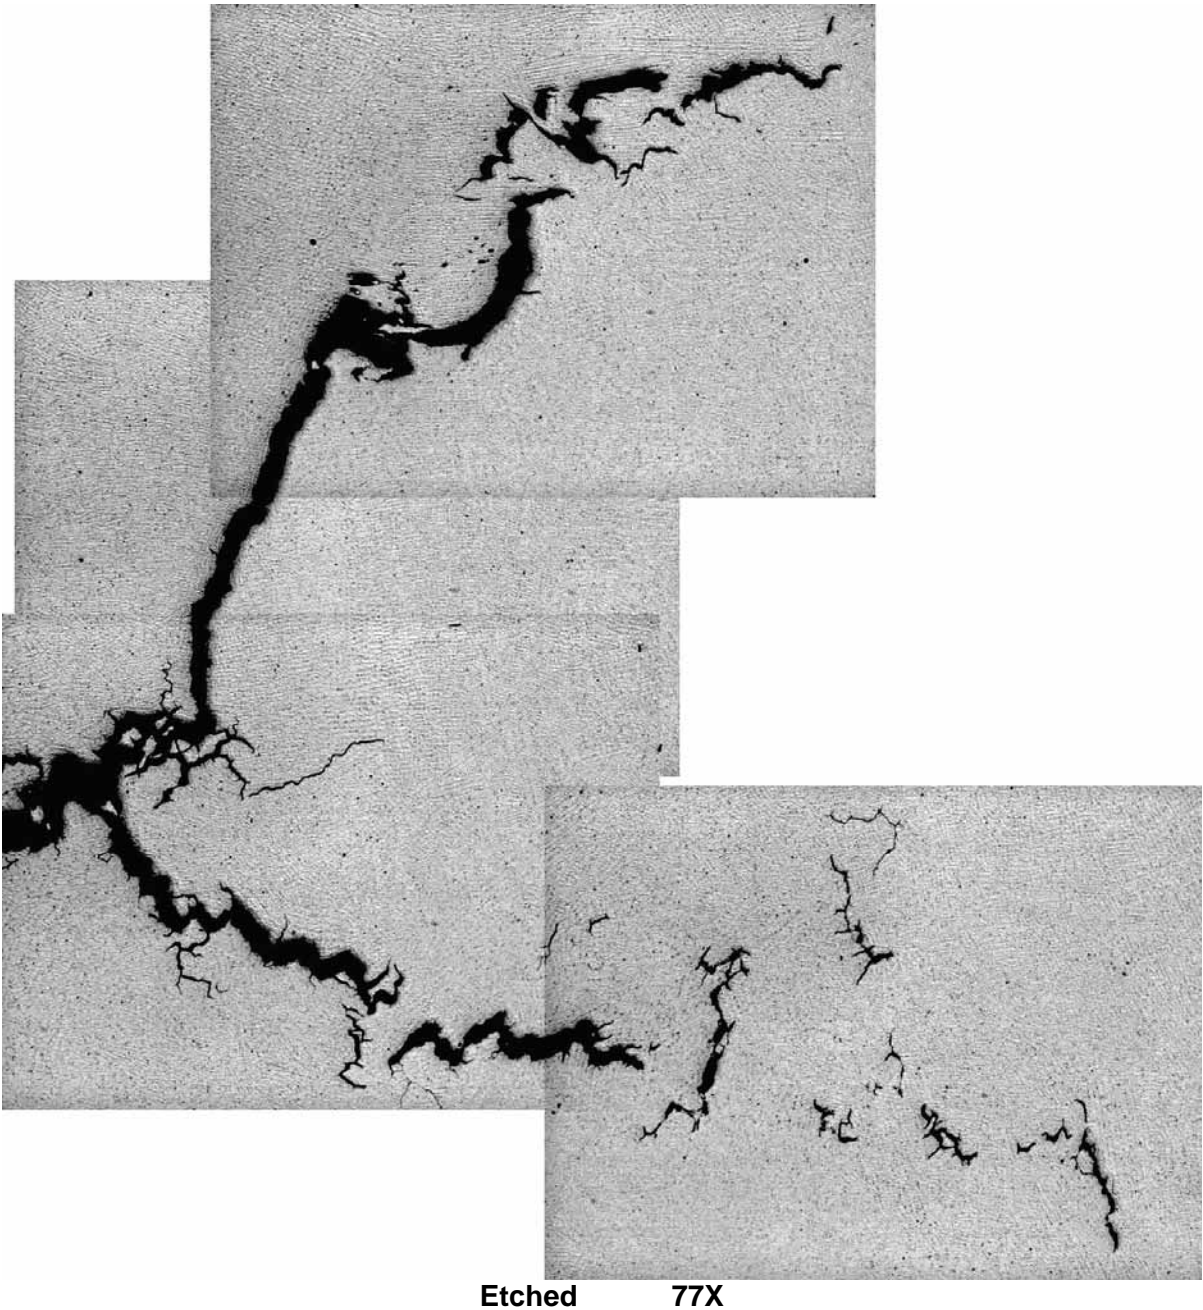
Figure 7.2.3.5: Crack tips toward the J-groove weld O.D.

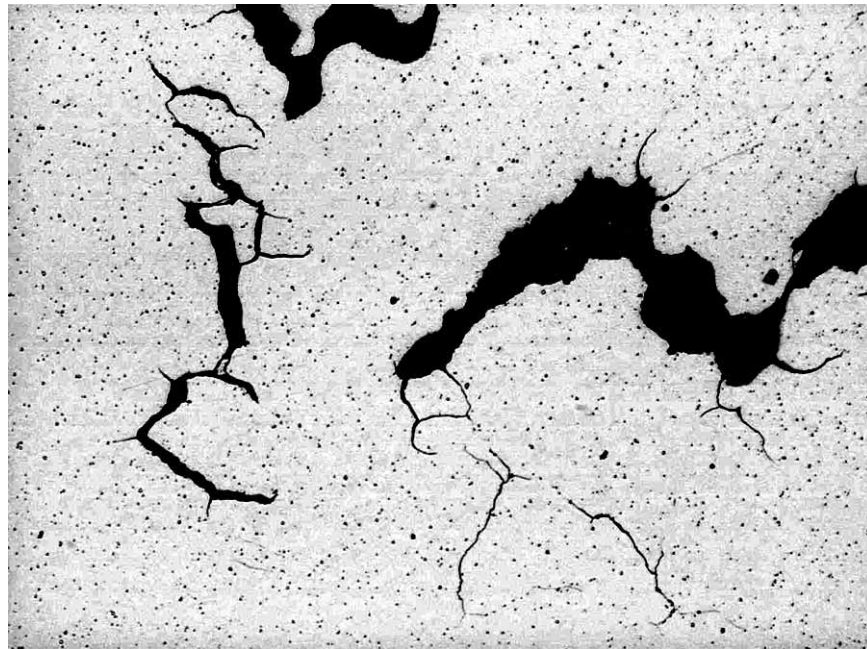
Etched 375X

Figure 7.2.3.6: Crack detail from Figure 7.2.3.5.

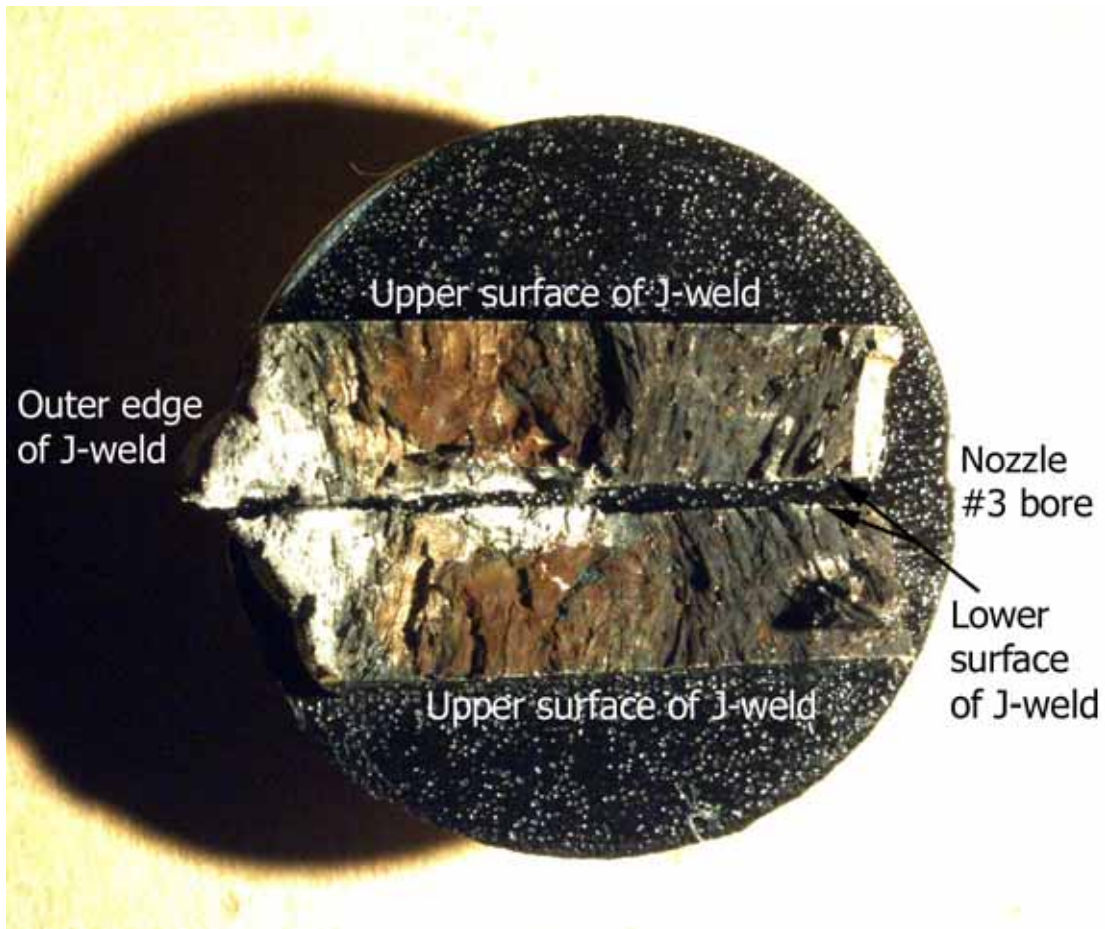
4X

Figure 7.2.4.1: Macro photograph of sample A2A6B3 with the middle portion of the axial cracking at $\sim 10^\circ$ opened-up for SEM. Refer to Figures 5.4 and 5.5 for the sample location.

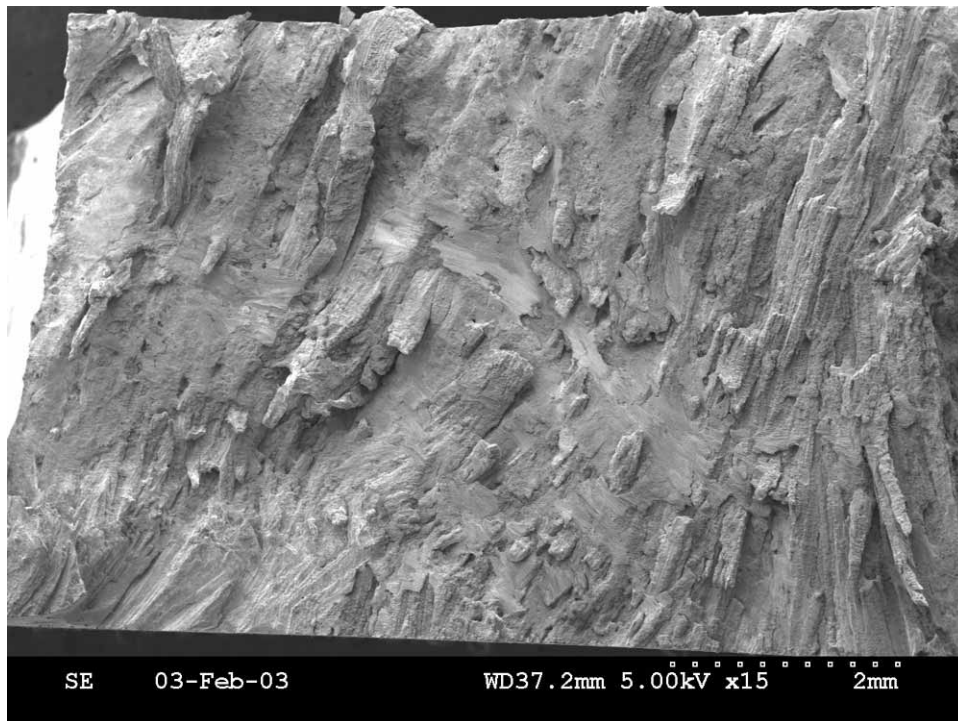
Figure 7.2.4.3: Higher magnification of the left section in Figure 7.2.4.2. Cracking is interdendritic exposing a well-defined columnar solidification structure.

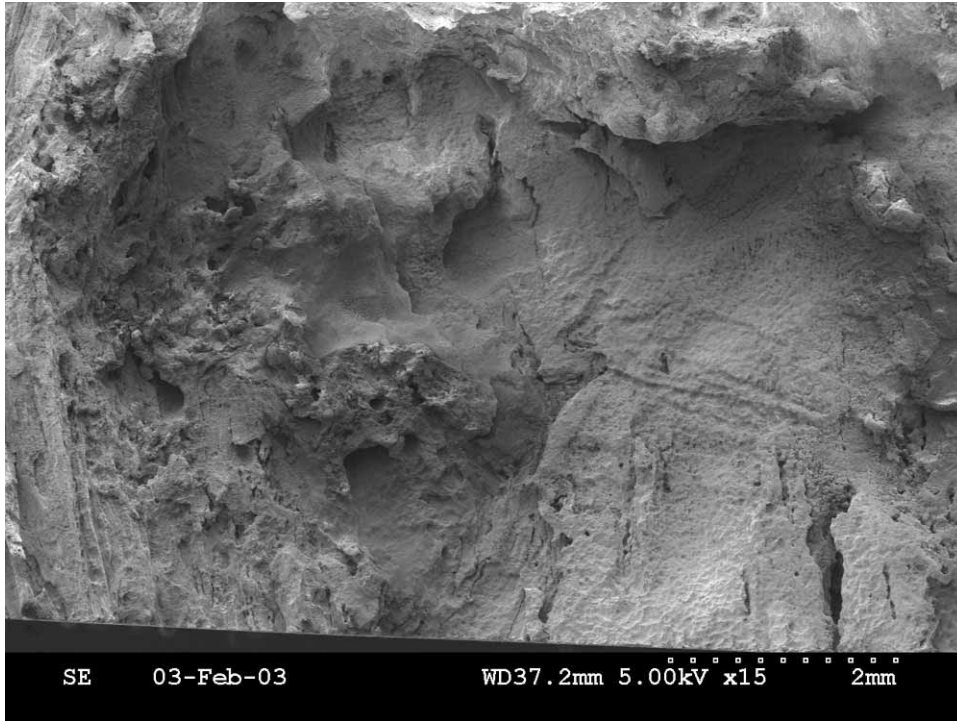
Figure 7.2.4.4: Higher magnification of the middle section in Figure 7.2.4.2. The fracture surface is heavily oxidized; the fracture mode is indeterminate.

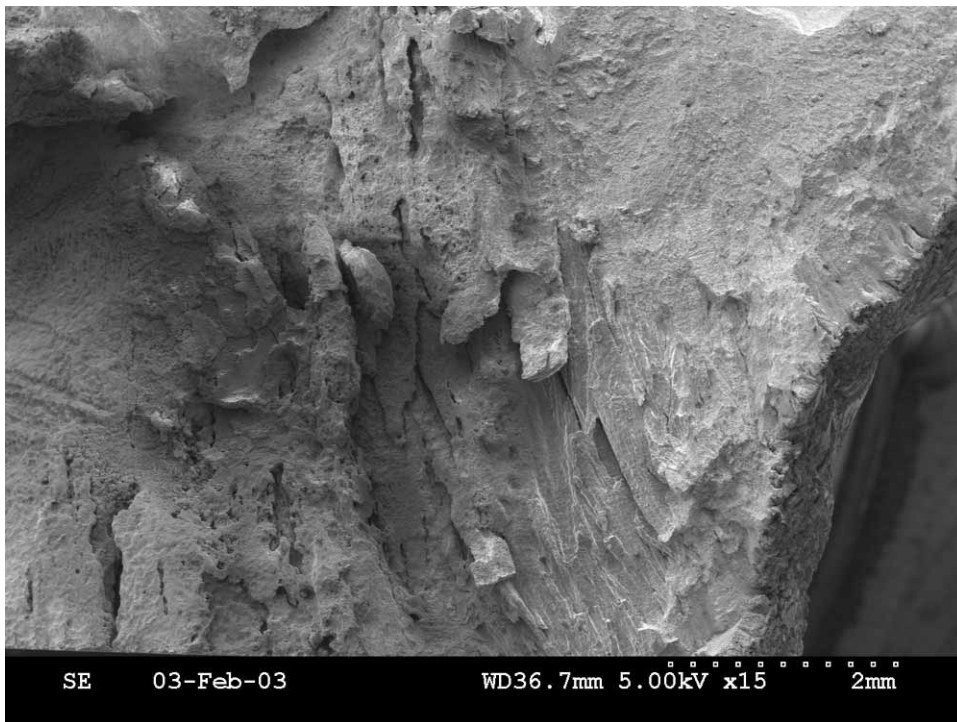
Figure 7.2.4.5: Higher magnification of the right section in Figure 7.2.4.2. Cracking to the left side of ductile tearing (lab fracture) is interdendritic.

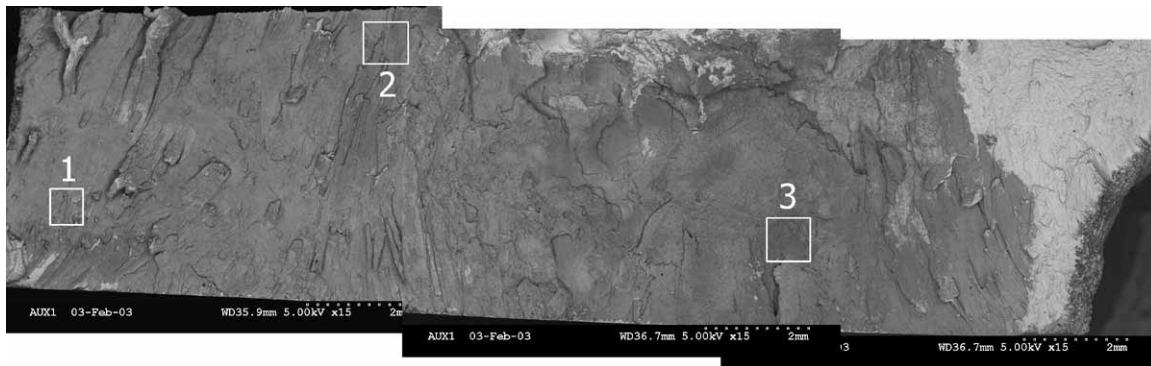
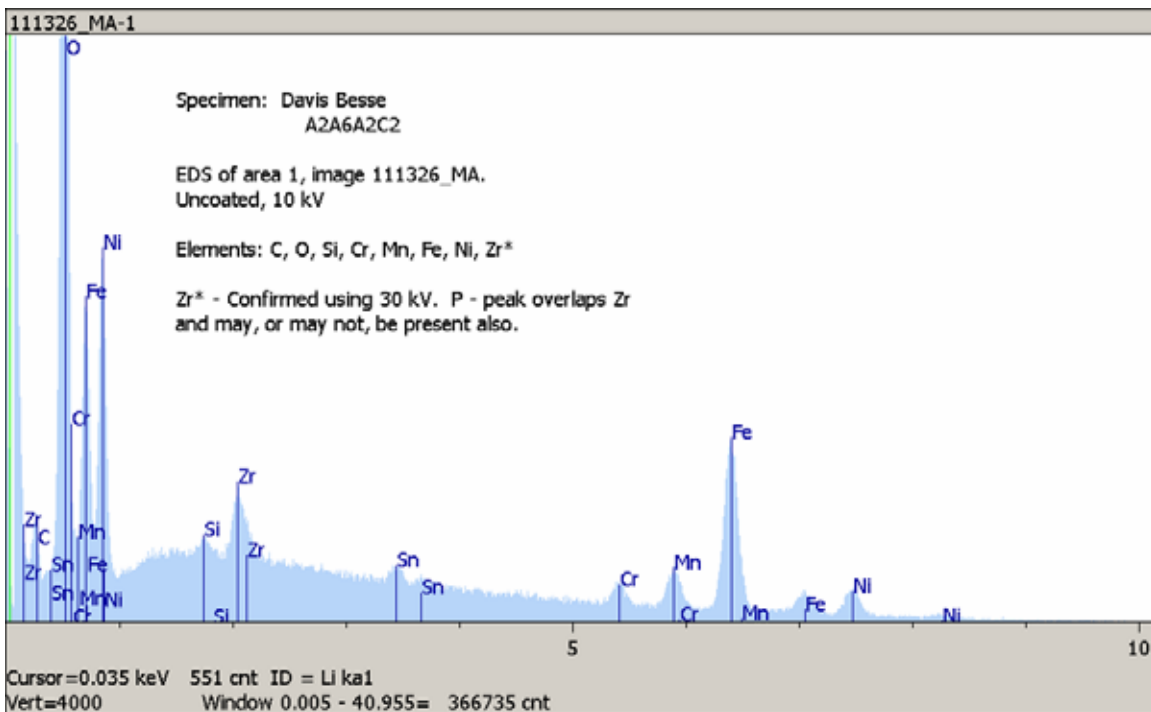
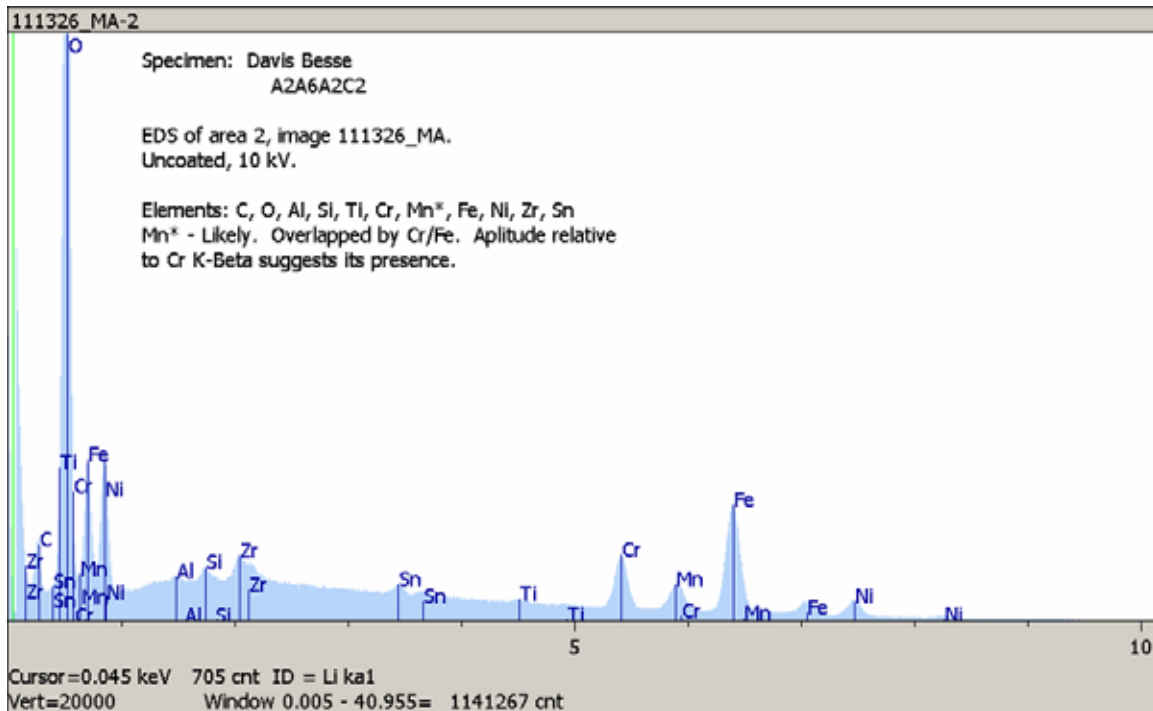
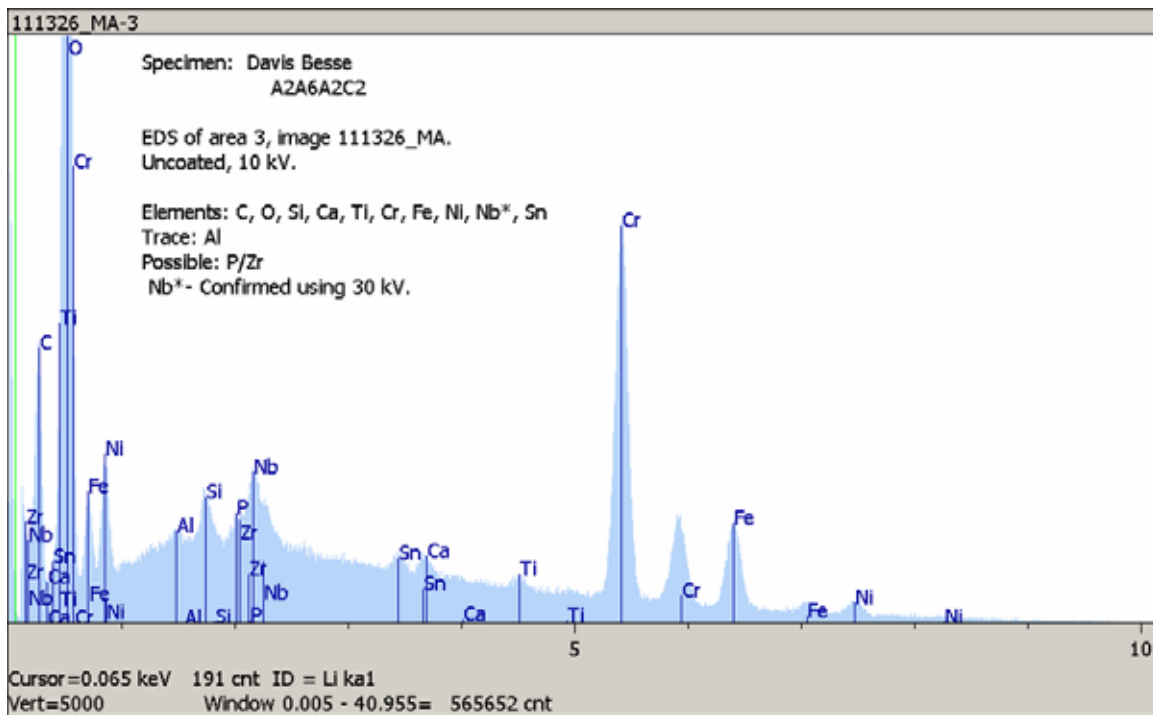
Figure 7.2.4.6: BSE micrograph mosaic of the open crack surface (same area as Figure 7.2.4.2) along with EDS results for three areas of the fracture surface. The dark area in the BSE image indicates the fracture surface was covered by a thick oxide layer. The light area (right side) indicates a fresh fracture surface due to crack opening-up (i.e., less oxide on surface). For area 1, the primary elements included carbon, oxygen, silicon, chromium, manganese, iron, nickel, and zirconium.

Figure 7.2.4.6 (cont.): For area 2, the primary elements included carbon, oxygen, silicon, chromium, manganese, iron, nickel, and zirconium. Similar results were obtained for area 3, except area 3 also contained niobium and calcium.

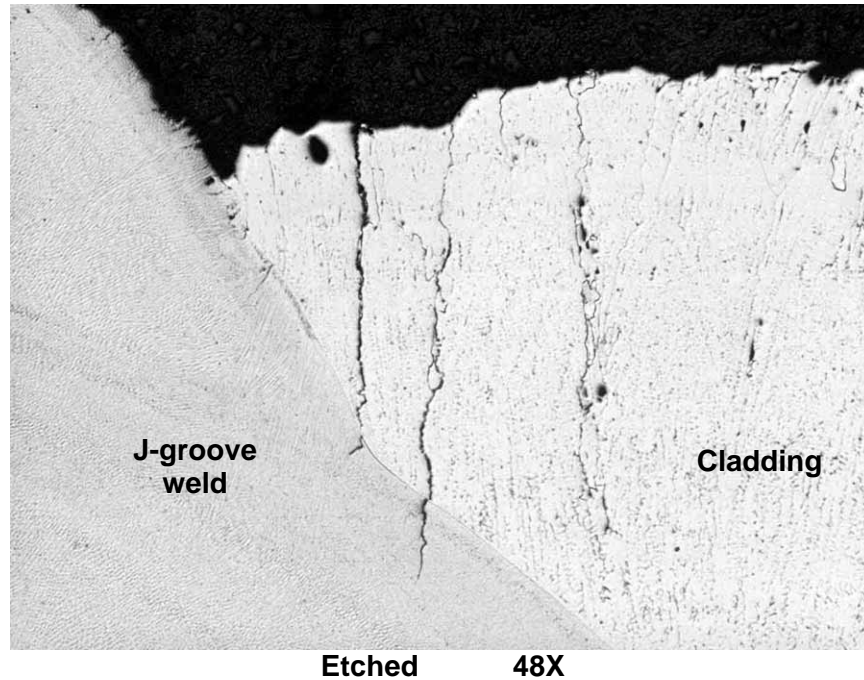
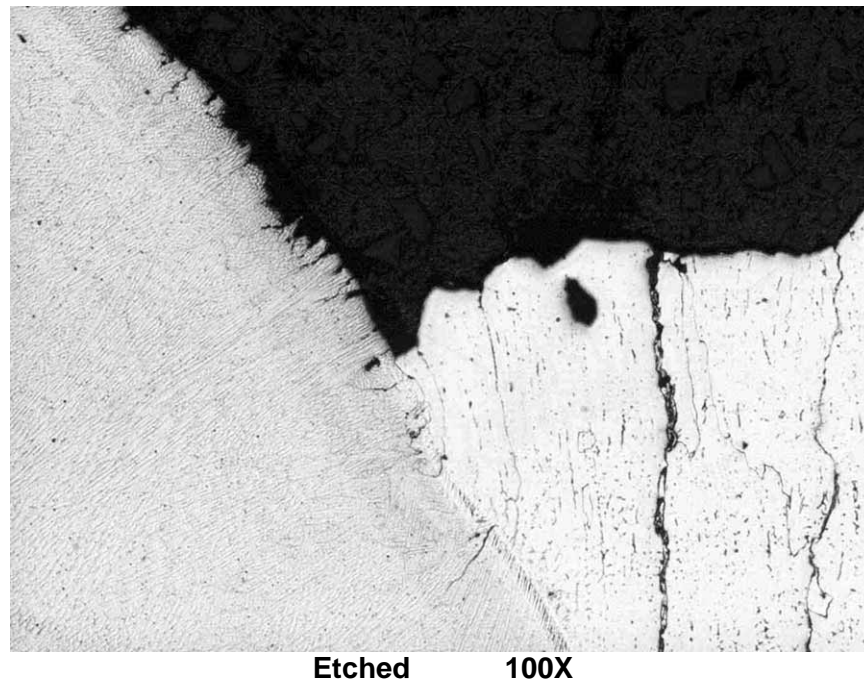
Figure 7.3.1.3: Intergranular or interdendritic cracking initiating at the cladding surface and extending into the J-groove weld. Note that the micrographs shown are mirror image of the photo in Figure 7.3.1.2. Intergranular attack (IGA) is also evident on the exposed surface of J-groove weld and cladding (surface exposed to oxygenated boric acid). This cracking is likely initiated by IGA.

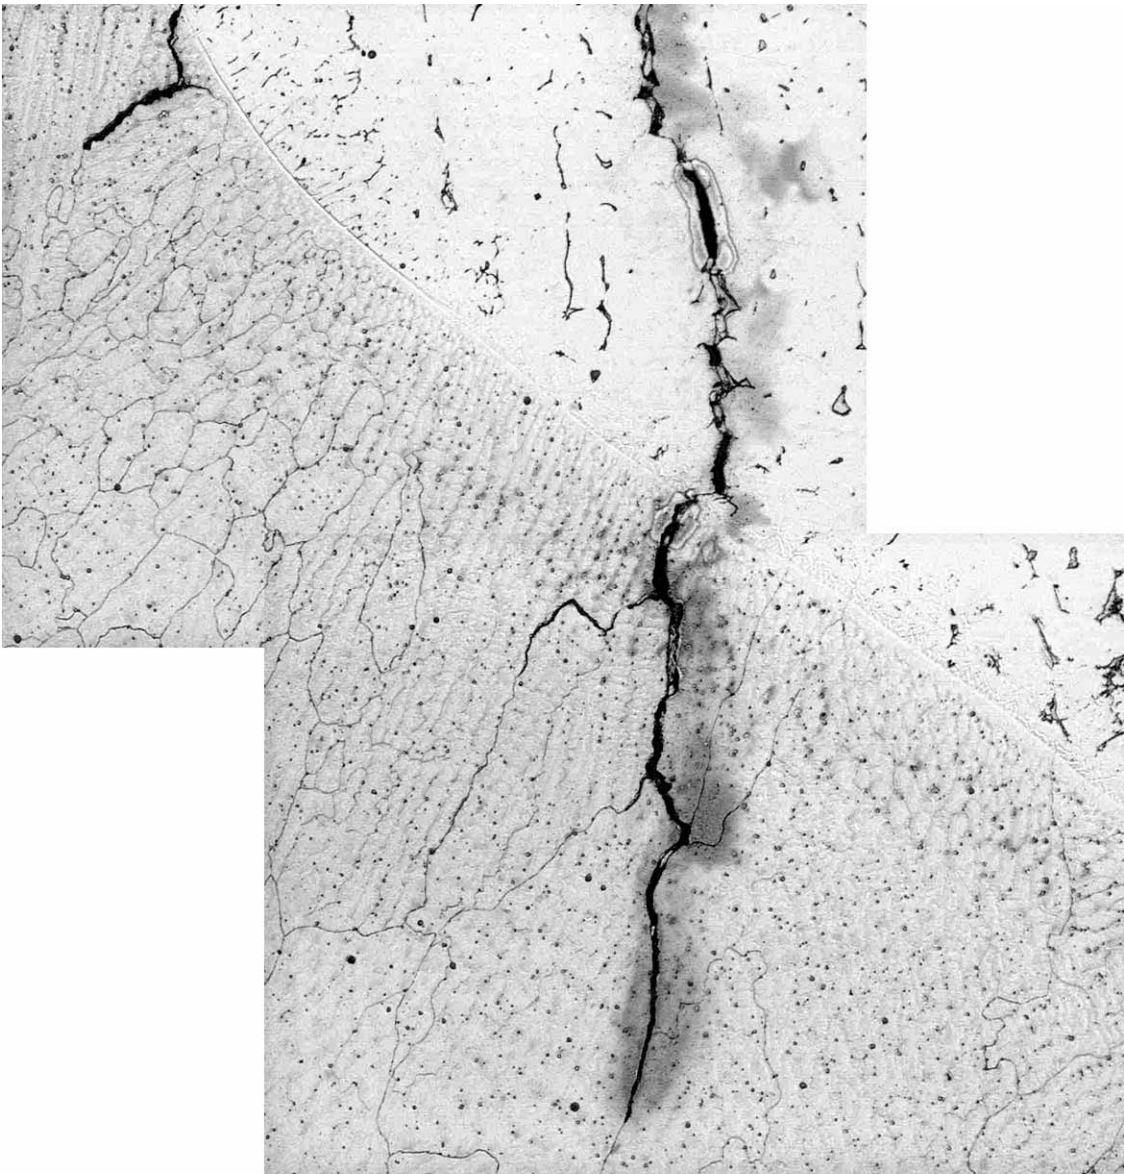
Etched 375X

Figure 7.3.1.4: Higher magnification micrograph showing intergranular or interdendritic cracking initiating at the cladding surface and extending into the J-groove weld.

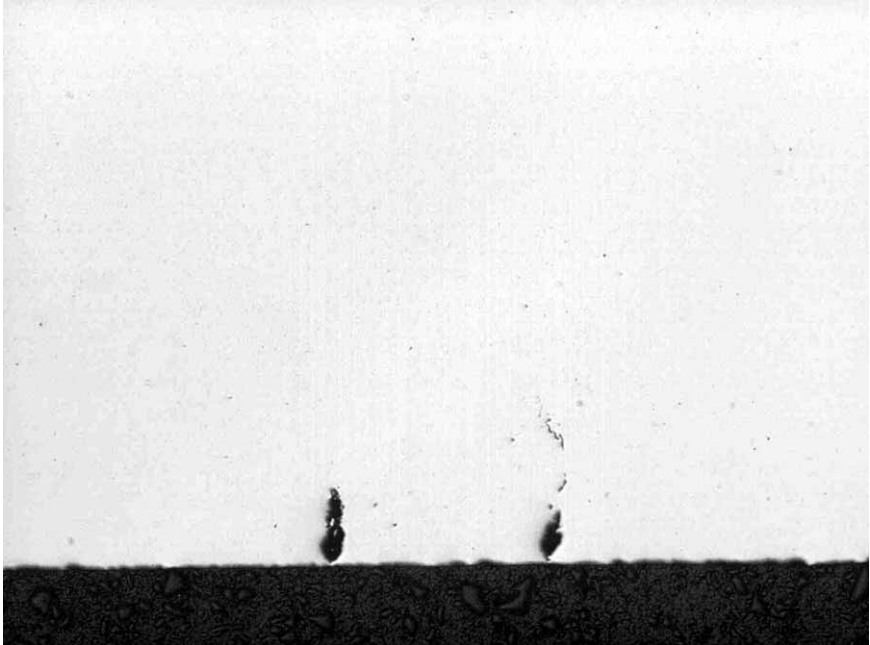
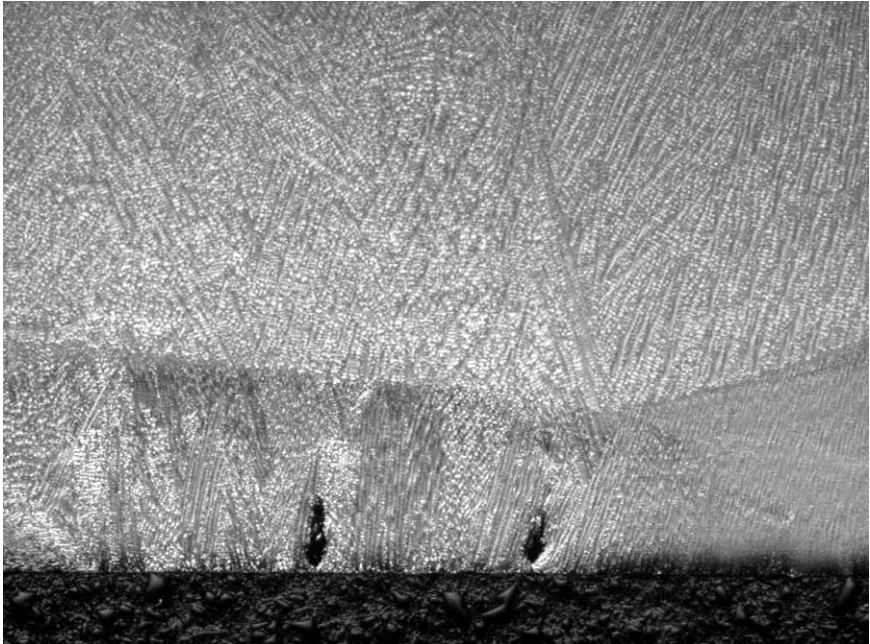
Figure 7.3.1.5: Low magnification micrographs showing shallow circumferential cracking in the J-groove weld.

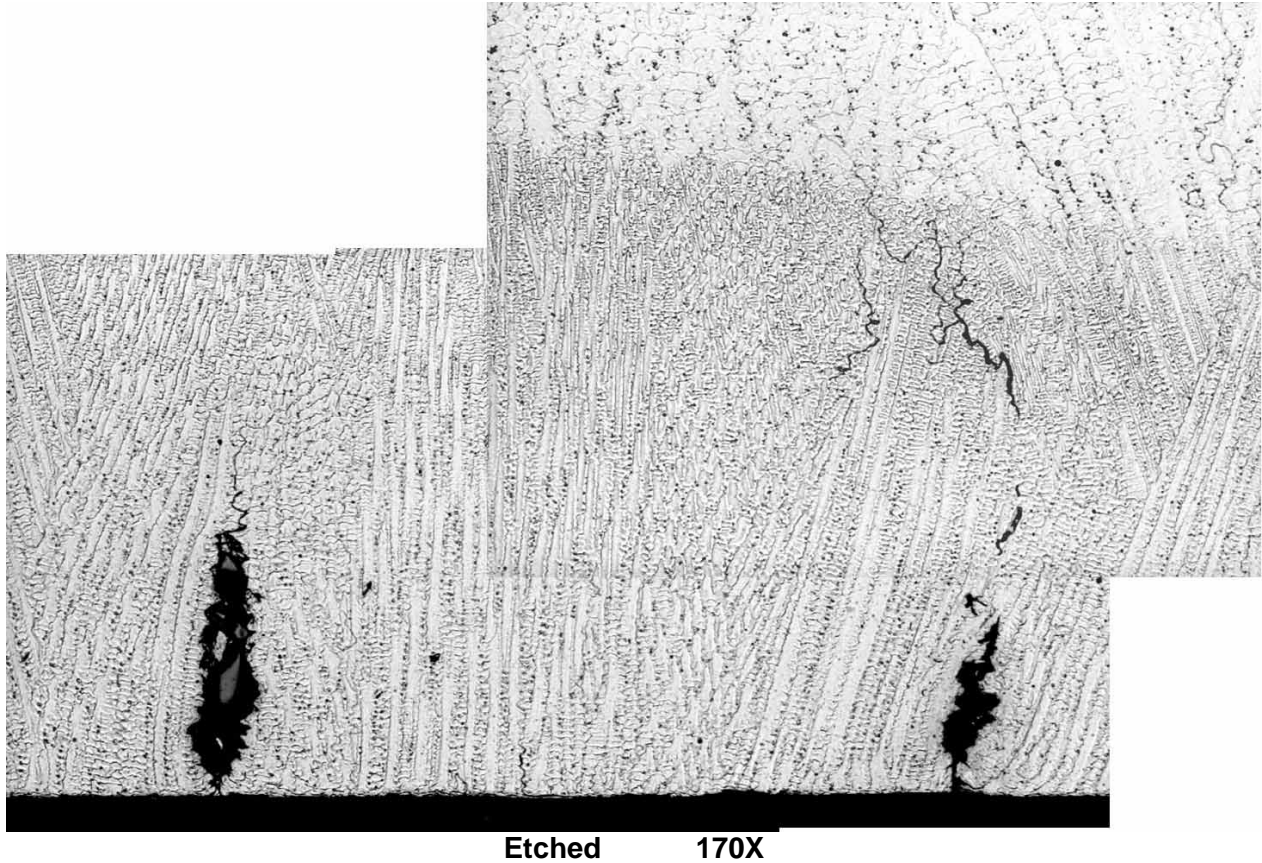
Figure 7.3.1.6: Micrograph showing the shallow circumferential cracks in the J-groove weld. The cracking is intergranular or interdendritic, with a maximum depth of approximately 0.019" below the surface. The two wider crack regions just below the surface may have been dendrites or grains encircled by cracks that subsequently dropped out during sample preparation.

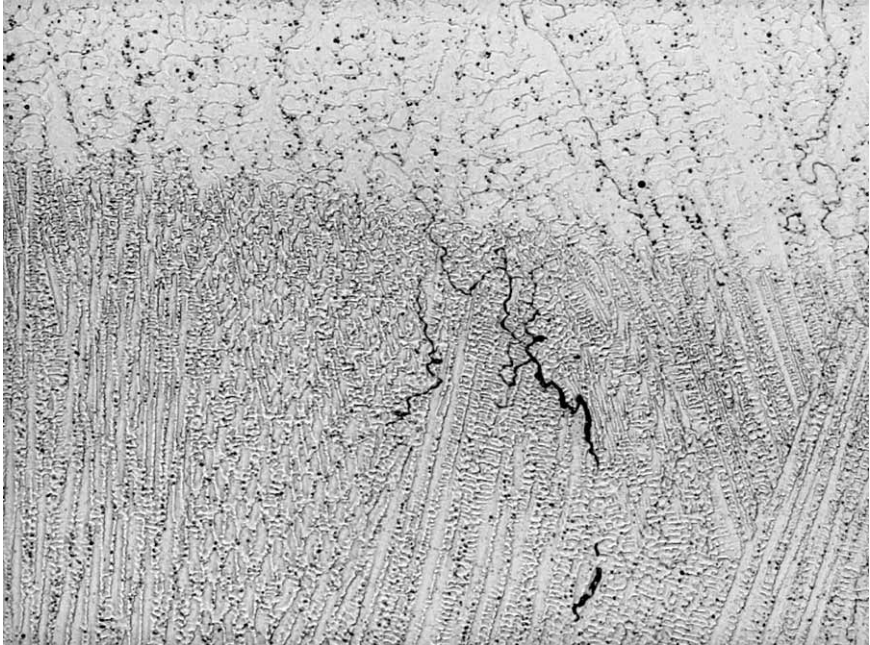
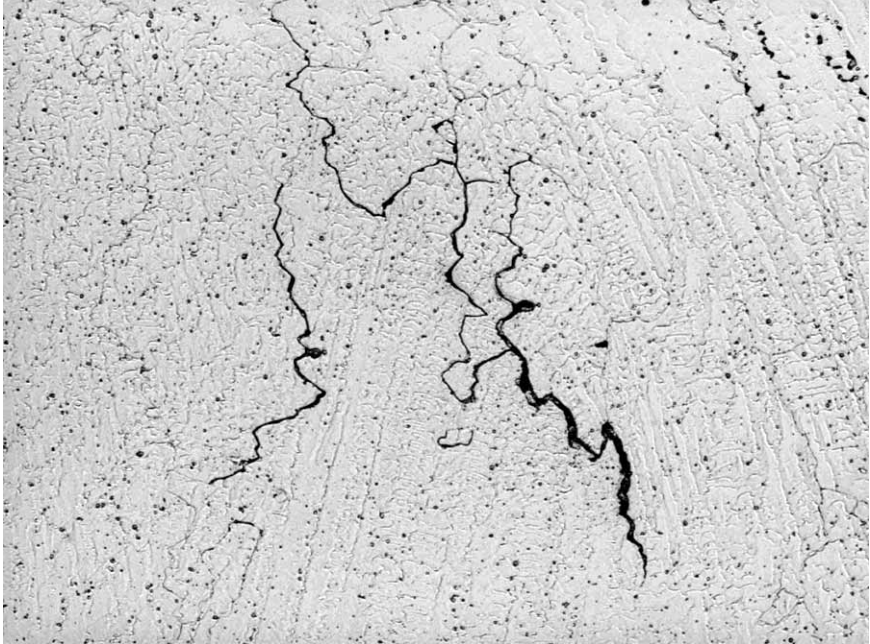
Figure 7.3.1.7: Micrographs showing crack tips of the circumferential cracking in the J-groove weld.

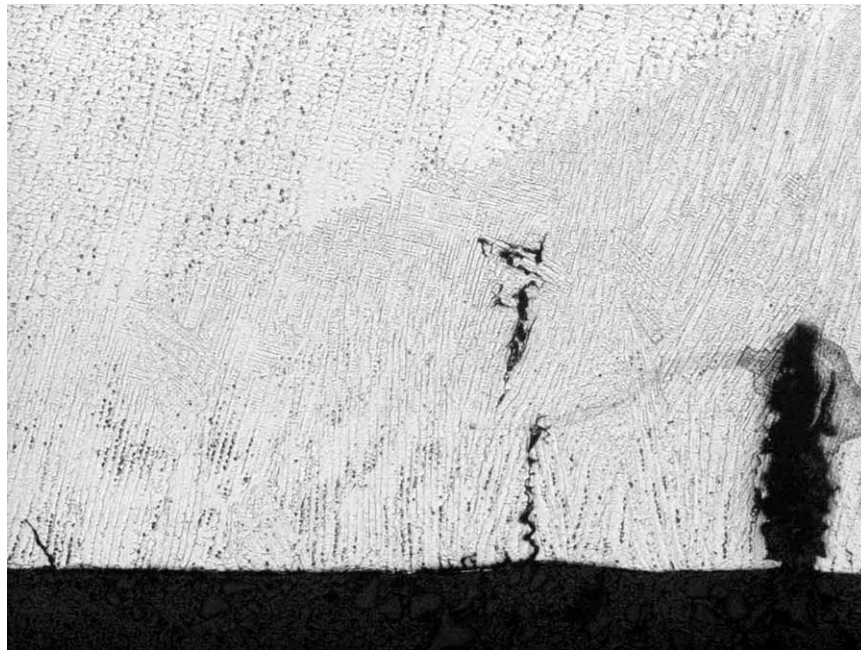
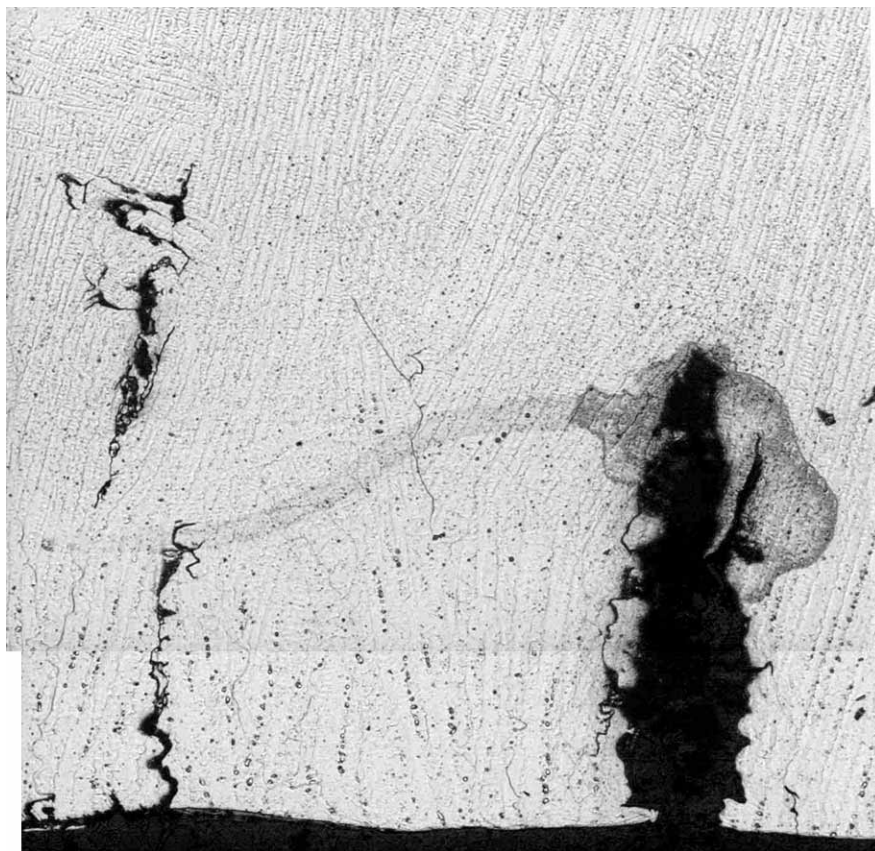
Figure 7.3.2.2: Micrograph showing the circumferential intergranular/interdendritic cracks in the J-groove weld. The maximum cracking depth is approximately 0.018" below the surface. The cavity just below the surface may be due to dendrites or grains encircled by the cracks that dropped out during sample grinding and polishing.

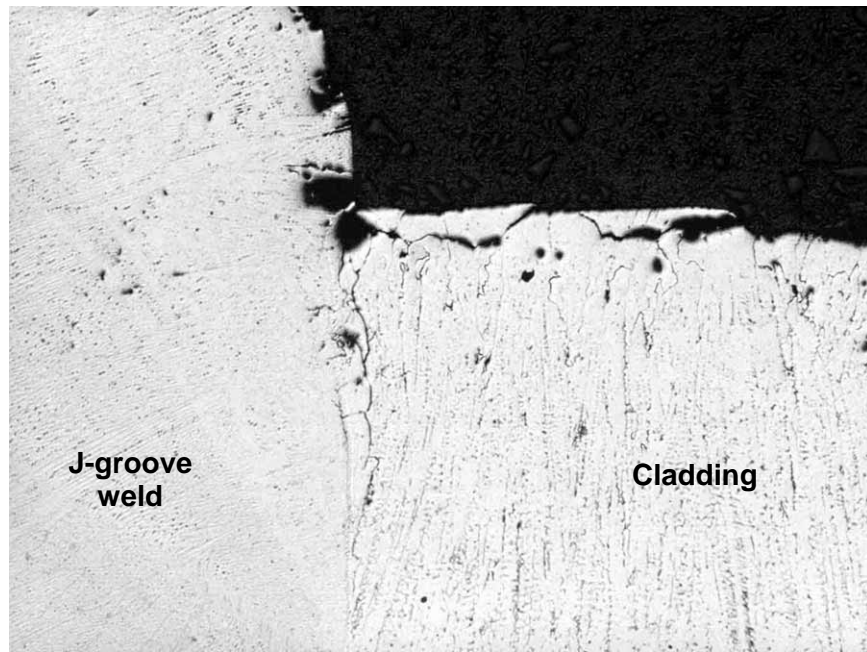
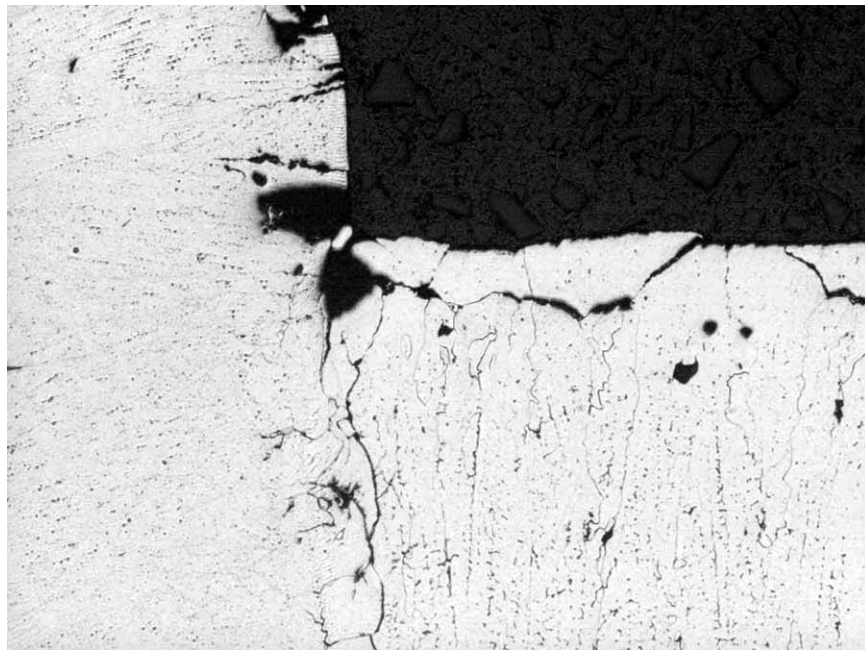
Figure 7.3.2.3: Micrographs showing the intergranular or interdendritic cracking between the J-groove weld and cladding interface. The micrographs shown here are mirror of the photo in Figure 7.3.2.1. Intergranular attack (IGA) is also evident on the exposed surface of J-groove weld and cladding (surface exposed to oxygenated boric acid). This cracking was likely initiated by IGA.

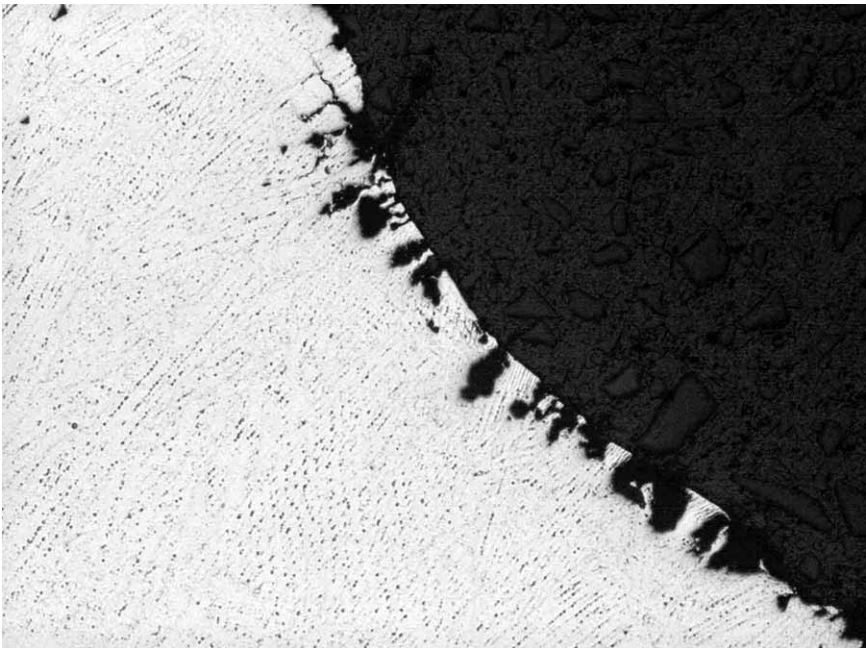
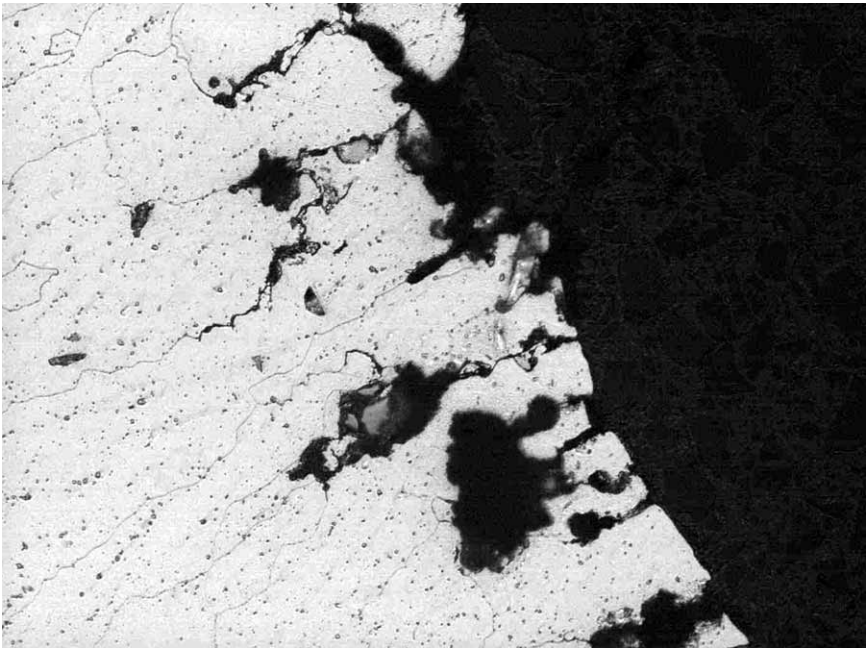
Figure 7.3.2.4: Intergranular attack (IGA) on the J-groove weld surface exposed to oxygenated boric acid.

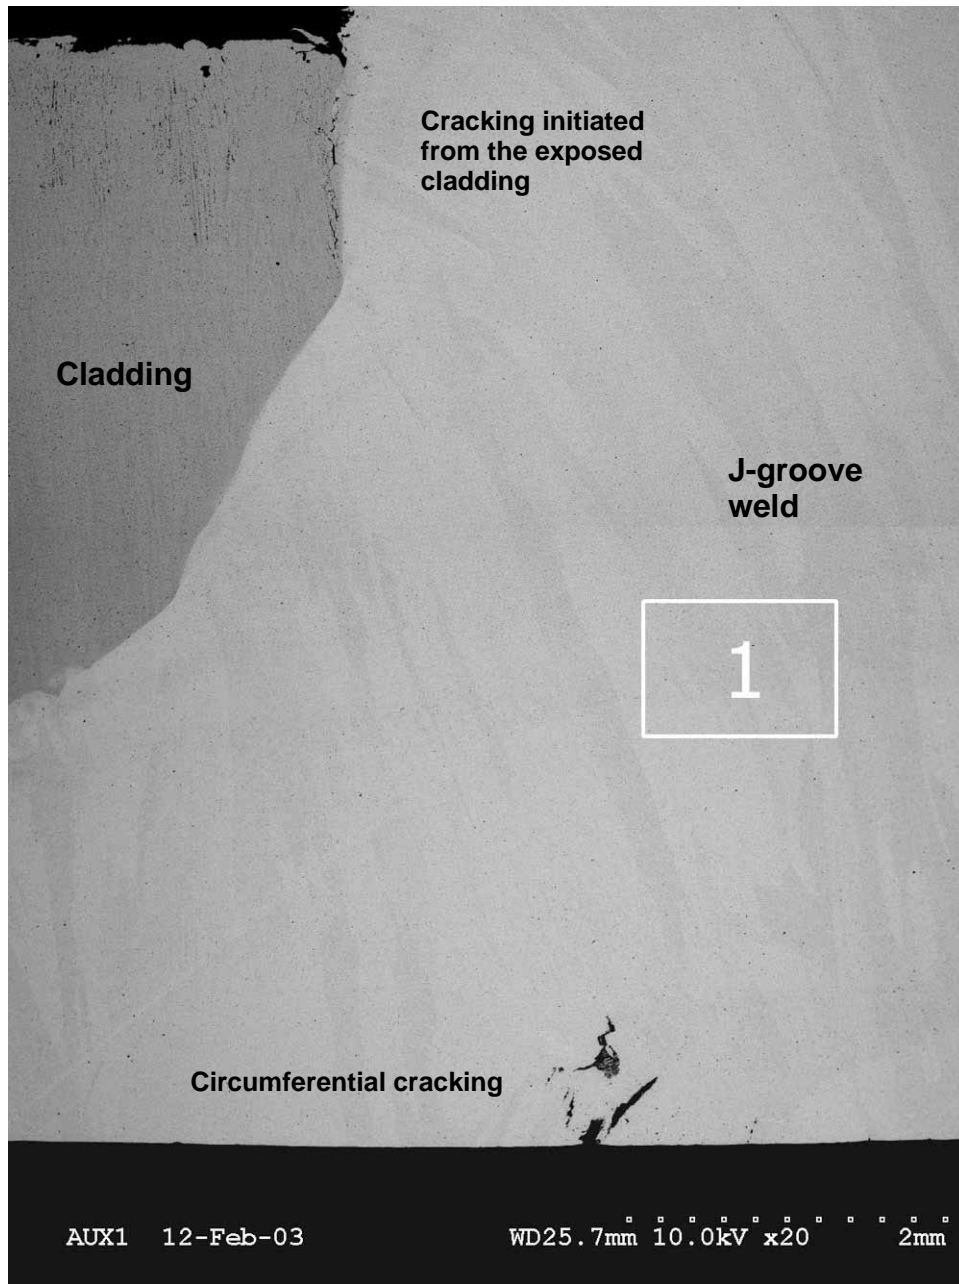
Figure 7.3.3.1: Low magnification BSE micrograph of sample A2A6A2D2 showing the cracking in the exposed cladding surface and the axial cracking in the J-groove weld surface exposed to RCS. The EDS spectrum collected from area 1 is presented in Figure 7.3.3.2.

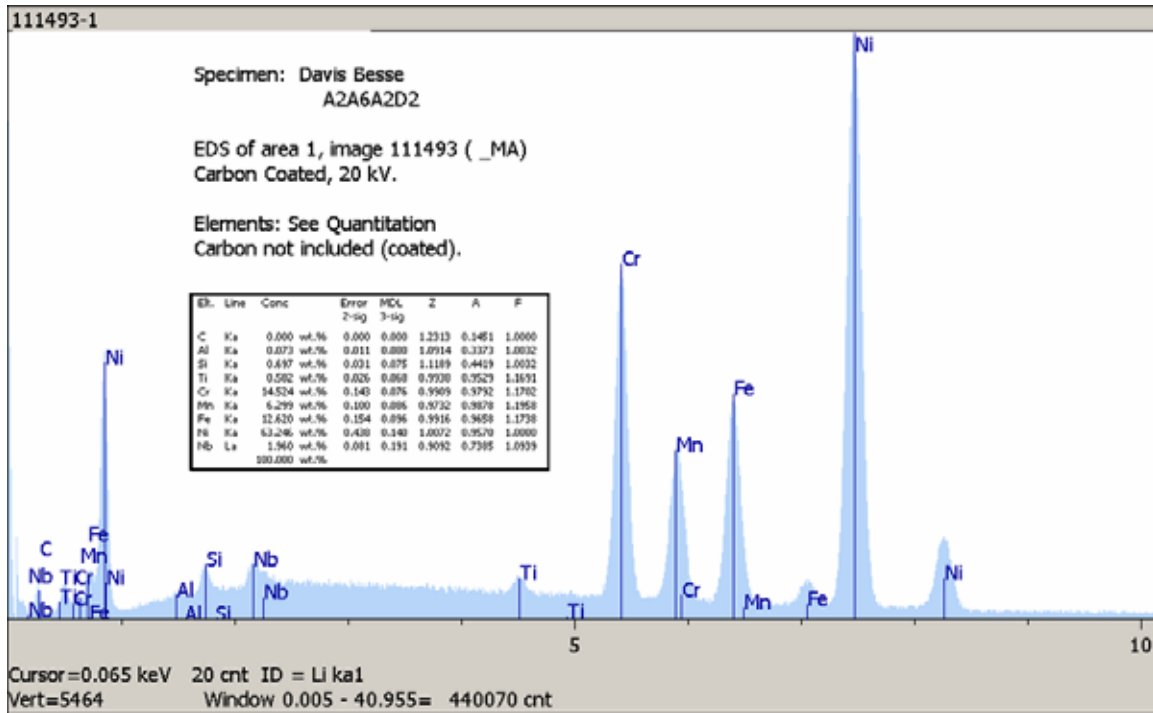
Figure 7.3.3.2: The EDS spectrum for area 1 in Figure 7.3.3.1. The semi-quantitative results from this area, which was located within the J-groove weld, were consistent with Alloy 182 weld metal.
