**Oyster Creek Nuclear Station
Technical Background, Basis and Report
Diesel Generator Cooling Fan Drive Test**

(Document containing Engineering Observations and
Parts Comparisons made during Diesel Generator Testing
@ The Joliet Generating Station and
a detailed discussion of the results of the test)

Prepared By: Dave Jones, Electrical Engineering Specialist
Reviewed By: Arvin Ho, EDG Subject Matter Expert, Exelon Corp. Office, West
Approved By: Steven Hutchins, Manager of Electrical, I&C and NSSS Systems

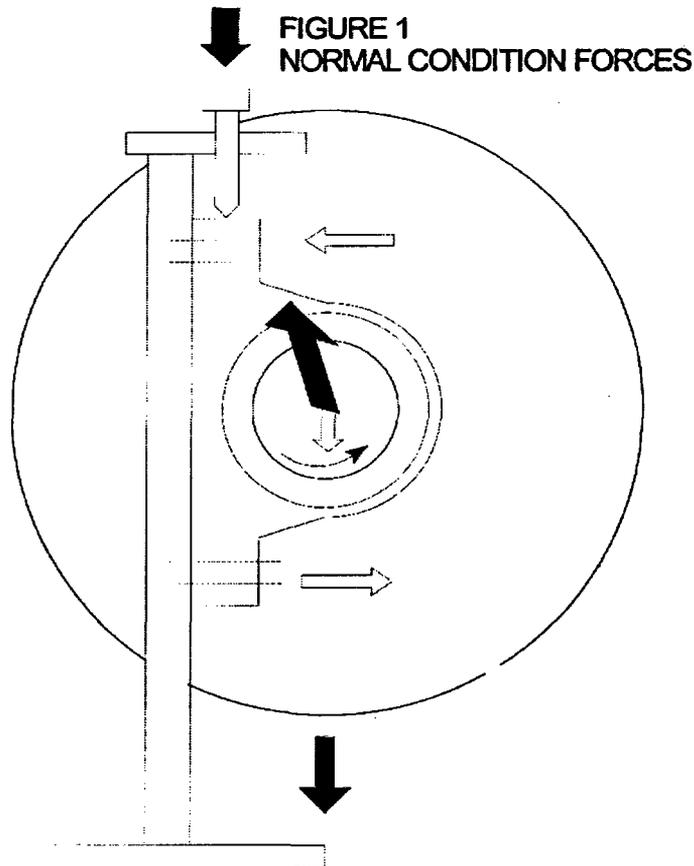
Forces were seen to change as the motion of the bearing moved to the right away from the pedestal and back to the left against the pedestal. As the bearing moves to the right, the shaft moves to the right with a slight lift in the vertical direction that removes some of the belt tension due to the adjusting screw at the upper foot of the bearing. The upper foot of the bearing was observed on the monitor to move as much as ¼ inch away from the adjusting screw until forces changed to pull the bearing back against the pedestal. As the

bearing moved back against the pedestal, there was a distinctive movement upward to place the upper bearing foot hard against the adjusting screw and the bearing housing flat against the pedestal. This portion of the movement was clearly restoring the position of the bearing to the “normal condition” as shown in Figure 1 above. The restoring force is the 11:00 vector force that signifies left side belt tension returned and the force pulling the bearing away from the pedestal was absent at that moment.
