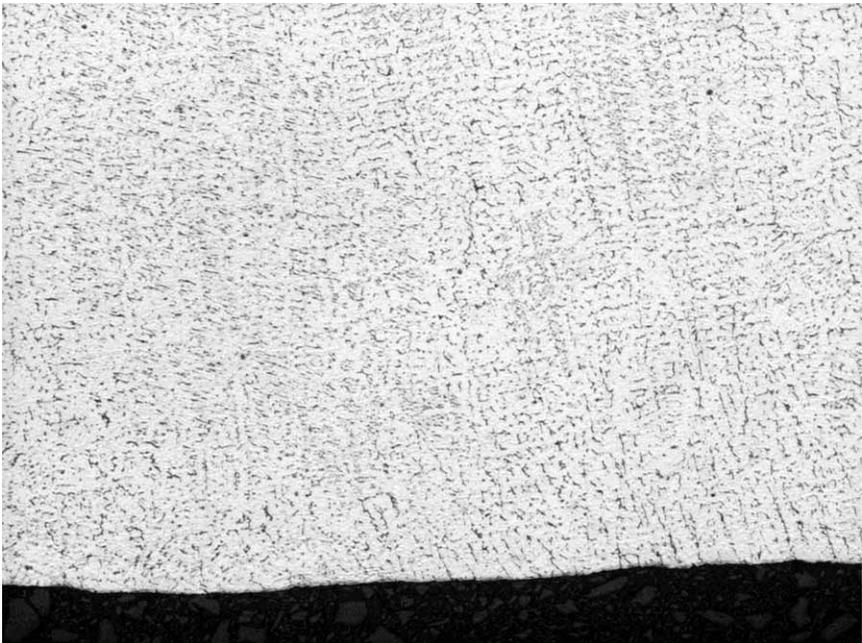
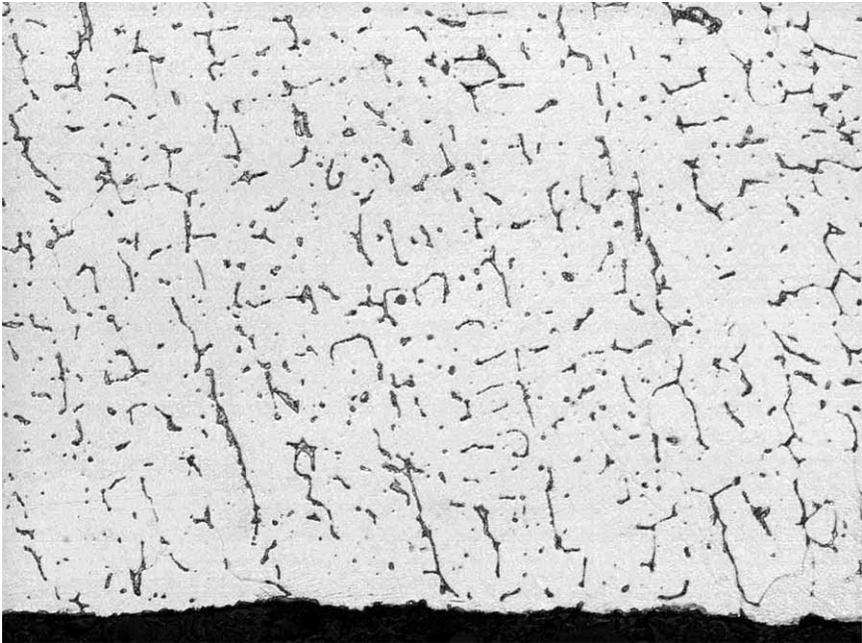
Figure 6.1.1.5: Typical clad microstructure near RCS side surface of the cladding. No intergranular attack (IGA) was present.

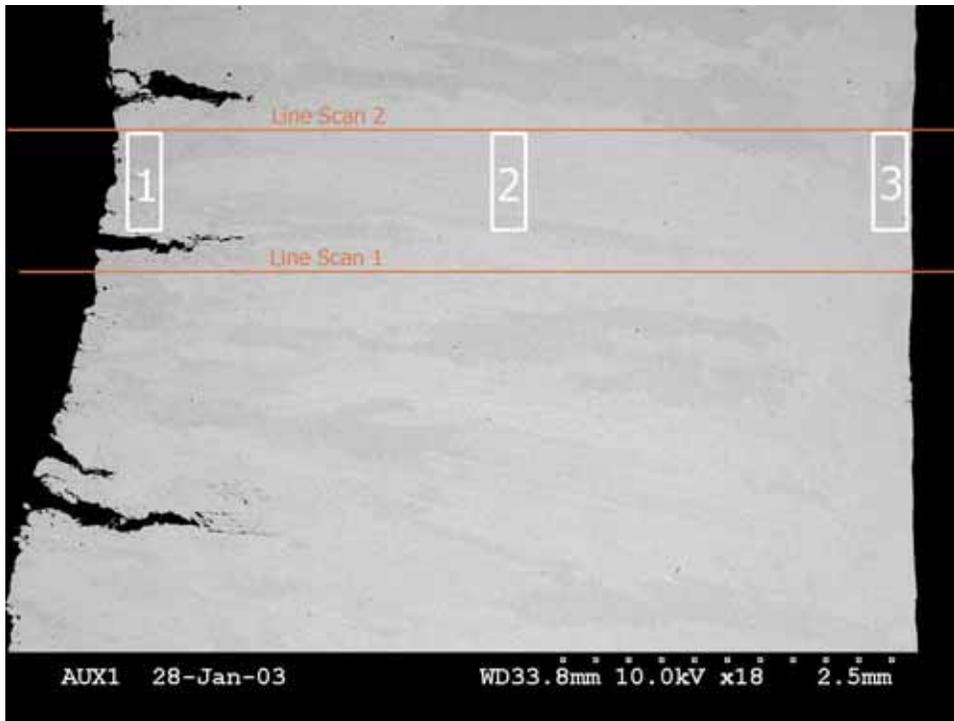
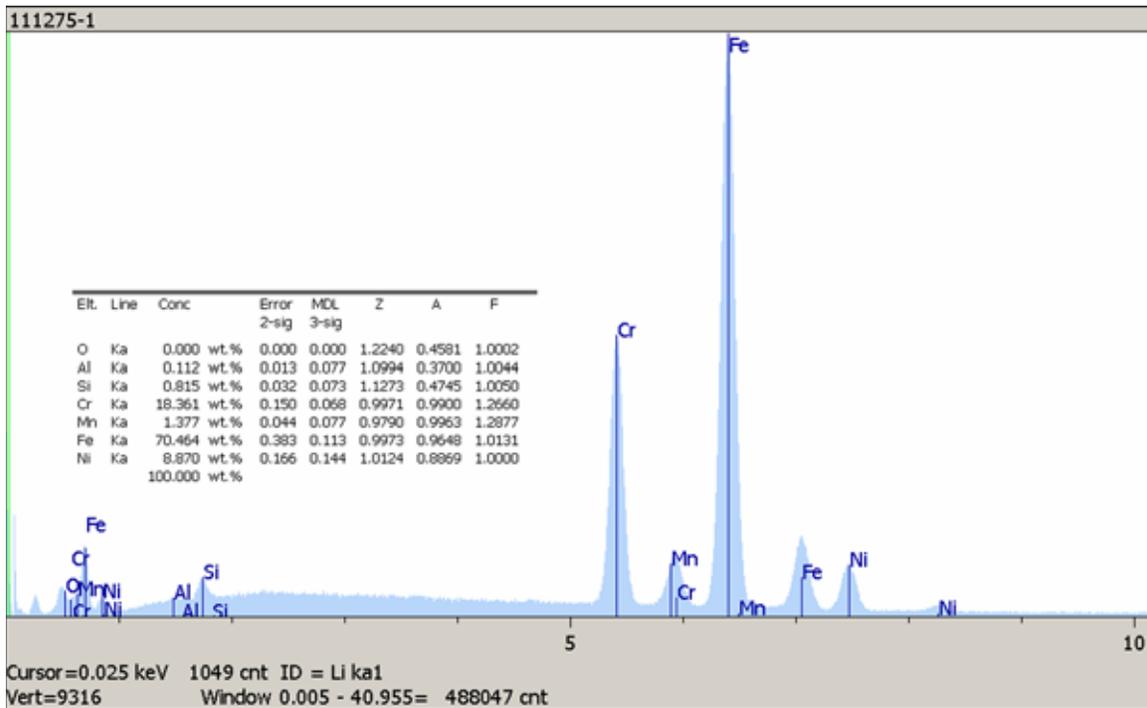
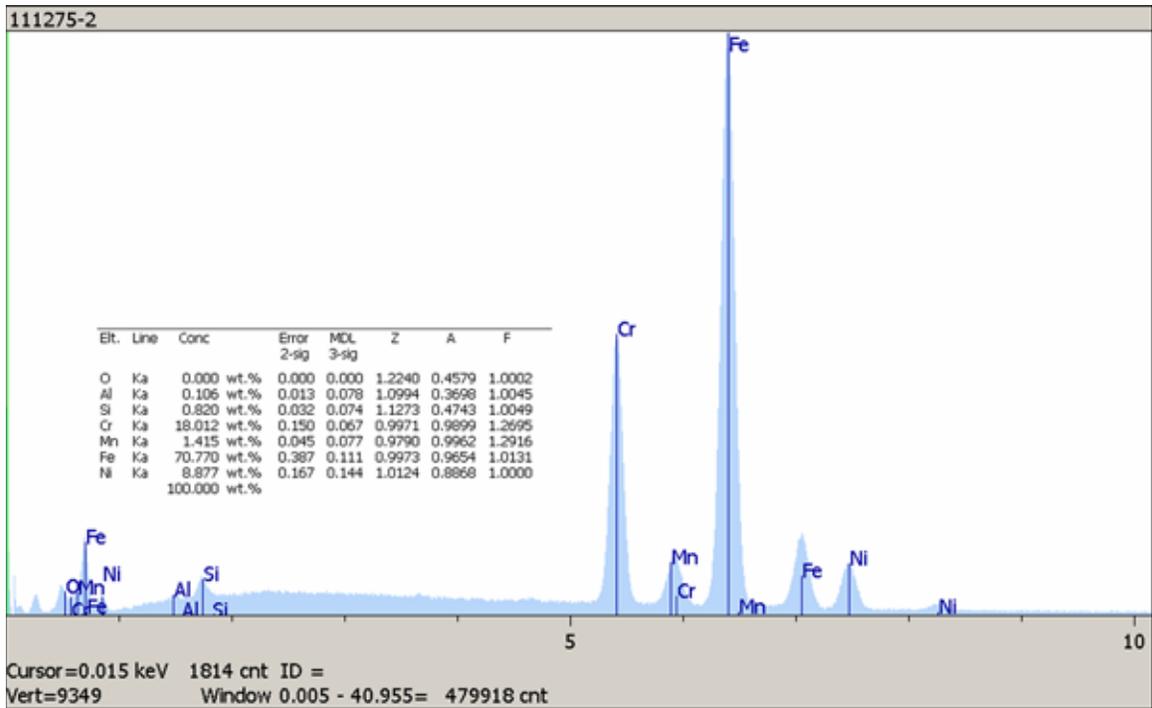
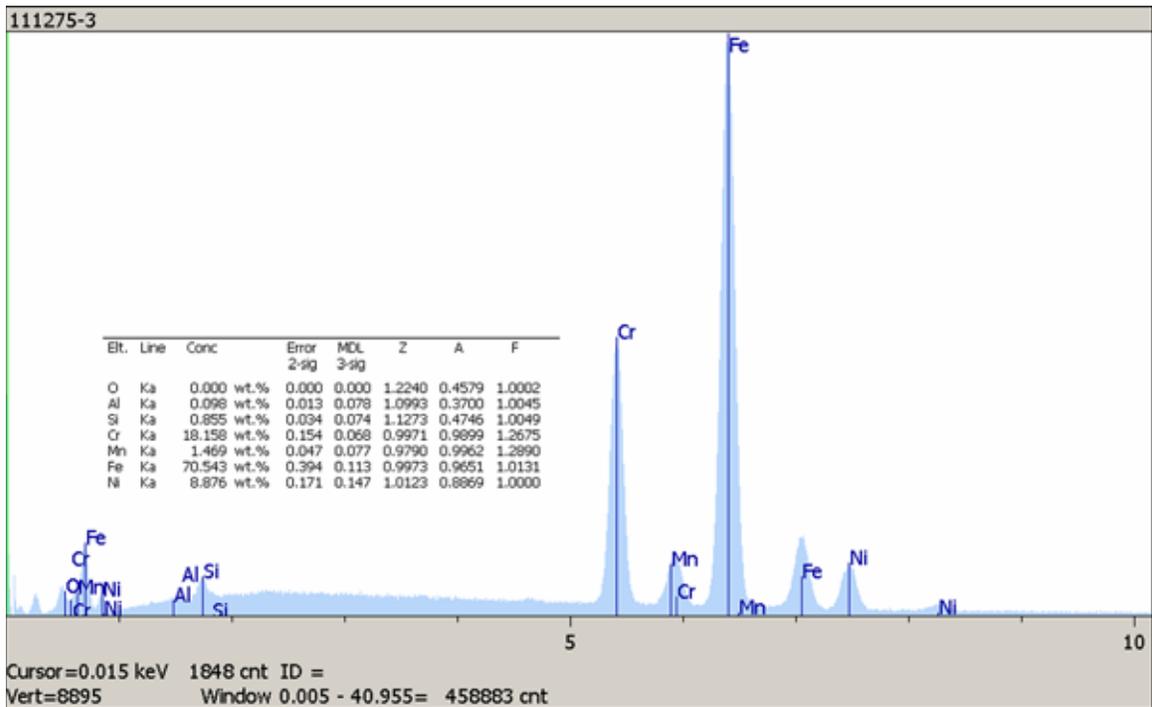
Figure 6.1.2.1: SEM micrograph showing the three deepest cracks in A2A7M. Crack tips are 0.042" to 0.069" (1.1 to 1.75 mm) below the surface. It is noted that these three crack tips are at approximately the same distance of 0.199" (5.06 mm) from the underside surface. EDS scans of areas 1, 2, and 3 and line scans 1 and 2 (not included) indicated a generally uniform chemical composition (including Cr content) across the cladding thickness.

Figure 6.1.2.1 (cont.): EDS results for Areas 2 and 3.

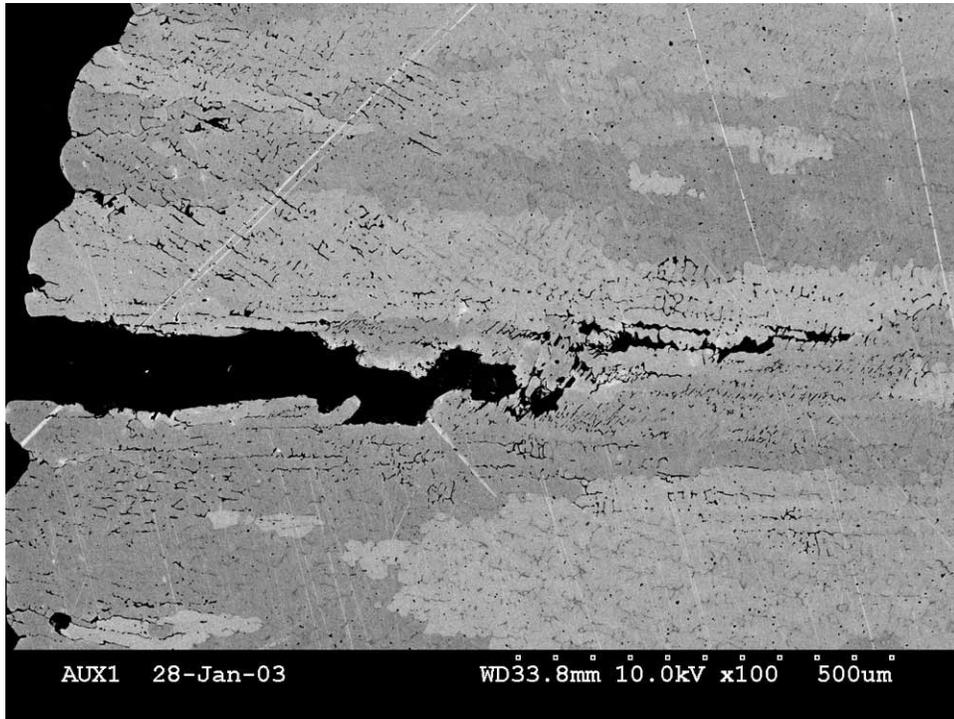
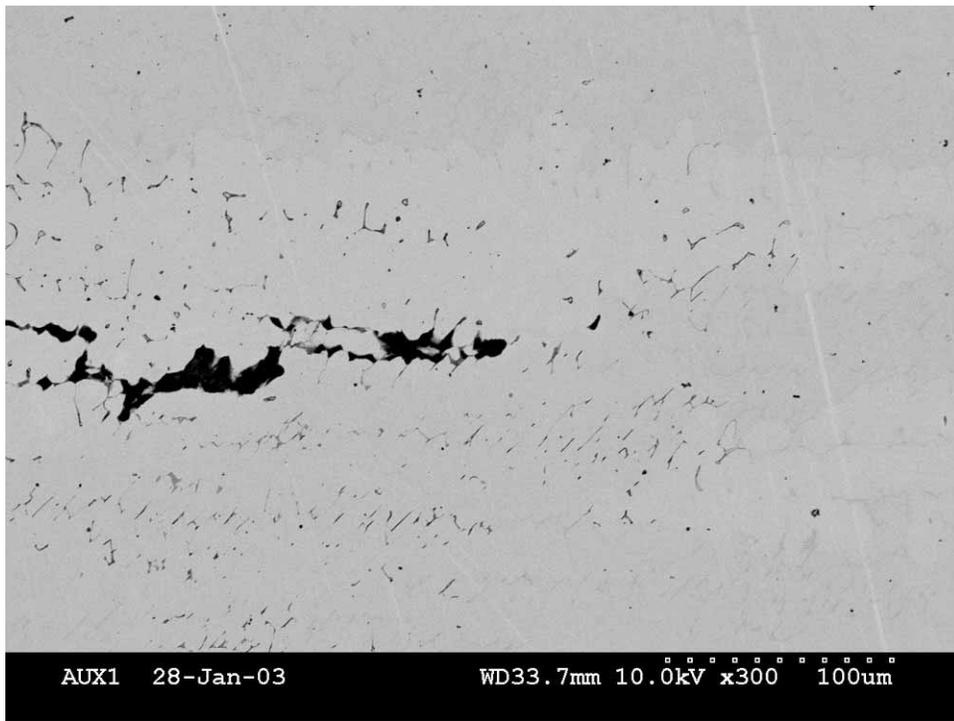
Figure 6.1.2.2: SEM micrographs showing interdendritic crack path along the elongated ferrite pools.

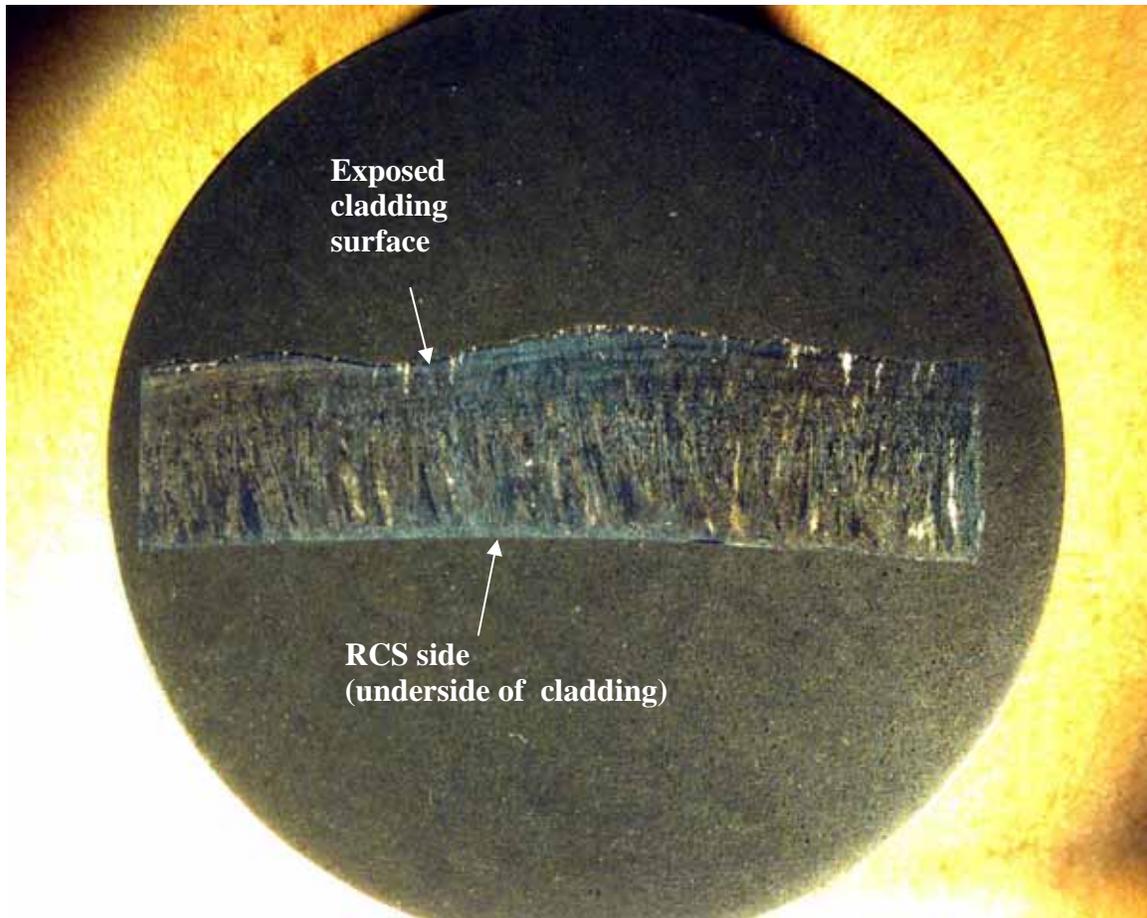
Figure 6.2.1.1: 4X macro photograph of metallurgical mount A2A7N. Refer to Figure 5.11 for the sample orientation.

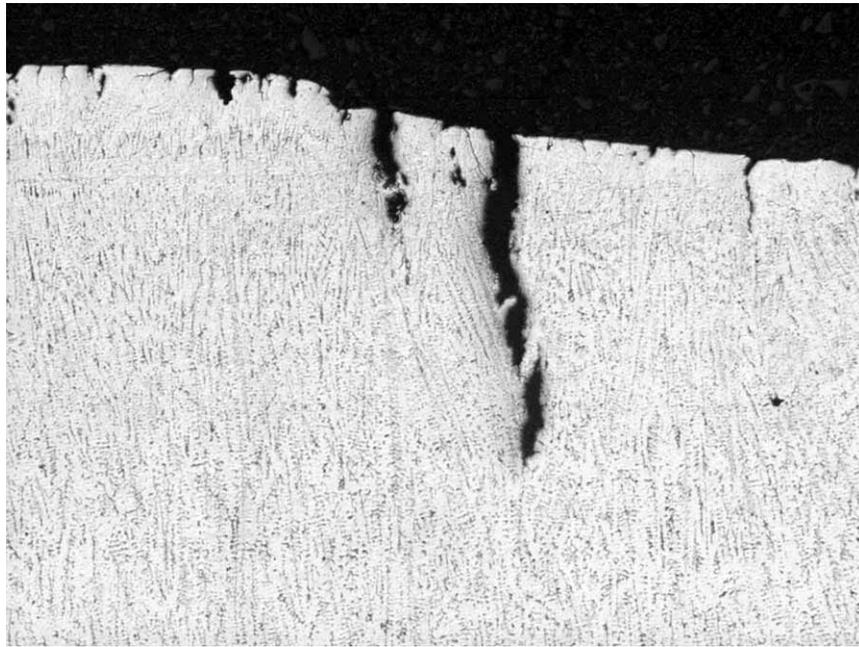
Figure 6.2.1.2: Micrograph of a crack observed on A2A7N. The crack tip is estimated to be approximately 0.036" (0.91 mm) below the surface.

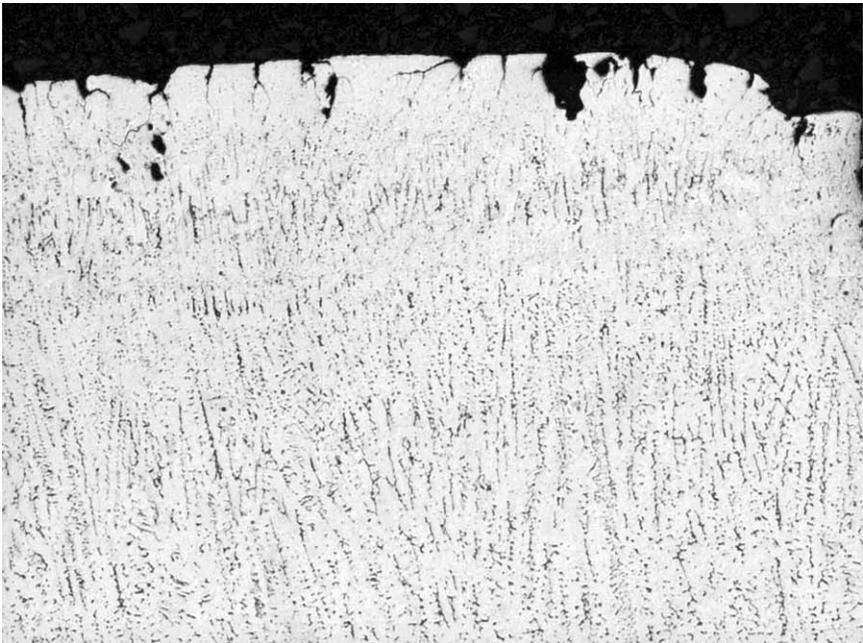
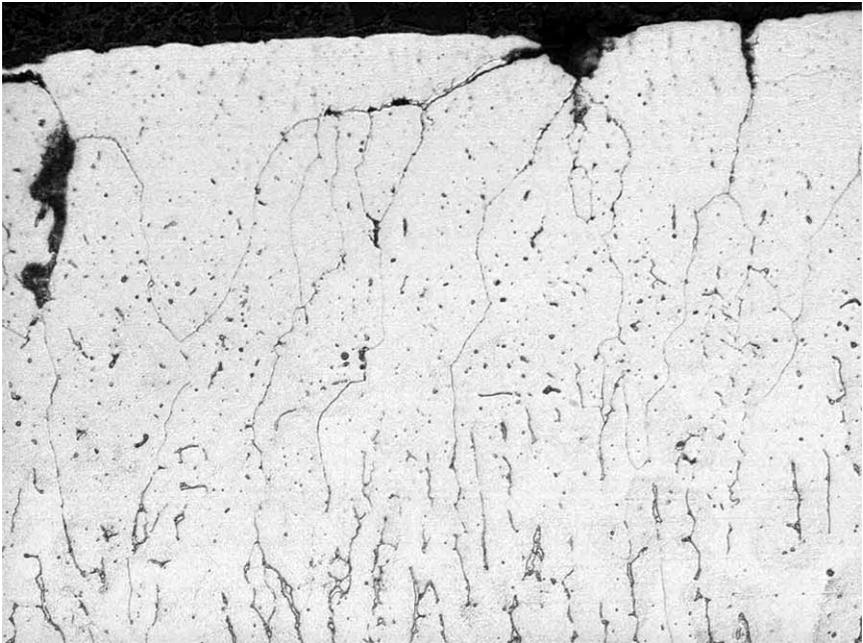
Figure 6.2.1.3: Micrographs showing intergranular attack (IGA) and intergranular cracking on the exposed stainless steel cladding.

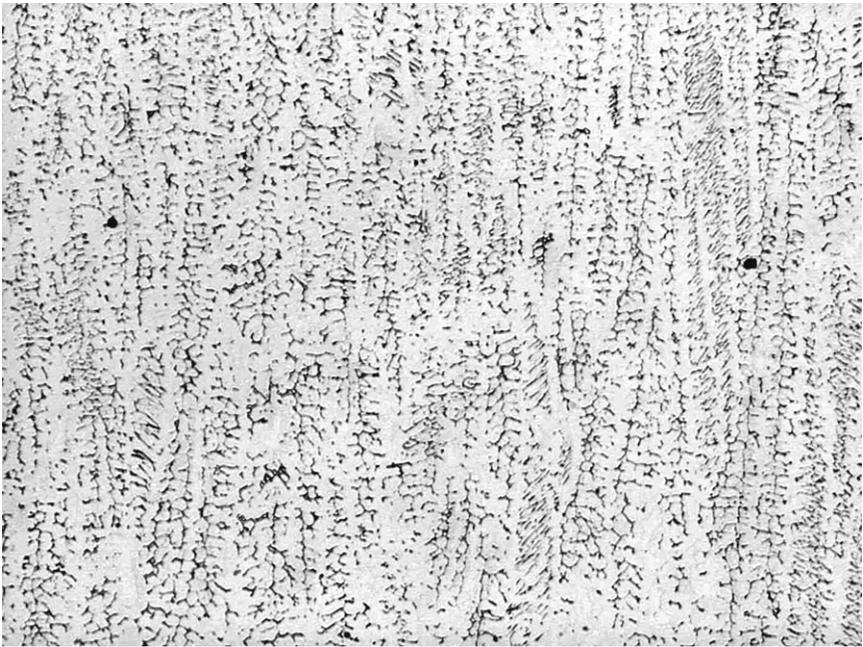
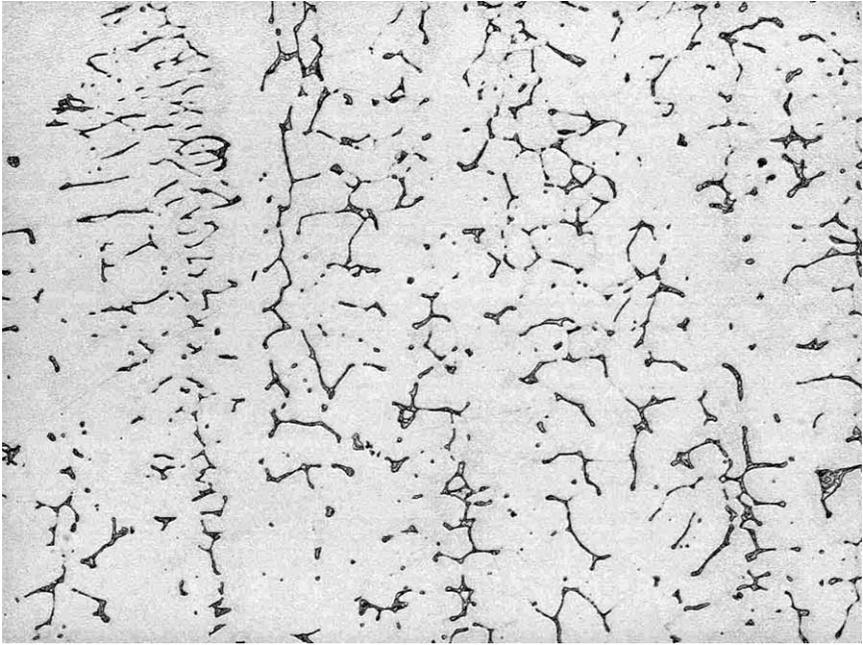
Figure 6.2.1.4: Typical clad microstructure in the mid-thickness of the cladding.

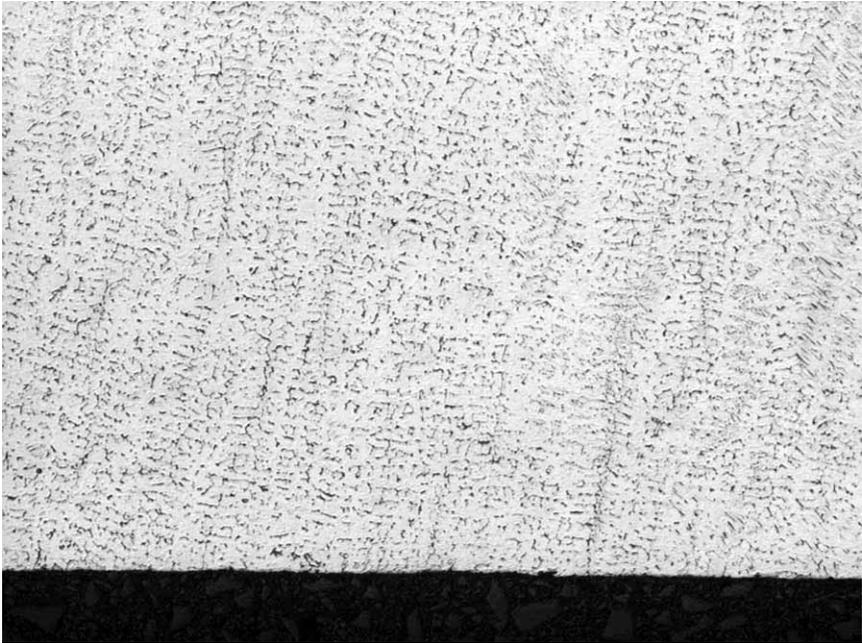
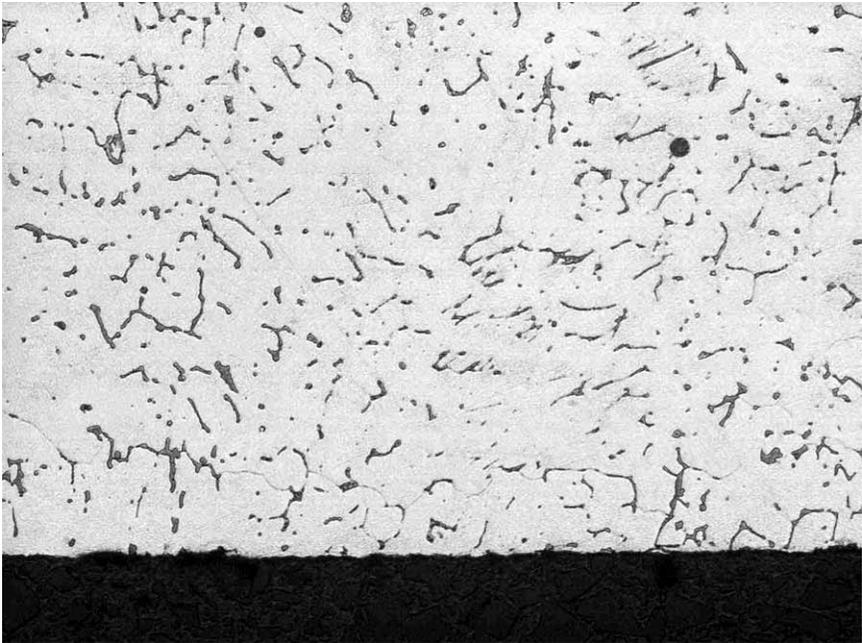
Figure 6.2.1.5: Typical clad microstructure near RCS side surface of the cladding. No intergranular attack (IGA) was present.

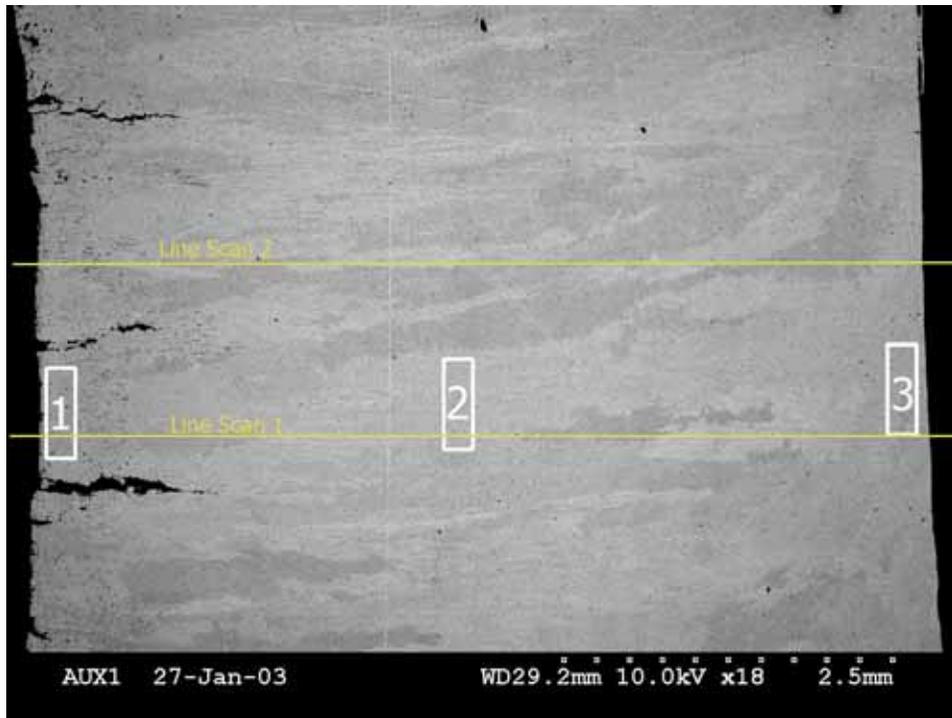
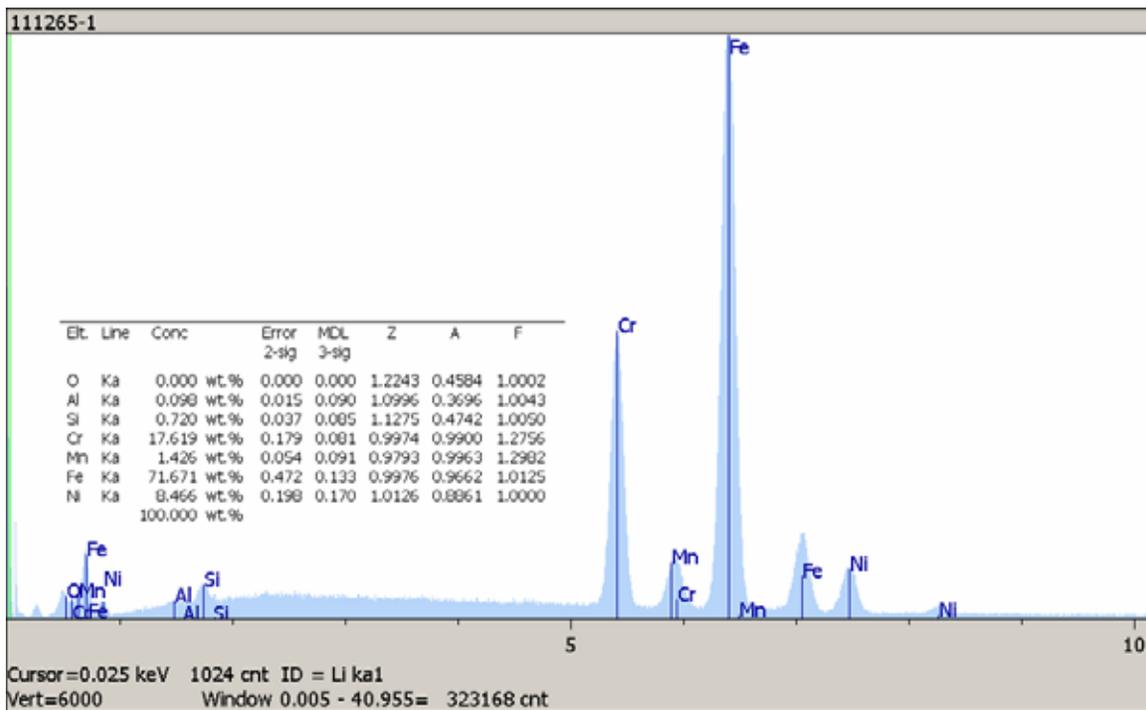
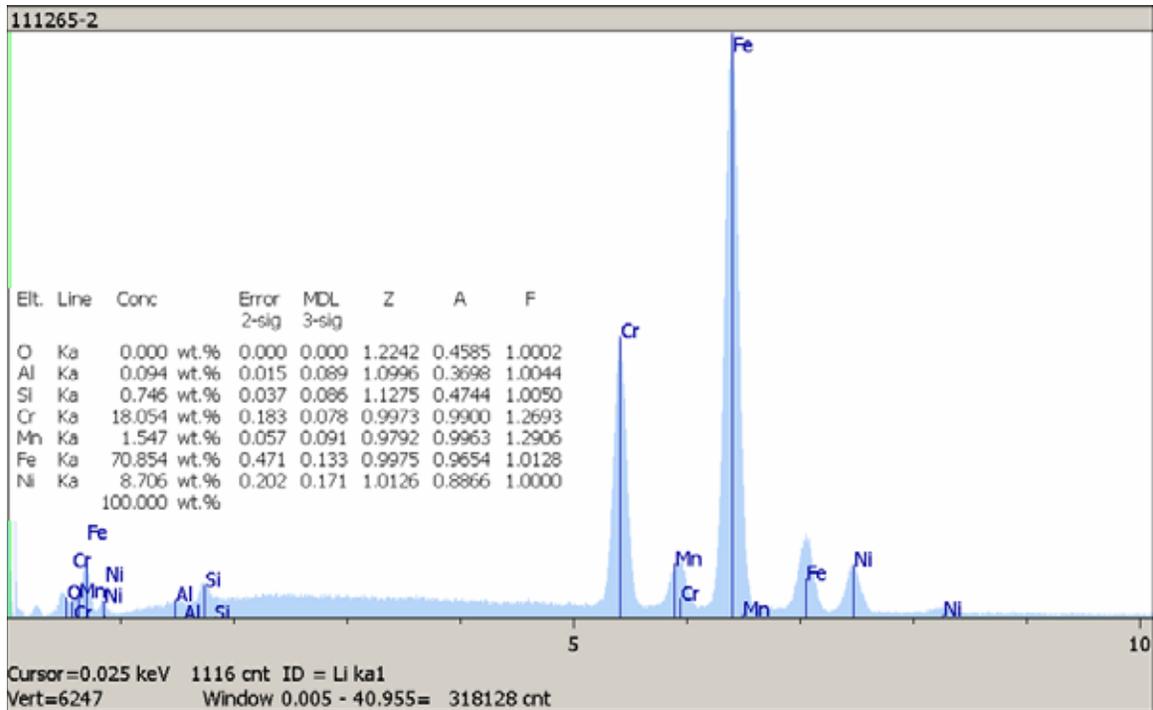
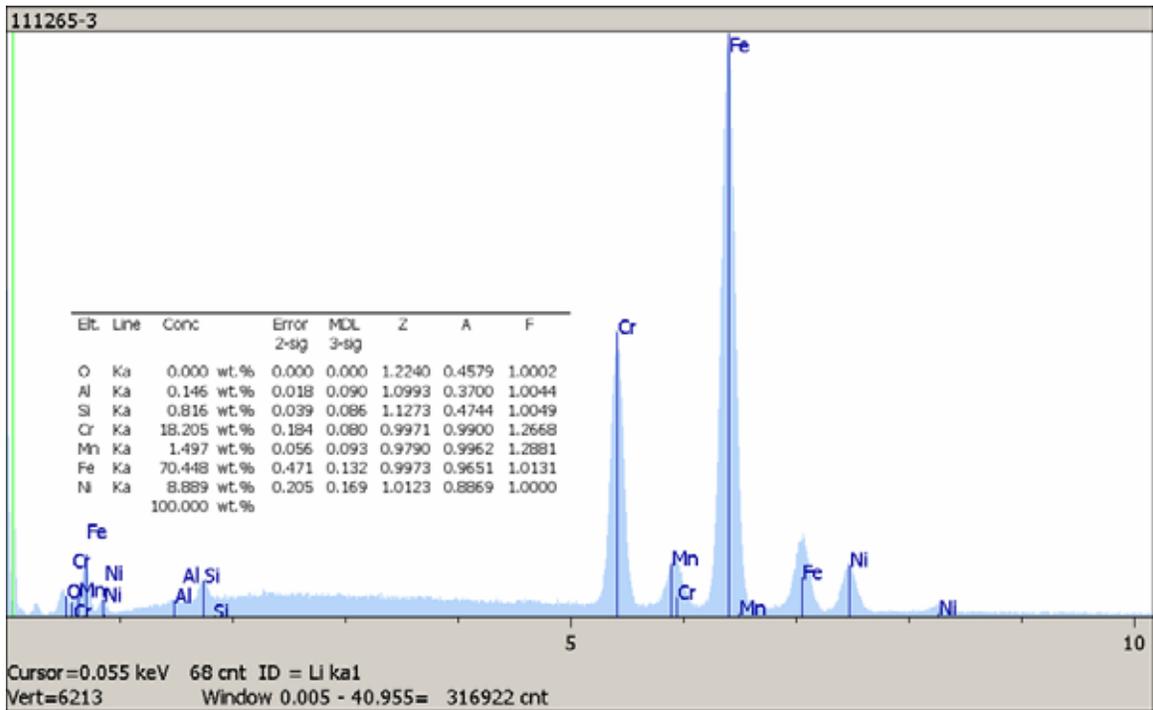
Figure 6.2.2.1: SEM micrograph showing the three deepest cracks in A2A7N. The maximum crack depth was approximately 0.056" (1.42 mm). EDS scans of areas 1, 2, and 3 and lines 1 and 2 (not included) indicated a generally uniform chemical composition (including Cr content) across the cladding thickness.

Figure 6.2.2.1 (cont.): EDS results for Areas 2 and 3.

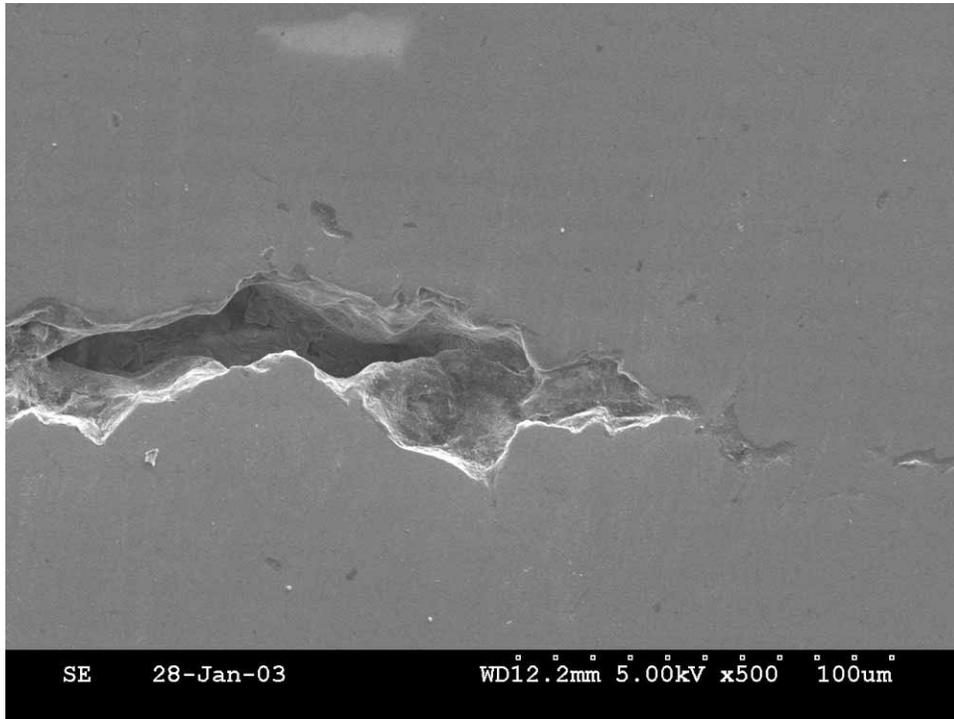
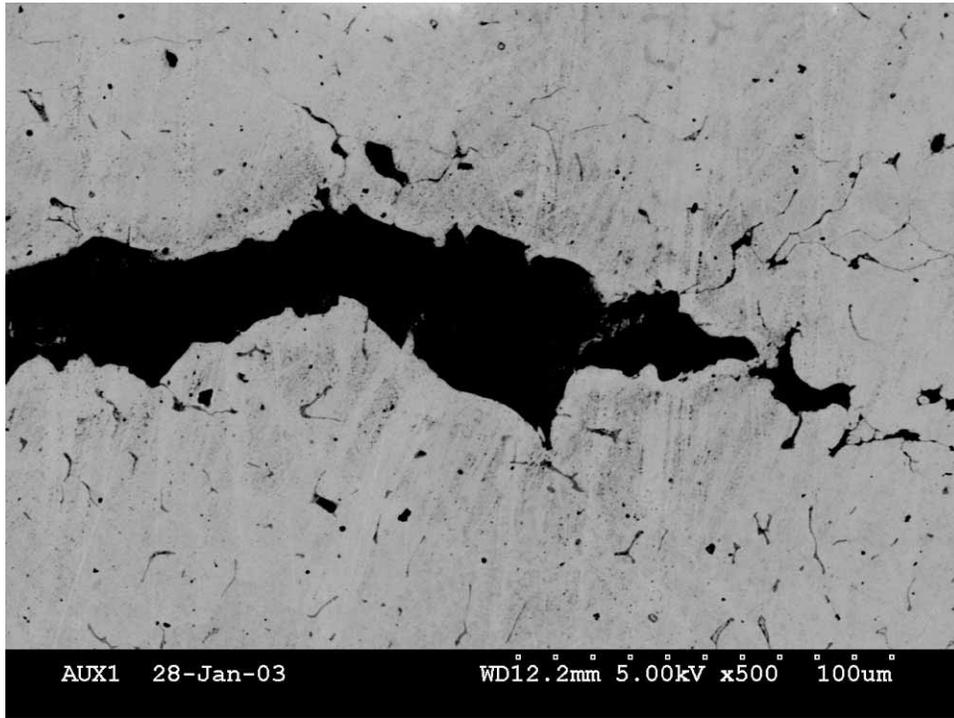
Figure 6.2.2.2: Higher magnification SEM micrographs of crack tip, showing the interdendritic crack path along the elongated ferrite pools.

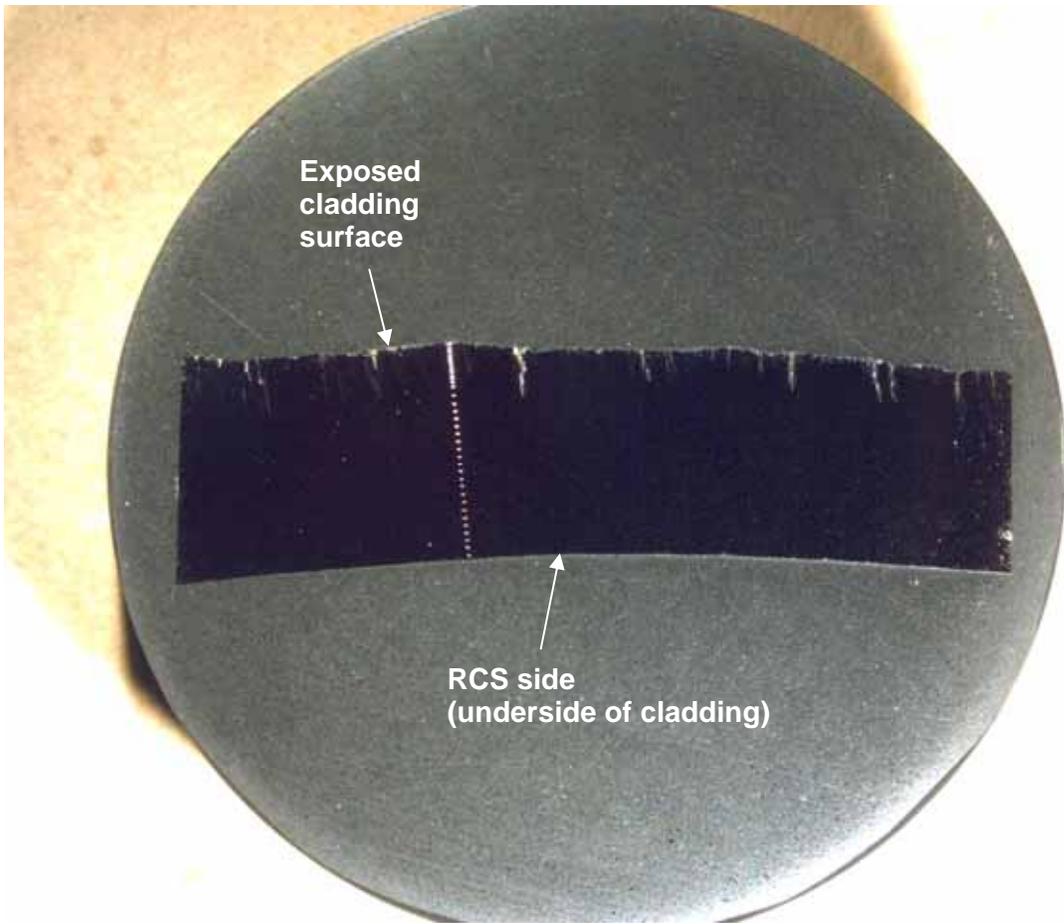
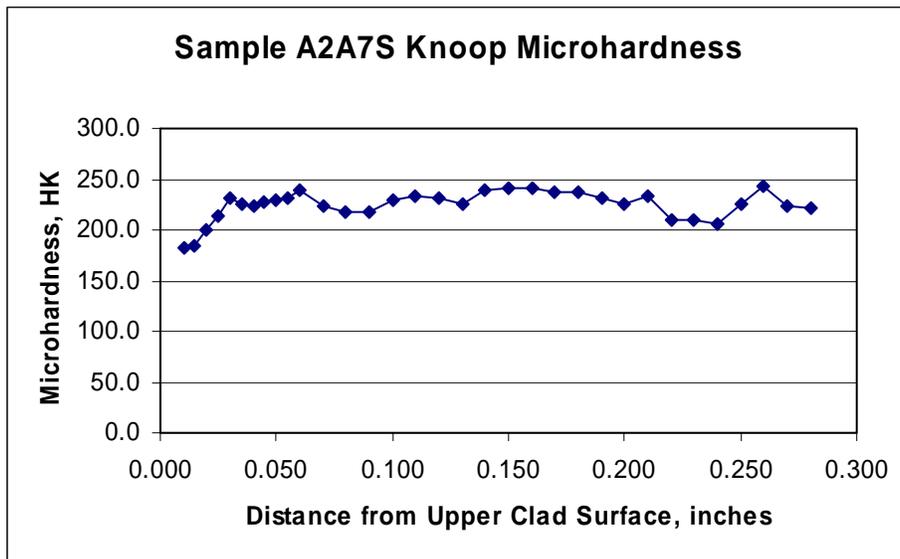
Figure 6.3.1.1: 4X macro photograph of metallurgical mount A2A7S. Refer to Figure 5.11 for the sample orientation. Knoop microhardness values exhibited lower hardness readings toward the exposed clad side (left side of graph), which was in contrast to A2A7M.

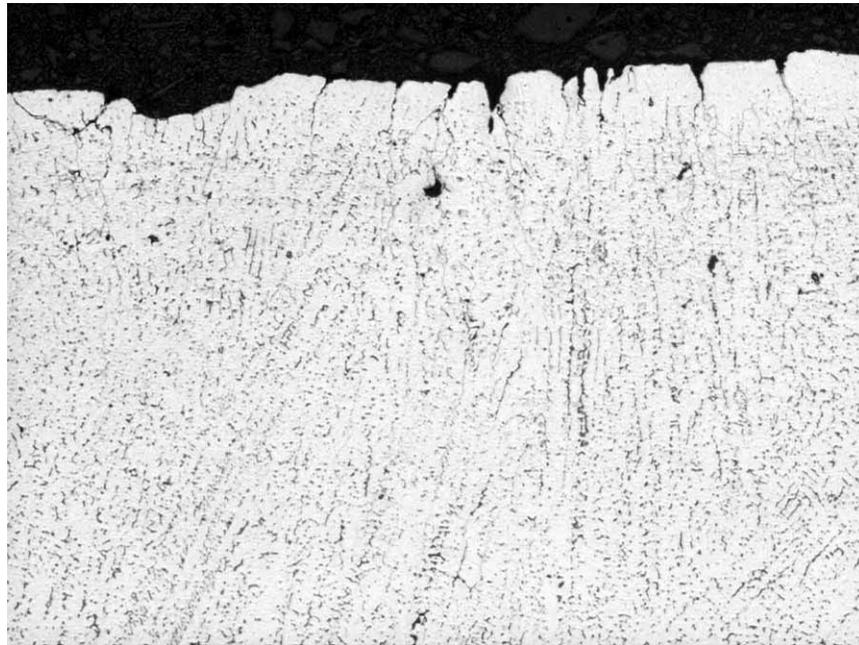
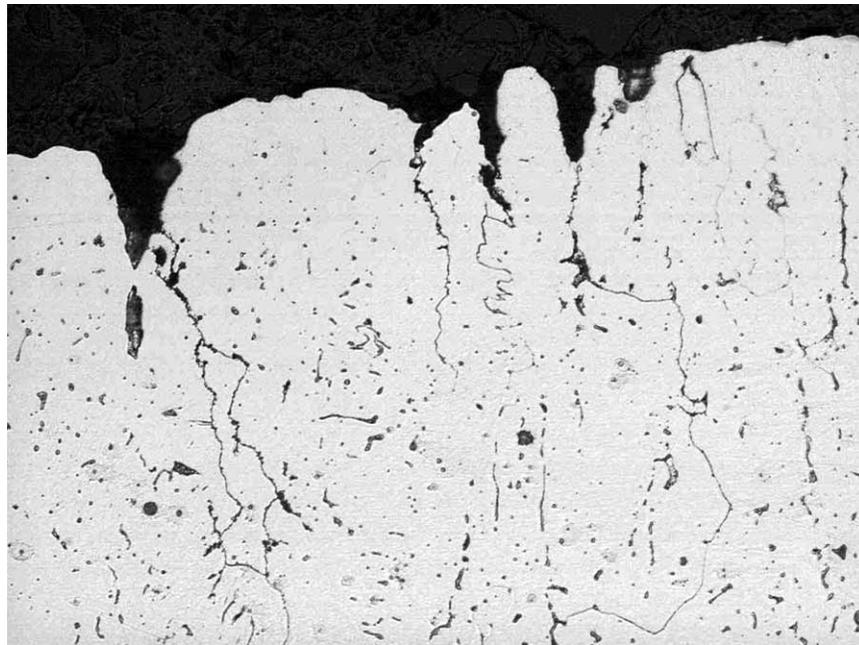
Figure 6.3.1.2: Micrographs showing intergranular attack (IGA) and intergranular or interdendritic cracking on the exposed stainless steel cladding.

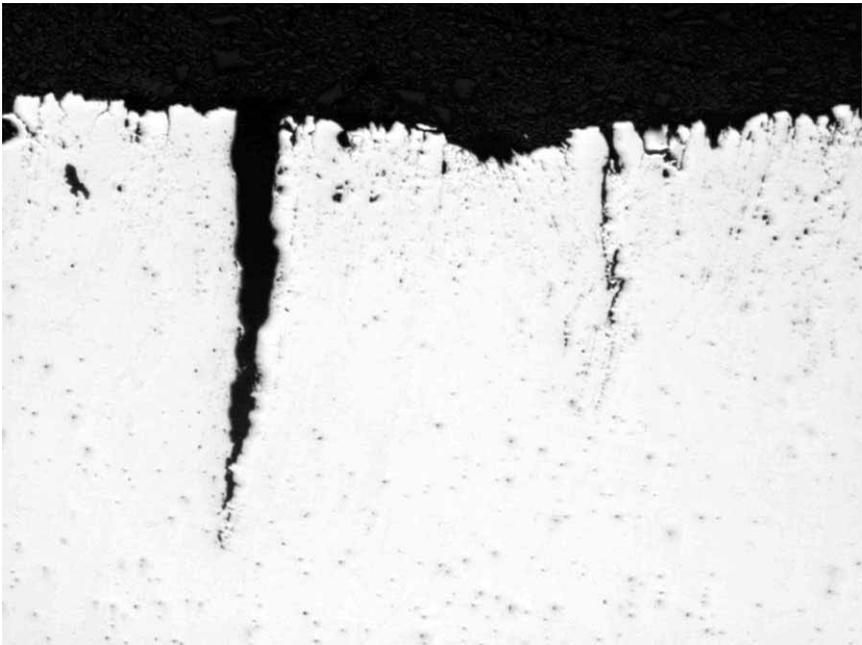
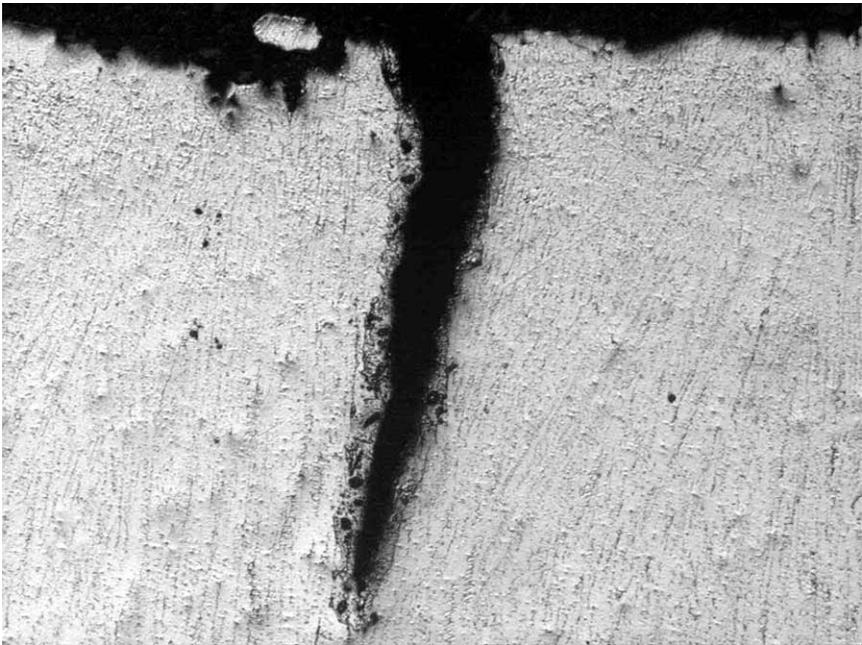
Figure 6.3.1.3: Micrographs of cracking observed on sample A2A7S. Different cracks are shown.

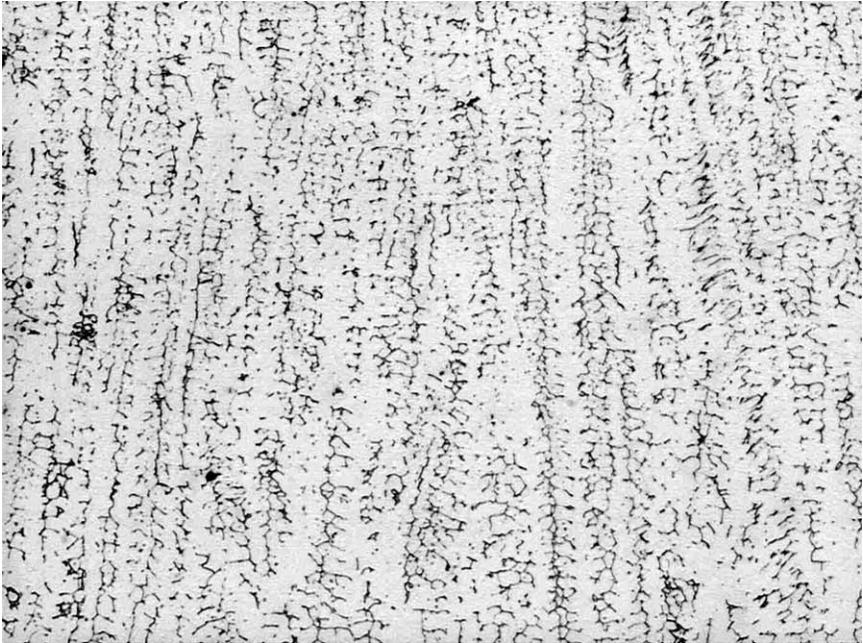
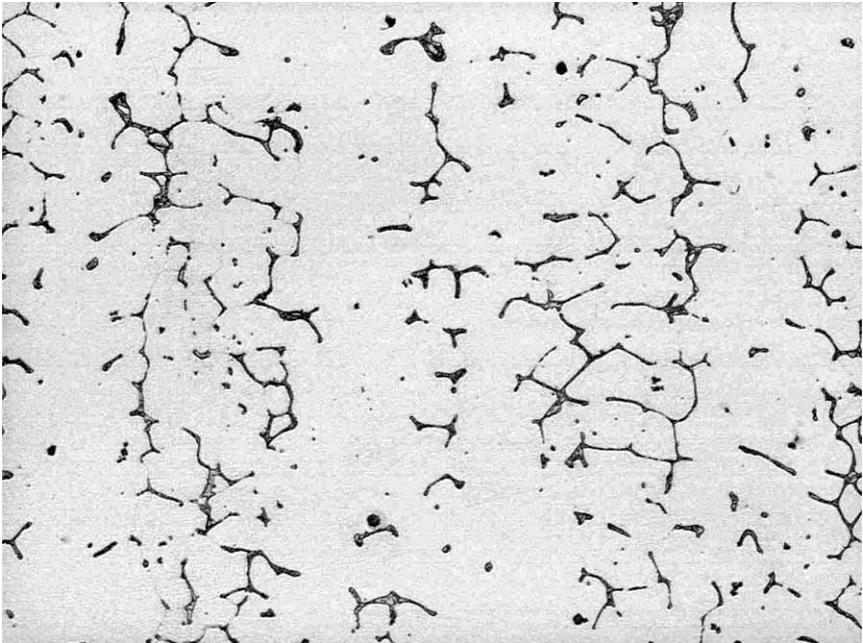
Figure 6.3.1.4: Typical clad microstructure in the mid-thickness of the cladding.

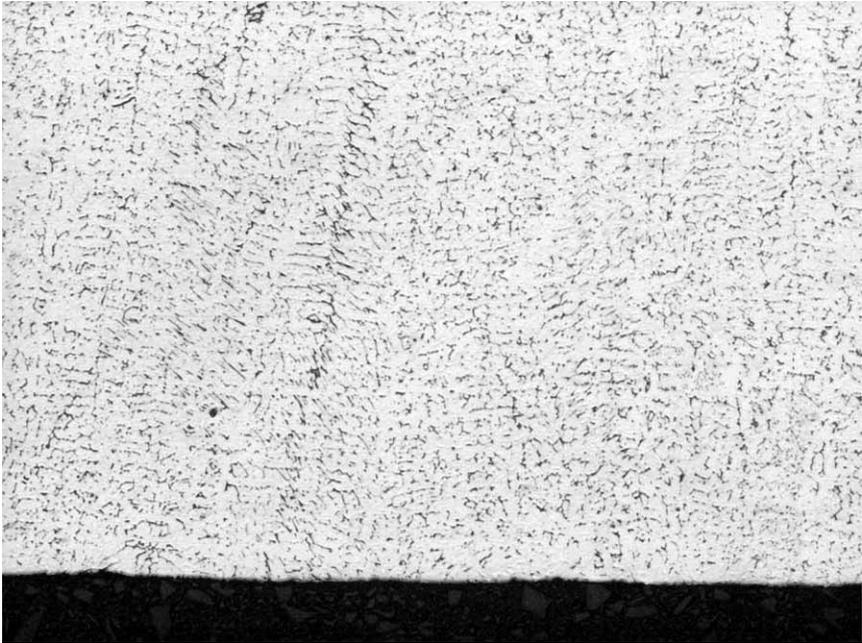
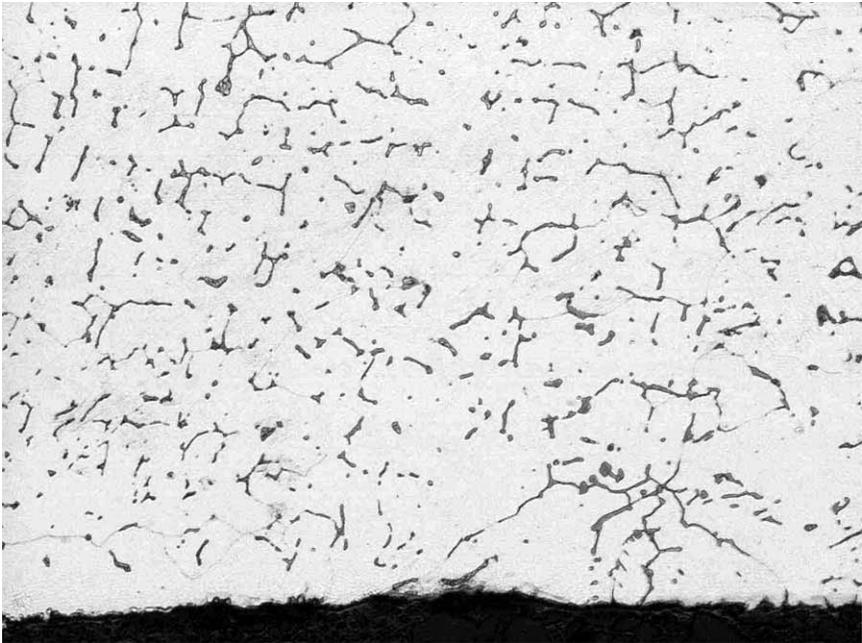
Figure 6.3.1.5: Typical clad microstructure near RCS side surface of the cladding. No intergranular attack (IGA) was present.
