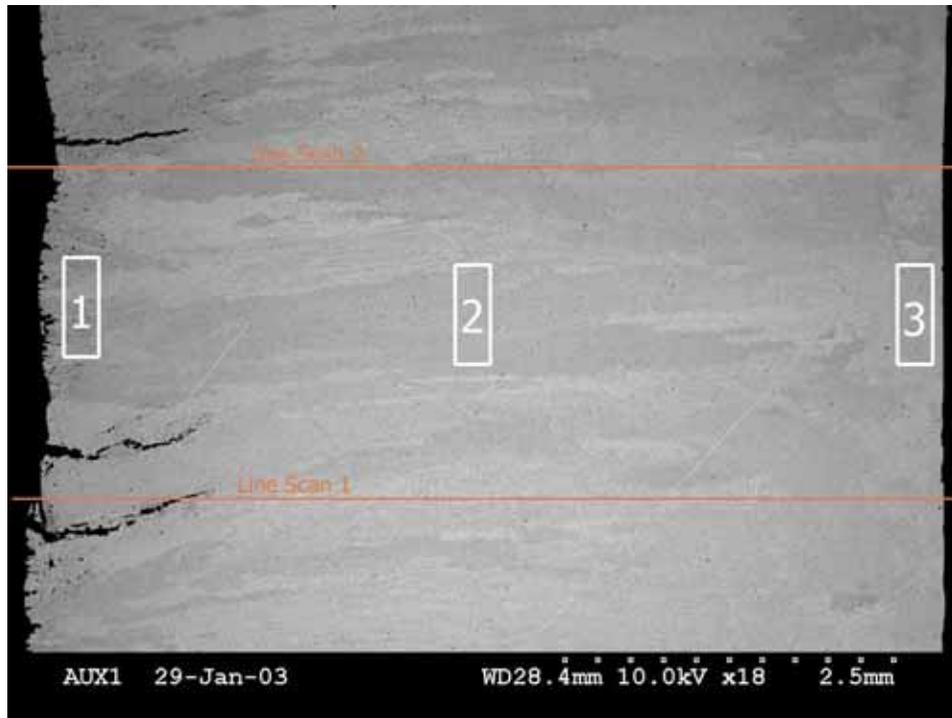
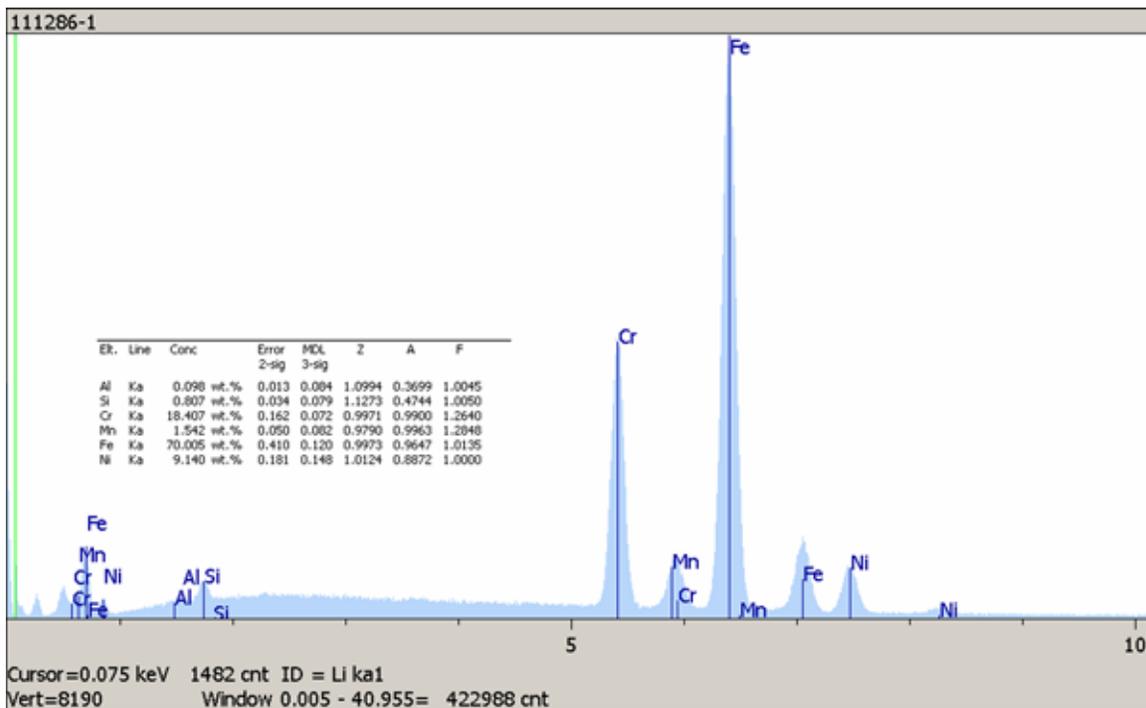
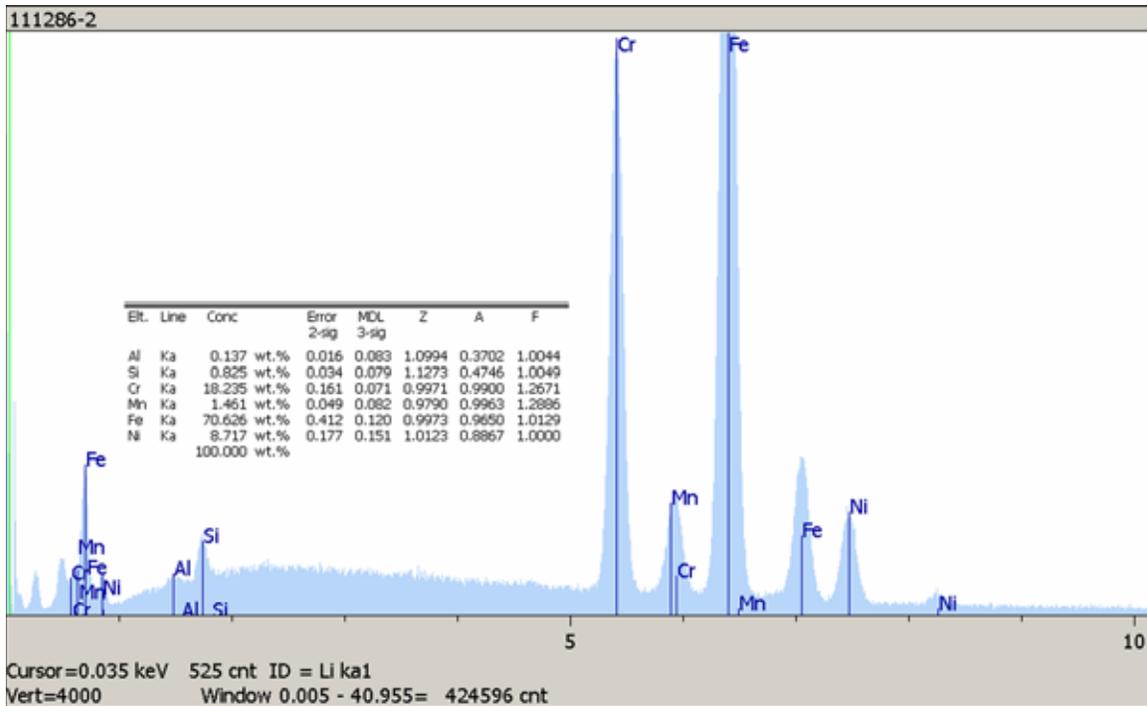
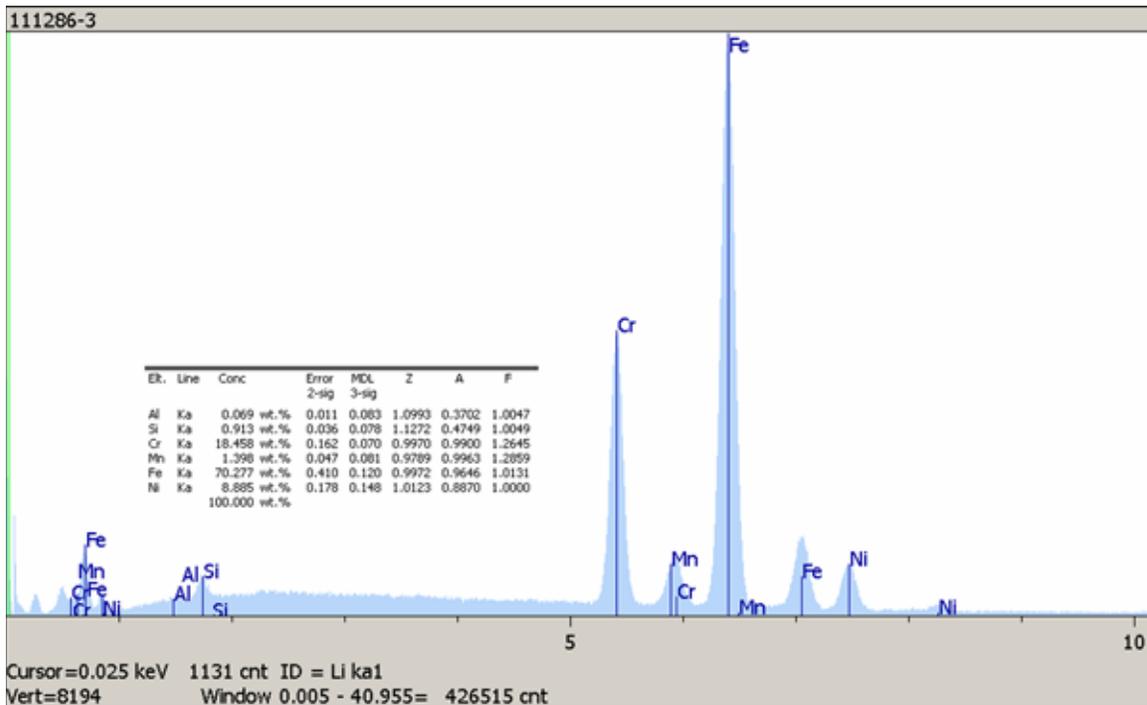
Figure 6.3.2.1: SEM micrograph of the three deepest cracks in A2A7S. The maximum crack depth was approximately 0.056" (1.42 mm). These three crack tips are approximately the same distance from the underside surface. EDS scans of areas 1, 2, and 3 and lines 1 and 2 (not included) indicated a generally uniform chemical composition (including Cr content) across the cladding thickness.

Figure 6.3.2.1 (cont.): EDS results for Areas 2 and 3. Note that the Cr peak was set at full screen height for Area 2.

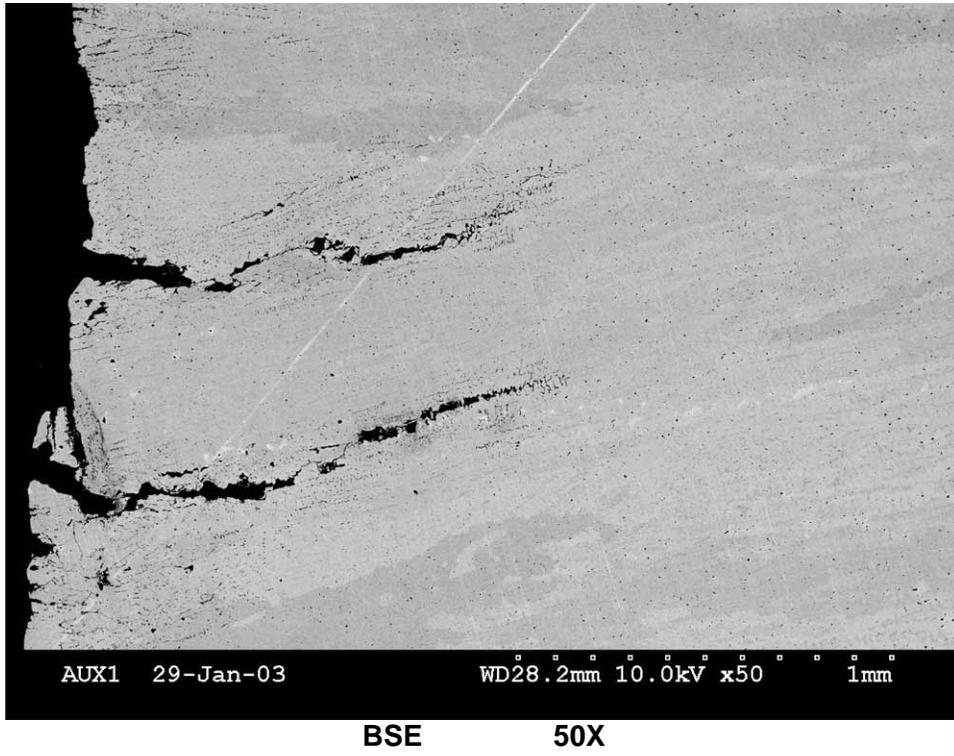
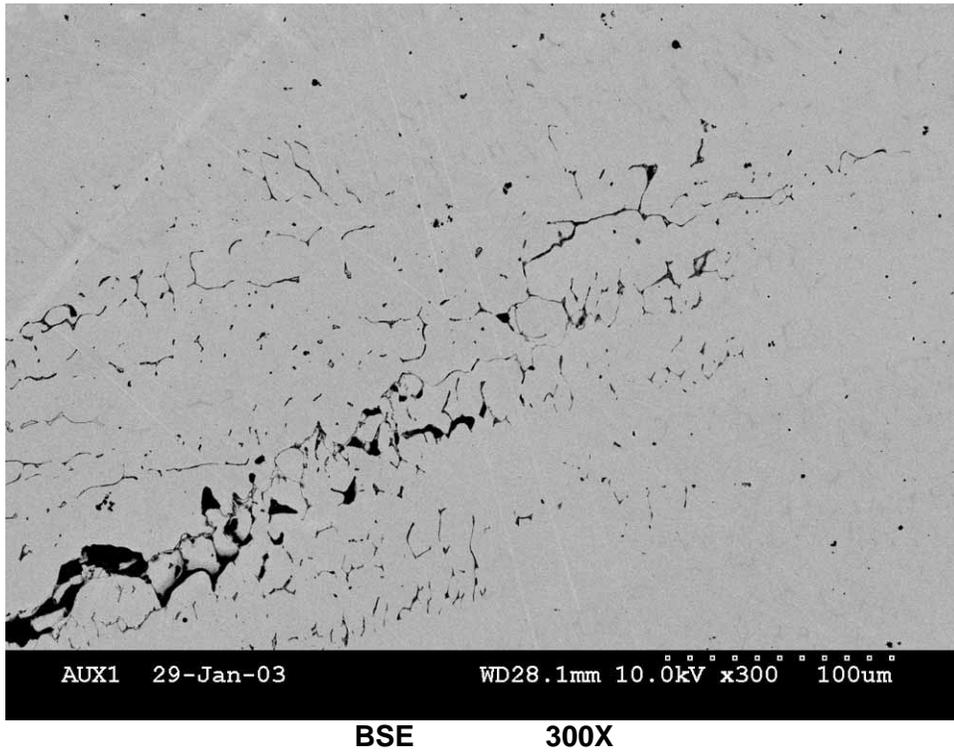
Figure 6.3.2.2: Higher magnification SEM micrographs of crack tip, showing the interdendritic crack path along the elongated ferrite pools.

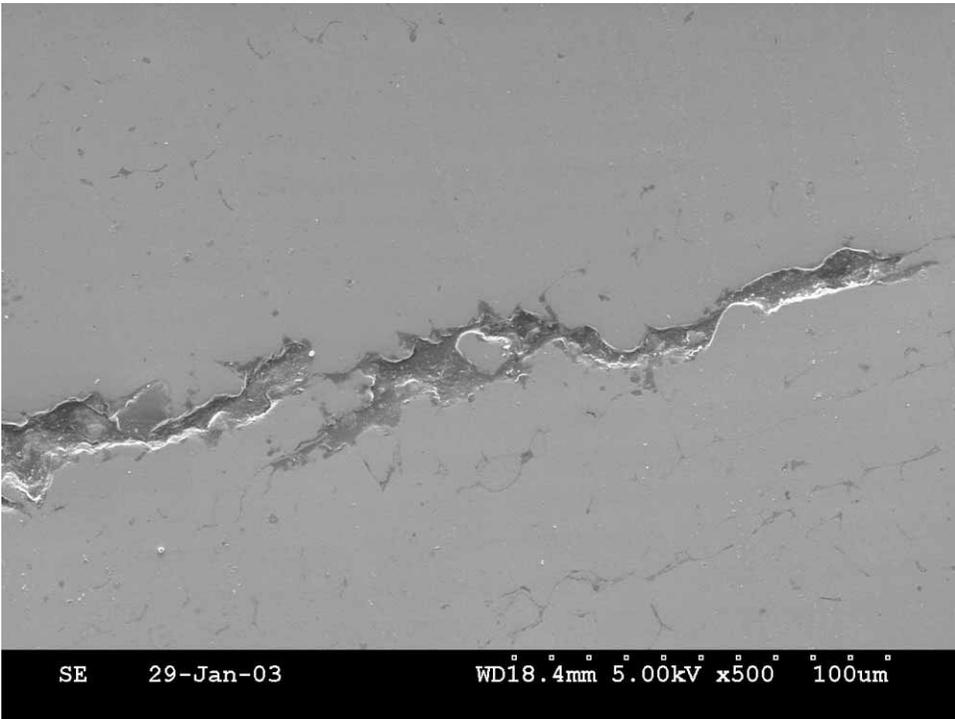
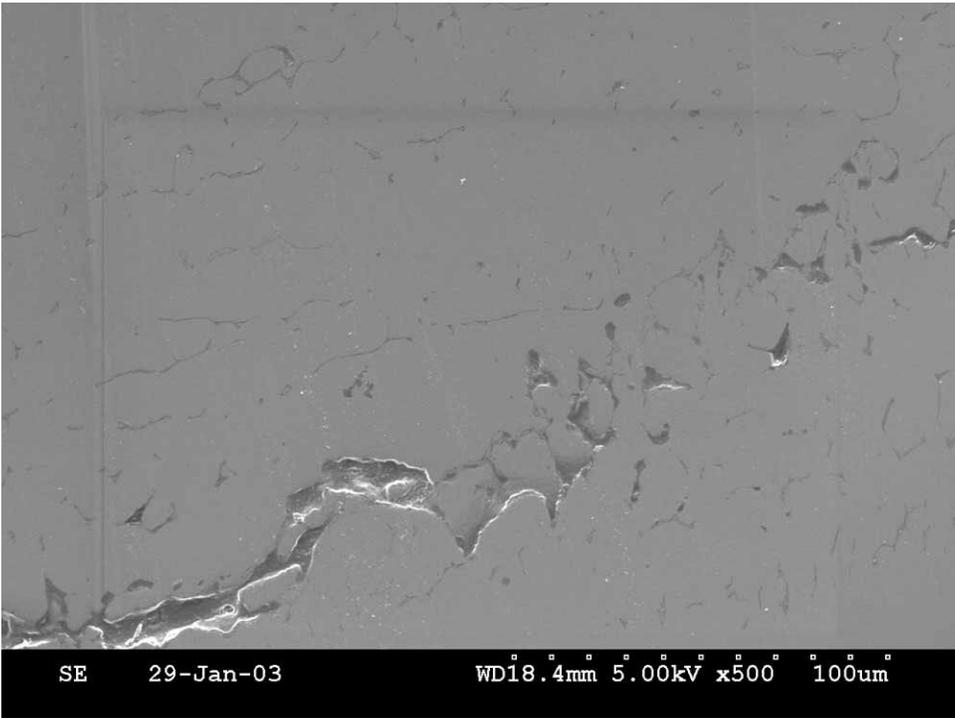
Figure 6.3.2.3: Secondary electron SEM images of crack tip, showing the interdentritic crack path along the elongated ferrite pools.

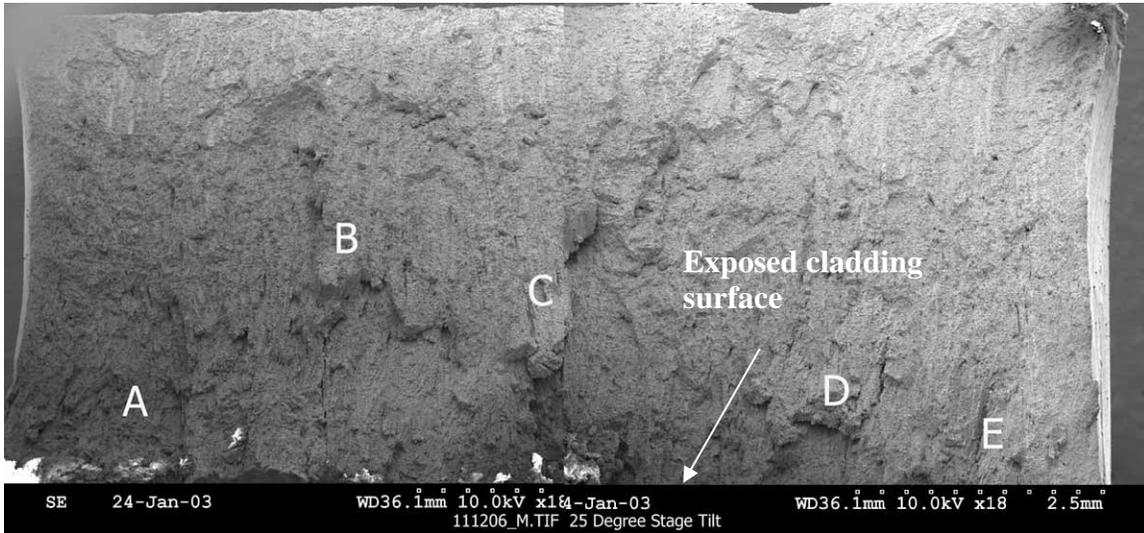
Figure 6.4.1.1: Low magnification SEM mosaic showing the opened main crack (sample A2A7-L1A). Refer to Figures 5.11 and 5.12 for the sample location. The exposed cladding surface is oriented downward in the SEM micrographs.

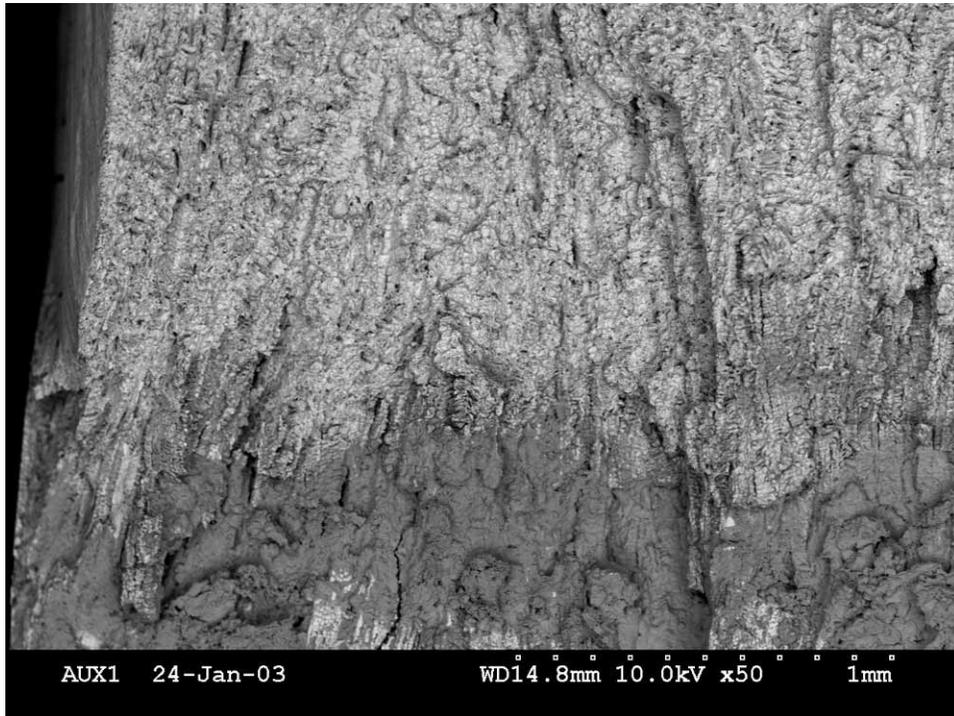
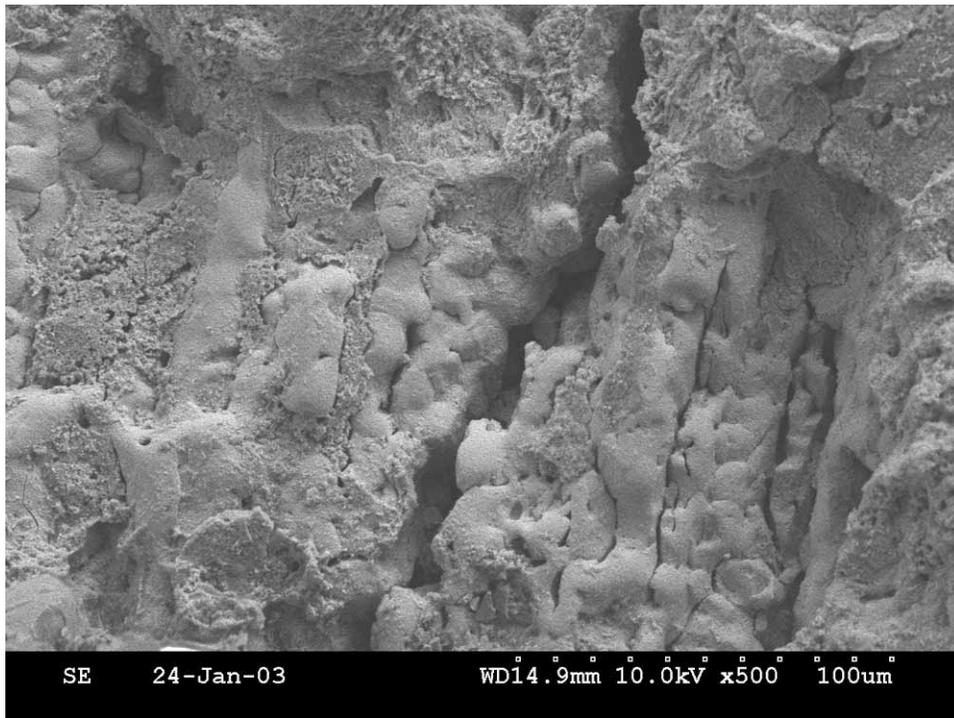
Figure 6.4.1.2: Near mosaic area “A”. Heavy deposits are present toward the exposed side of the cladding (darker contrast in BSE micrograph). Fracture morphology is interdendritic in nature.

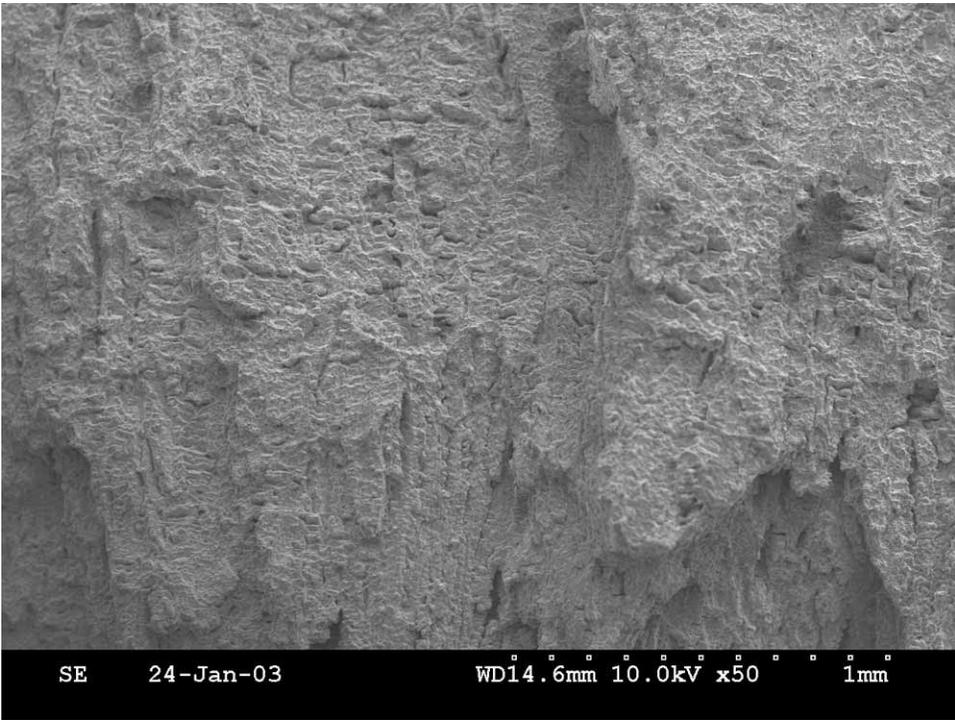
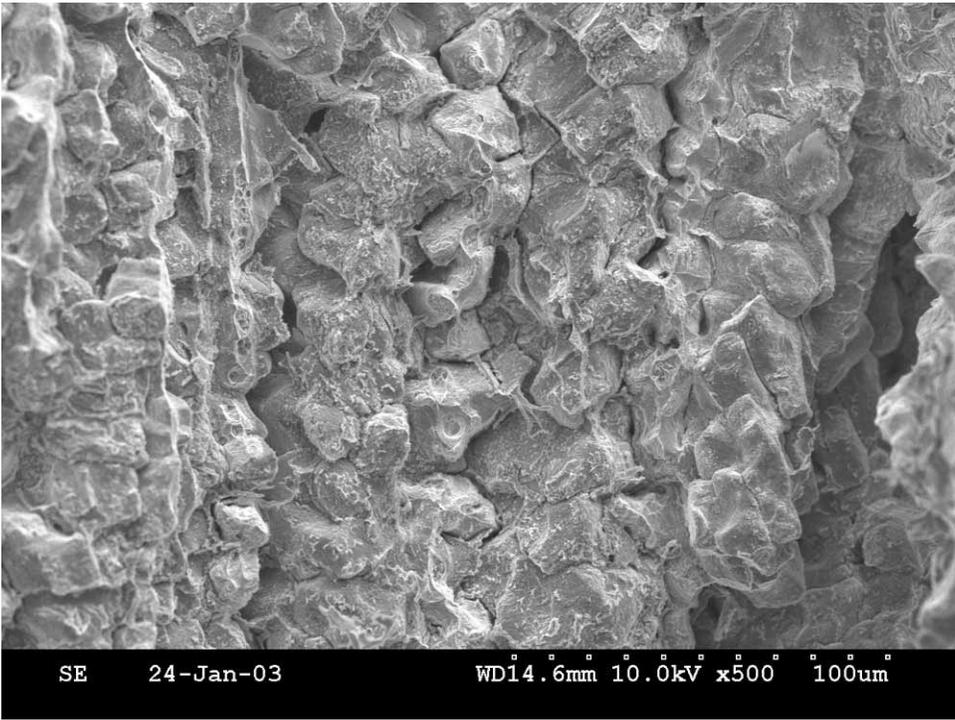
Figure 6.4.1.3: Near mosaic area "B". Cracking is intergranular/interdendritic.

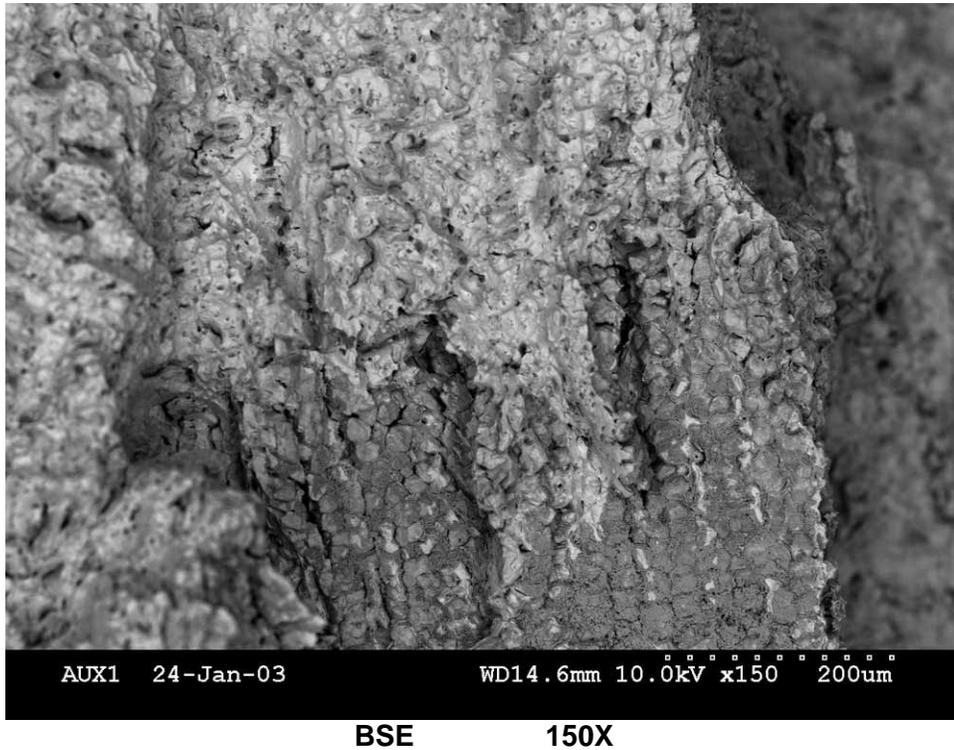
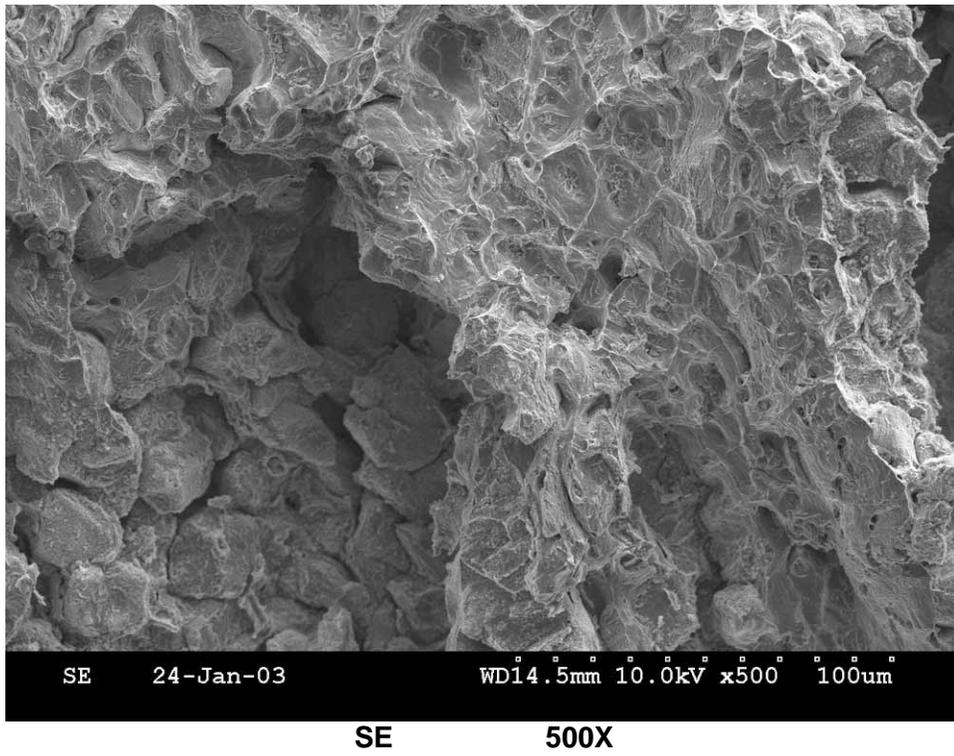
Figure 6.4.1.4: Near mosaic area "C". Fracture mode is intergranular or interdendritic for in-service cracking and ductile tearing for lab opened-up fracture.

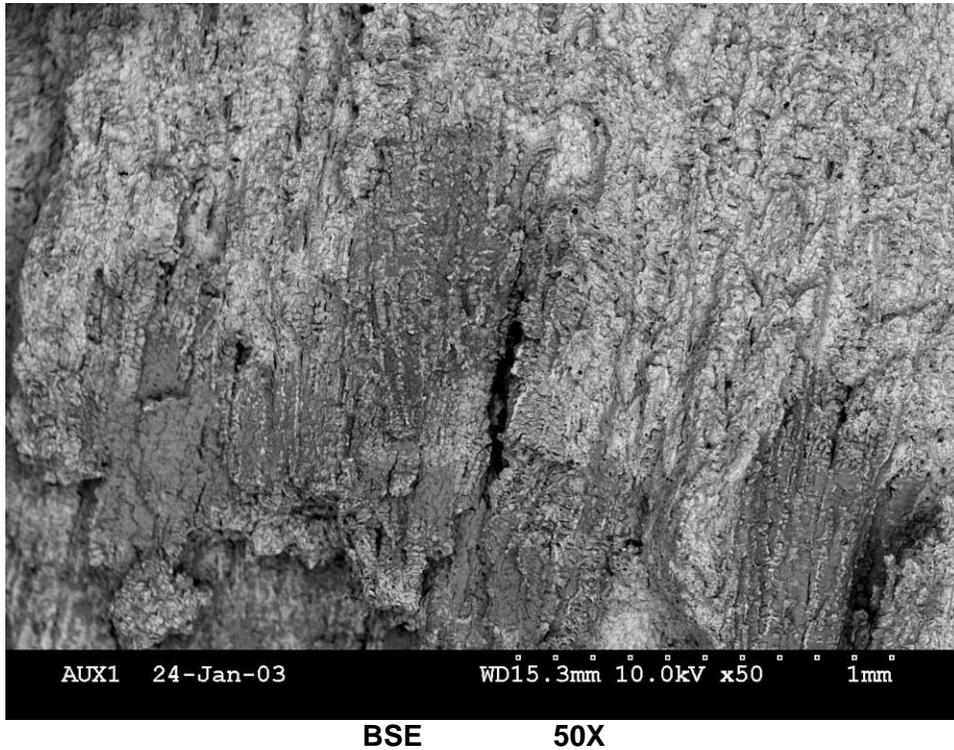
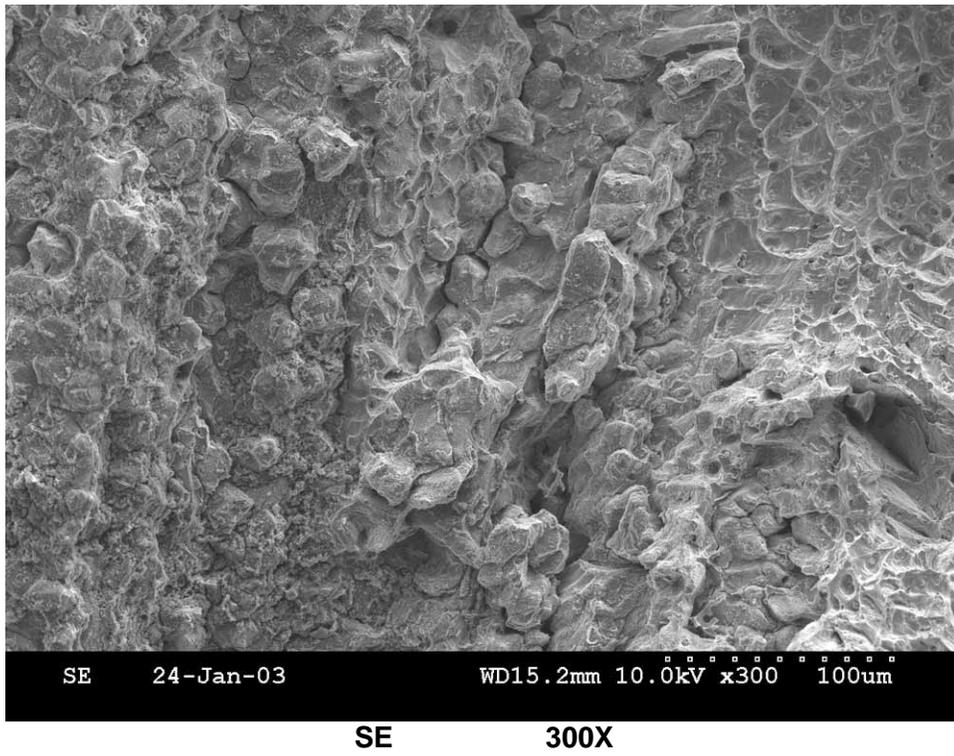
Figure 6.4.1.5: Near mosaic area "D". Fracture mode is intergranular or interdendritic for in-service cracking and ductile tearing for lab opened-up fracture (upper right).

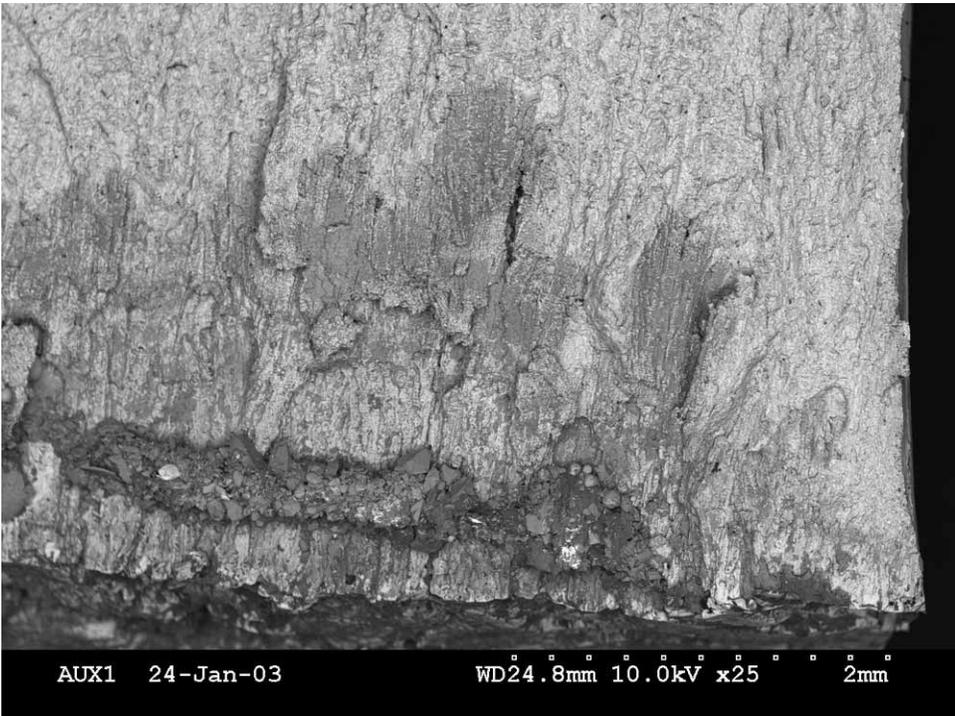
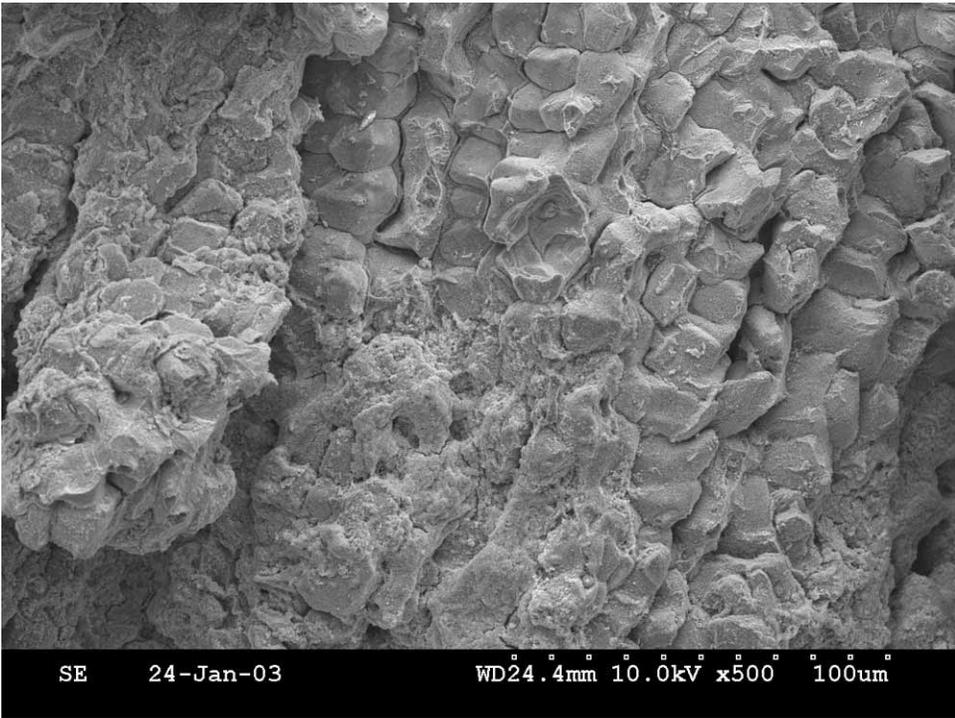
Figure 6.4.1.6: Near mosaic area "E". Cracking is intergranular/interdendritic.

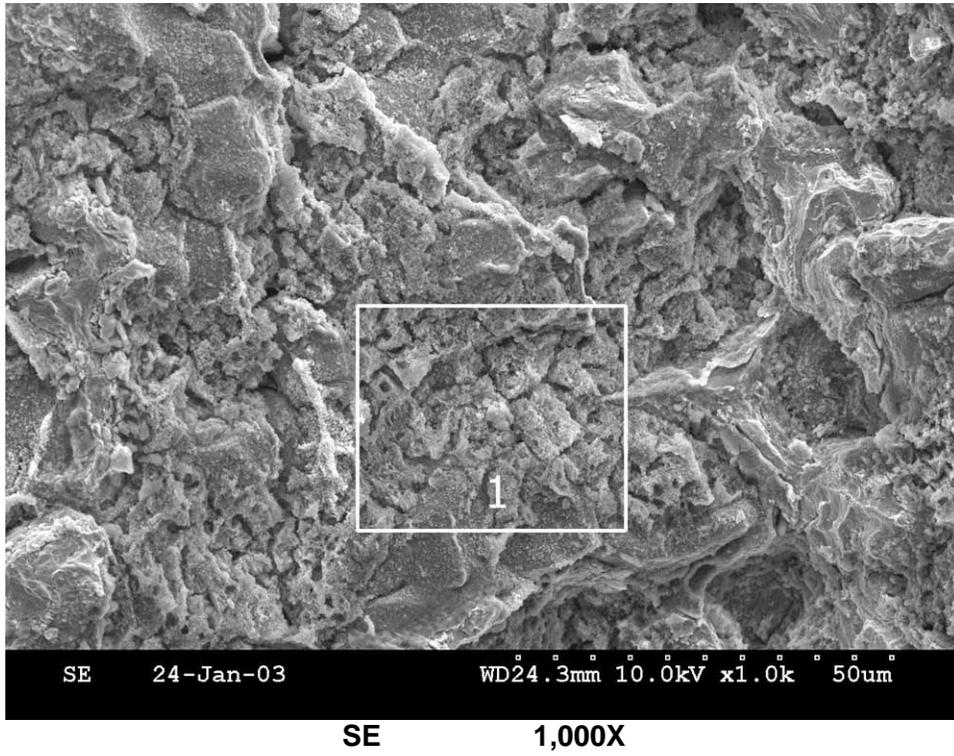
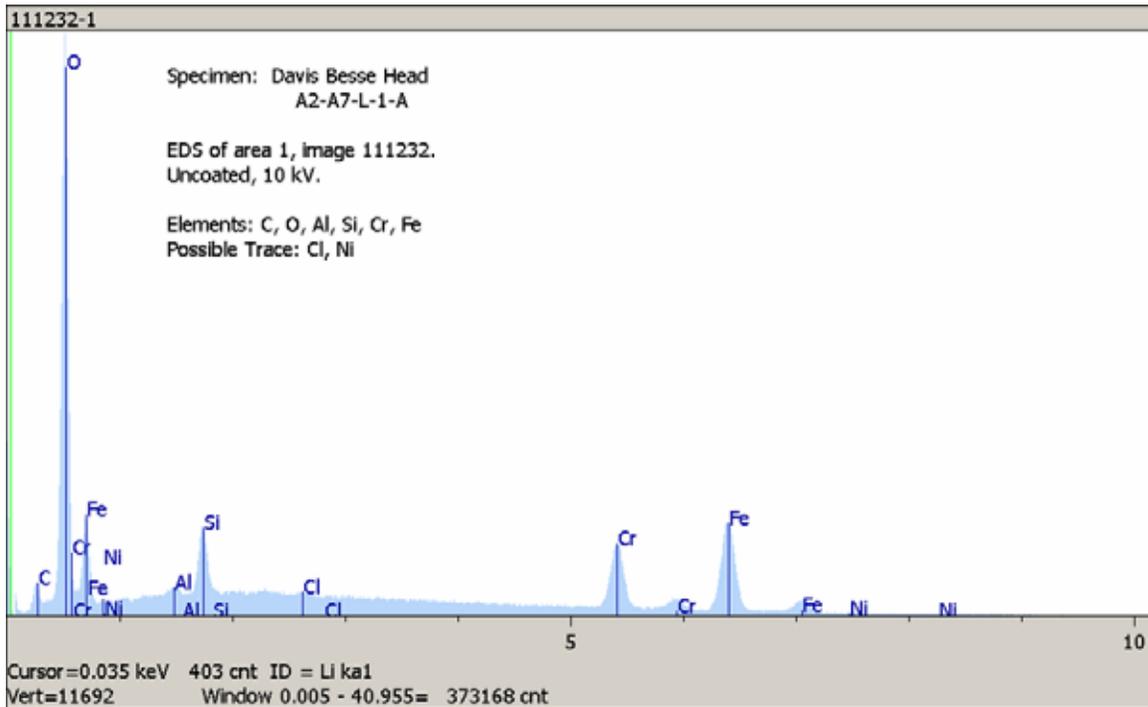
Figure 6.4.1.7: SEM micrograph and EDS results for deposited region near area "E". The corrosion deposits contained carbon, oxygen, along with iron, aluminum, silicon, and chromium. Possible trace levels of nickel and chlorine were also detected in this area.
