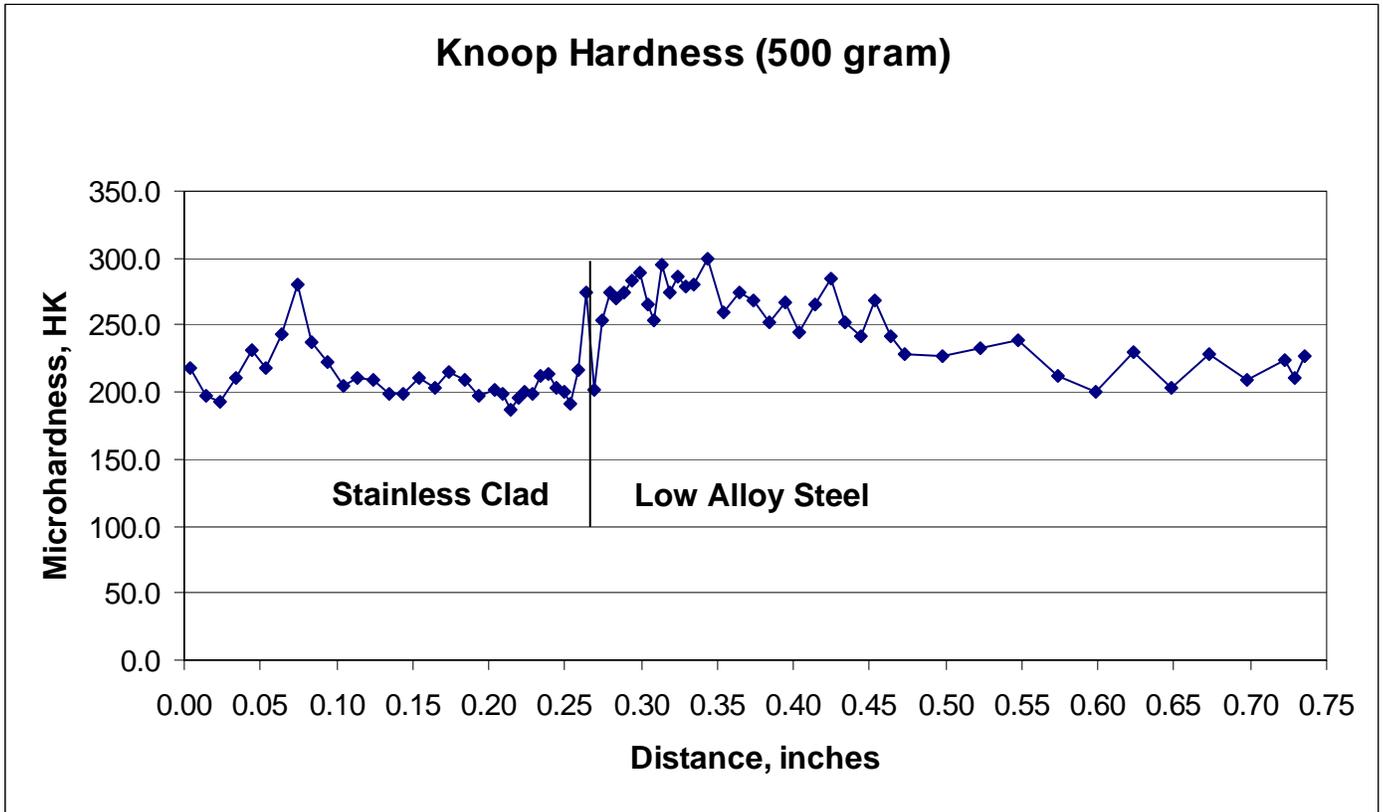
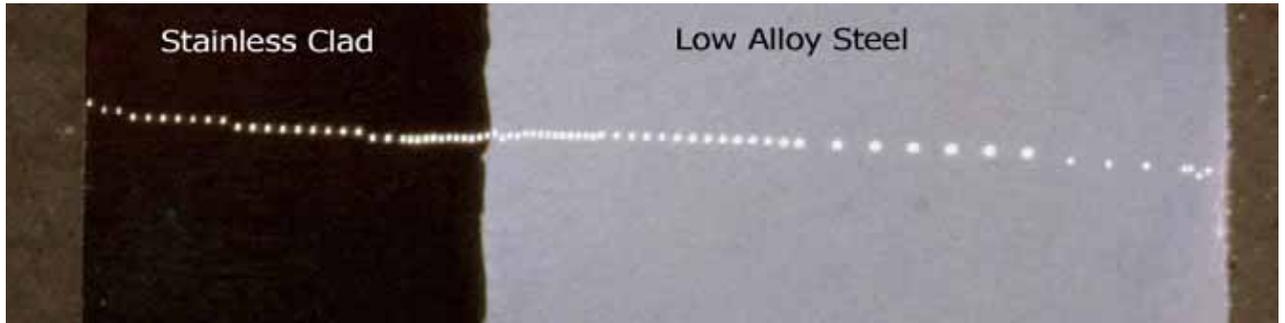
Figure 4.2.7: Microhardness data and low magnification photograph for Sample B2C2B3.

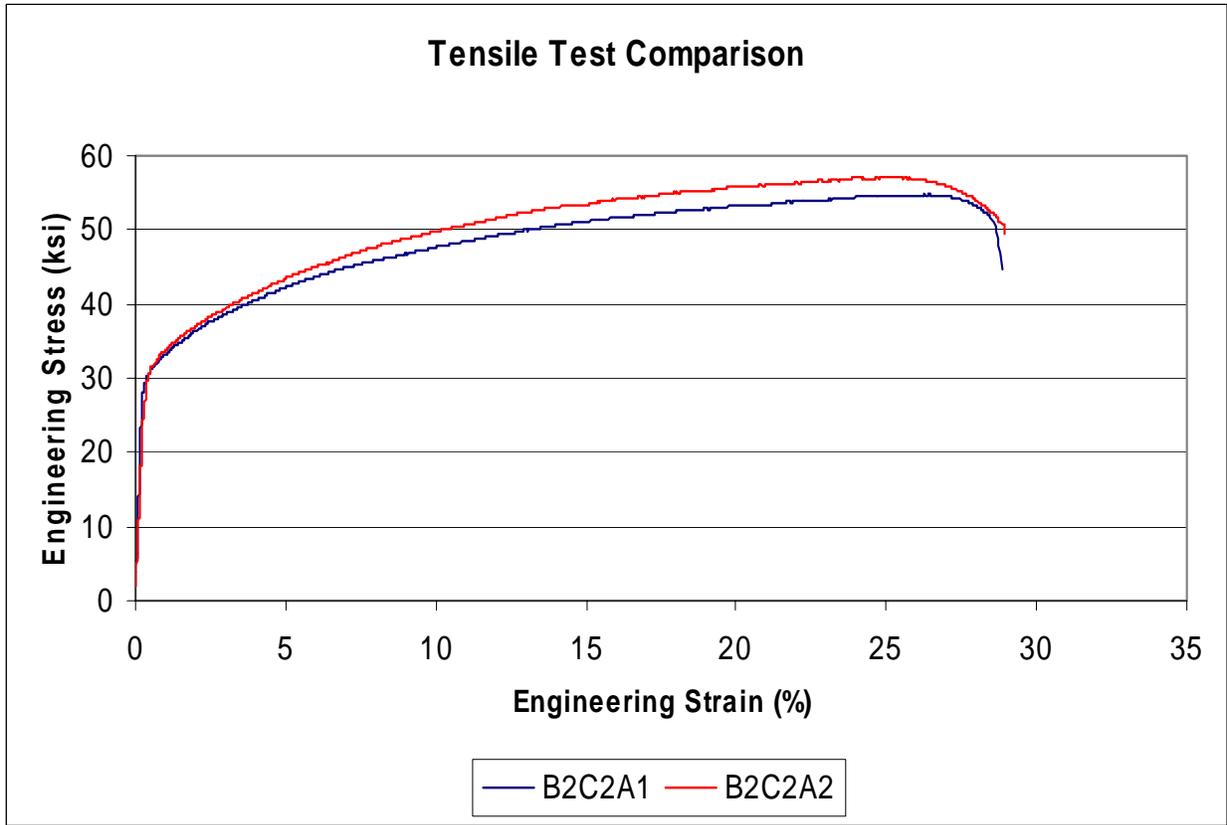
B2C2A1	B2C2A2
UTS	54,800 psi	57,100 psi
2% Offset YS	30,500 psi	31,300 psi
Elongation	28.7%	28.7%
Reduction in Area	39.3%	34.3%

Figure 4.3.2: Tensile test results for specimen B2C2A1 (near RCS) and specimen B2C2A2 (near low alloy steel).

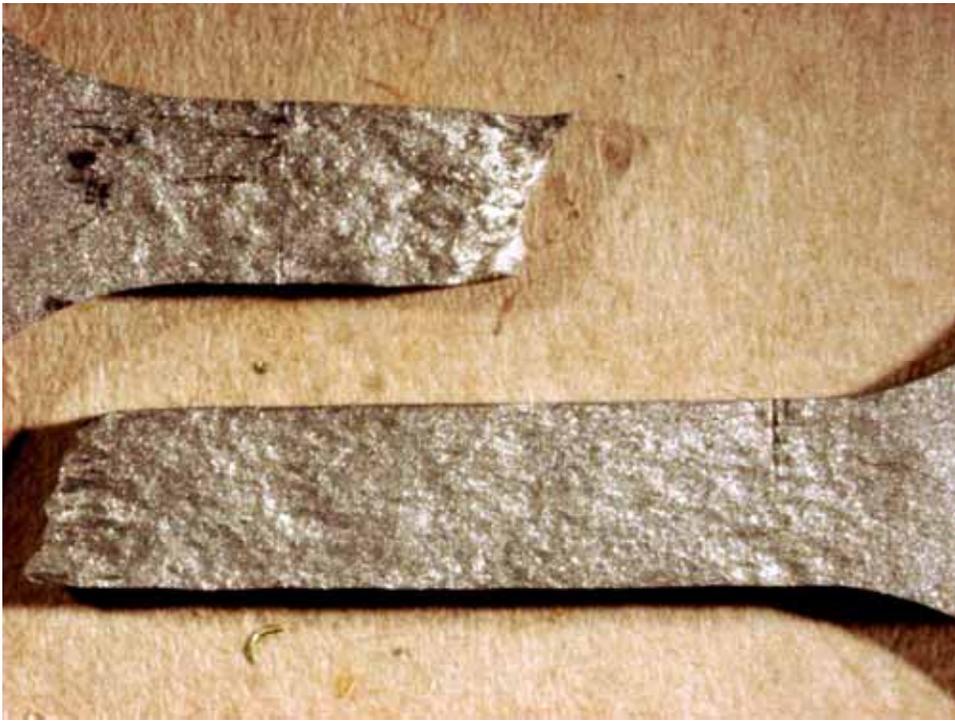
B2C2A1 5X

Figure 4.3.4: Higher magnification photographs showing fracture location of tensile specimens.

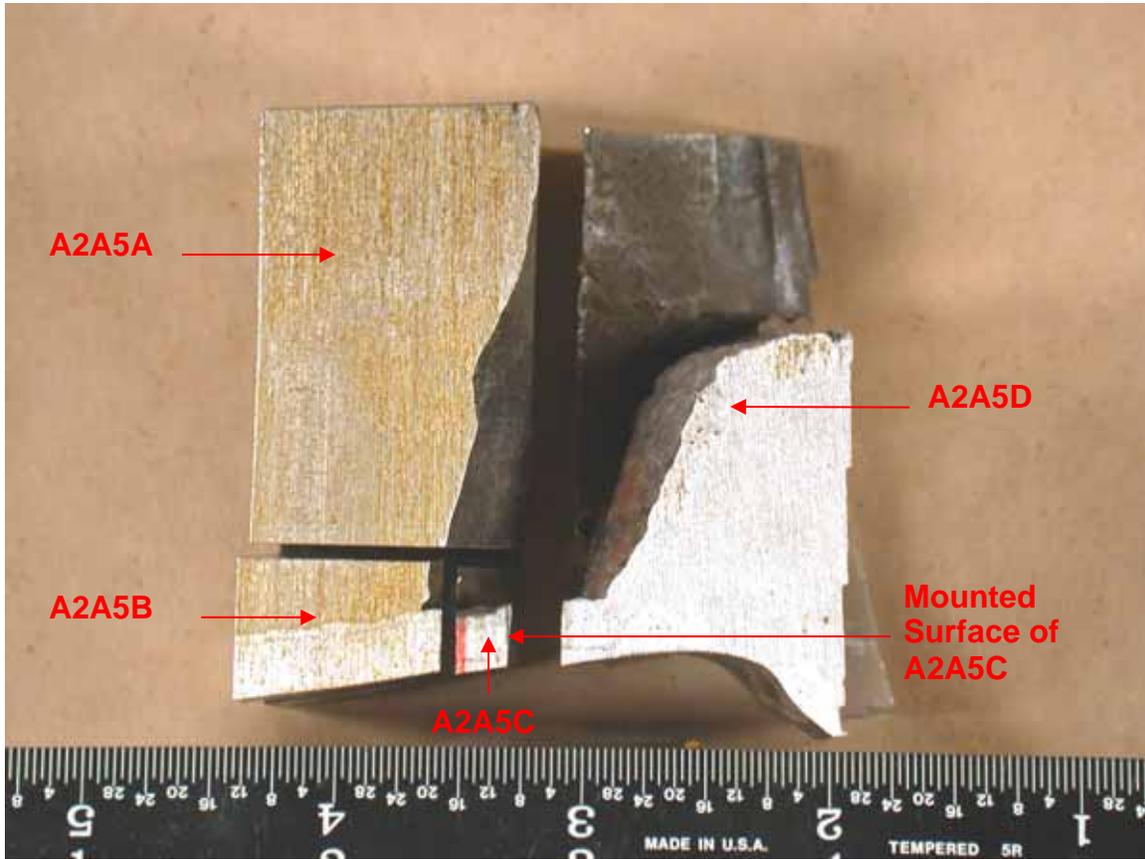
Figure 5.3 (cont.): Piece A2A5 after sectioning, looking down on the front face of previous photo. The mounted surface on sample A2A5C is indicated. This area contained the thinnest measured cladding (0.202”).

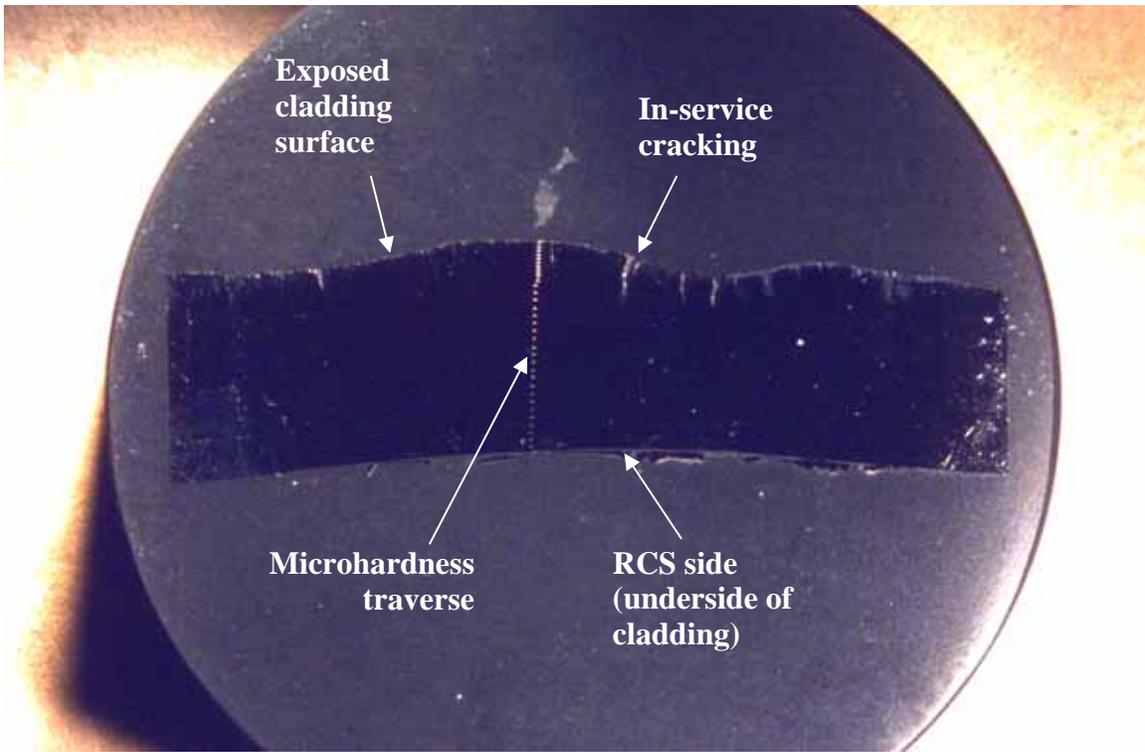
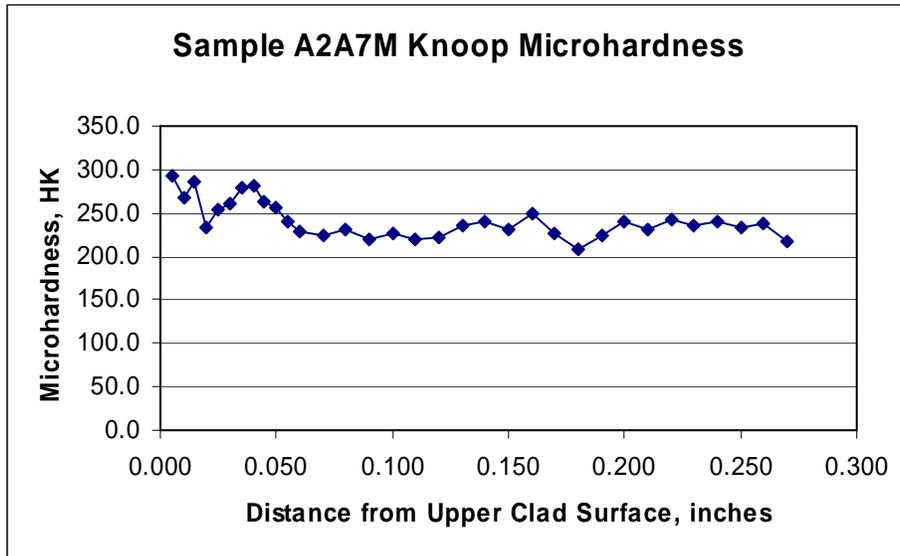
Figure 6.1.1.1: 4X macro photograph of metallurgical mount A2A7M. Refer to Figure 5.11 for the sample orientation. Cladding thickness ranged from 0.227" to 0.277" (5.77 to 7.04 mm). Knoop microhardness values exhibited a hardness elevation near the exposed cladding surface.

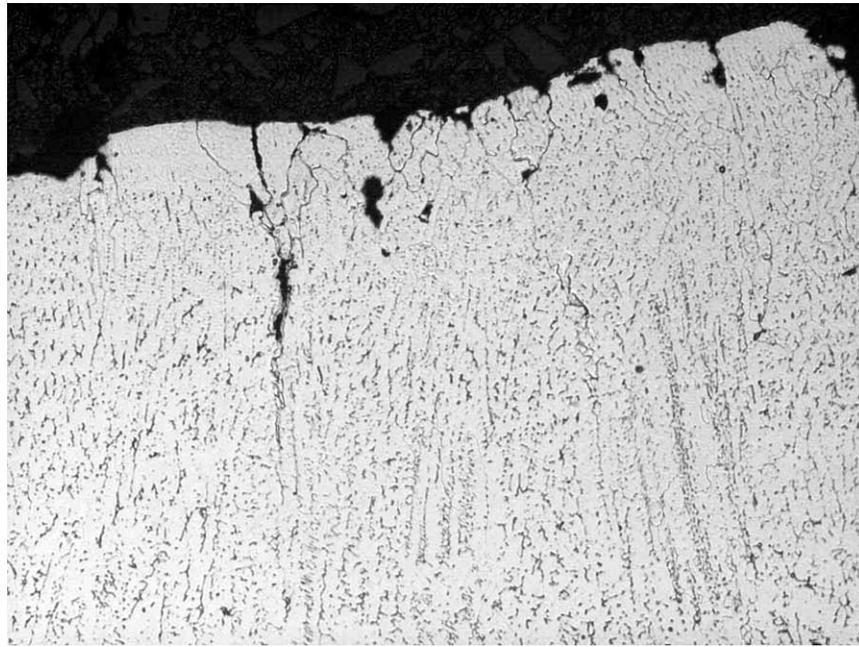
100X

Figure 6.1.1.2: Micrographs showing intergranular attack (IGA) and intergranular or interdendritic cracking on the exposed stainless steel cladding.

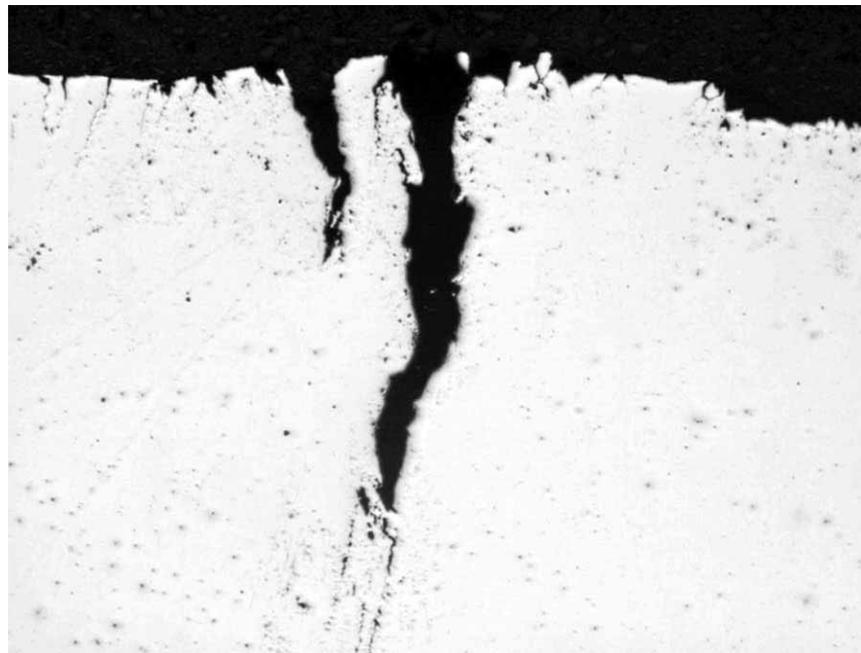
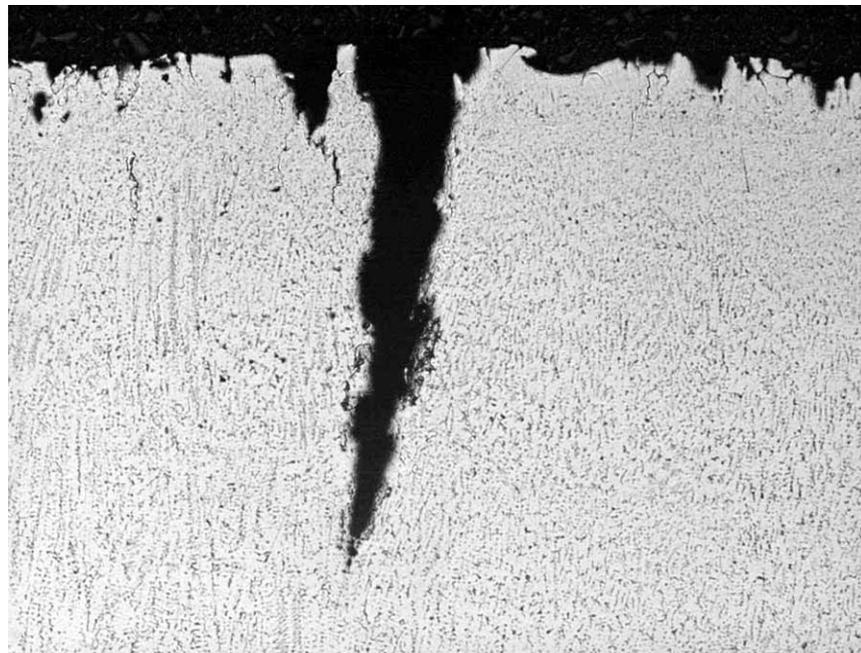
Figure 6.1.1.3: Micrographs showing the deepest crack observed in A2A7M. Fine intergranular or interdendritic cracks emanating from the crack tip are visible. The crack tip is estimated to be approximately 0.057" (1.47 mm) below the surface. The cracks in the above two photos are the same, but are shown at slightly different planes due to re-polishing.

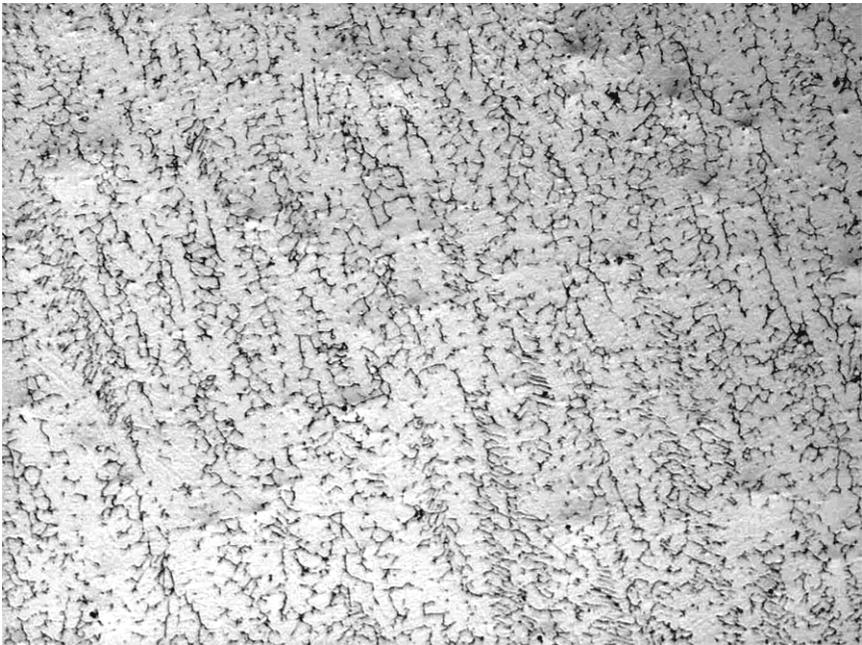
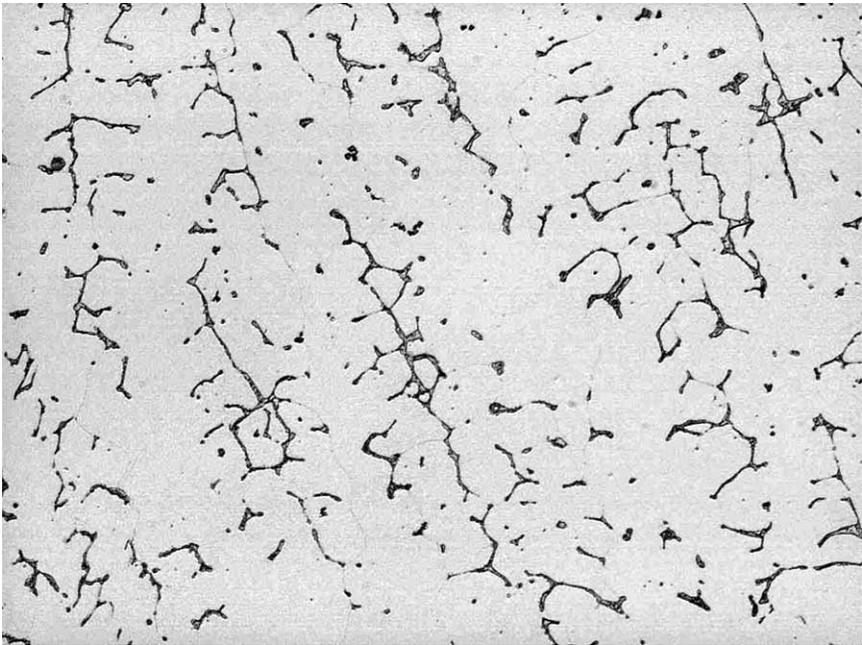
Figure 6.1.1.4: Typical clad microstructure in the mid-thickness of the cladding.
