**BWX Technologies, Inc.**

**FINAL REPORT:**  
**EXAMINATION OF THE REACTOR VESSEL (RV) HEAD DEGRADATION  
AT DAVIS-BESSE**

**PREPARED FOR  
FRAMATOME ANP, INC.**

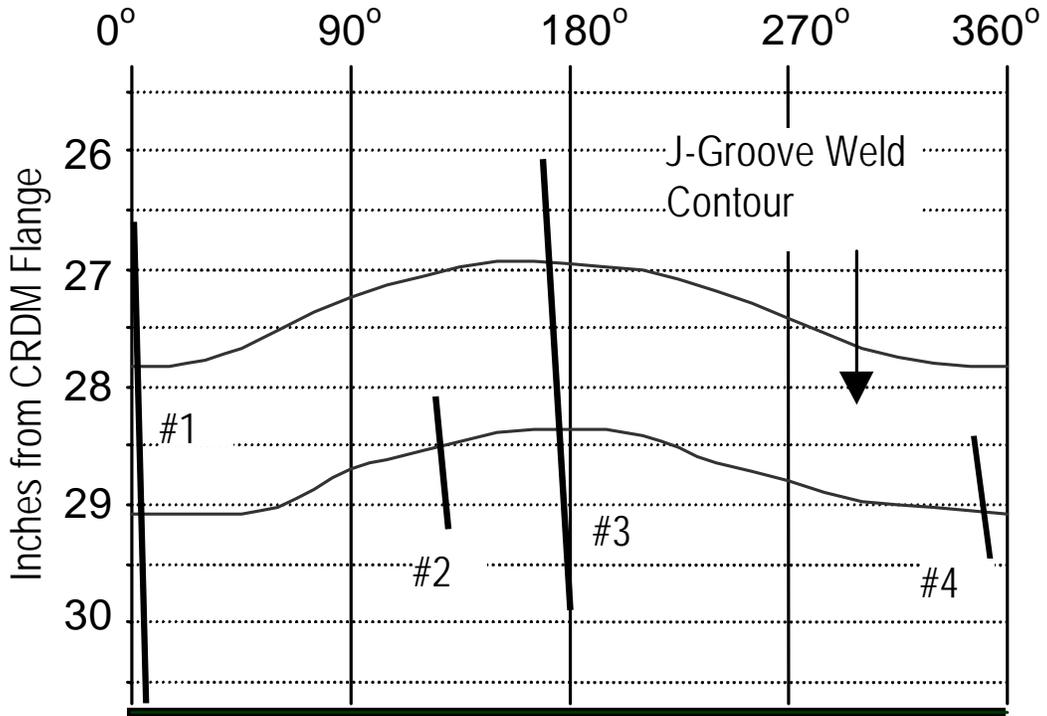
Figure 1.1.2: On-site NDE of nozzle #3 showed 4 axial cracks. Cracks #1 and #3 were through-wall, while cracks #2 and #4 were partially through-wall.

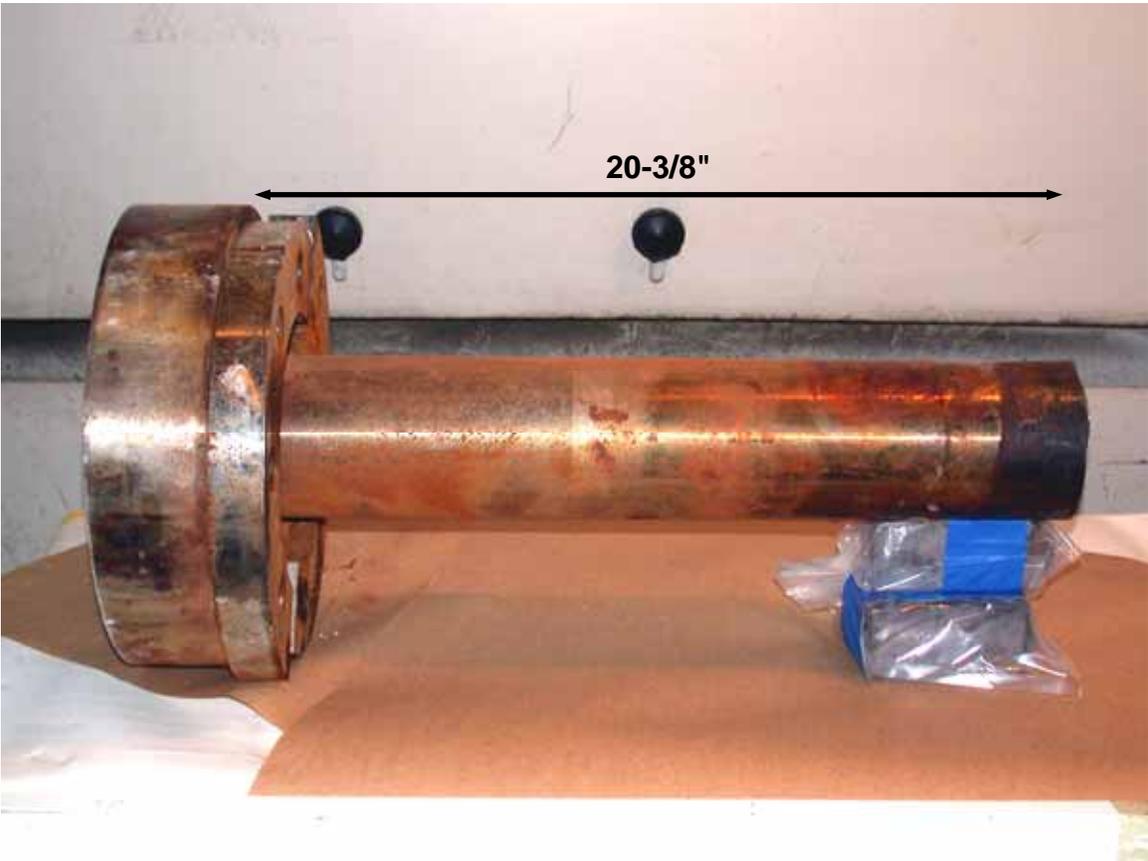
Figure 2.1.1 provides a side view macro photograph showing the as-received condition of nozzle #2. The measured distance from the underside of the flange to the end of the nozzle was  $20\text{-}3/8$ " and the reduced diameter portion of the nozzle end measured  $3\text{-}3/8$ ". These measurements indicated approximately  $7\text{-}5/8$ " of the nozzle end was bored away during the nozzle removal process from the RV head. Figure 2.1.2 shows the end view of nozzle #2. It was determined that the boring tool extended approximately 3" up into the lower end of the nozzle. Visual inspections on the lower end of this nozzle revealed no evidence of cracking; it is believed that the cracks were bored out during the removal process.

**Figure 2.1.1: Nozzle #2 side view. Approximately 7-5/8" was bored away during the removal process.**

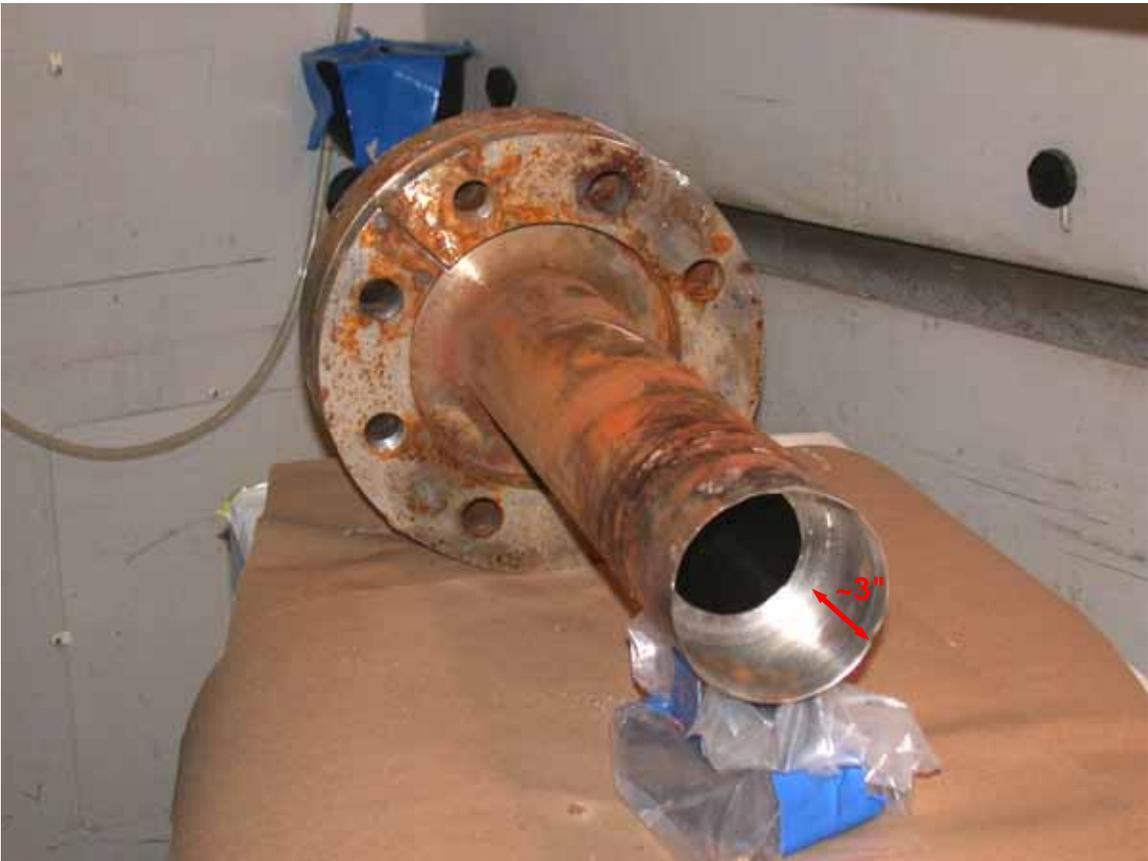
**Figure 2.1.2: Nozzle #2 end view looking at bottom. The boring tool extended ~3" up from the bottom of the nozzle. There was no evidence of cracking found.**

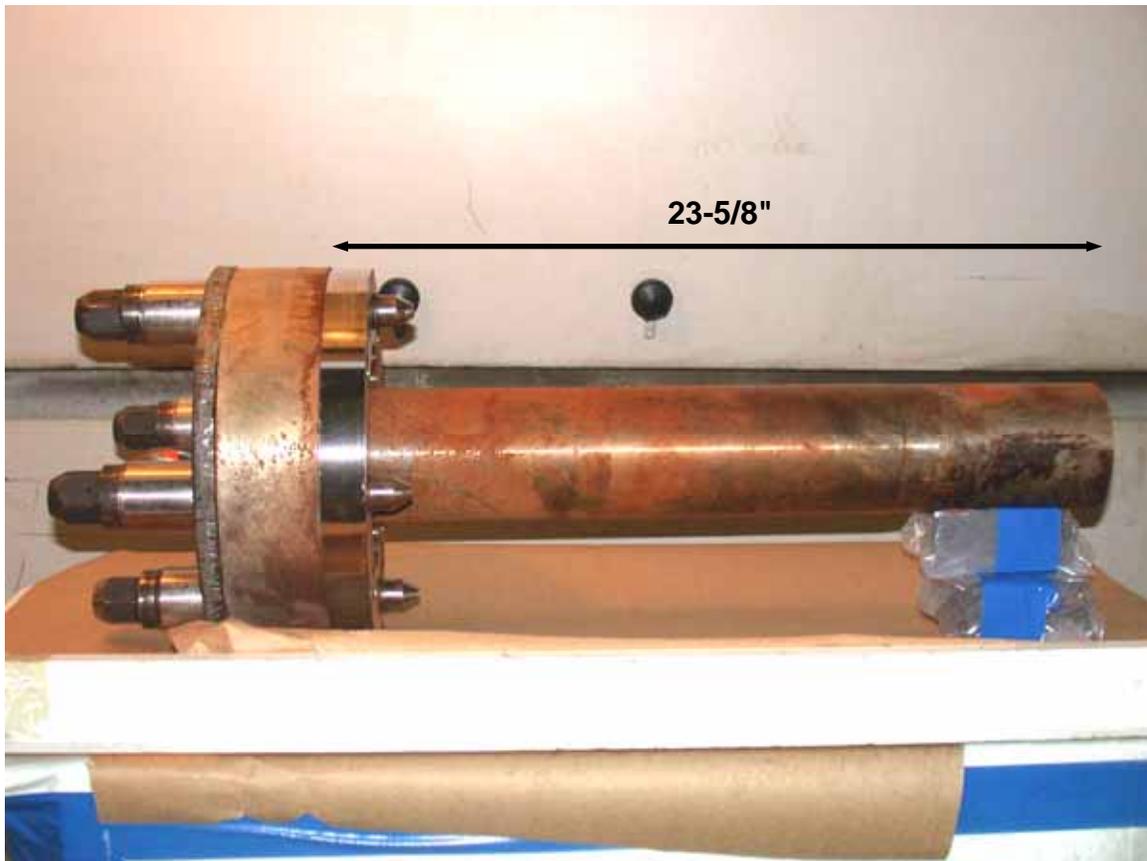
An overall photograph showing the as-received condition of nozzle #3 is presented in Figure 2.2.1. The measured distance from the underside of the flange to the end of the nozzle was  $23\text{-}5/8$ " and the reduced diameter portion of the nozzle end measured  $6\text{-}1/2$ ". These measurements indicated approximately  $4\text{-}1/2$ " of the nozzle end was bored away

Figure 2.2.1: Nozzle #3 side view. Approximately 4-1/2" was bored away during the removal process. 0° orientation is upward in photo.

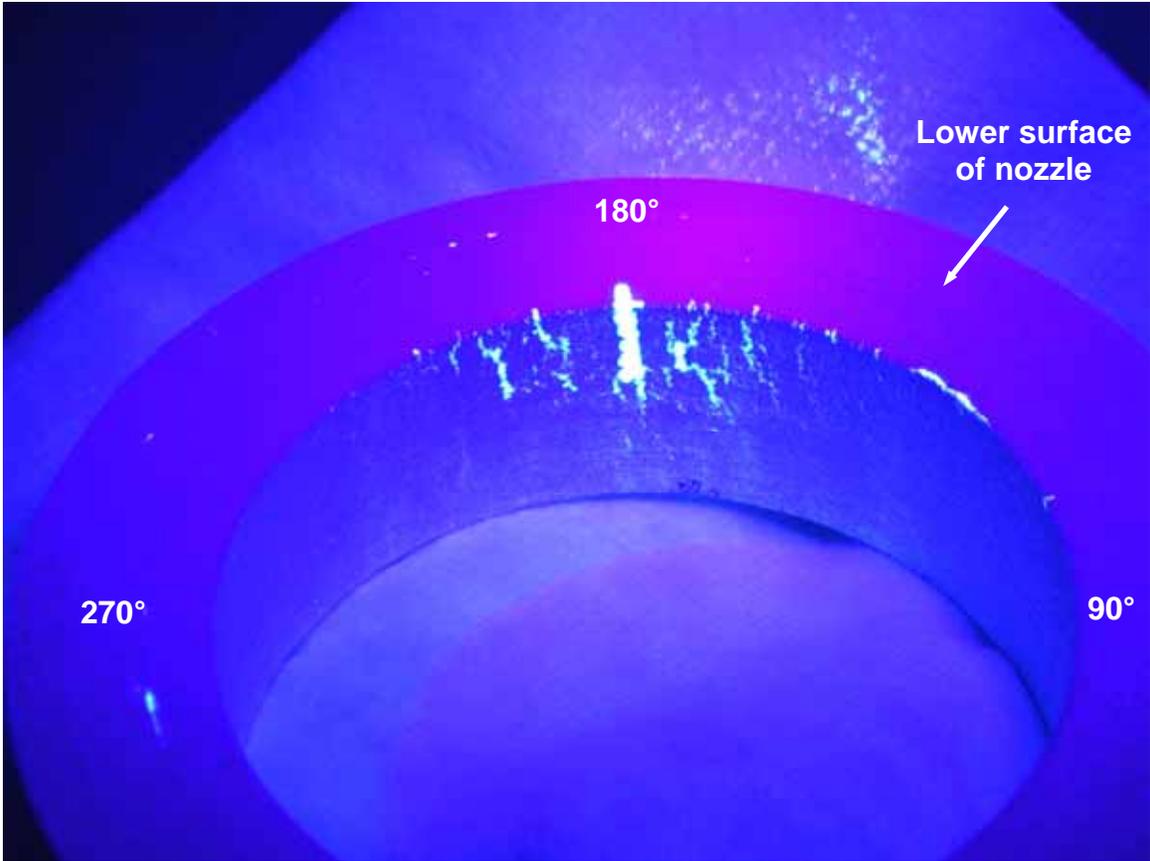
A fluorescent dye penetrant test was performed on the exposed surfaces of piece C. This test revealed several axial cracks present on the lower portion of the nozzle inner diameter (ID) surface near the 180° orientation (i.e., uphill side of nozzle opposite the cavity). Refer to Figure 2.4.1 for the results of this examination. The largest crack in this area extended approximately 0.5" in length axially and ~0.125" deep radially from the ID surface of the nozzle. No other indications were found. It is evident that all other cracks identified by on-site NDE were within the 4-1/2" section bored away during the CRDM nozzle removal process.

**Figure 2.4.1: Photograph taken under a black light showing the PT results for nozzle #3. Several axial cracks were present near 180°; the largest crack extended ~0.5" in length axially and ~0.125" deep radially from the ID surface.**

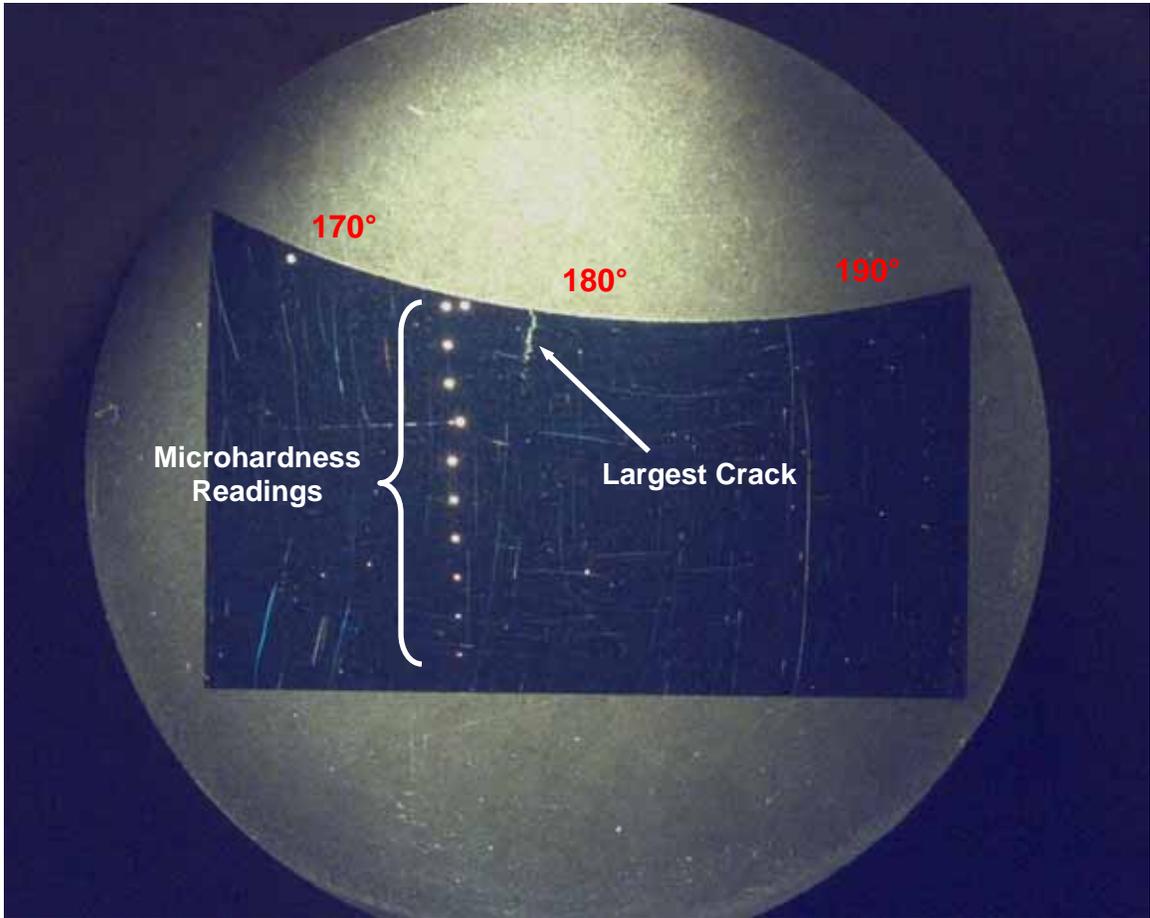
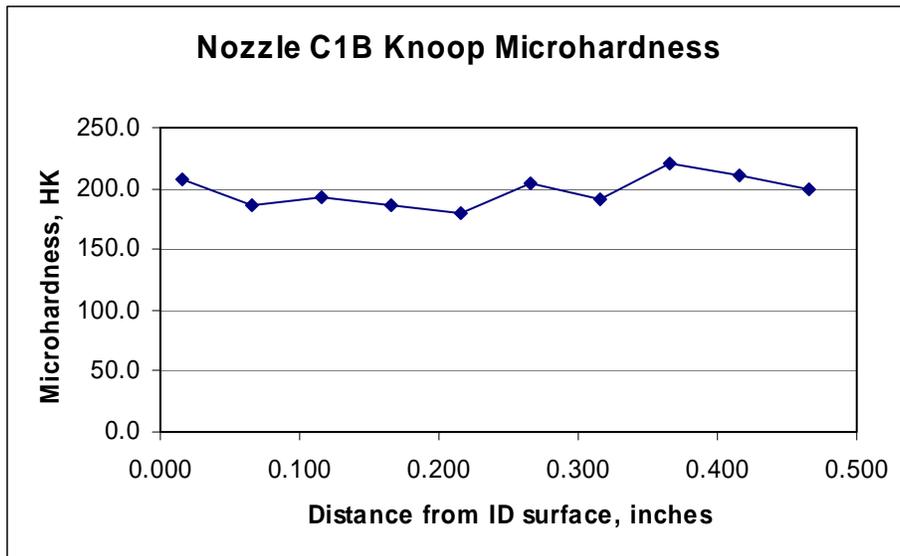
Figure 2.6.1 provides a low magnification photograph of the mounted sample C1B. In this photograph, the largest crack is visible near 180° along with the string of Knoop microhardness indents near 175°. The base material hardness was generally uniform across the nozzle wall in the area tested and ranged from HK 179.1 to 221.3 (refer to the table in Figure 2.6.1).

**Figure 2.6.1: Low magnification photograph of the nozzle #3 C1B metallographic mount showing location of largest crack and Knoop microhardness indents (top) and microhardness results (bottom).**

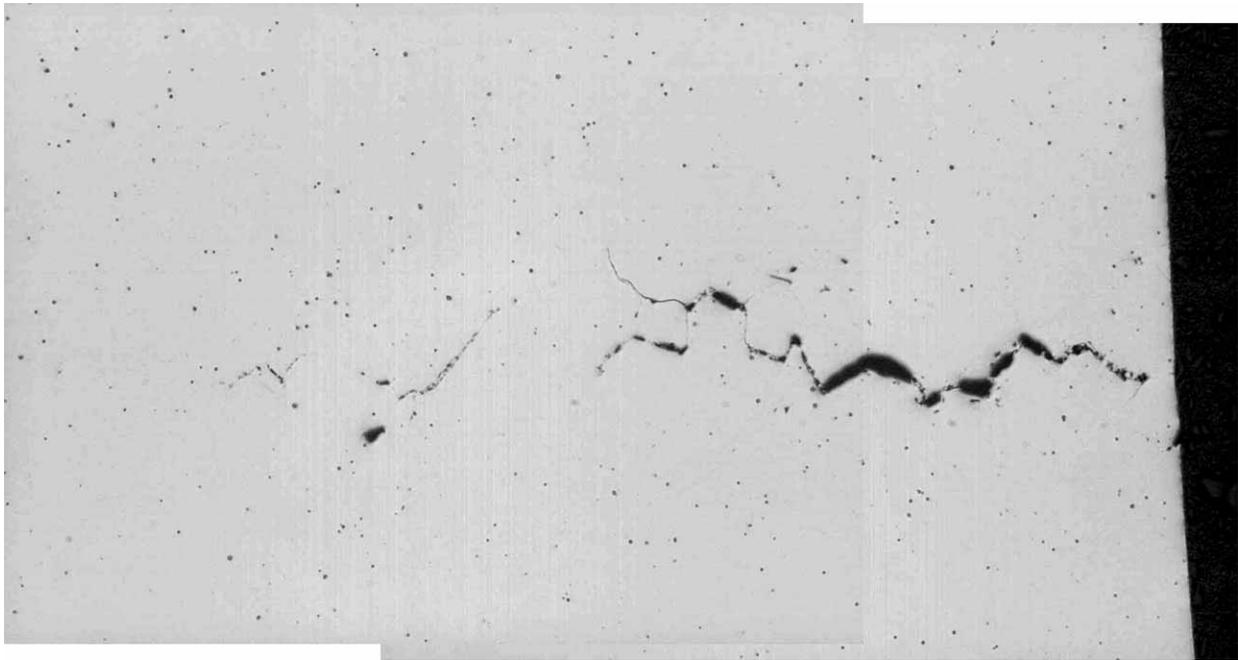
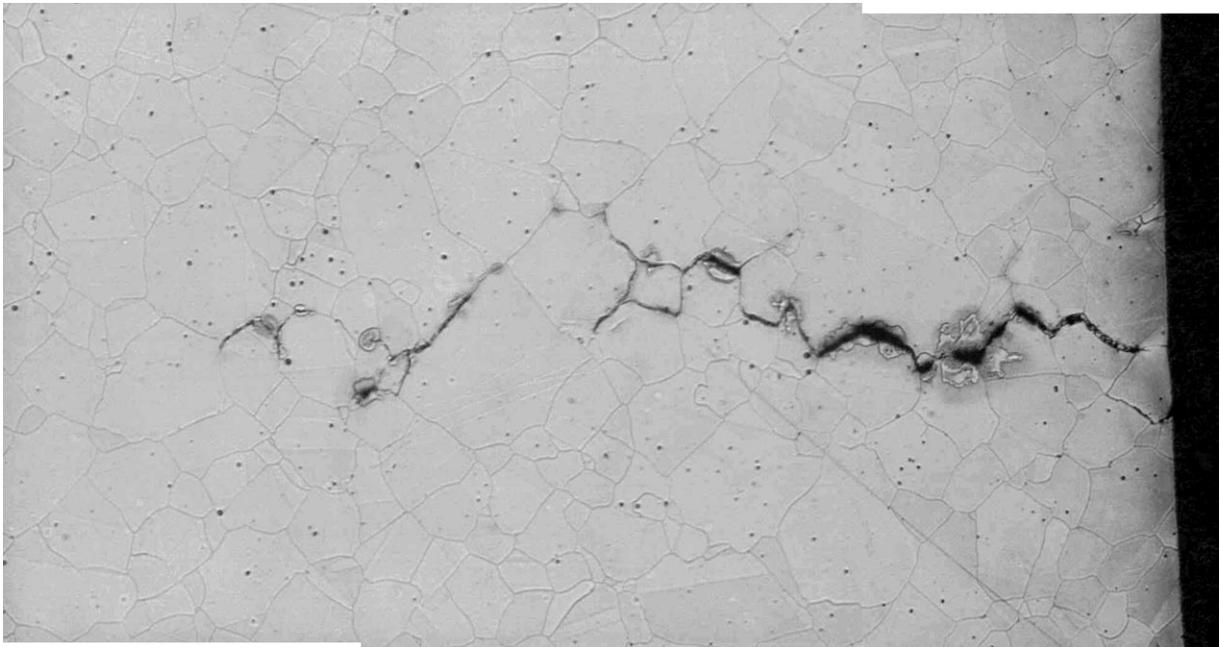
Figure 2.6.2 provides higher magnification micrographs of the largest crack at 180°, which extended approximately 0.1" below the nozzle ID surface. The crack path is clearly intergranular in nature. The same crack morphology was observed for a smaller crack located near 170° (Figure 2.6.3). This crack extended approximately 0.05" below the nozzle ID surface. Micrographs showing the typical appearance of the nozzle base material microstructure are provided in Figure 2.6.4 (100X) and Figure 2.6.5 (375X). The microstructure consisted of equiaxed grains ranging in size from ASTM 1 to 6, with an average size of ASTM 3. Also observed throughout the microstructure were titanium or niobium carbonitrides (large yellow-to-orange color particles in Figure 2.6.6) and a semi-continuous to discontinuous network of grain boundary carbides.

**Figure 2.6.2: Micrographs showing the intergranular nature of the largest crack near 180°. The crack extended approximately 0.1" below the nozzle ID surface (located to the right in these micrographs).**

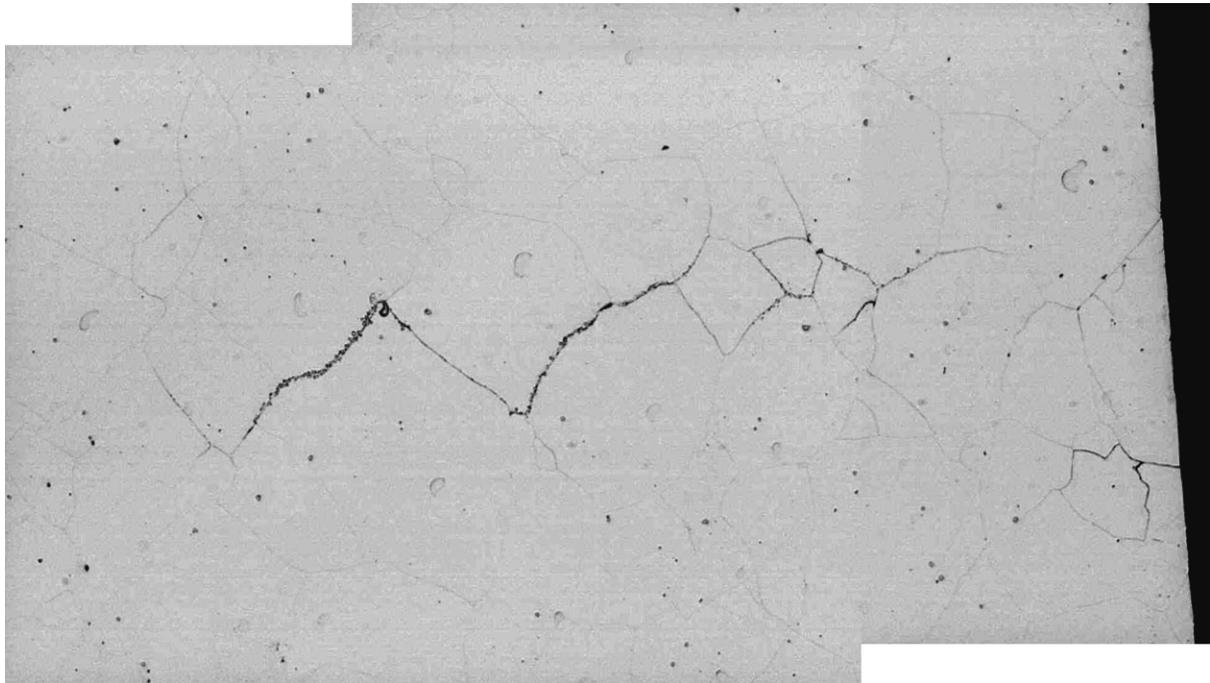
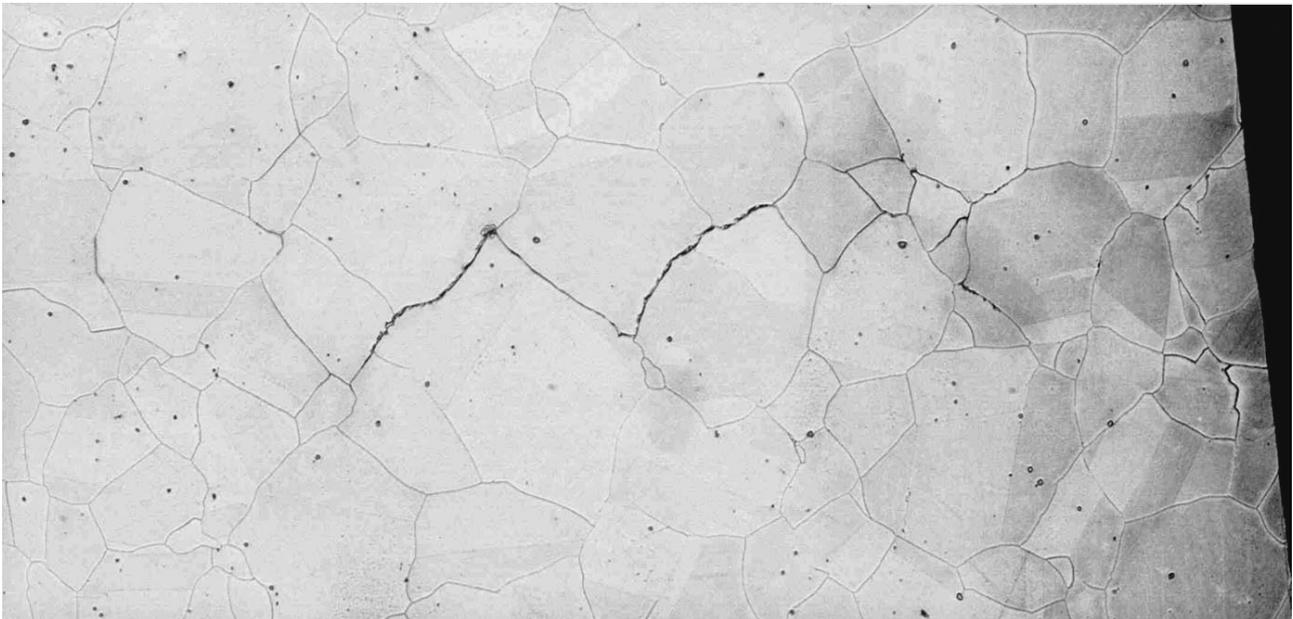
**Figure 2.6.3: Micrograph showing the intergranular nature of a smaller nozzle crack located near 170°. This crack penetrated approximately 0.05" below the nozzle ID surface (located to the right in these micrographs).**

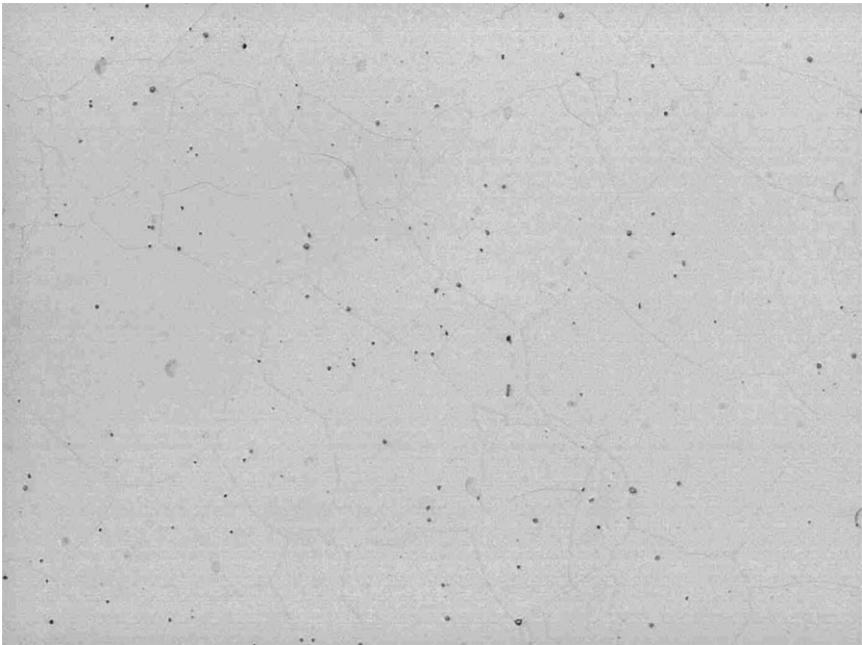
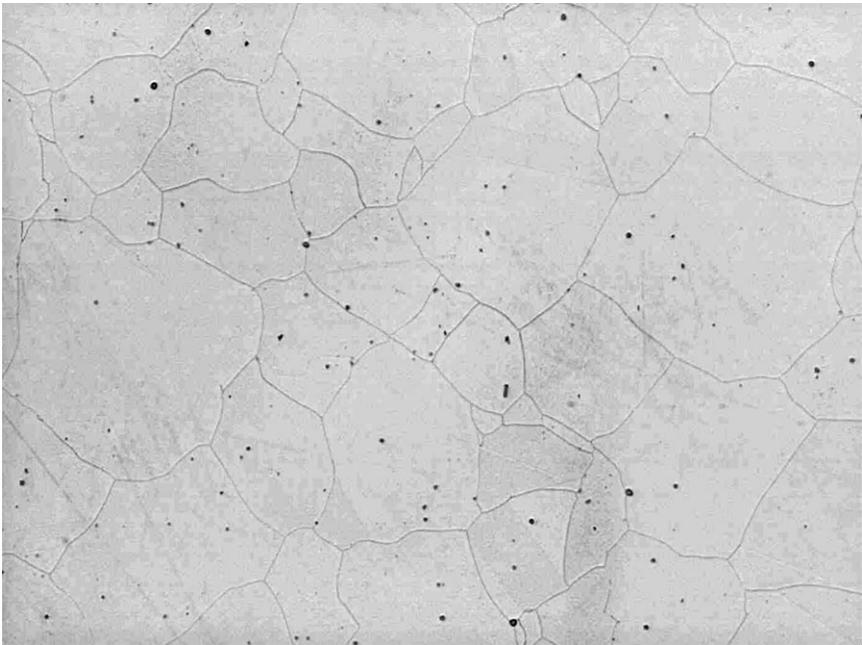
**Figure 2.6.4: Typical micrographs of the nozzle base material. The grain size ranged from ASTM 1-6 and averaged ASTM 3.**

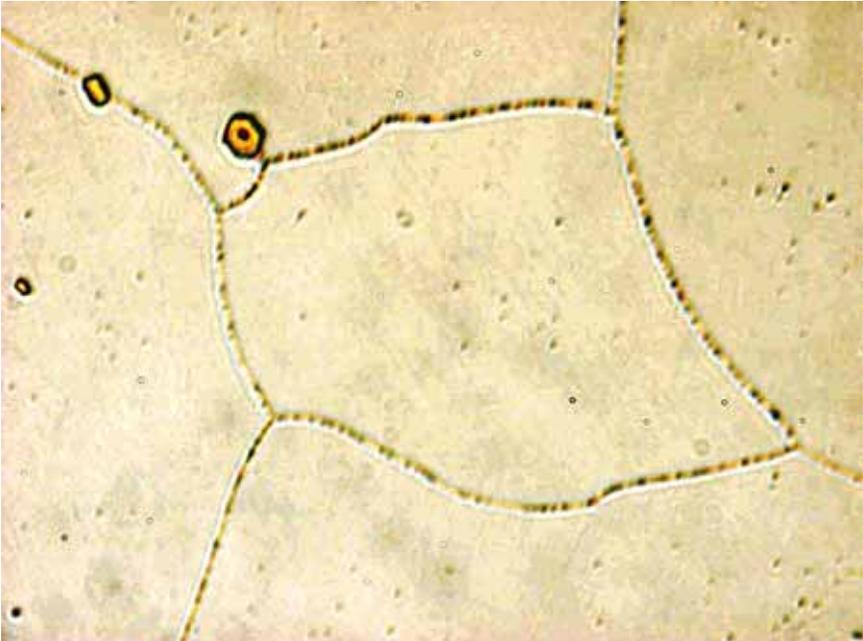
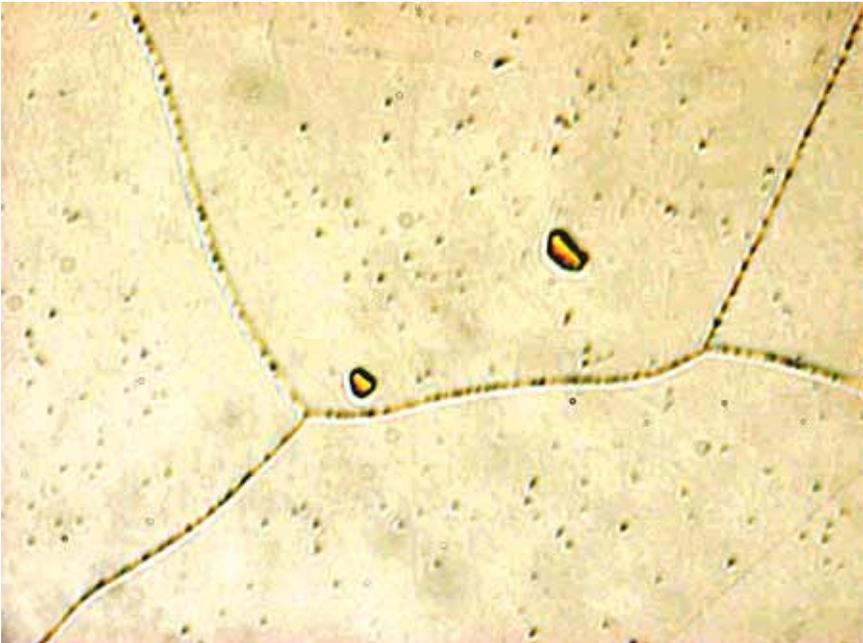
**Figure 2.6.6: Higher magnification micrographs showing the discontinuous nature of the carbides at the grain boundaries.**

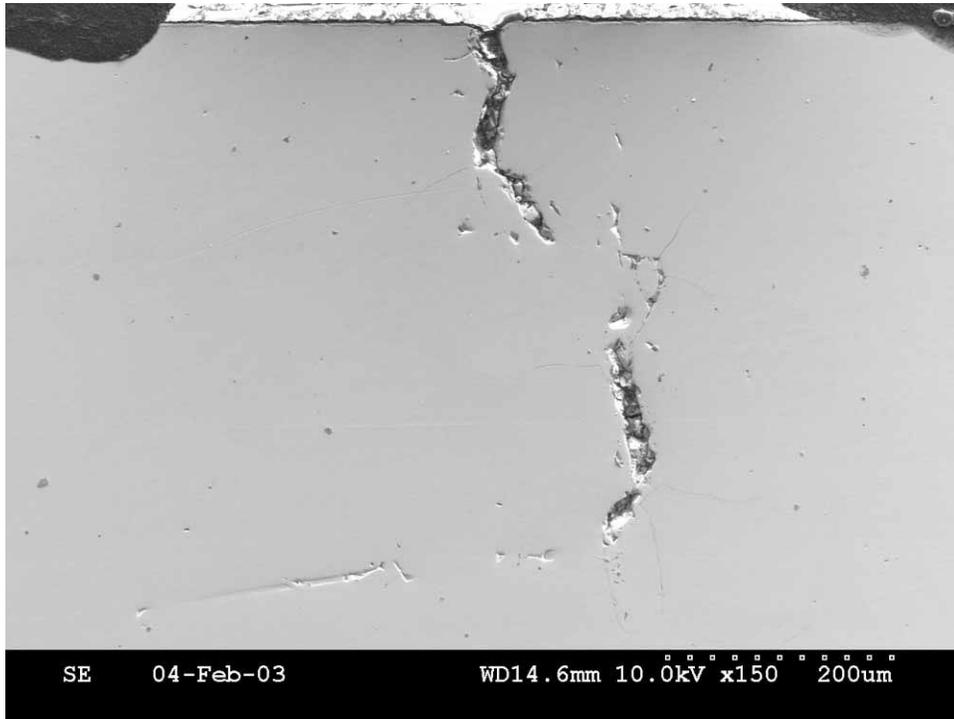
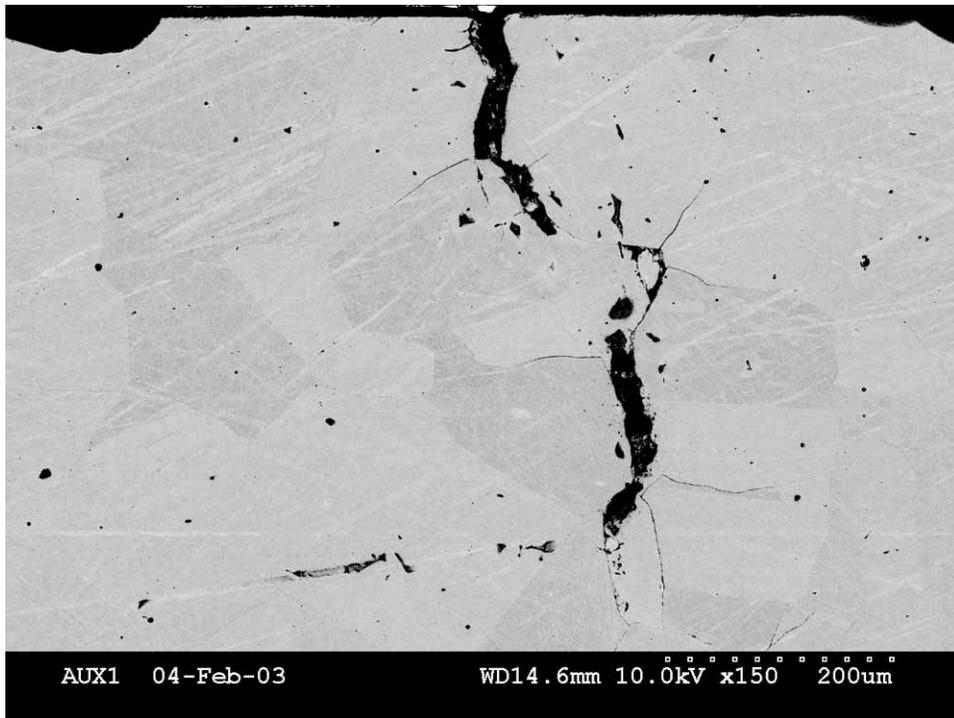
Figure 2.7.1: Low magnification SE (top) and BSE (bottom) taken near the nozzle ID surface (upper edge of micrographs). 150X

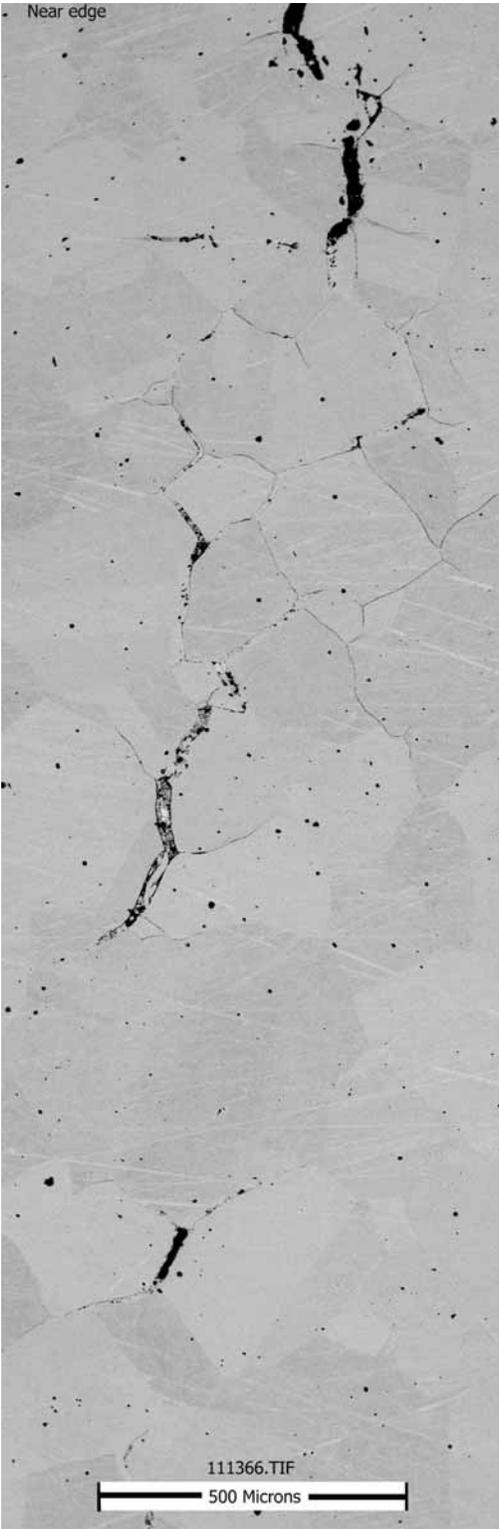
Figure 2.7.2: Mosaic showing full crack length (BSE), which was approximately 0.08" below the ID surface. Cracking was intergranular. ~82X
