**FINAL REPORT:
EXAMINATION OF THE REACTOR VESSEL (RV) HEAD DEGRADATION
AT DAVIS-BESSE**

**PREPARED FOR
FRAMATOME ANP, INC.**

SUMMARY

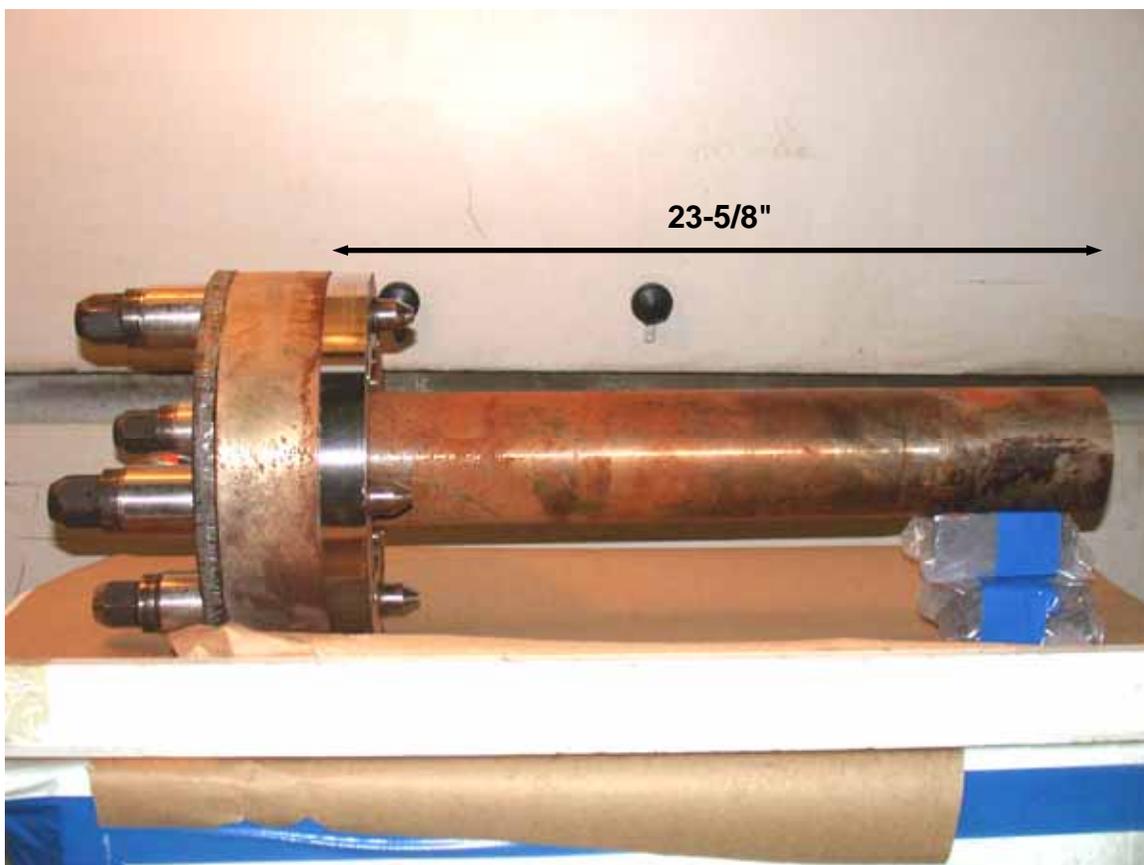
An overall photograph showing the as-received condition of nozzle #3 is presented in Figure 2.2.1. The measured distance from the underside of the flange to the end of the nozzle was 23-5/8" and the reduced diameter portion of the nozzle end measured 6-1/2". These measurements indicated approximately 4-1/2" of the nozzle end was bored away

Figure 2.2.1: Nozzle #3 side view. Approximately 4-1/2" was bored away during the removal process. 0° orientation is upward in photo.

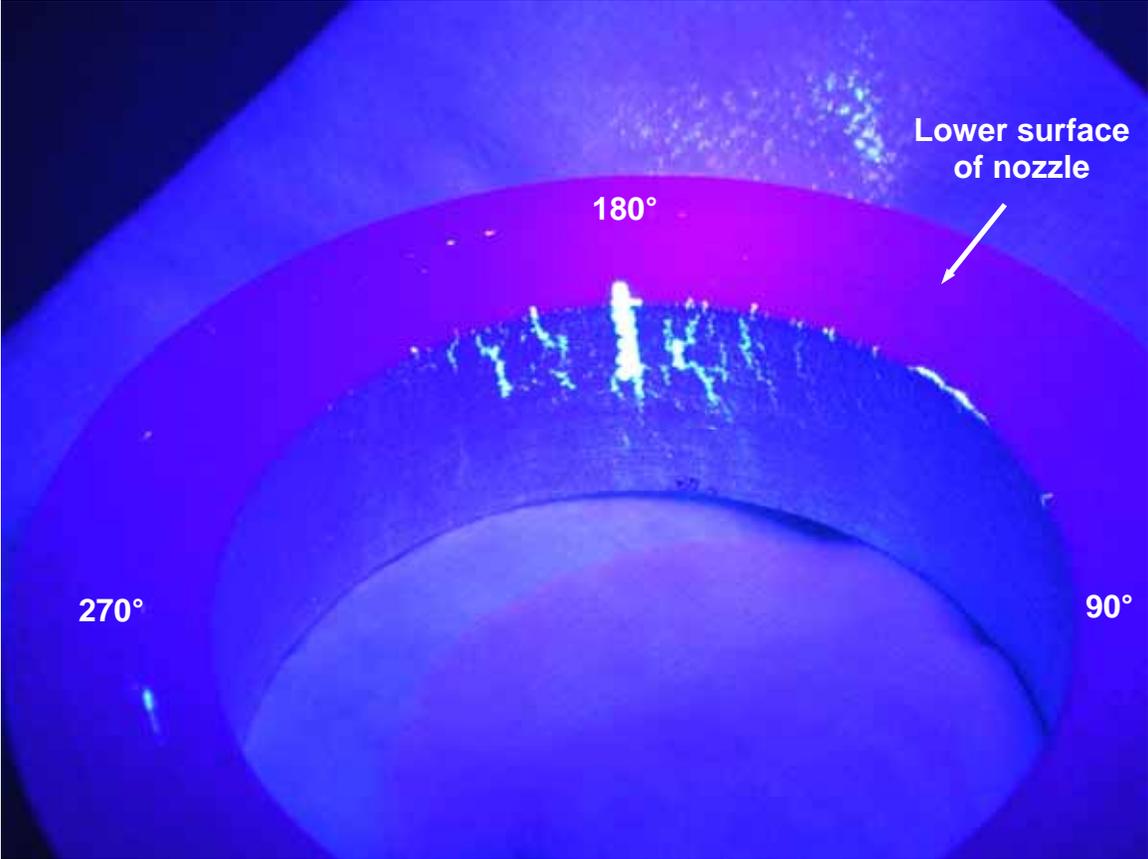
A fluorescent dye penetrant test was performed on the exposed surfaces of piece C. This test revealed several axial cracks present on the lower portion of the nozzle inner diameter (ID) surface near the 180° orientation (i.e., uphill side of nozzle opposite the cavity). Refer to Figure 2.4.1 for the results of this examination. The largest crack in this area extended approximately 0.5" in length axially and ~0.125" deep radially from the ID surface of the nozzle. No other indications were found. It is evident that all other cracks identified by on-site NDE were within the 4-1/2" section bored away during the CRDM nozzle removal process.

Figure 2.4.1: Photograph taken under a black light showing the PT results for nozzle #3. Several axial cracks were present near 180°; the largest crack extended ~0.5" in length axially and ~0.125" deep radially from the ID surface.

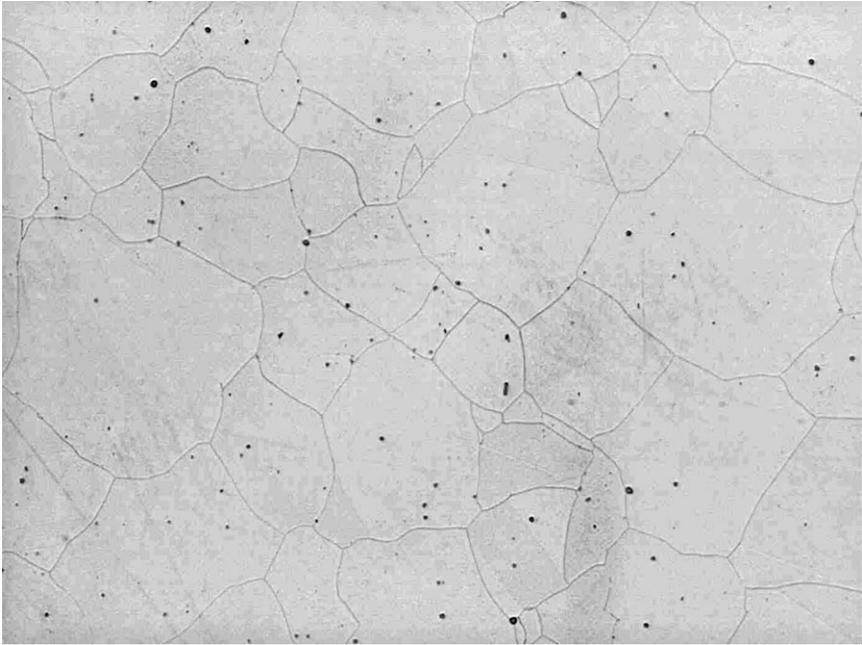
Figure 2.6.4: Typical micrographs of the nozzle base material. The grain size ranged from ASTM 1-6 and averaged ASTM 3.
