Subject: Duke Energy
Oconee Nuclear Station, Unit 1, 2, and 3
Docket No. 50-269,-270,-387
Third Ten Year Inservice Inspection Interval
Request for Relief No. 04-ON-006

Proposed Relief in Accordance with 10 CFR 50.55a (a)(3)(ii)**Inservice Inspection Hardship****Duke Energy Corporation**

Third 10-Year Interval – Inservice Inspection Plan**ASME Section XI Code – 1989 Edition with No Addenda**

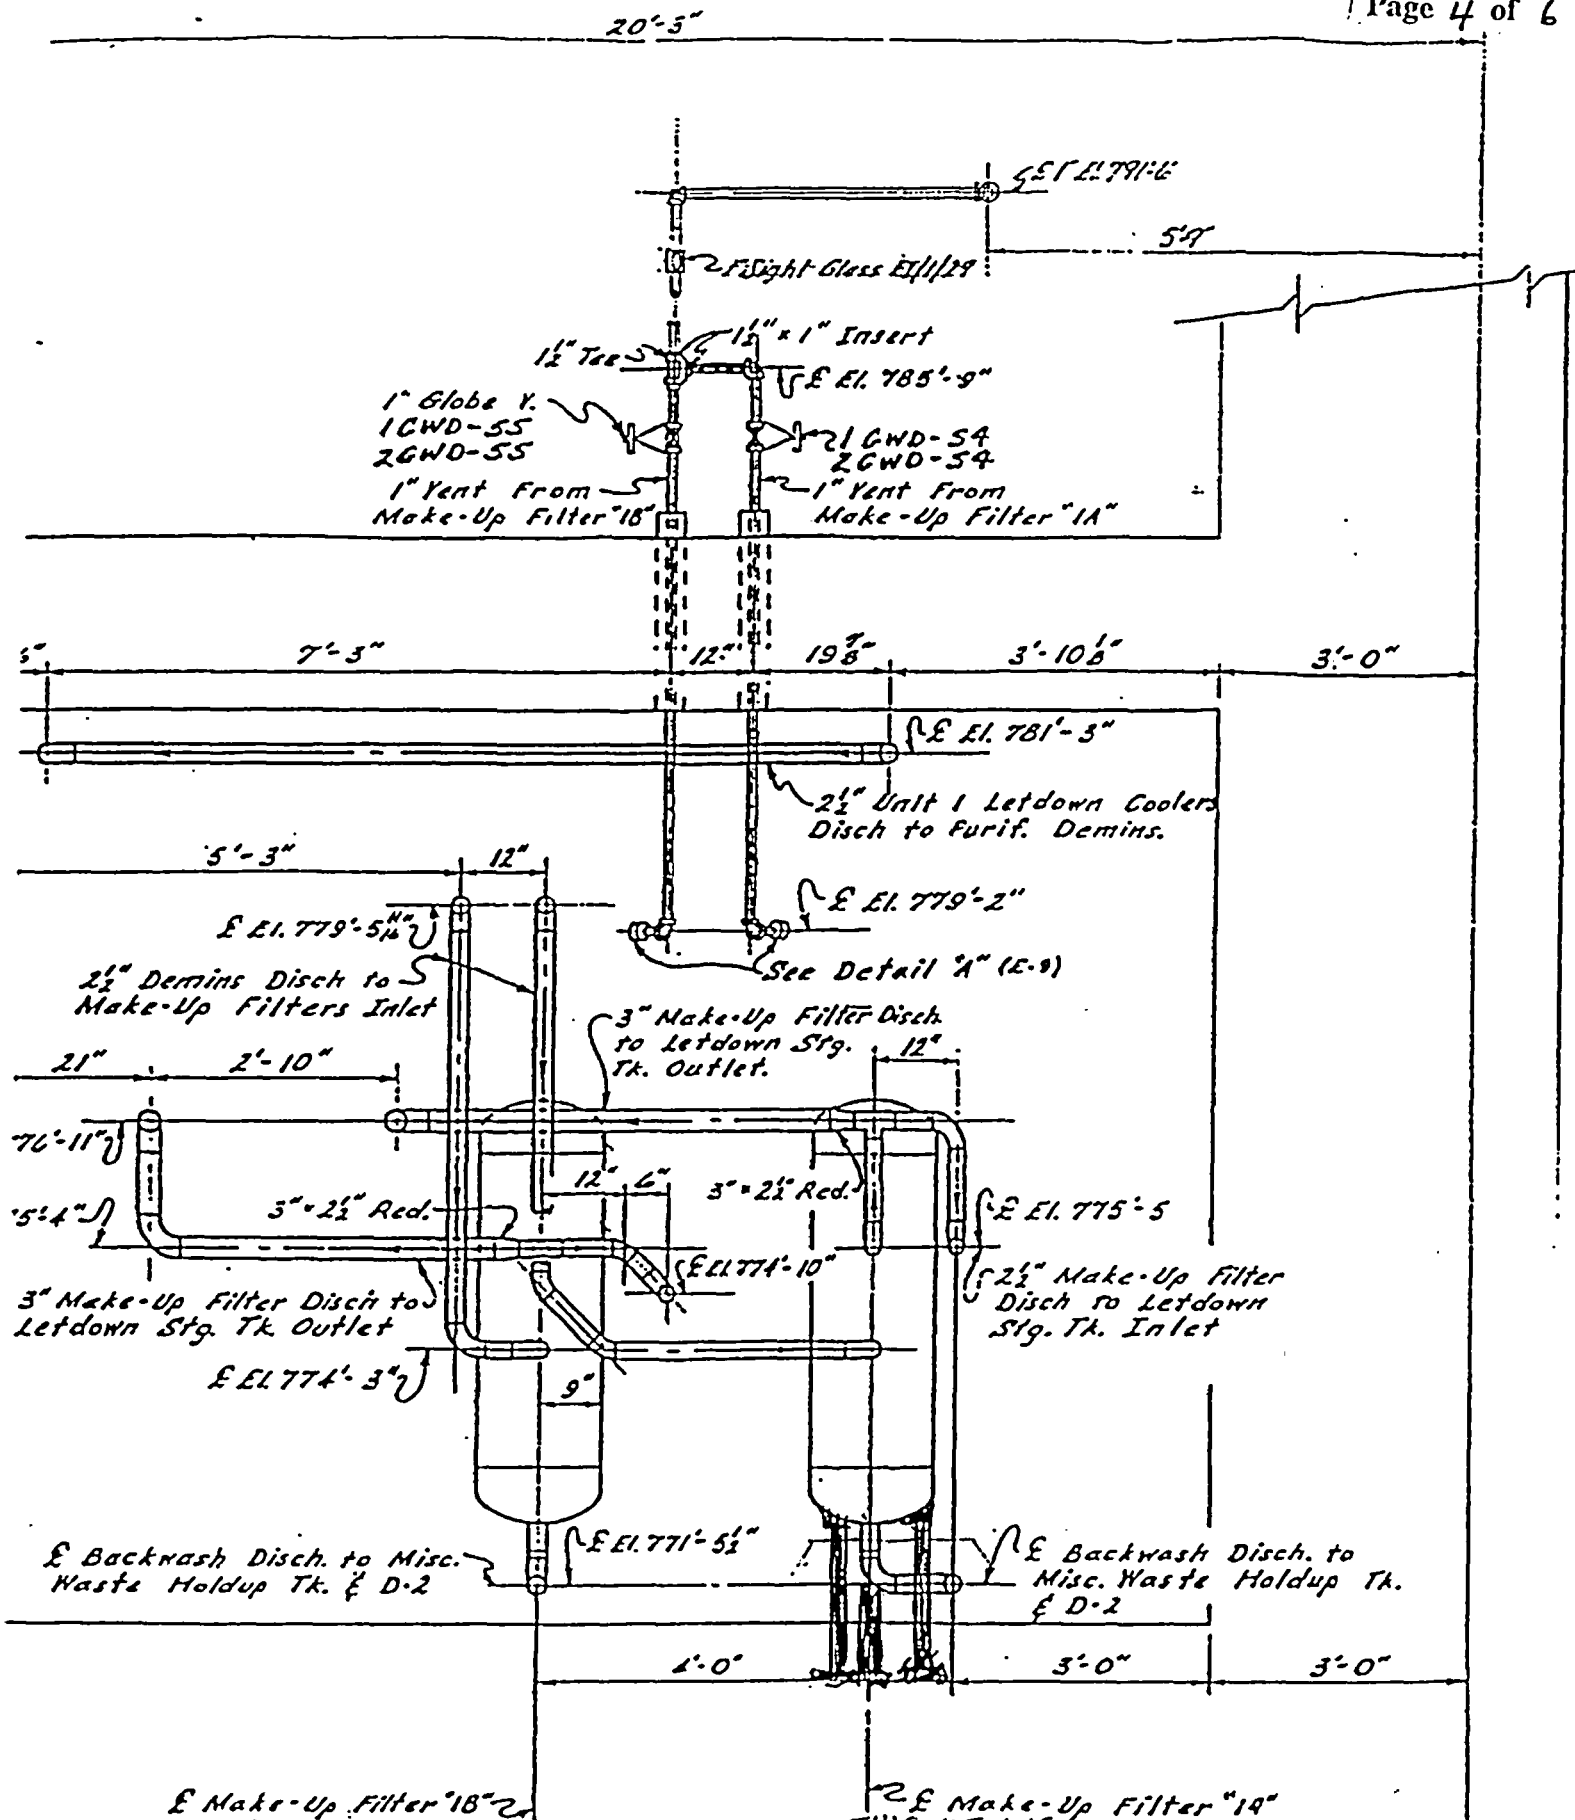
CAMERA LOWERED FROM HATCH ABOVE - INSULATION COVERED PART OF ANGLES TO TANK - LEGS SOUTHEAST, NORTH, WEST, LEGS VISIBLE - BASE PLATES VISIBLE - EVERYTHING ELSE NOT LOOKED AT - PARTIALLY
