*Pacific Gas and
Electric Company*

PG&E Letter DCL-04-119

Docket No. 50-275, OL-DPR-80
Diablo Canyon Unit 1
Licensee Event Report 1-2004-002-00
Technical Specification (TS) 3.0.3 Required Shutdown Due to TS 3.7.7,
"Vital CCW System," Limiting Condition for Operation (LCO) Not Met

4. TITLE TS 3.0.3 Required Shutdown Due to TS 3.7.7, "Vital CCW System," Limiting Condition for Operation Not Met
--

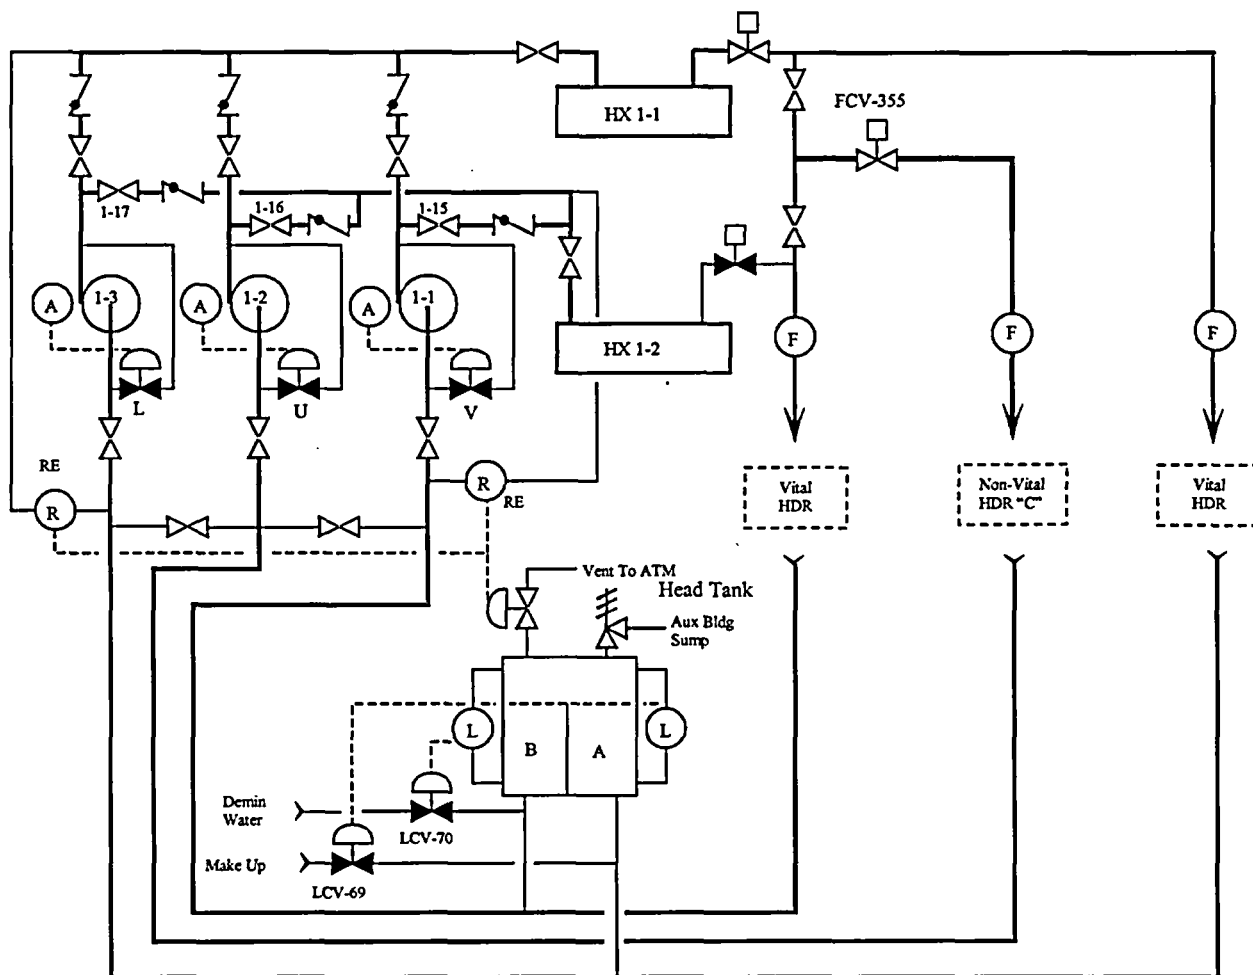
Figure 1

For a graphical representation of the CCW System, refer to Figure 1. Additional information on the design and operation of the system, along with a list of the components served, is presented in the Final Safety Analysis Report, Section 9.2.2, "Component Cooling Water System."

Component Cooling Water System
