**DOCKET NUMBER 50-483
CALLAWAY PLANT UNIT 1
UNION ELECTRIC CO.
FACILITY OPERATING LICENSE NPF-30
STEAM GENERATOR CONDITION MONITORING REPORT**

Document Identifier 51 - 5044435 - 00

Title Steam Generator Condition Monitoring at RF 13

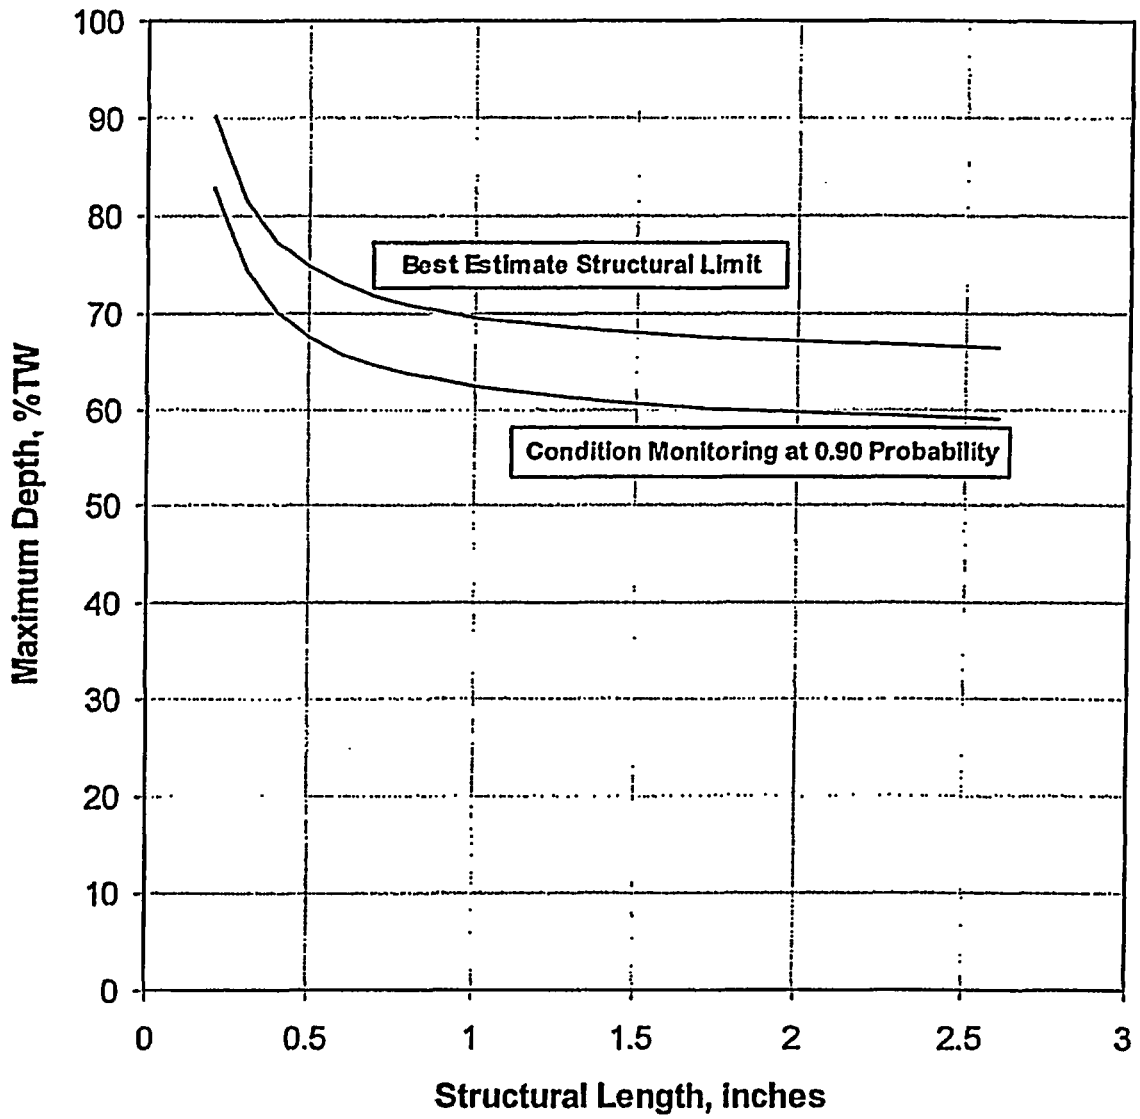
Figure 2.1 Structural Limit Curves Applicable to Wear Degradation

The combinations of wear scar lengths and depths leading to a $3\Delta P$ burst pressure of 3900 psi are shown in Figure 2.1 for Callaway steam generator tubing. The upper curve, termed the structural limit curve using the nomenclature of the EPRI Steam Generator Degradation Specific Flaw Handbook⁶, is based on a best fit burst pressure equation and average, at temperature, material properties. The lower curve in Figure 2.1 is the Condition Monitoring Limit Curve. This curve includes NDE sizing uncertainties as well as uncertainties in material properties and in the burst pressure equation. The Condition Monitoring Limit curve shows the locus of NDE inferred degradation lengths and depths leading to a burst pressure of 3900 psi at 0.90 probability at 50% confidence. Indications with NDE inferred lengths and depths at or below the Condition Monitoring Limit Curve meet the required deterministic structural performance criteria for minimum degraded tube burst pressure. As is shown below, all instances of degradation at Callaway plot below CM curves and thus CM is met via NDE sizing and analysis.

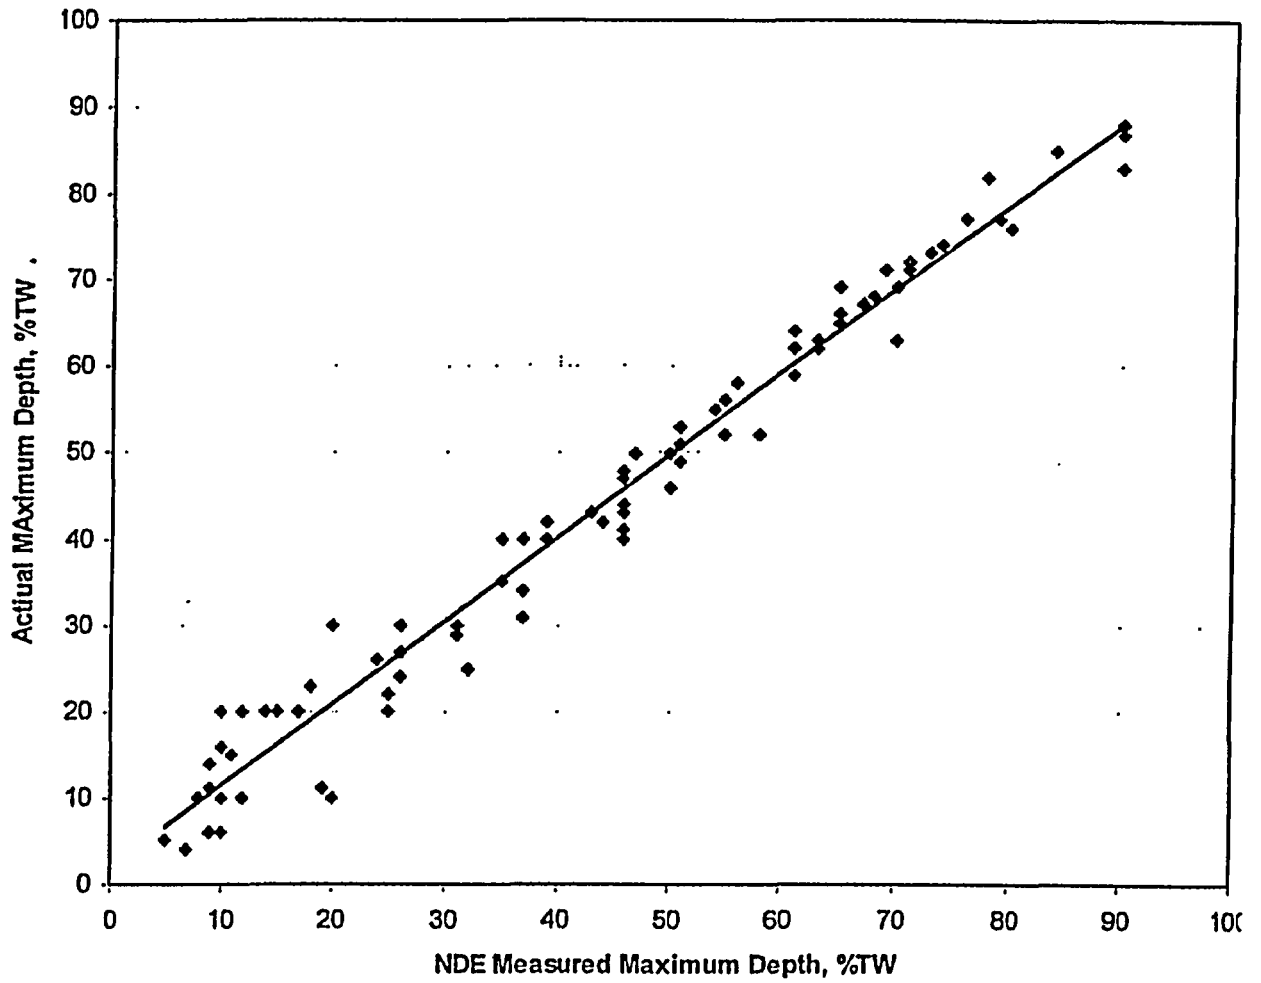
Figure 2.2 Actual Depth Versus NDE Measured Depth, Wear Scar Geometry ETSS 96004.3

In applying NDE measured degradation dimensions to infer structural integrity, systematic errors, measurement uncertainties, and shape effects must be considered. Historically, most NDE depth measurements refer to maximum depth. Figure 2.2 shows a plot of maximum wear scar depth from destructive examinations results versus NDE measured depths⁷ using the eddy current technique applicable to Callaway. The best fit straight line shows an intercept of 2.92% TW and a slope of 0.96, resulting in a small systematic error. The scatter in actual depth about the best-fit line is normally distributed with a standard deviation of 3.52% TW. This value is termed the standard error of estimate in conventional straight-line linear regression evaluations. From Figure 2.2 it is seen that, at a measured NDE depth of 40% TW, the best estimate of actual maximum

depth is 43.9% TW. Actual maximum depths will scatter about this value with a standard deviation of 3.52% TW. For wear indications the systematic sizing error is small. The slope value is about 1.0. This allows plotting of the best estimate structural limit and the CM curve on the same plot. The best estimate structural limit is a function of actual degradation length and depth. The CM limit curve is expressed as a function of NDE depth and NDE length readings. Often the systematic error in NDE sizing is such that NDE readings are significantly larger than the actual degradation depths and lengths. In these cases inclusion of both the best estimate structural limit curve and the condition monitoring limit curve on the same plot would lead to confusion since the CM curve, referring to NDE readings, could plot above the best estimate structural limit curve which refers to actual physical dimensions. When compared on an equal basis such as best estimate actual degradation dimensions, CM curves are below best estimate structural limit curves by about 1.5 times the NDE depth sizing standard deviation.

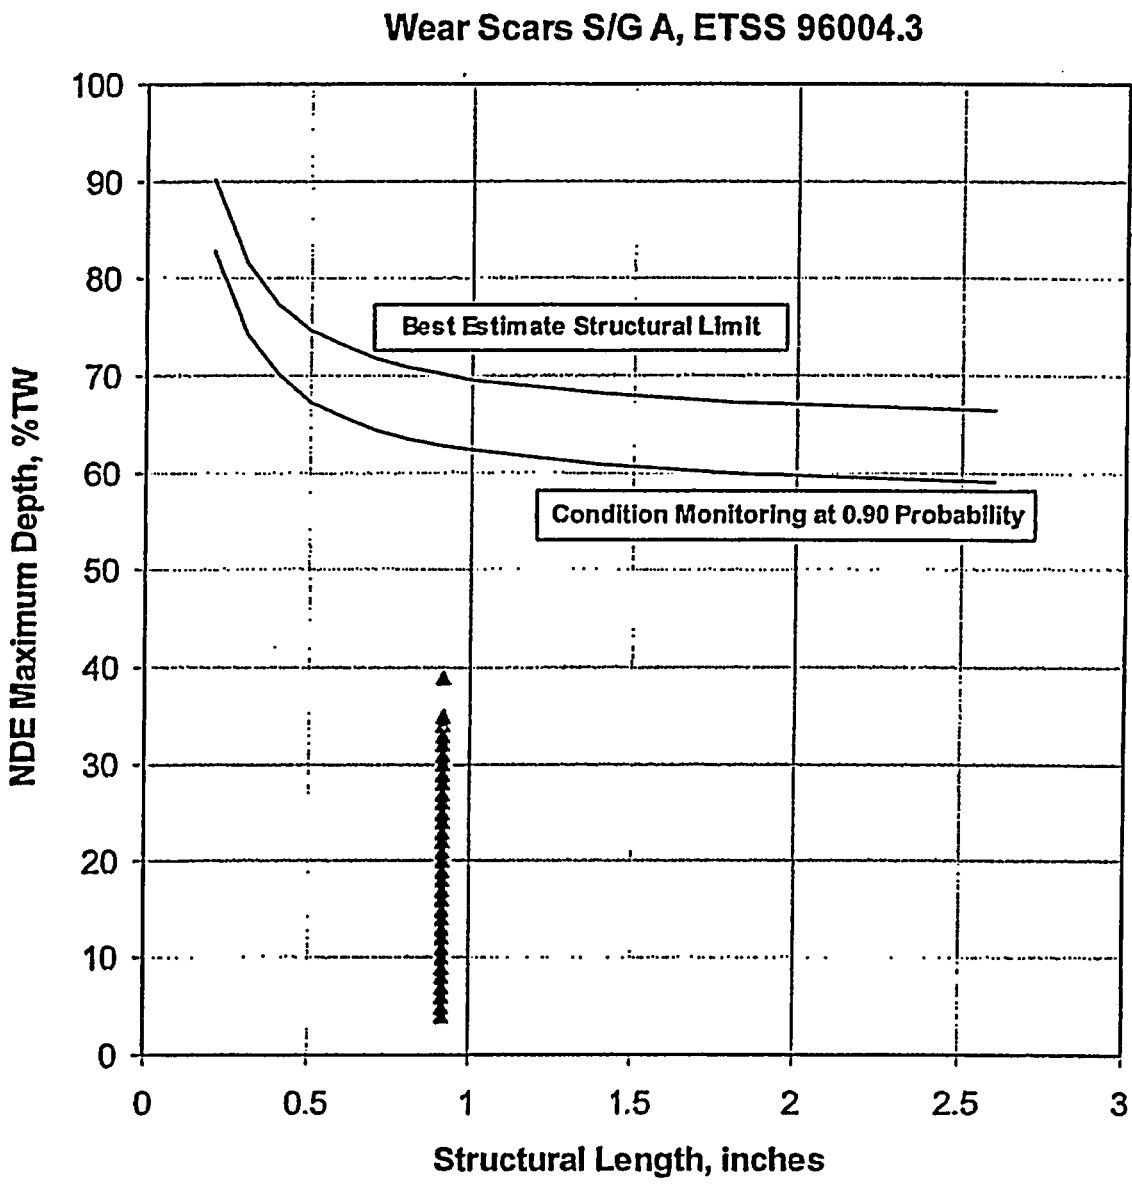
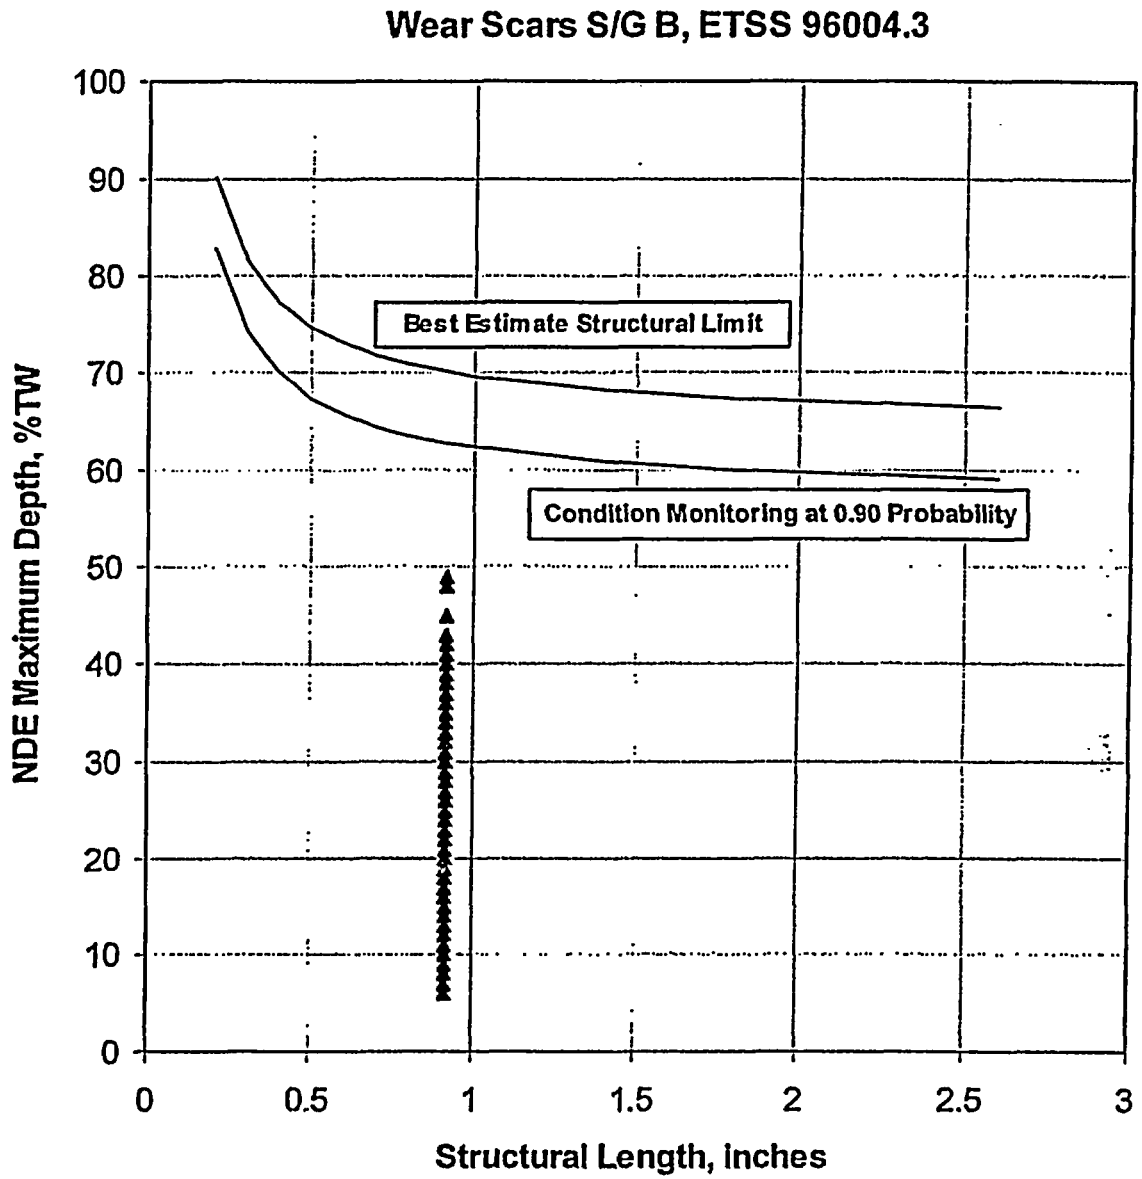
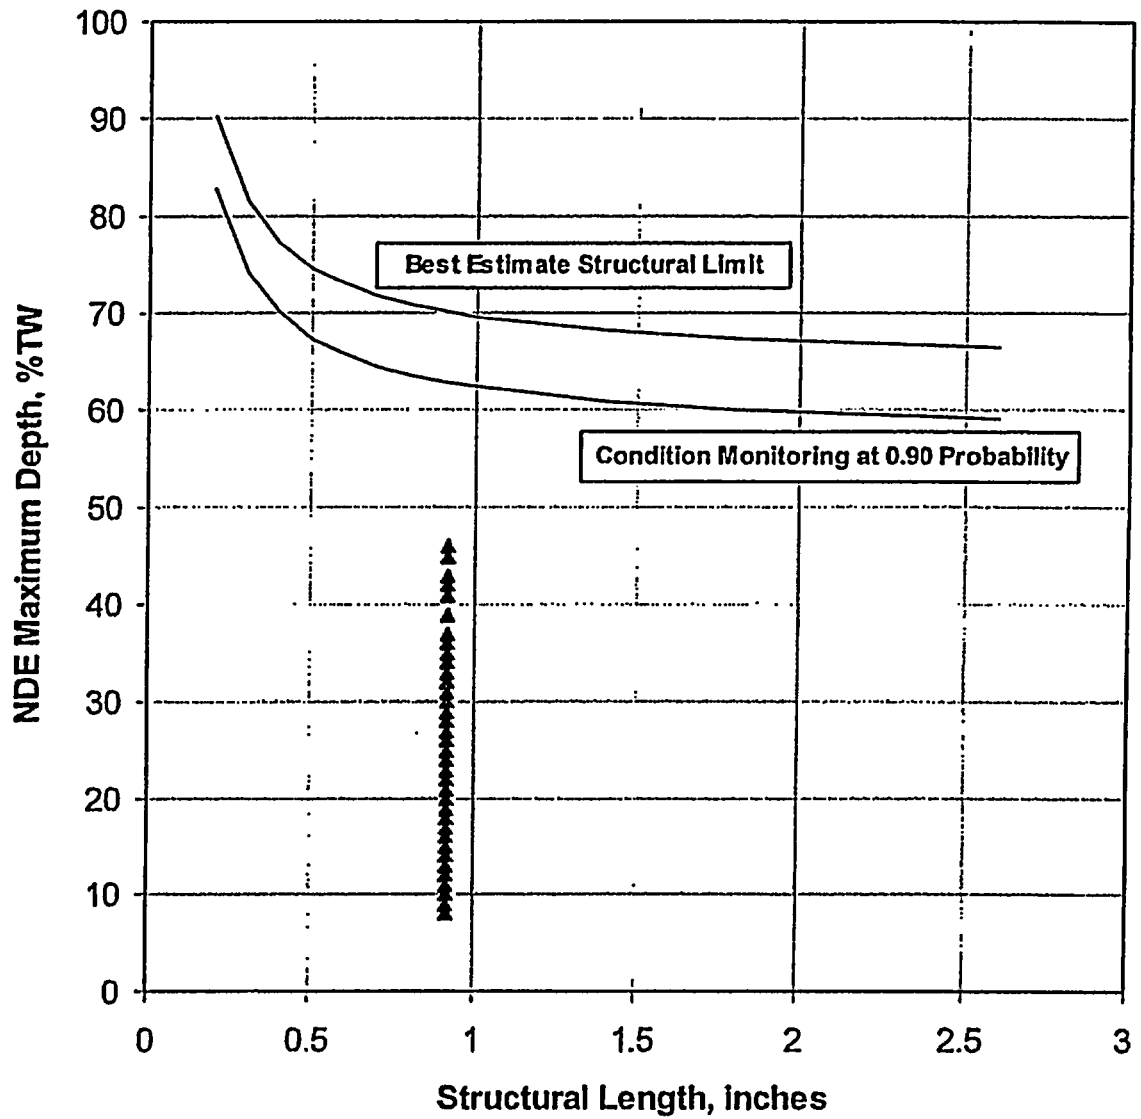
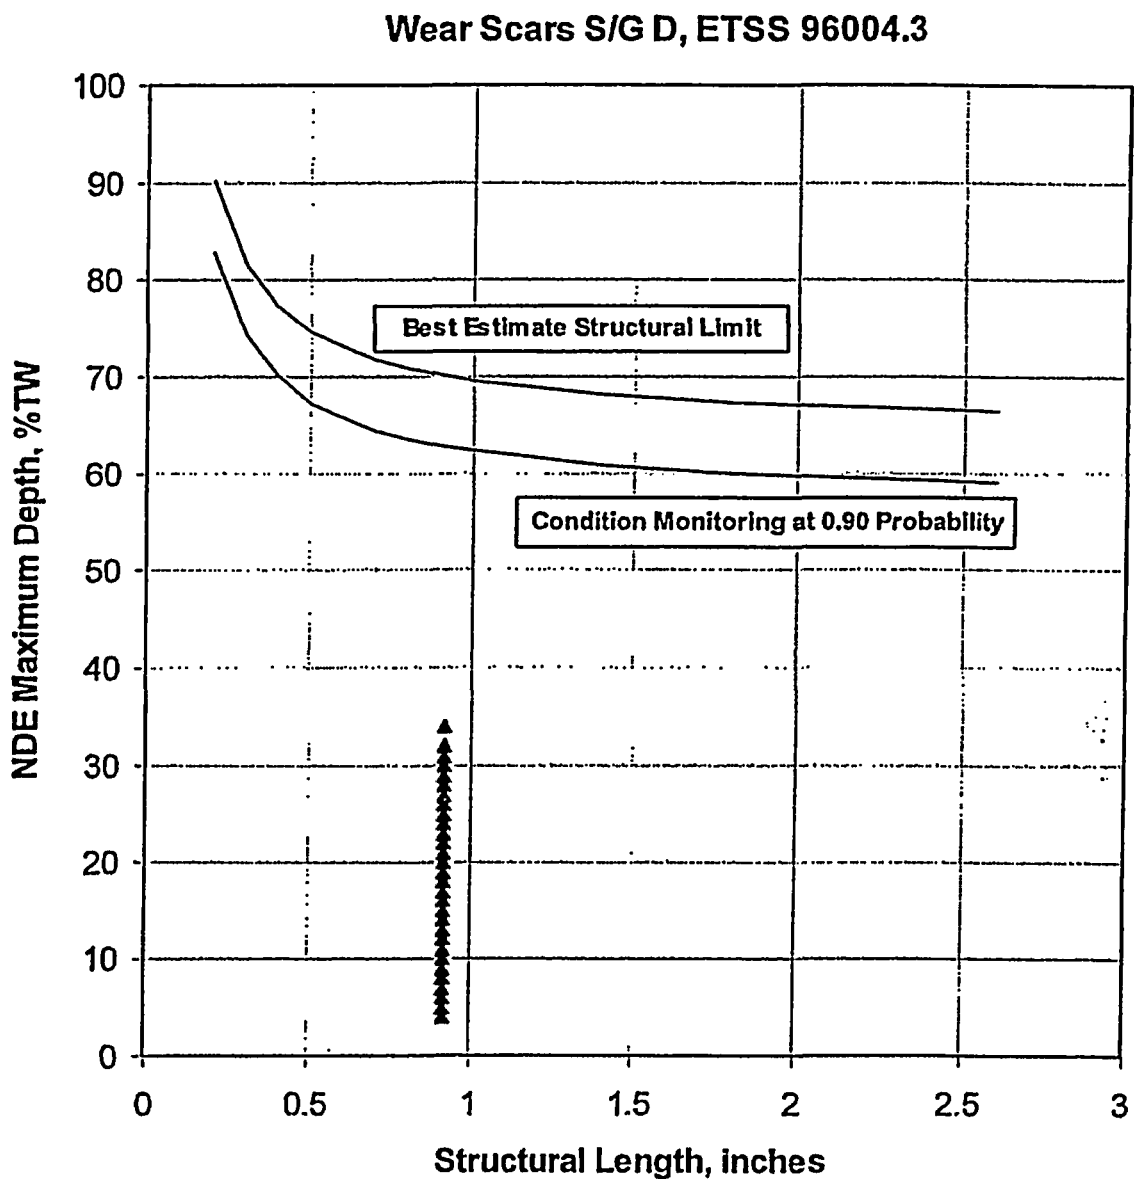
Condition monitoring structural limit plots are shown in Figures 2.3 through 2.6 for AVB wear scars at Callaway. Figures 2.3 through 2.6 show plotted points representing AVB wear scars observed at RF 13. The length plotted is the bounding scar length for AVB wear which occurs when the tube and AVB do not have a perpendicular intersection. The plotted points fall well below the CM Limit curve. Required structural integrity is demonstrated. Since through wall tearing and burst will not occur at $3\Delta P$, leakage integrity at an FLB/SLB differential pressure of 2560 psi is also demonstrated.

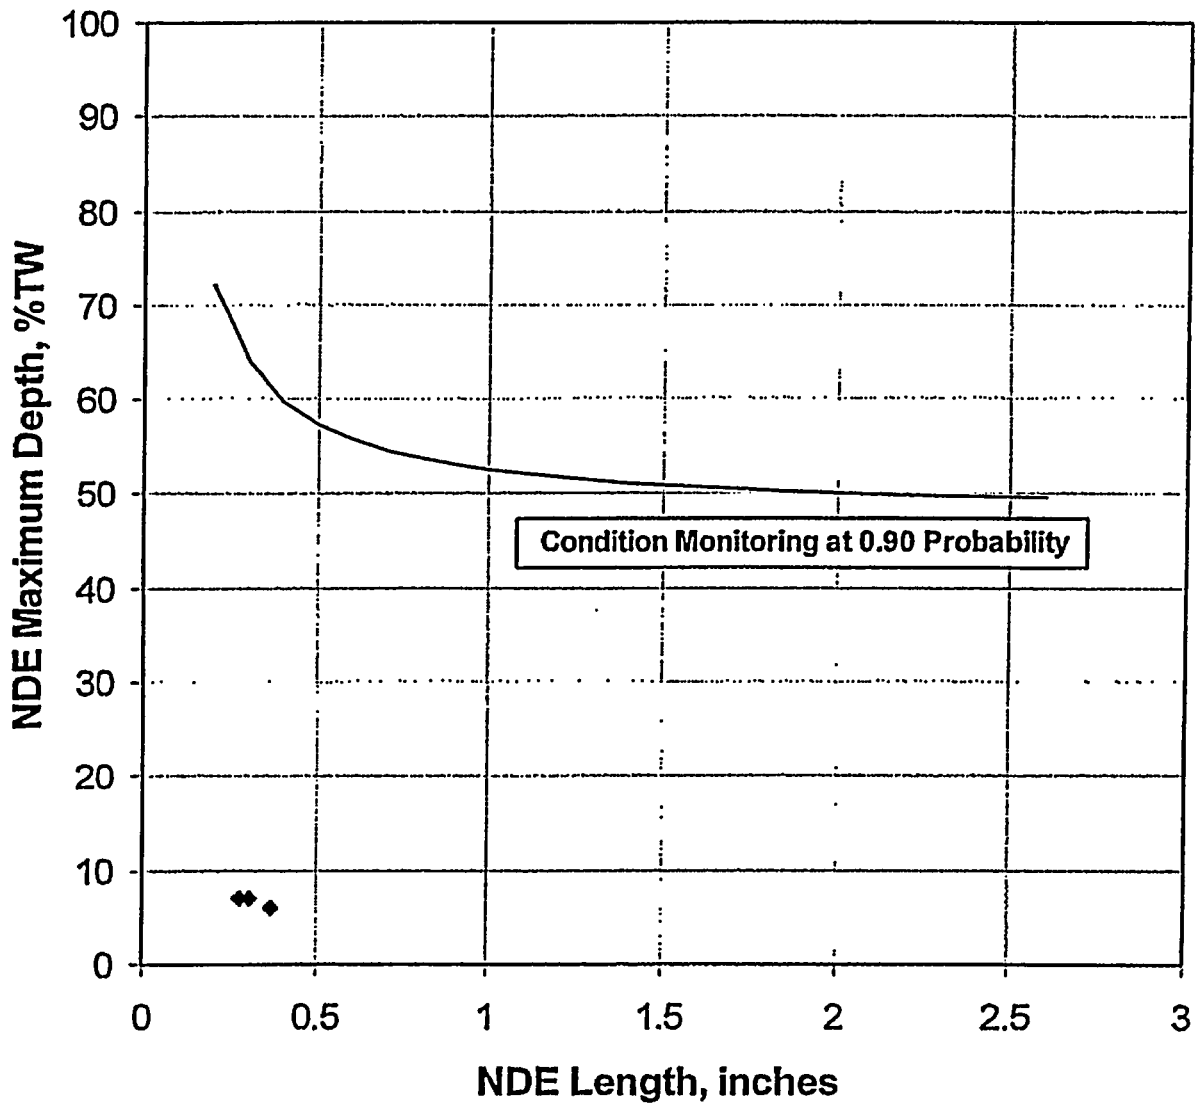
Figure 2.7 Condition Monitoring Plot For Volumetric Degradation

Figure 2.7 illustrates that OD volumetric indications in steam generators B and C meet $3\Delta P$ condition monitoring requirements. Of the total of 4 volumetric indications, 3 were located at tube support plates and 1 was located near the top of the tubesheet. All are low level indications in terms of extent, depth and signal amplitude. These indications meet both structural and leakage integrity requirements by a wide margin. The tube support indications are believed to be distorted wear indications and the OD indication near the top of the tubesheet is probably some combination of IGA and ODSCC.

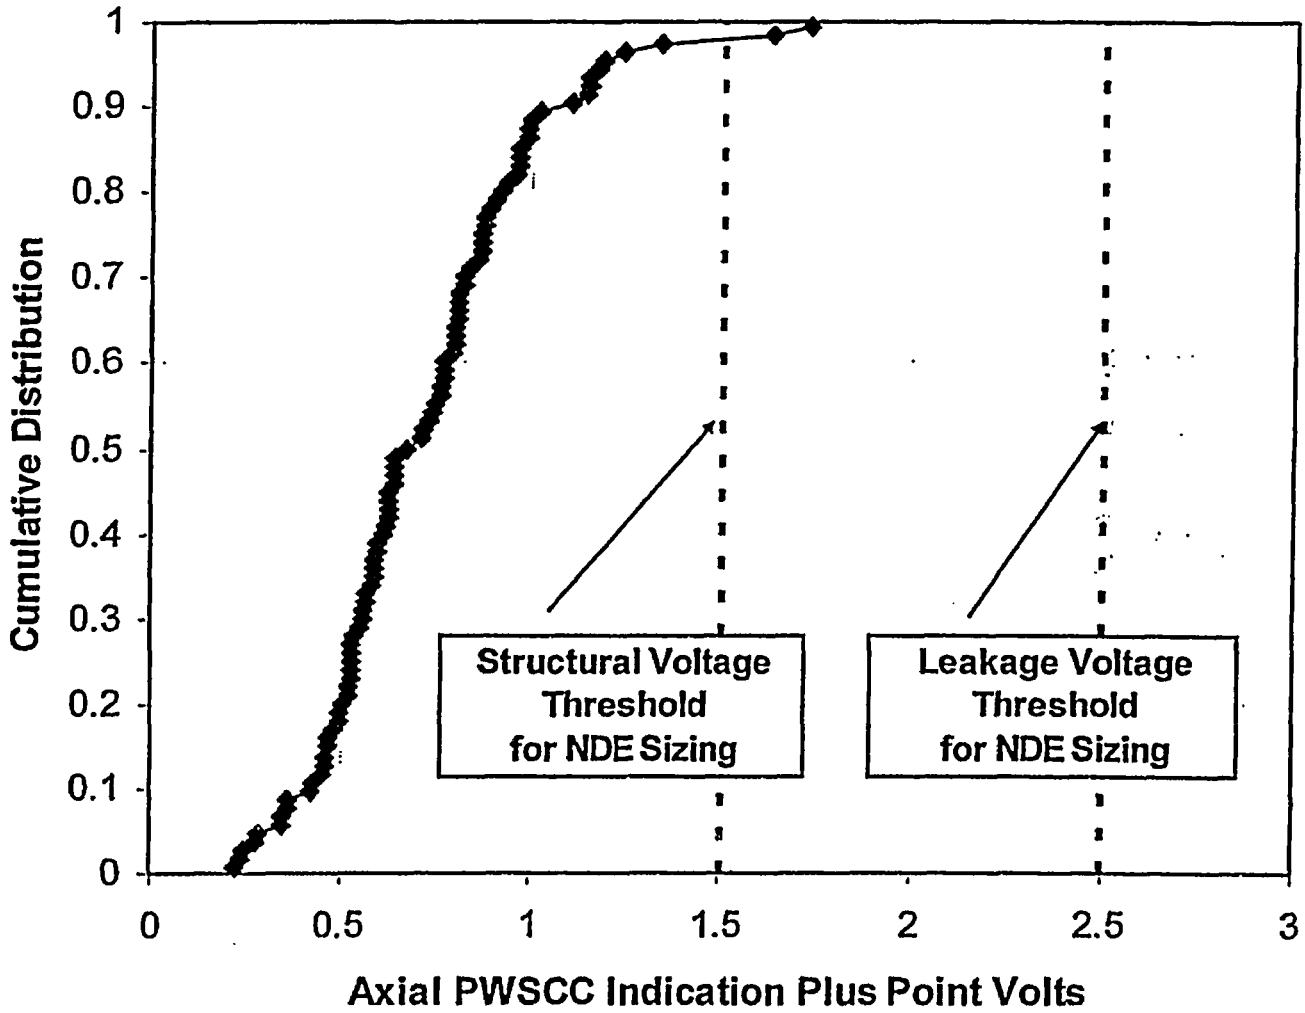
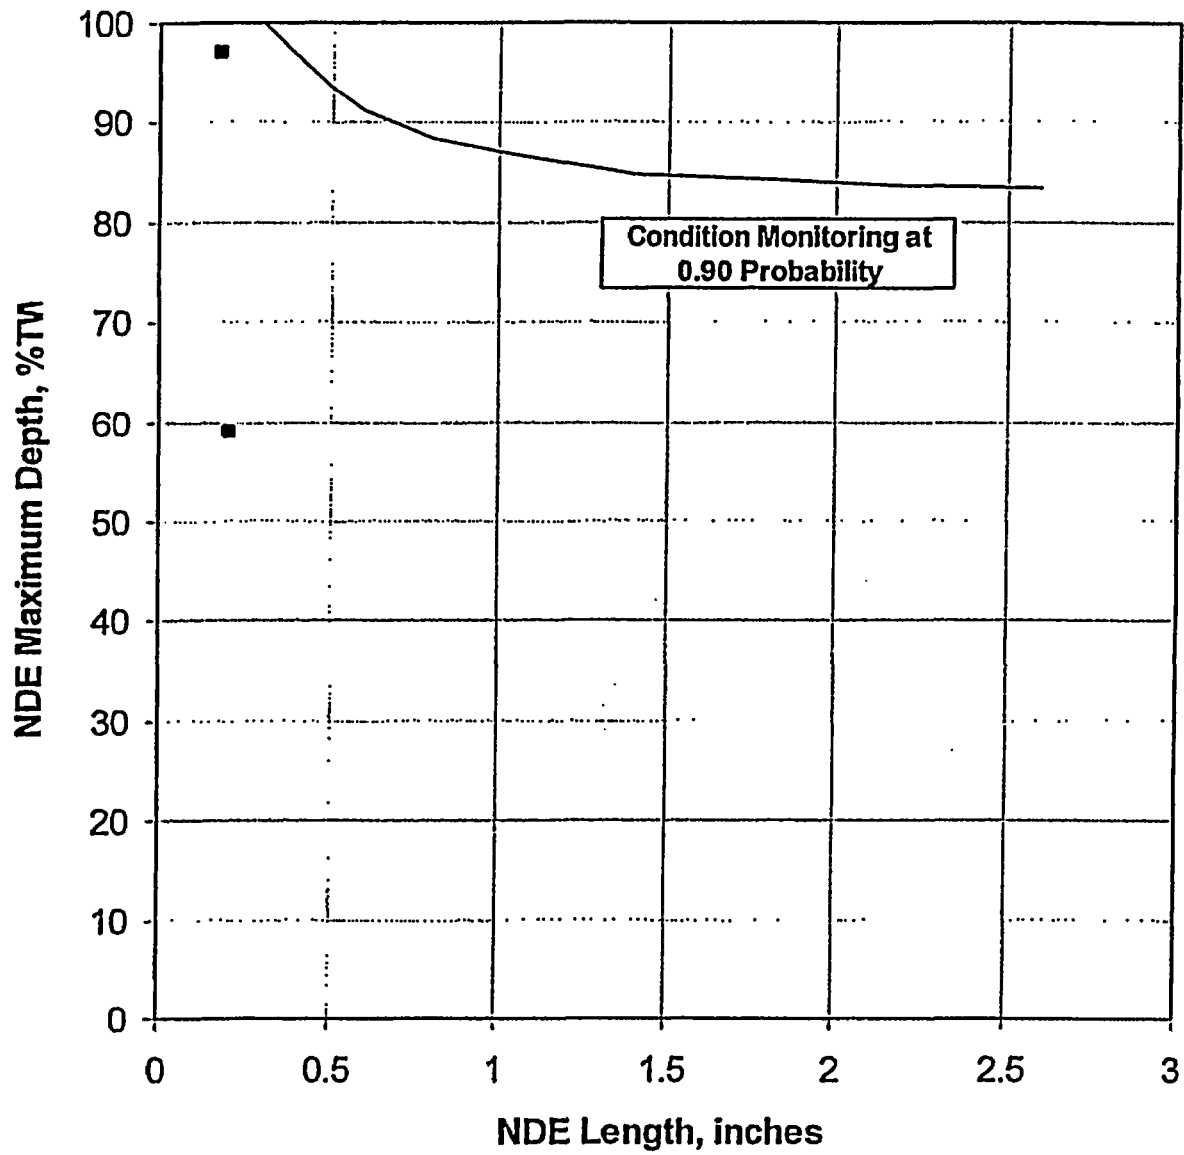
Axial PWSCC indications were all located at the top of tubesheet expansion transition and all had very short lengths. The maximum indication length was 0.25 inches. Considering material property, burst equation and NDE sizing uncertainties an axial PWSCC crack can be 0.275 inches long and 100% TW and meet $3\Delta P$ condition monitoring structural integrity requirements. All axial PWSCC indications thus meet condition monitoring structural integrity requirements. The same conclusion is evident from the distribution of Plus Point voltages shown in Figure 2.8. Only 2 axial PWSCC indications exhibited a voltage greater than the 1.5 volt threshold value in order to require NDE sizing. Figure 2.9 shows that the NDE measured length and depths demonstrate $3\Delta P$ structural integrity.

Based on data in the EPRI Steam Generator In Situ Pressure Test Guidelines², axial PWSCC indications must exhibit a Plus Point voltage of 2.5 volts before leakage integrity at postulated FLB/SLB conditions becomes an issue or sizing is required. The maximum Plus Point voltage for all observed axial PWSCC indications was 1.73 volts. See Figure 2.8. Thus, leakage integrity is demonstrated. The same statement holds true of axial ODSCC indications. Figure 2.10 shows that the maximum observed Plus Point voltage is well below the 1.0 volt leakage threshold value.

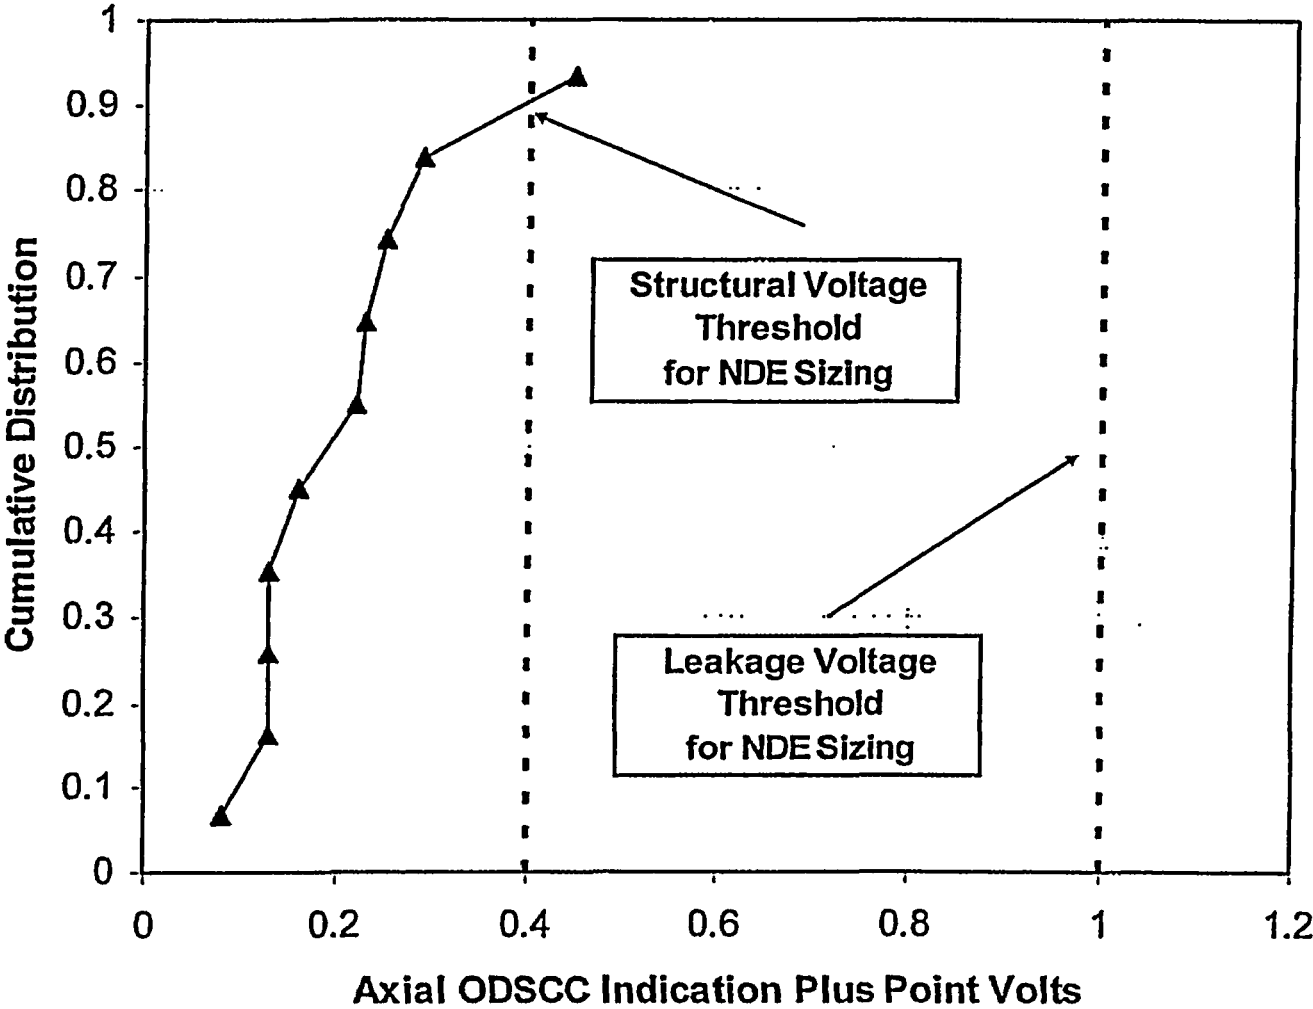
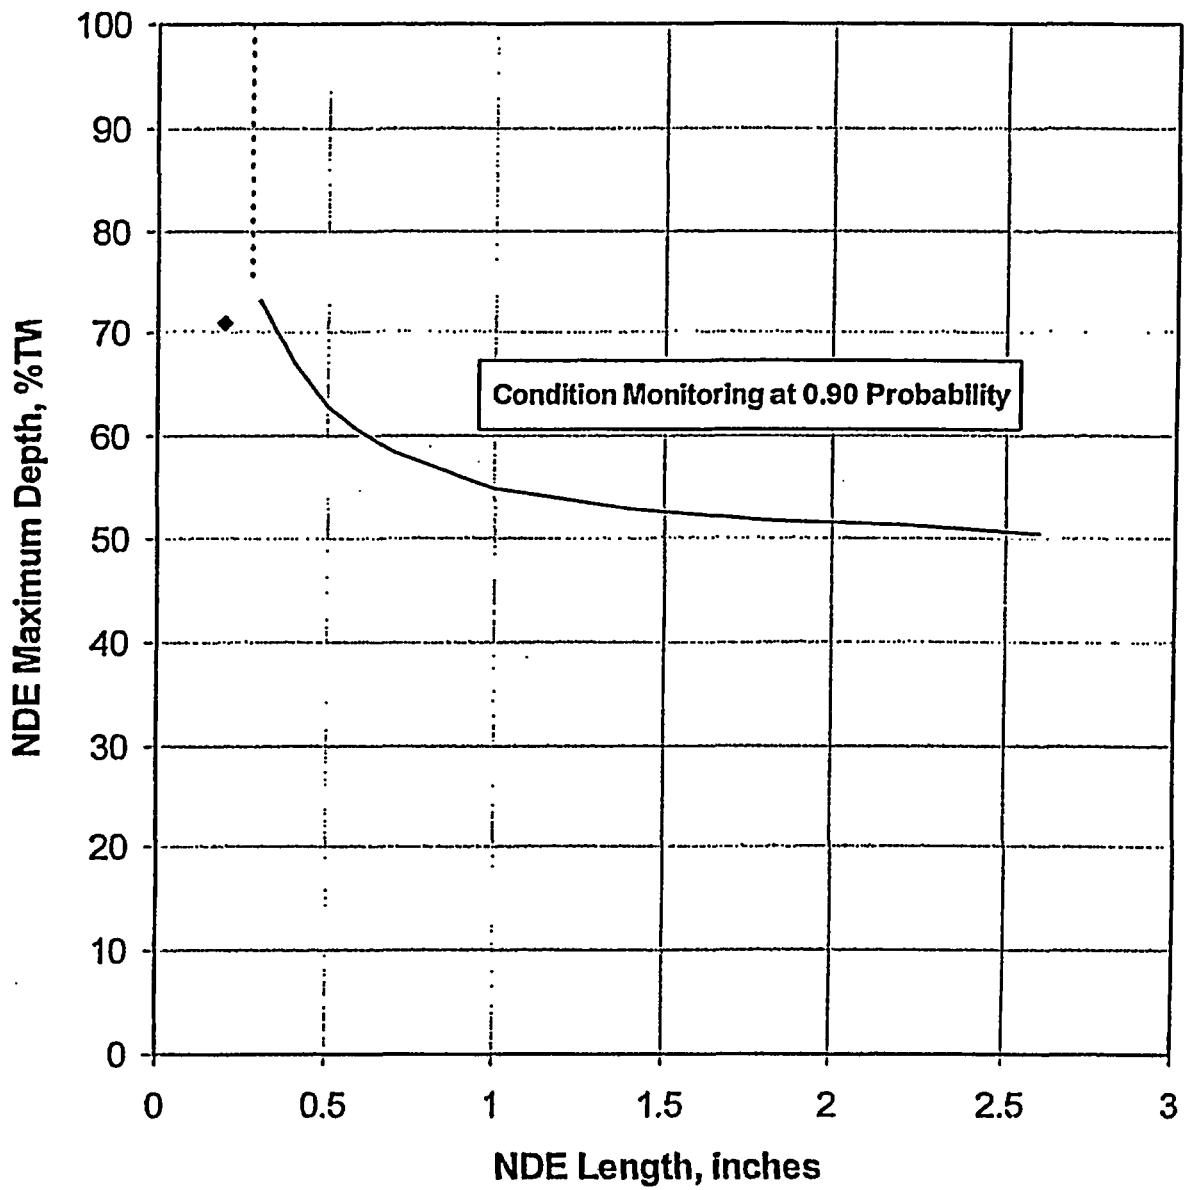
Axial ODSCC indications were all located near expansion transitions. Figure 2.10 shows that all but 1 indication were below the Plus Point voltage threshold where NDE sizing was required. This confirms the low level of degradation severity for both OD and ID axial indications. Figure 2.11 illustrates that the NDE measured depth and length for the 1 OD indication above the structural sizing threshold demonstrates condition monitoring 3ΔP structural integrity.

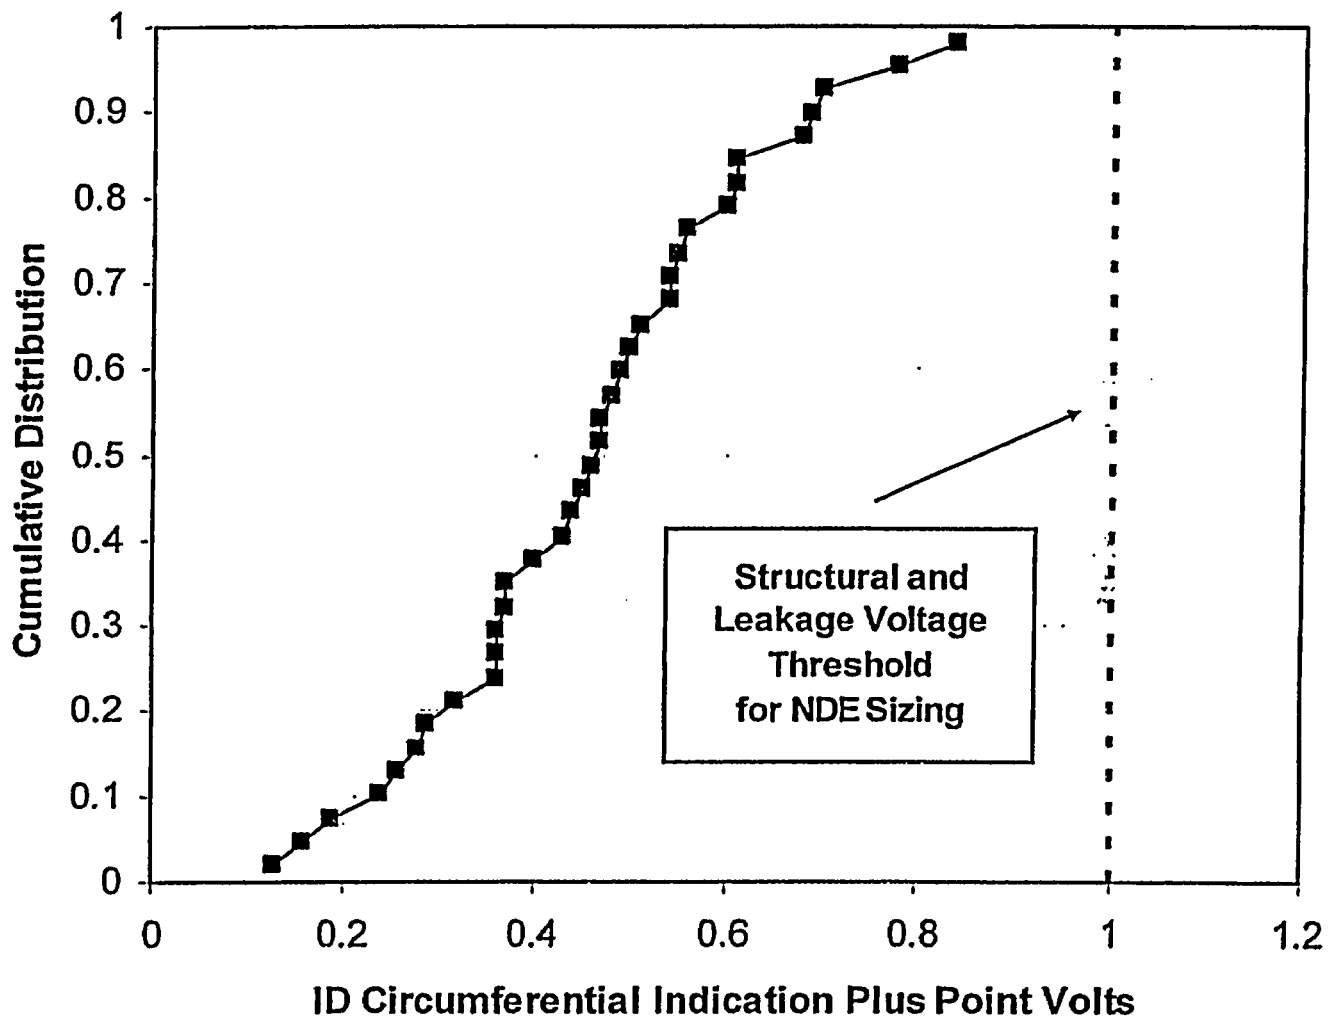
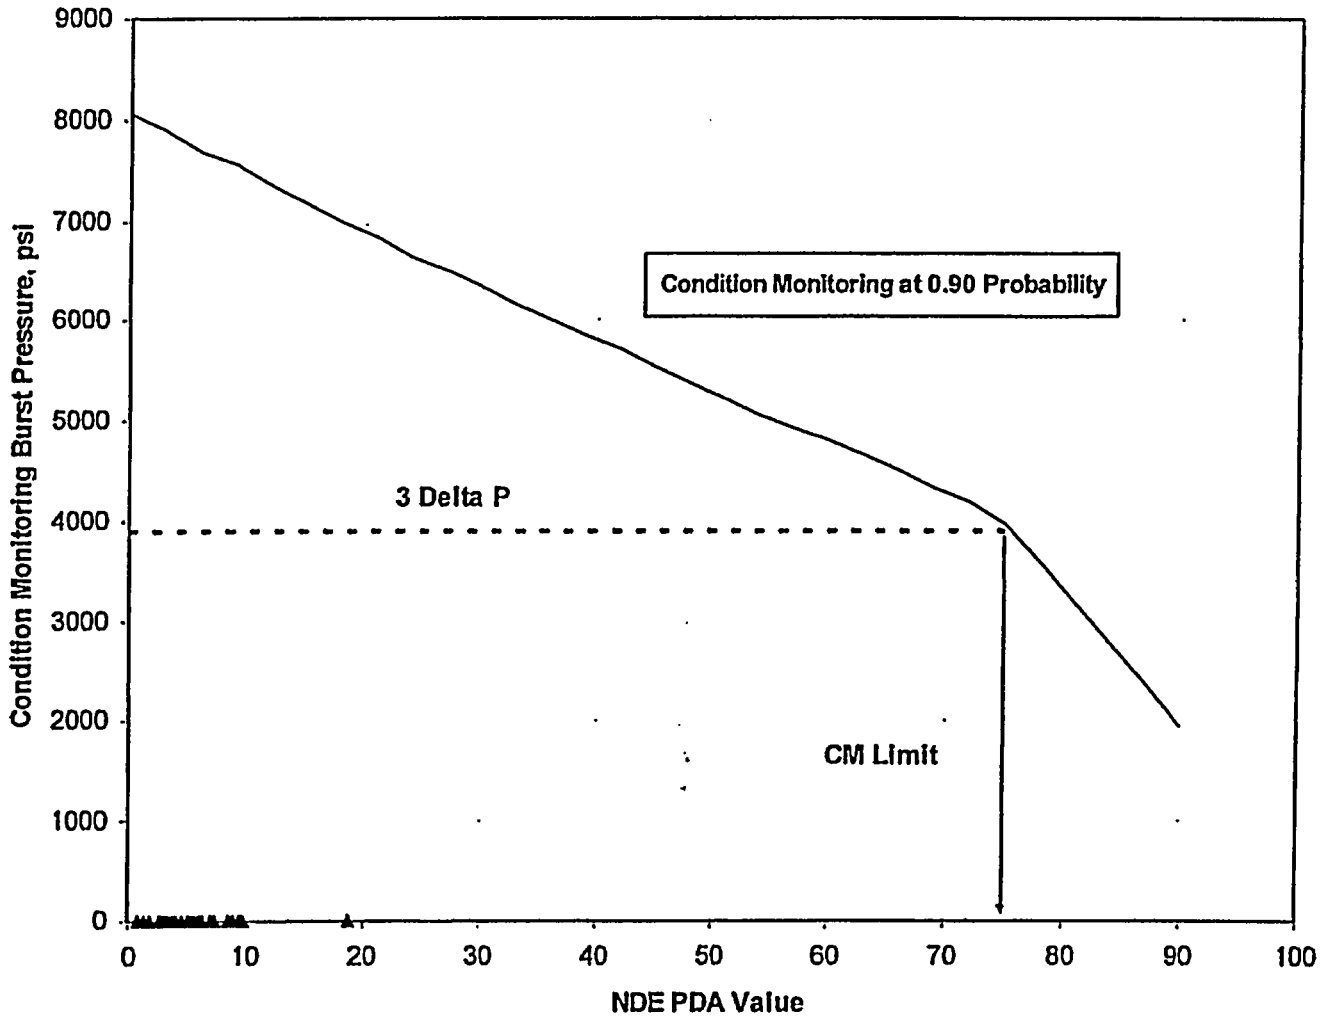
A total of 33 circumferential PWSCC indications were found in the vicinity of the top of tubesheet expansion transitions. Only 3 circumferential PWSCC indications were found at some distance below the expansion transition as opposed to about 32 in the last inspection. All indications exhibited limited circumferential extent. The maximum NDE PDA value was 19 compared to the condition monitoring limits of 75 NDE PDA. Hence, the degradation found met condition monitoring structural integrity requirements by a large margin. Plus Point voltage levels were all below 1.0 volts satisfying both 3ΔP structural integrity and FLB/SLB leakage integrity requirements on a voltage threshold basis as described in the Callaway RF13 Degradation Assessment⁴. See Figure 2.12. Crack profiling of circumferential indications was performed even though not required. NDE PDA values are plotted on the x axis of Figure 2.13. The large margin to the CM limit of 75 NDE PDA is illustrated.

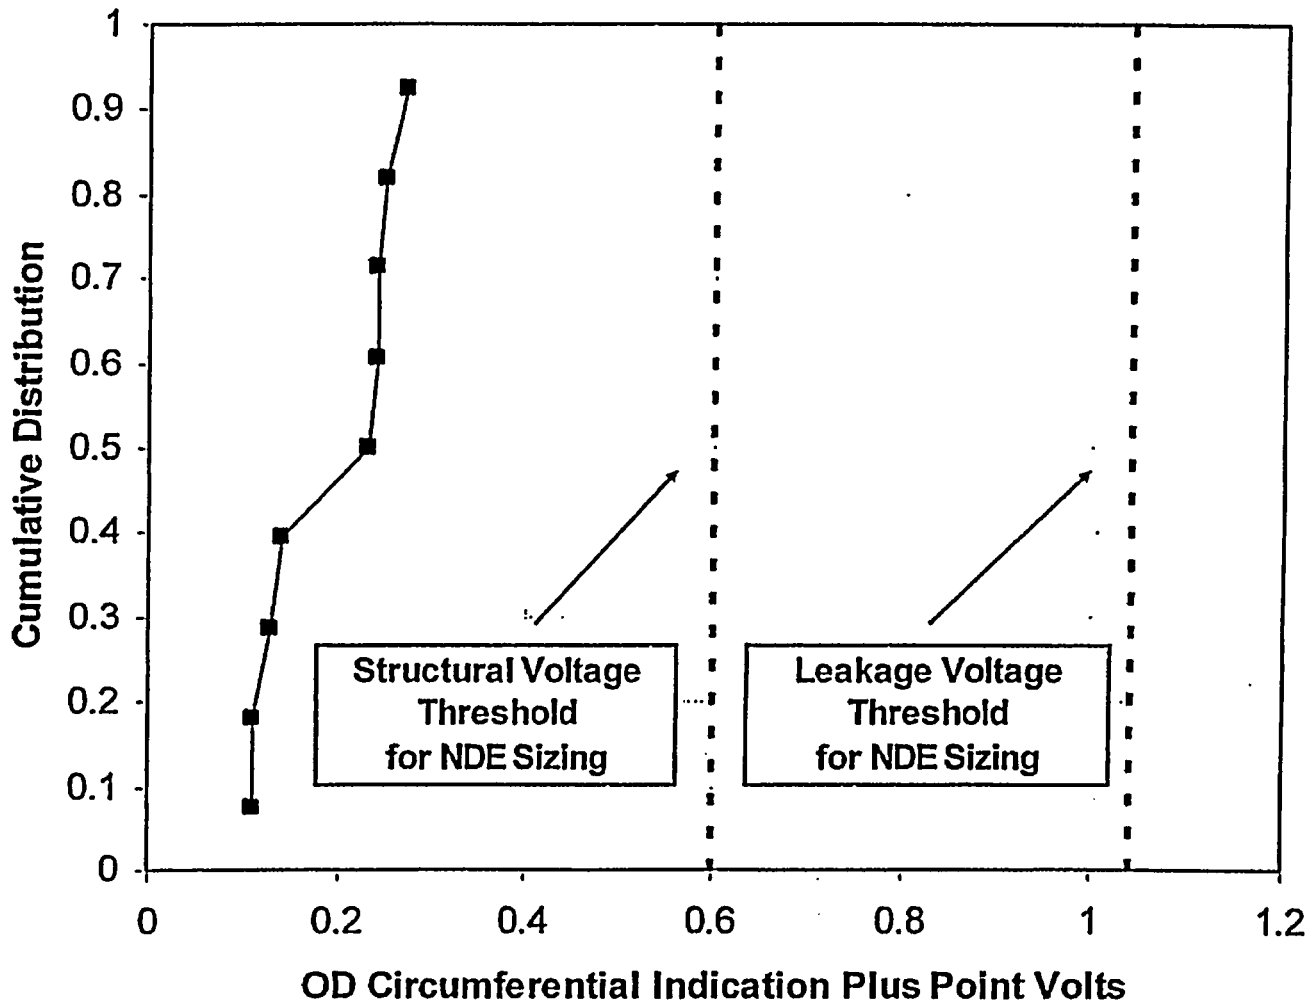
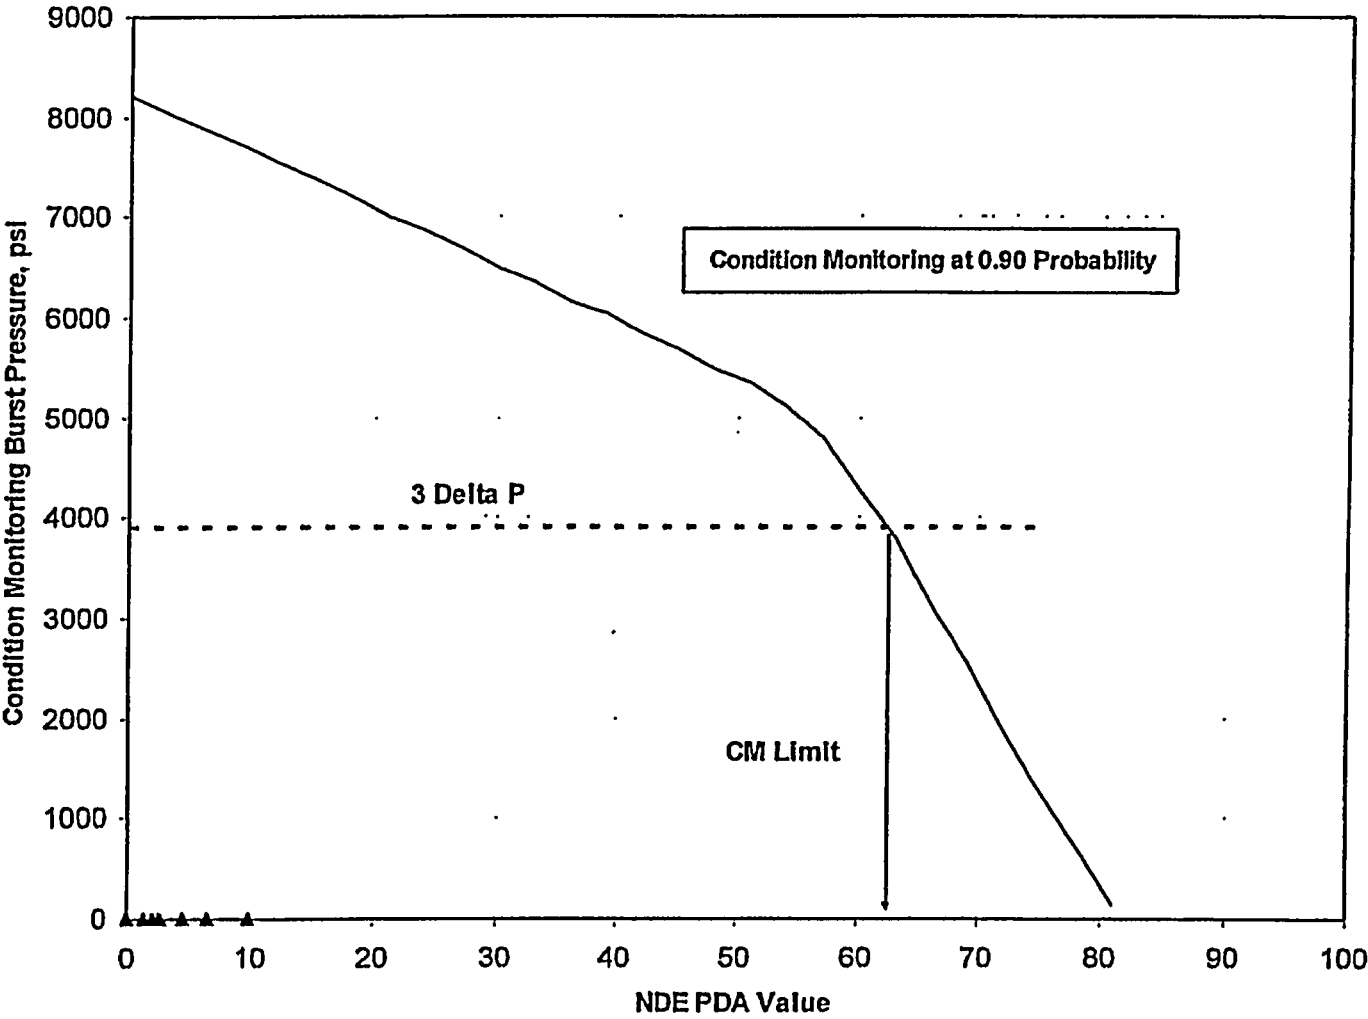
A total of 9 indications of OD circumferential cracking were found at RF13. All of these indications were in the vicinity of expansion transitions. As in the case of PWSCC circumferential indications, the circumferential extent, PDA values and Plus Point

voltage level of ODSCC circumferential indications are small. The largest circumferential extent is 150 degrees, the largest PDA value is 9.8 versus a condition monitoring limit of 62 and the largest Plus Point voltage is 0.27 volts. The very mild nature of ODSCC circumferential degradation is illustrated in Figures 2.14 and 2.15. On a voltage basis alone, both $3\Delta P$ structural integrity and FLB/SLB leakage integrity condition monitoring requirements are demonstrated.
