**DOCKET NUMBER 50-483
CALLAWAY PLANT UNIT 1
UNION ELECTRIC CO.
FACILITY OPERATING LICENSE NPF-30
STEAM GENERATOR CONDITION MONITORING REPORT**

Document Identifier 51 - 5044435 - 00

Title Steam Generator Condition Monitoring at RF 13

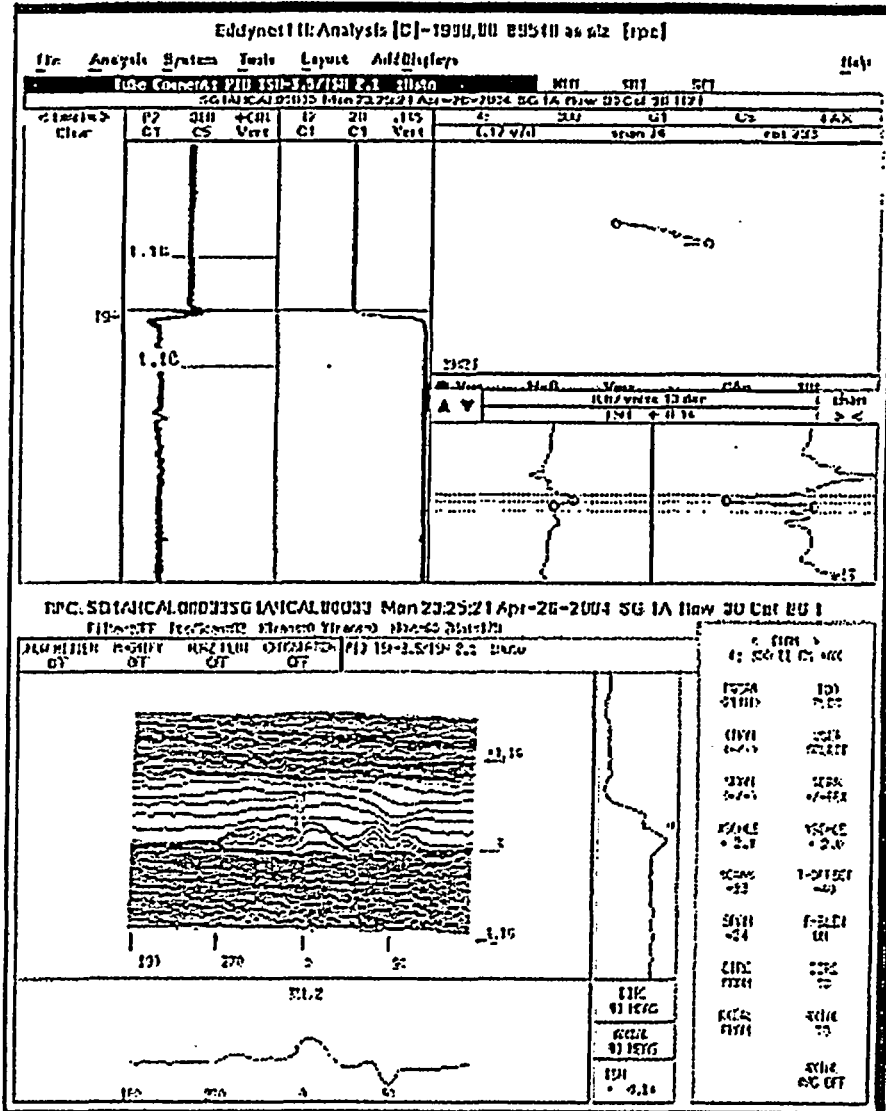
Figure 2.16 Plus Point Terrain Map for Combined Axial and Circumferential PWSCC Indications Near Expansion Transition, Axial Coil

There were two instances of combined axial and circumferential PWSCC indications near expansion transitions. Figure 2.16 and 2.17 present Plus Point terrain maps for the largest of the two occurrences of combined cracks. The configuration is essentially "L" shaped with some gap between the axial and circumferential cracks. The cracks are small and individual Plus Point voltages, 0.78 volts maximum, are well below the NDE sizing thresholds for either $3\Delta P$ structural concerns or FLB/SLB leakage possibility for either axial or circumferential cracks. Additionally, there are extensive burst test data⁸ for combined axial and circumferential cracks near expansion transitions. Figure 2.18 illustrates the very high burst pressures for small axial and circumferential ID cracks in close proximity. Burst pressures are about twice the $3\Delta P$ value demonstrating a large margin of structural integrity.
