# **Loss of Control of Cesium-137 Well Logging Source Resulting in Radiation Exposures to Members of the Public**

**U.S. Nuclear Regulatory Commission  
Region IV  
Arlington, TX 76011-4005**

Manuscript Completed: April 2004  
Date Published: October 2004

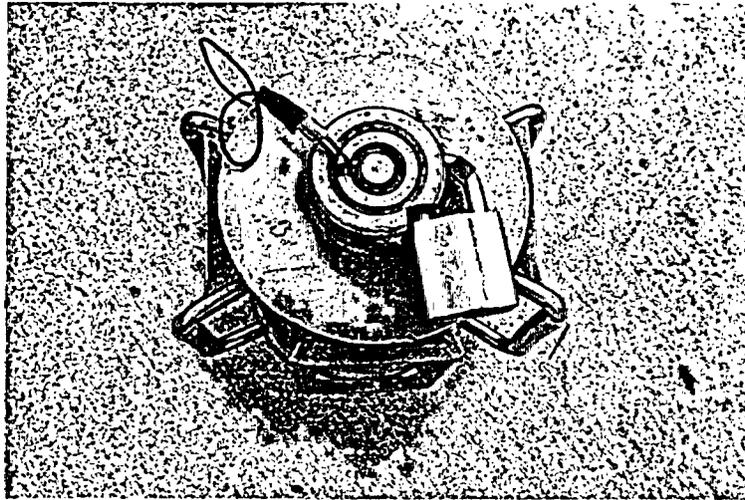
**Figure 2.4.1** Top view of the source storage container with the shield plug in place and locked. The cable attaching the plug to the body of the container is also seen in the photograph

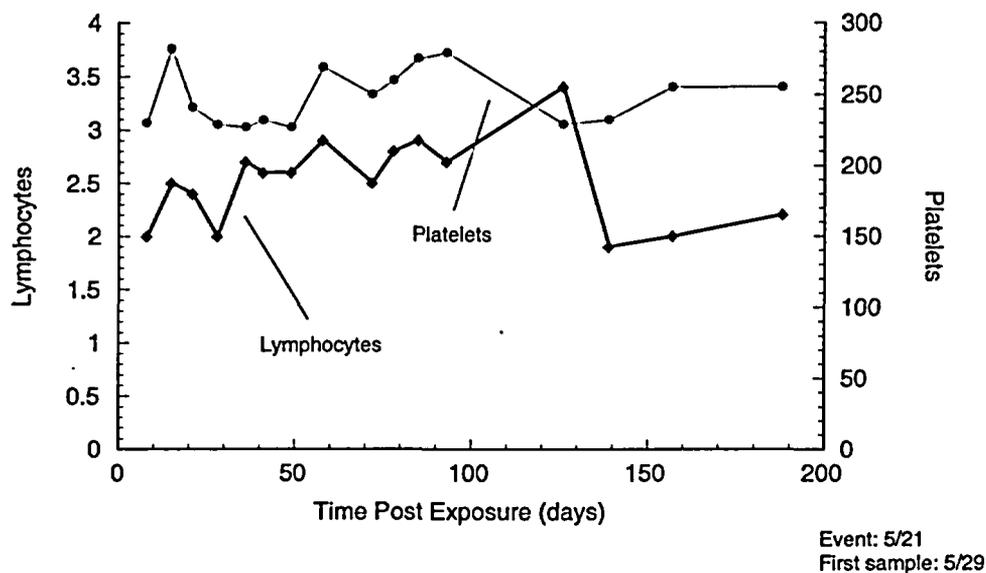
**Figure 6.2.2 Lymphocyte and platelet counts for one of the workers, Worker D, from blood samples taken at approximately weekly intervals starting about one week after the event.**

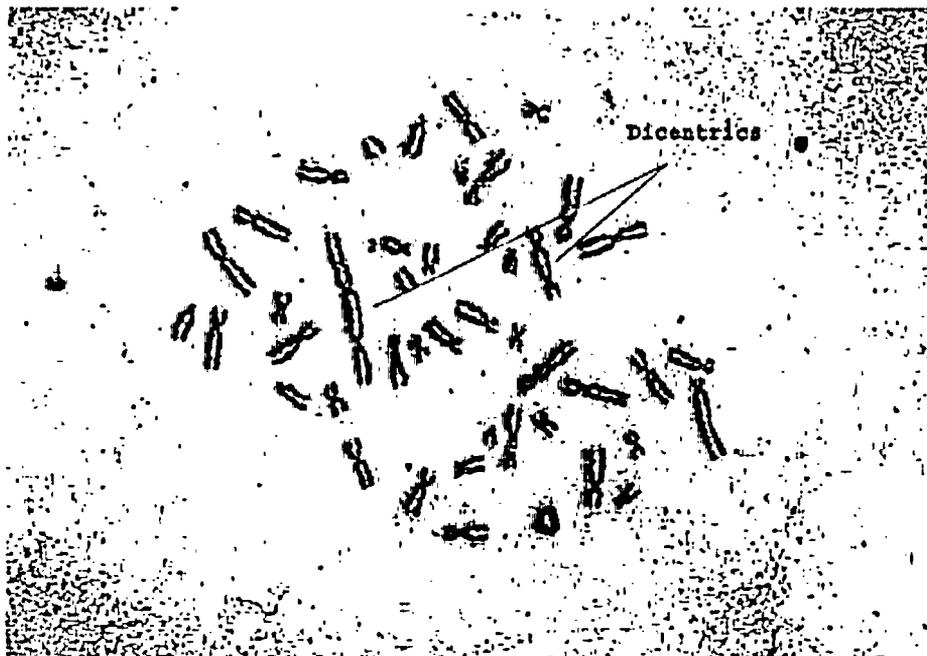
**Figure 7.1 Photograph of a microscope slide showing a group of chromosomes and four, or possibly five, dicentrics, two of which are pointed out by the lines**
