Loss of Control of Cesium-137 Well Logging Source Resulting in Radiation Exposures to Members of the Public

**U.S. Nuclear Regulatory Commission
Region IV
Arlington, TX 76011-4005**

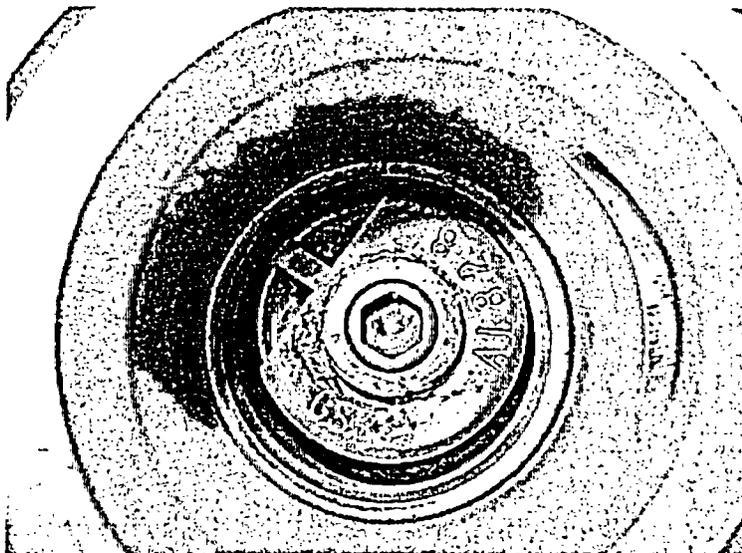
Figure 2.4.2 Top view of the source storage container with the shield plug removed showing the source assembly in place within the container storage well

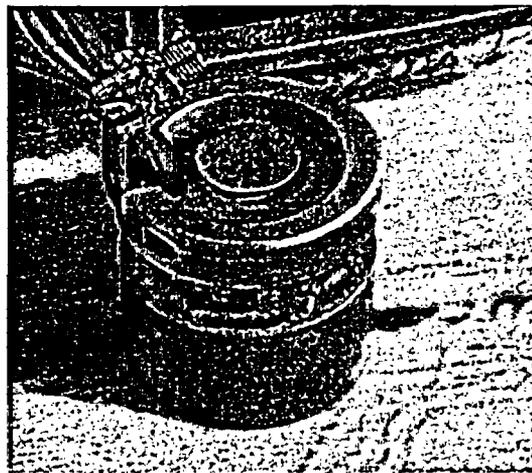
The AIT visited the licensee's training facility in Kellyville, Oklahoma. During this site visit, the team observed, and participated in, a simulated logging operation at STC's well logging pad used to train engineers, operators, and other STC logging personnel. The exercise included loading and unloading of "dummy sources" (source assemblies identical to those used in the field but without radioactive material in them) into logging tools and source containers. During these observations of training sessions, the team was permitted to examine and manipulate the "dummy source" and the associated safety equipment. During manipulation of the source storage container and its associated container plug, the team was able to create conditions whereby the plug assembly would not drop into the container, even when the logging source was not in the container. The team observed that when the retaining cable attached to the plug assembly became twisted, the decreased length of the cable and tension produced by the twisting did not allow the plug to fall into the container as designed. In fact, this condition allowed the plug to rest/seat in a position that was sufficient to permit locking the plug even though a source was not in the container, contrary to the intended safety function.

Figure 5.3.2.1 Photographs of the source container shield plug showing the thin, flexible, cable/clamp assembly (left) and a more rigid replacement assembly (right).

The team believes that the larger size clamp is more likely to get caught (i.e. "hung up") on the outer lip of the storage container, preventing the plug from dropping into the container. It appeared that various STC field locations were repairing these storage container plug cables with different size and weight clamps and cable, some of which had the potential of causing the clamp to hang up on the lip of the storage container.

In addition, although the licensee had indications from previous events that the plug assembly does not always function as designed, it does not appear that STC performed an adequate equipment failure analysis of the plug insert assembly. Specifically, aside from dirt/debris build up on the plug, the licensee did not consider other failure modes, such as the influence of the retaining cable. This limited equipment failure analysis probably also contributed to the continued practice of using replacement parts (cable and clamp) that may have been different from those in the system design, thereby defeating the intended safety function of the plug assembly, which appeared to work reliably, and as intended, only when the proper parts were used.

In the licensee's written investigation report of the Edinburg, Texas event, STC noted that one of the corrective actions taken in response to the event was to review the design of all source shields to ensure that the plug drops when a source is not contained therein. After this review, the licensee concluded that, as designed, all of STC's source shields (storage containers) will provide this "drop." Although the plug did not drop in the Edinburg event, the licensee concluded that the failure was due to build up of drilling mud on the plug assembly; however it does not appear that STC considered other possible reasons for the container plug failure (e.g., the retainer plug cable and/or clamp size).
