SERIAL: BSEP 04-0140

Subject: Brunswick Steam Electric Plant, Unit No. 1
Docket No. 50-325/License No. DPR-71
Licensee Event Report 1-2004-002

4. TITLE
Manual Reactor Shutdown During Loss of Offsite Power Event

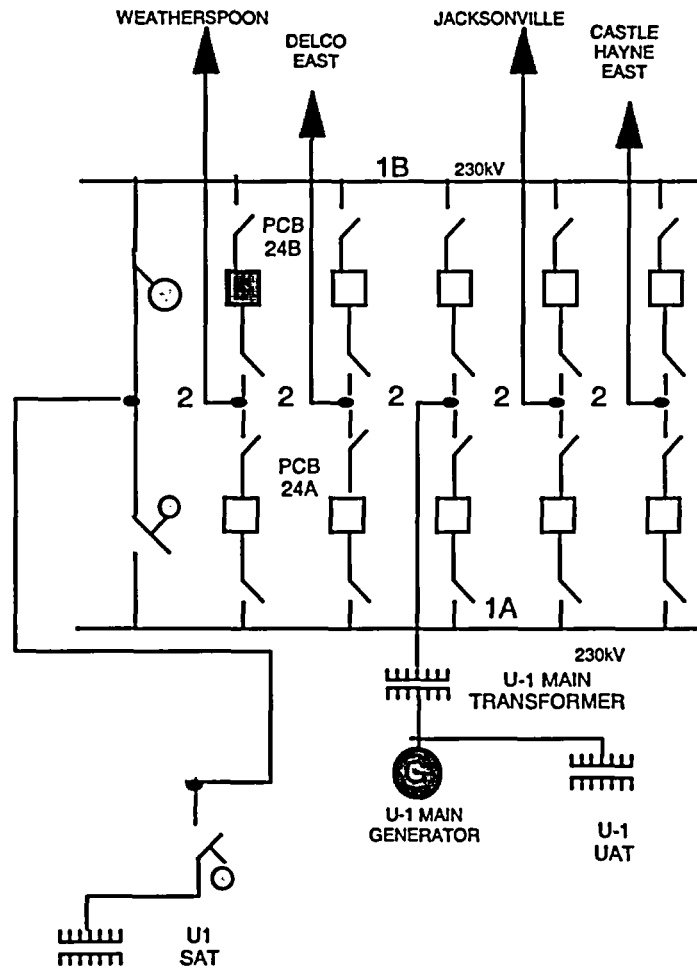
Unit 1 Switchyard Arrangement

EVENT DESCRIPTION (Reference attached drawing for supporting information)

Upon sensing the faulted condition created by the insulator failure, PCBs 24A and 24B opened. PCB 24B, being the preferred breaker, reclosed and tripped after 15 seconds and again after 50 seconds since the fault was still present. PCB 24A did not attempt to reclose since it requires PCB 24B to remain closed for a period of time before it will attempt to close. Even though PCB 24B cycled open as designed, instrumentation indicates that fault current was still present through the breaker contacts after the third trip. At this point the 230 kV 1B bus B phase differential relay operated resulting in a primary lockout of the 1B bus.

The cause of the event is attributed to a combination of conditions involving the failure of PCB 24B and the switchyard breaker scheme in affect at the time of the event. If either of these conditions had not been present, the event would not have occurred.

Breaker testing and vendor component failure analysis concluded that PCB 24B failed due to an internal bushing failure, which resulted in current flashover within the breaker. The bushing failure is attributed to moisture intrusion. The fault condition in combination with moisture produced an arc which was sensed by the bus differential relay and ultimately resulted in a primary lockout of the 1B bus. The root cause of this event is attributed to an inadequate PCB maintenance process. Specifically, preventive and corrective maintenance being applied to the breakers has not identified the adverse trend of moisture build up in the bushings as a problem that requires corrective action.

PCB 24B breaker was the preferred breaker in the recloser scheme. The scheme is designed such that on an initial fault signal, both breakers (i.e., PCB 24A and B) open, then after a predetermined time delay, the preferred breaker will close. The non-preferred breaker will not attempt to close. If the fault conditions still exist, the preferred breaker will open again. After a predetermined time, the preferred breaker will close. If the fault conditions still exist, the preferred breaker will open and remain open (i.e., lockout).

- PCB 24B degraded bushing has been replaced and the breaker restored to service.
- Leak checks of site PCBs will be performed and a plan developed to correct identified deficiencies based on leak detection results by December 15, 2004.
- Preventive and corrective maintenance processes will be revised as needed to establish adequate measures for identifying and trending moisture intrusion into PCBs and ensure needed corrective actions to resolve identified moisture intrusion related deficiencies are identified within the corrective action program for timely resolution.
- The breaker scheme on both units has been aligned such that the SAT is connected to the non-preferred bus.
- Applicable plant procedures will be revised to reflect the preferred breaker scheme for SAT alignment.
