Subject: Brunswick Steam Electric Plant, Unit Nos. 1 and 2
Docket Nos. 50-325 and 50-324/License Nos. DPR-71 and DPR-62
Licensee Event Report 1-2004-003

LICENSEE EVENT REPORT (LER)

4. TITLE
Operation Prohibited by Technical Specifications due to Inoperable Emergency Diesel Generator

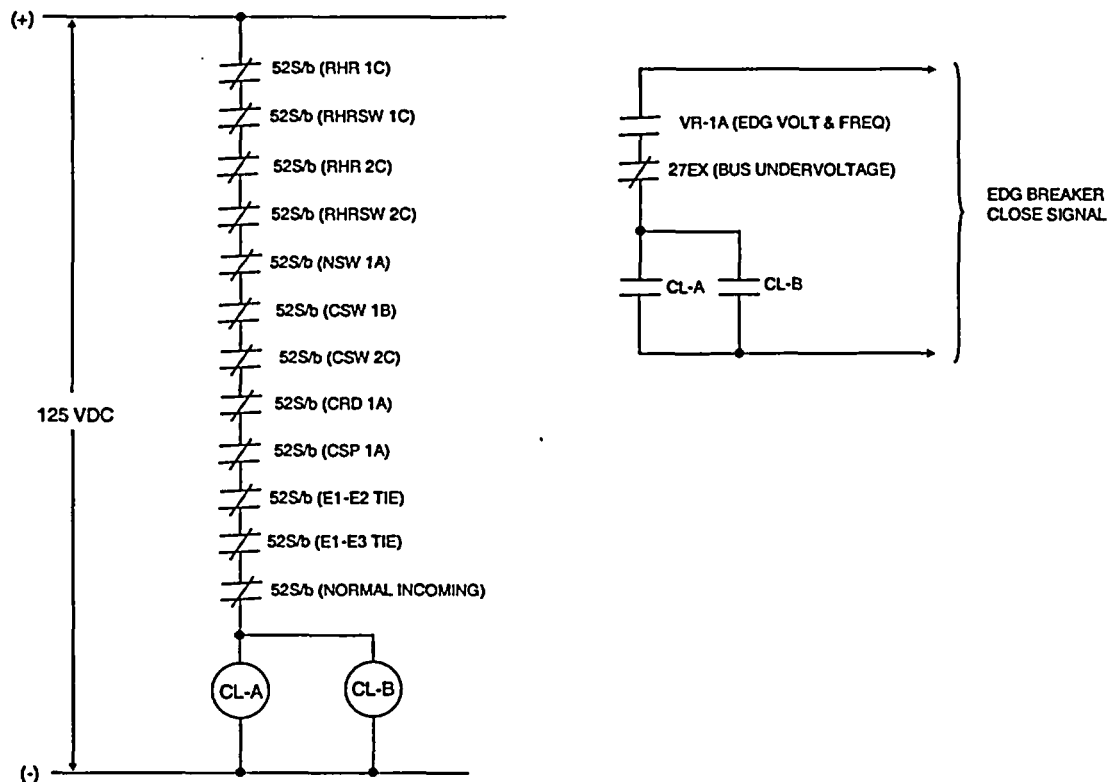
Trouble-shooting activities revealed that the dust cover for relay 1-E1-AE7-CL-B (i.e., subsequently referred to as CL-B), a General Electric model HGA surface mount relay, was found to be mispositioned. The base of the cover was pushed into the relay base, causing its armature to be picked up and the EDG load shed contact to be closed. The cover had been modified to provide room for required wiring; however,

The following provides a simplified schematic diagram of the emergency bus E1 control logic associated with the CL-B relay.

The CL-A and CL-B relays energize when all rotating load (i.e., motor) breakers on the 4.16 kV emergency bus, as well as the bus normal incoming power breaker and both emergency bus tie breakers are open. The relay output contacts are wired in the EDG output breaker control logic. Normally-open contacts from the two relays are wired in parallel with each other and then in series with the bus undervoltage signal (i.e., relay 27EX) and the EDG voltage and frequency permissive (i.e., relay VR-1A) to provide a close signal to the EDG output breaker. During the August 14, 2004, event the EDG was started by the loss of the SAT. Therefore, the EDG was at rated voltage and frequency prior to losing power to the emergency bus via the UAT. This satisfied the voltage and frequency close permissive for the EDG output breaker. As discussed above, the mispositioned cover on the CL-B relay, which verifies all loads are stripped, resulted in the relay

being maintained in the operated position. This prematurely satisfied the load shed close permissive for the EDG output breaker. Upon emergency bus E1 receiving an undervoltage condition, the 27EX relay provided the last permissive to close the EDG output breaker.

There are two root causes associated with this event. First, the relay was inadvertently struck or pushed causing the relay to become held in the operated state. Second, the relay cover sides were modified by cutting them back to a maximum extent which made the cover more susceptible to being mispositioned if struck. Both root causes were required to be present in order to cause EDG No. 1 to become inoperable.

1. Engineering Change (EC) 58696 was written and approved to allow HGA surface mounted relay covers to be removed. The relay covers were removed from relays 1-E1-AE7-CL-A and 1-E1-AE7-CL-B. EC 58696 also demonstrated that modified covers do not present a seismic / operability concern.

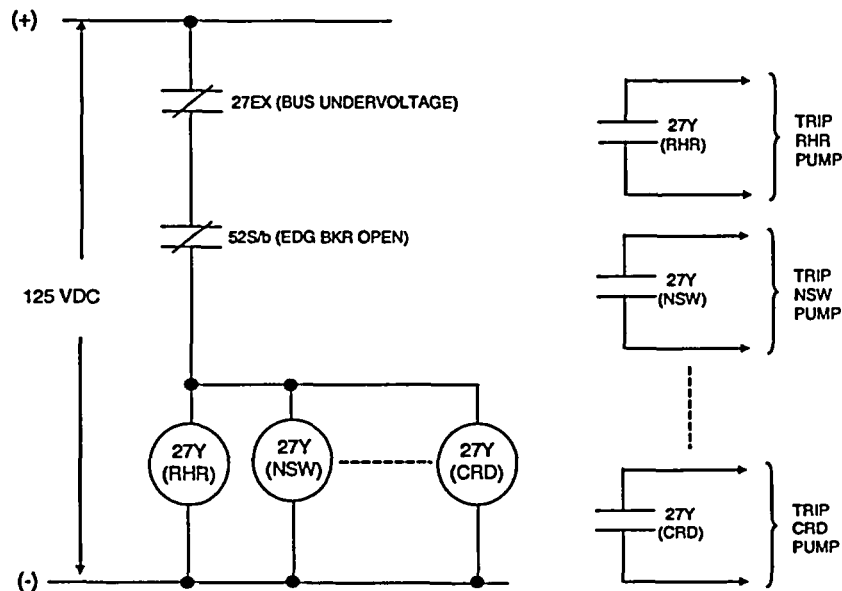
In addition to providing the EDG breaker close permissive, the loss of voltage relay 27EX concurrently initiates a load shed signal to all rotating loads on the emergency bus via auxiliary relays 27Y (i.e., one relay per motor load), as shown in the following diagram.

Closing of the EDG breaker interrupted the load shed signal and prevented the load shed. When the EDG breaker began to close, the 52S/b contact in series with the 27Y relays opened faster than required for the relays to pickup and trip the motor breakers.
