Point Beach Nuclear Plant Unit 2
Docket 50-301
License No. DPR 27

Response to Request for Additional Information; Unit 2 Fall 2003 (U2R26)
Steam Generator Eddy Current Examinations (TAC No. MC2070)

RESPONSE TO REQUEST FOR ADDITIONAL INFORMATION POINT BEACH NUCLEAR PLANT UNIT 2 FALL 2003 (U2R26) STEAM GENERATOR EDDY CURRENT EXAMINATIONS

**STEAM GENERATOR TUBESHEET MAP AND SCHEMATIC
POINT BEACH NUCLEAR PLANT UNIT 2**

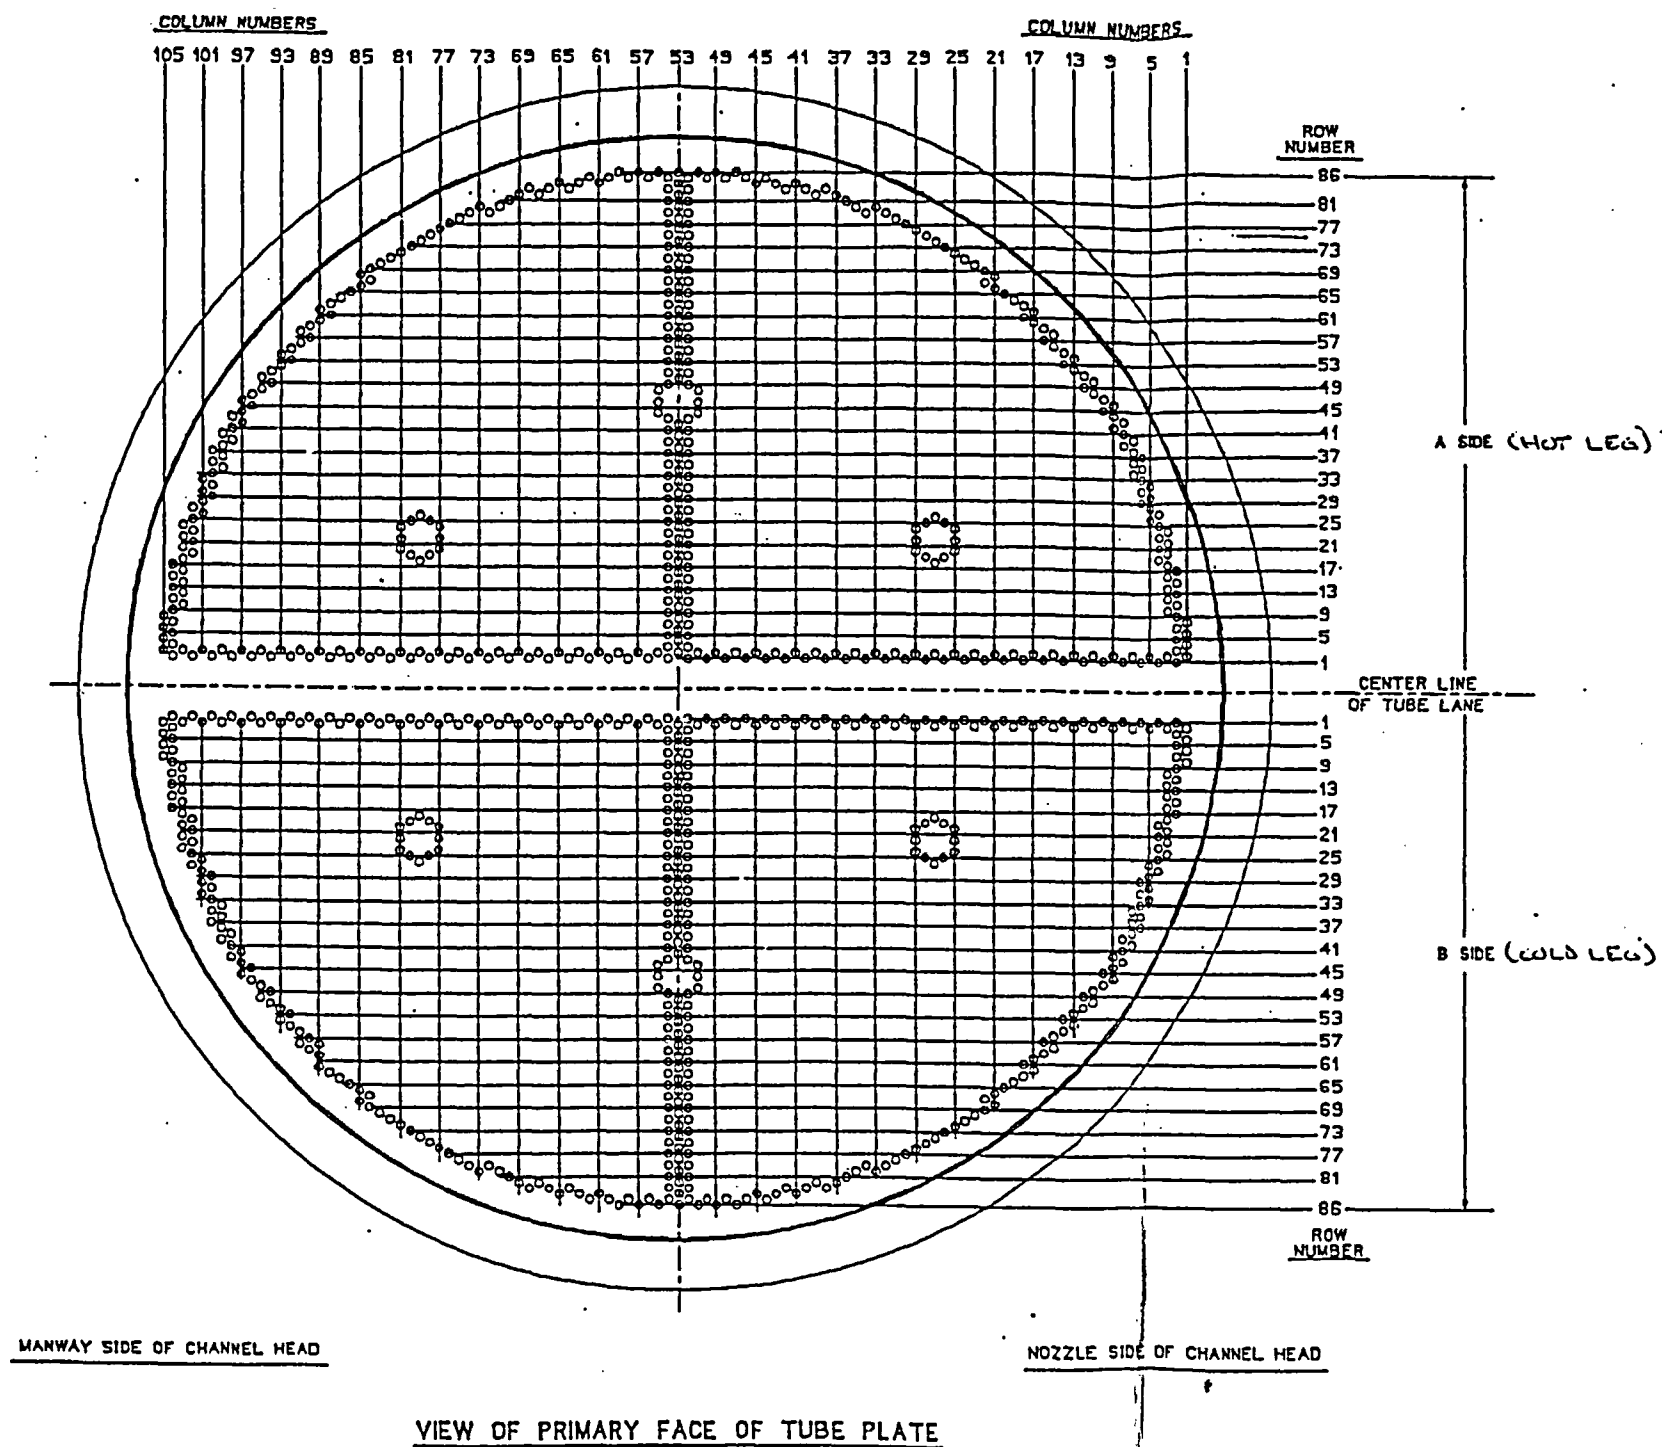
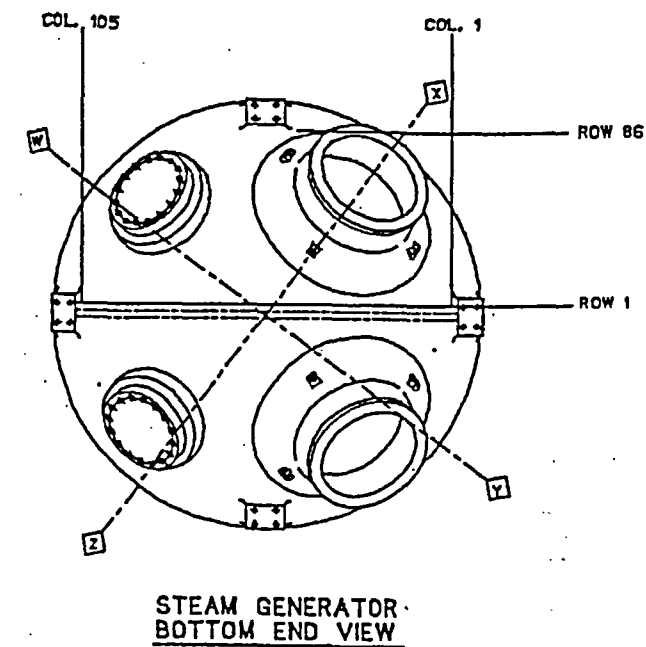
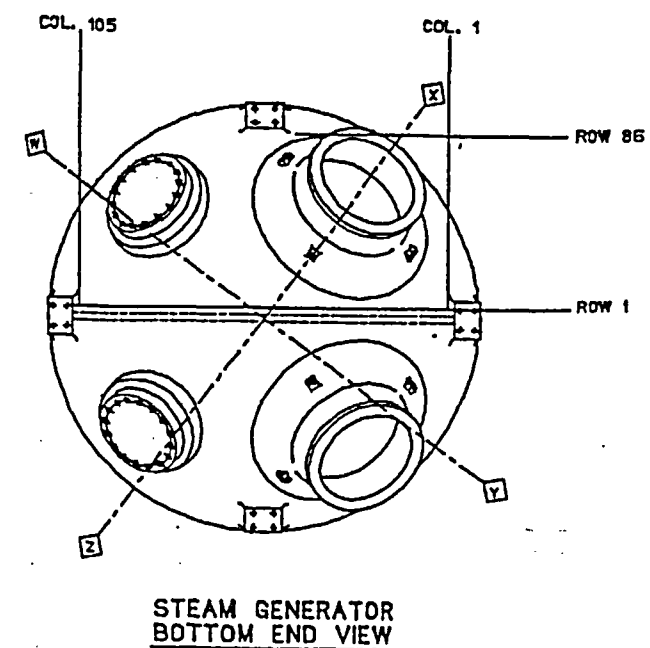
STEAM GENERATOR 24X-1B
Figure 5-10B — Tube Plugging Record
Shop Order 12173
Page 1 of 1

PLUGGED IN 1998 AS A RESULT OF LOOSE PARTS WEAR
@ PLUGGED IN 2003 DUE TO EXCESSIVE TUBE NOISE
