Crystal River Nuclear Plant
Docket No. 50-302
Operating License No. DPR-72

Subject: LICENSEE EVENT REPORT 50-302/2004-003-00

4. TITLE
Reactor Trip And Emergency Feedwater Actuation Caused By 230 Kilovolt Switchyard/Transmission Faults

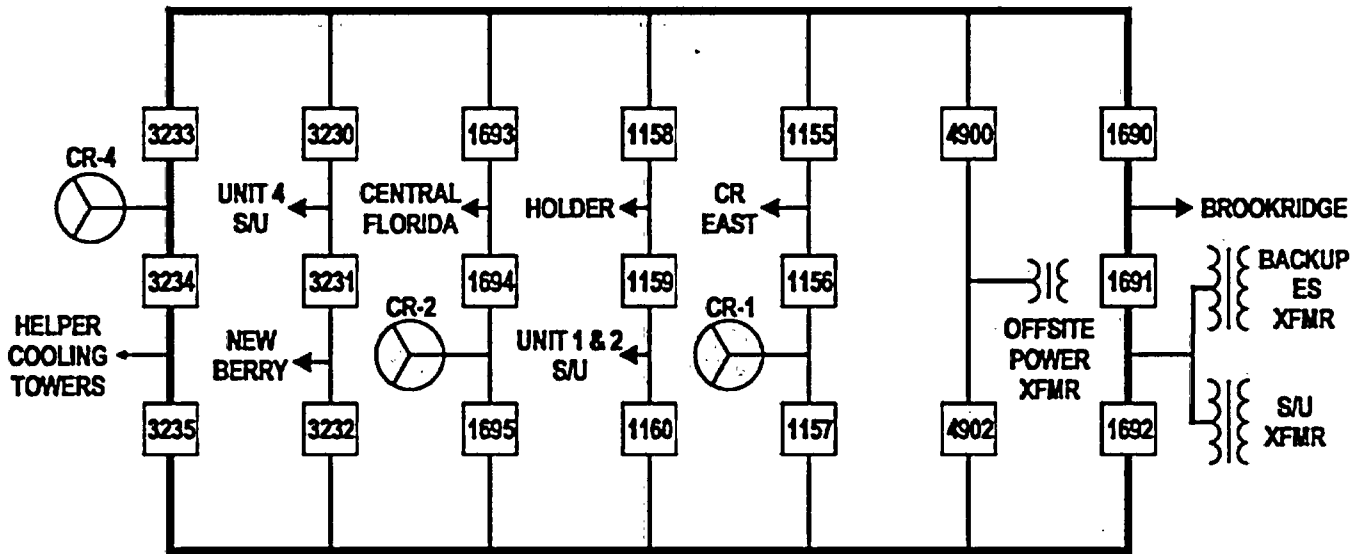
FIGURE 1

At 11:02 on September 6, 2004, a fault on the 230 kilovolt (kV) Brookridge transmission line [FK, CBL] resulted in the opening of Breakers 1690 and 1691 (see Figure 1) [FK, BKR]. Mechanical failure of an insulator string [FK, INS] resulted in a phase-to-ground fault when the transmission line dropped into the metal transmission tower [FK, TWR]. That transmission tower is located along the transmission corridor approximately two miles from the CR-3 switchyard. This removed one of the sources of power to the BEST and Startup transformer [EB, XFMR].

At 11:51, on September 6, 2004, a fault on the 230 kV switchyard south bus [FK, BU] resulted in the opening of Breaker 1692 (see Figure 1). A phase-to-ground fault on Breaker 3232 resulted in actuation of the primary and backup bus differential relaying schemes [FK, 87] resulting in the tripping of Breakers 3235, 3232, 3231, 1695, 1160, 1157, 4902 and 1692. This removed the remaining source of power to the BEST and Startup transformer. Improved Technical Specification (ITS) 3.8.1, Condition A, was entered for loss of the BEST.

The cause for loss of the 230 kV Brookridge transmission line was mechanical failure of a vertical string of insulators on the "A" phase due to diameter loss and consequent failure of one of the carbon steel pins connecting the insulators to one another. The porcelain "ball and socket" insulators were stamped "LAPP 20000 1968," indicating that they were manufactured by the Lapp Insulator Company and were 1968 vintage. The diameter loss was caused by possible leakage current which led to spark erosion and severe electrochemical corrosion of the carbon steel pin. Corrosion/erosion reduced the cross section of the carbon steel pin sufficiently to result in tensile overload. The passing of Tropical Storm Frances resulted in tropical storm force winds that placed additional stress on the carbon steel pin. A phase-to-ground fault occurred when the "A" phase transmission line dropped and came in contact with the metal transmission tower.

The tripping of the 230 kV switchyard south bus was due to a flashover ("B" phase-to-ground) on breaker 3232 due to contamination from wind and salt spray from the passing of Tropical Storm Frances. The bus differential relaying schemes functioned as designed based on the fault condition of the breaker and isolated the fault by opening breakers 3235, 3232, 3231, 1695, 1160, 1157, 4902 and 1692. Since the relaying functioned as designed to protect the adjacent equipment from the fault and the fault occurred as a result of Tropical Storm Frances, there were no inappropriate acts or equipment failures. Therefore, there is no corrective action to prevent recurrence of this condition.

1. CR-3 Administrative Instruction AI-704, "Reactor Trip Review and Analysis," was performed.
2. The failed vertical string of insulators was replaced. Vertical and "V" string insulators on the 230 kV Brookridge transmission line towers located along the transmission corridor adjacent to the CR-3 access road were inspected. Thirteen additional vertical strings of insulators were subsequently replaced on the 230 kV Brookridge transmission line.
3. A 230 kV switchyard south bus reenergization plan was created and implemented. The primary purpose of this plan was to reveal internal breaker faults prior to bus restoration. No internal breaker faults were identified. The 230 kV switchyard south bus breakers were closed and the 230 kV switchyard south bus was restored on September 7, 2004.

4. Breaker 3232 was evaluated. Physical evidence was found to confirm that a flashover had occurred from the "B" phase to ground. A series of tests were performed on the breaker with results being acceptable. In addition, an internal inspection was performed on the "B" phase of the breaker with results being acceptable. A complete hot wash was performed on insulators and breakers on the 230 kV switchyard south bus prior to CR-3 restart. A visual inspection of other sections of the 230 kV switchyard buses was also performed. The determination was made that additional hot washing was not required.
