OCAN100403

October 28, 2004

SUBJECT: Response to Generic Letter 2004-01, Requirements for Steam Generator
Tube Inspections
Plant Name Arkansas Nuclear One, Units 1 and 2
Docket Nos. 50-313 and 50-368
License No. DPR-51 and NPF-6

Response to Generic Letter 2004-01 for ANO-1 and ANO-2

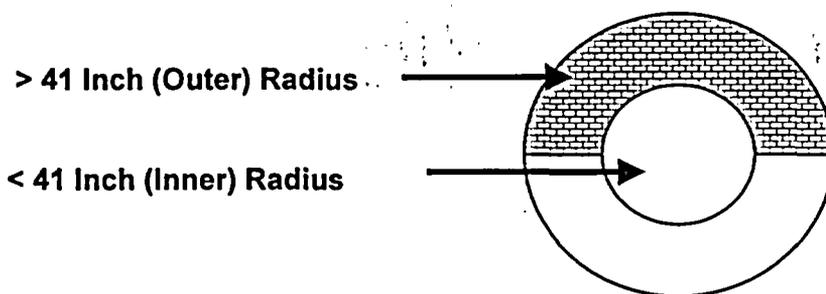
- 50% (100% of one half of the SG) of the tubes in the outer periphery (radius > 41 inches)
- 20% of the tubes in the inner section (radius < 41 inches)

No cracking was identified in the inner section (radius < 41 inches) but four circumferential indications were identified in the 50% sample in the "B" steam generator. The following table lists the indications:

Row	Tube	Arc	Depth (in.)	Radius	Assigned Leakage (gpm)
115	4	0.19	50	55.36	0.000823
125	2	0.24	72	56.39	0.00137
136	78	0.20	97	55.82	0.000823
137	75	0.21	97	55.69	0.000823
