**CROW BUTTE MINE
DAWES COUNTY, NEBRASKA**

2004 POND INSPECTION REPORT

By: David V. Coe, PE
Nebraska Registration No. E - 4295

October 27, 2004

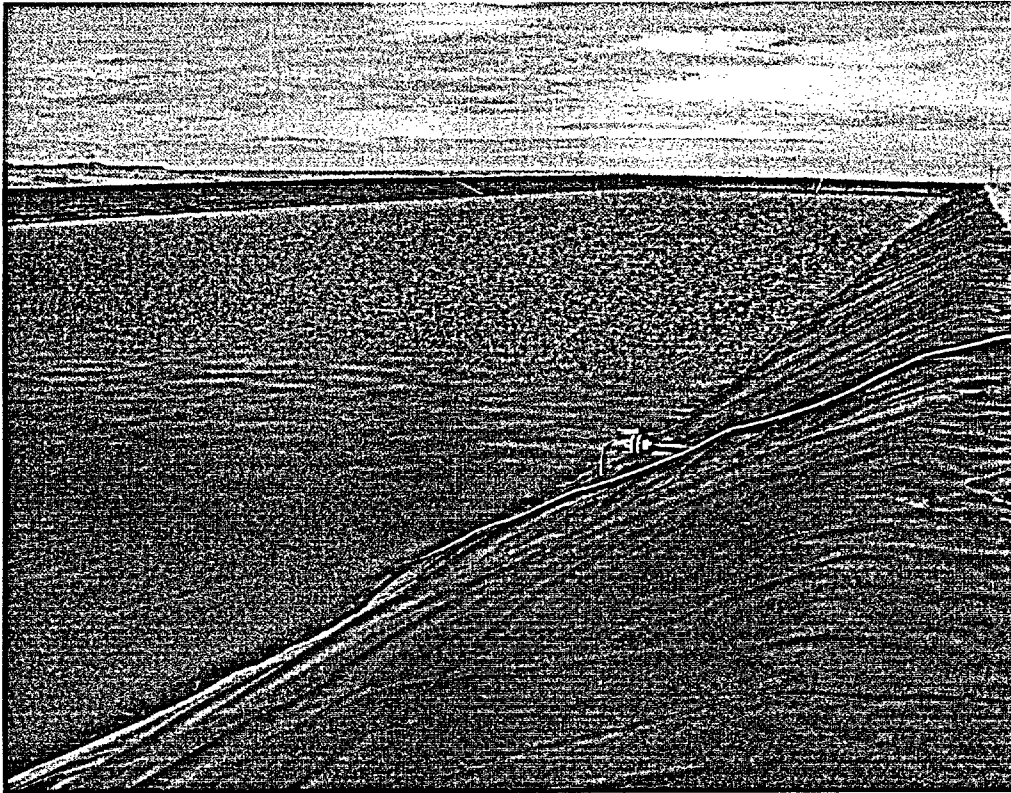
Northwest view of evaporation pond #1, date: 10/19/04

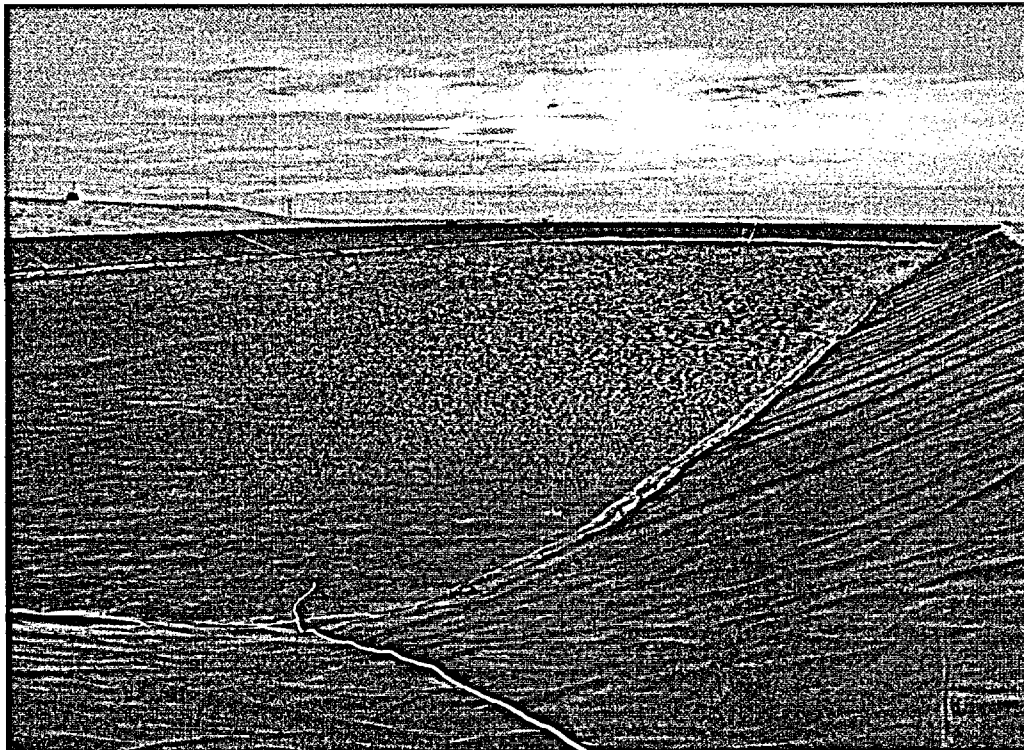
Northwest view of pond #3. Date: 10/19/04

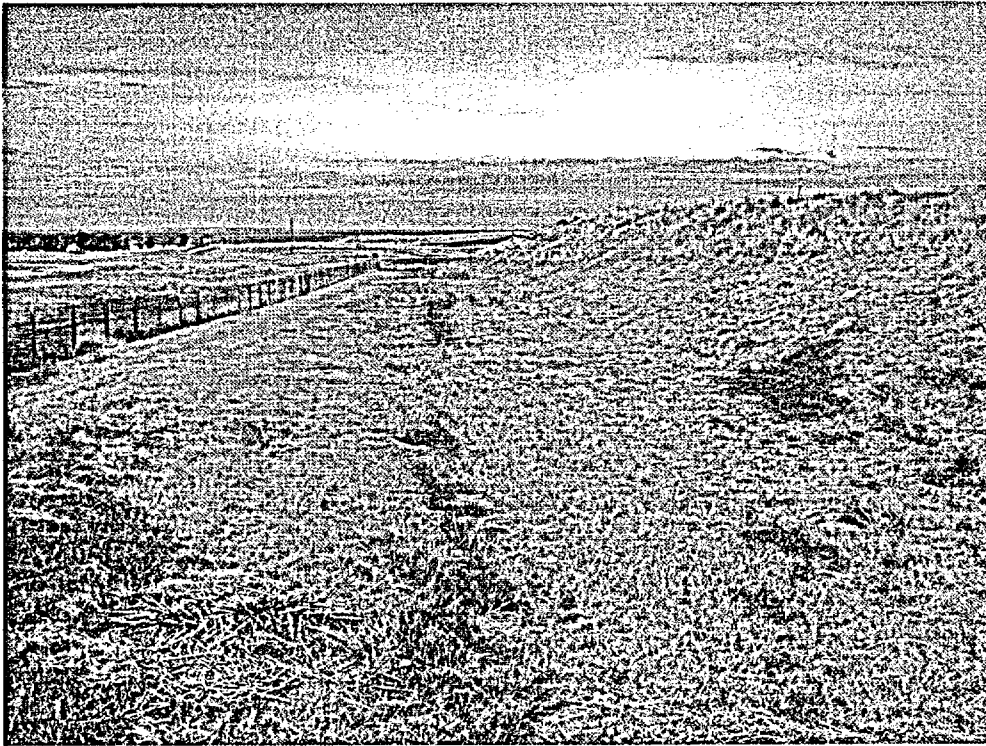
North view of west embankment of pond #3. Date: 10/19/04

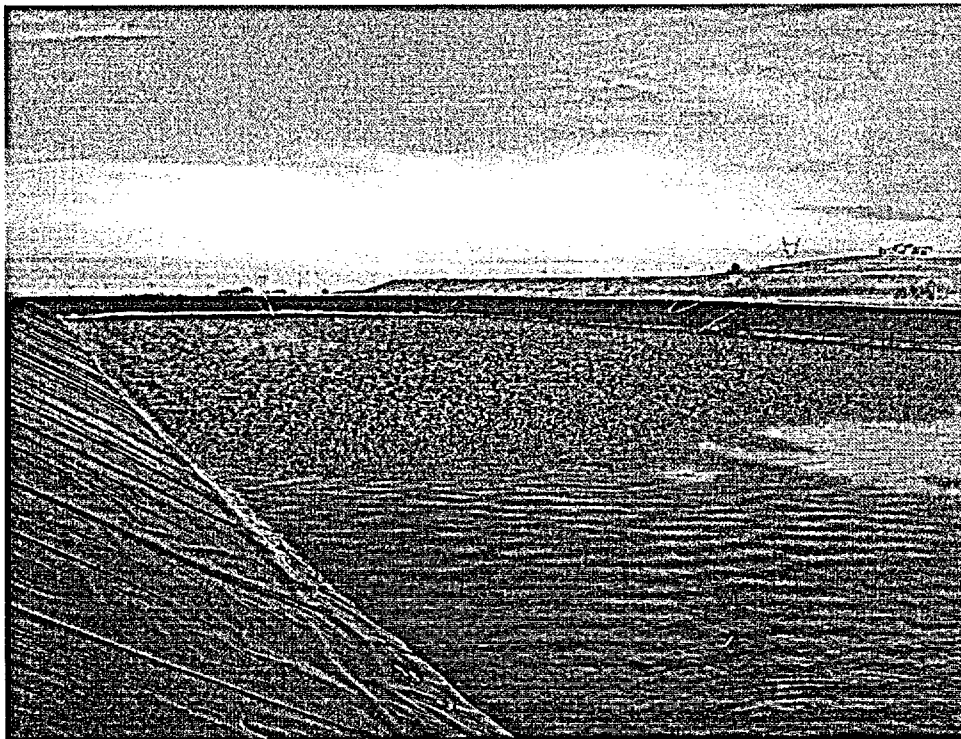
Northeast view of pond #4. Date: 10/19/04

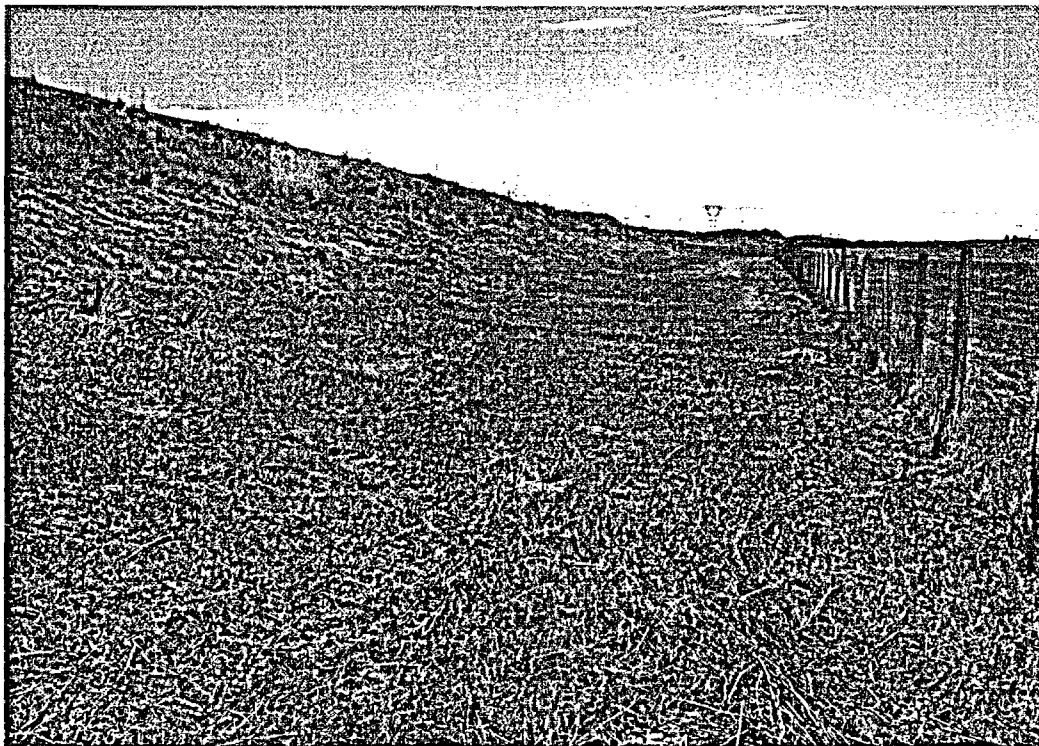
West embankment of Pond #4, dated: 10/19/04

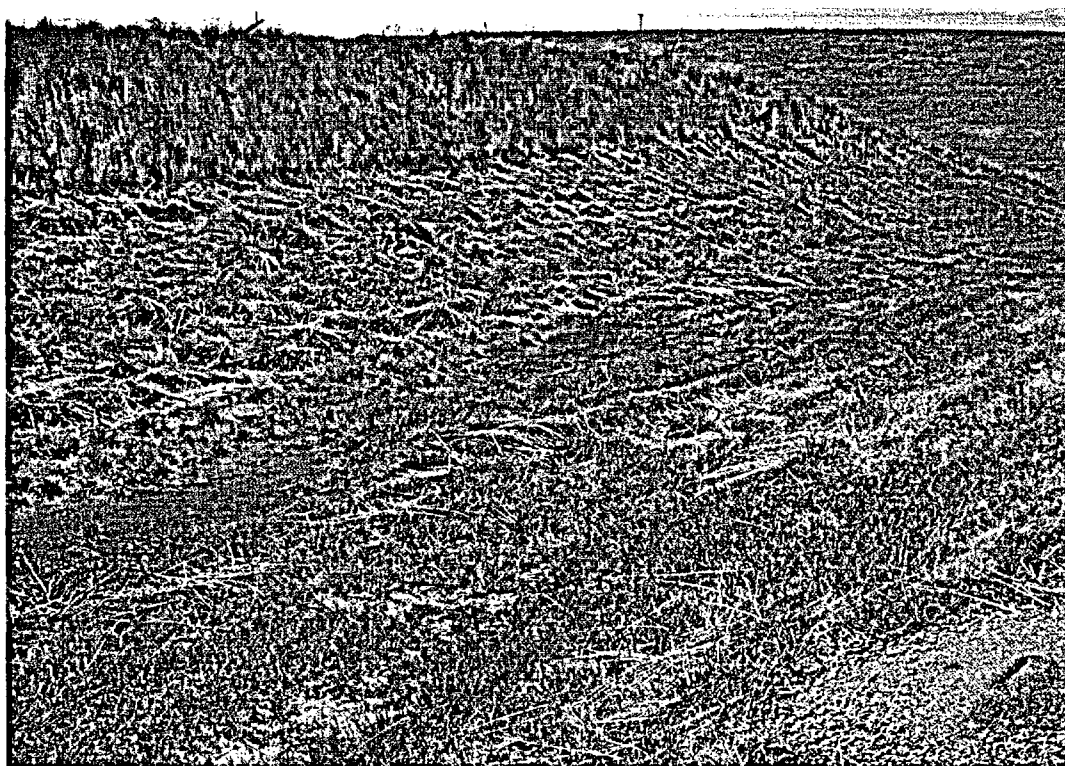
There was water collecting in the diversion ditch between ponds 3 & 4. This is probably a result of the recent rains. The same condition of water collecting near the toe of the embankment slope was observed in 2003 inspection. I believe the diversion ditch has a high point near the west end which prevents the water in the ditch to drain to the west. With the standing water in the ditch line; it is difficult to determine if there is a significant drainage problem with the toe of the pond embankment slope. I did not notice any running water in the ditch line.

Damp area in roadway between ponds #3 & #4. Damp area was in line with wheel way of vehicle traffic. Date: 10/19/04

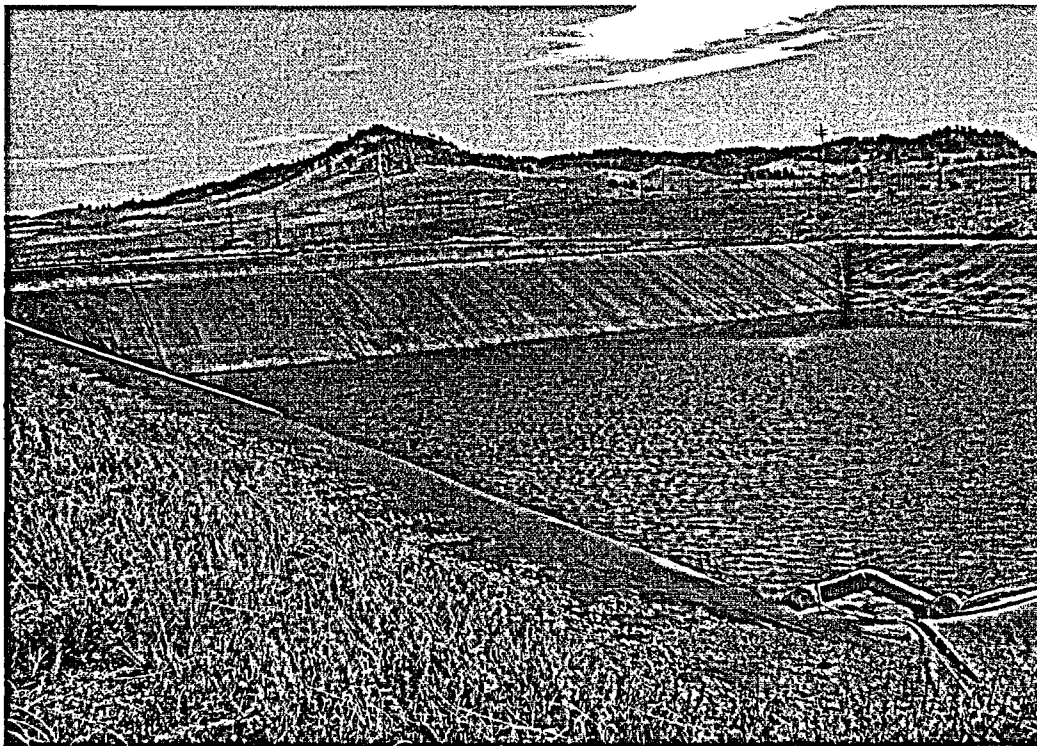
Southeast view of Cell #1 (west) of R & D Ponds. 10/19/04

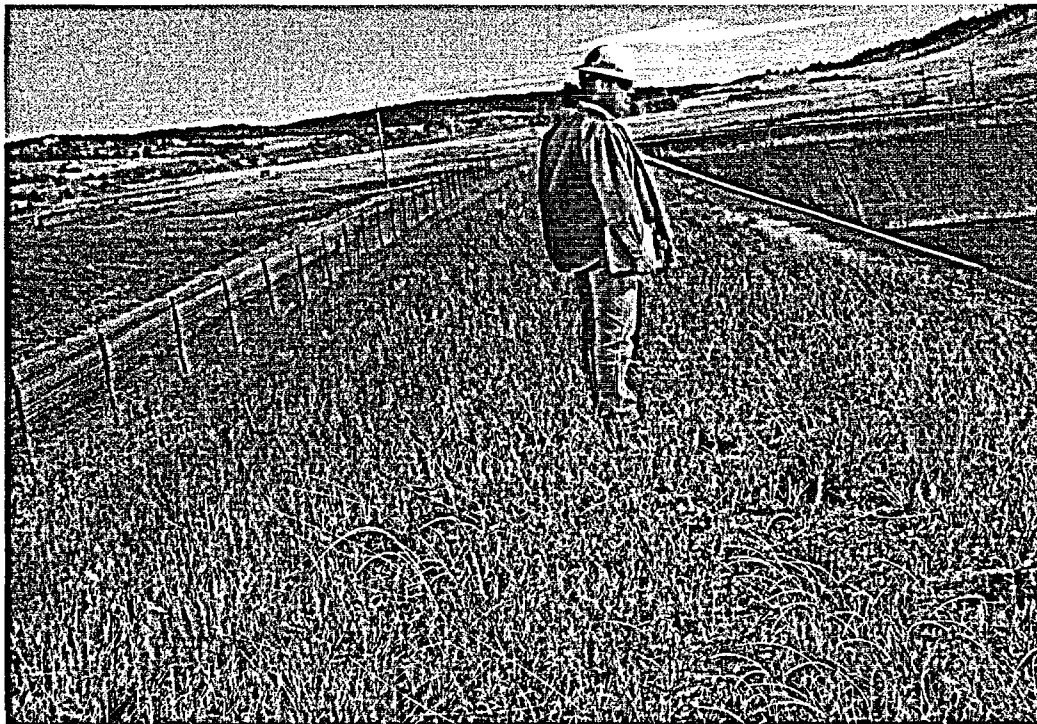
**East view of north embankment of R&D ponds. Excellent vegetative cover.
Date: 10/19/04**

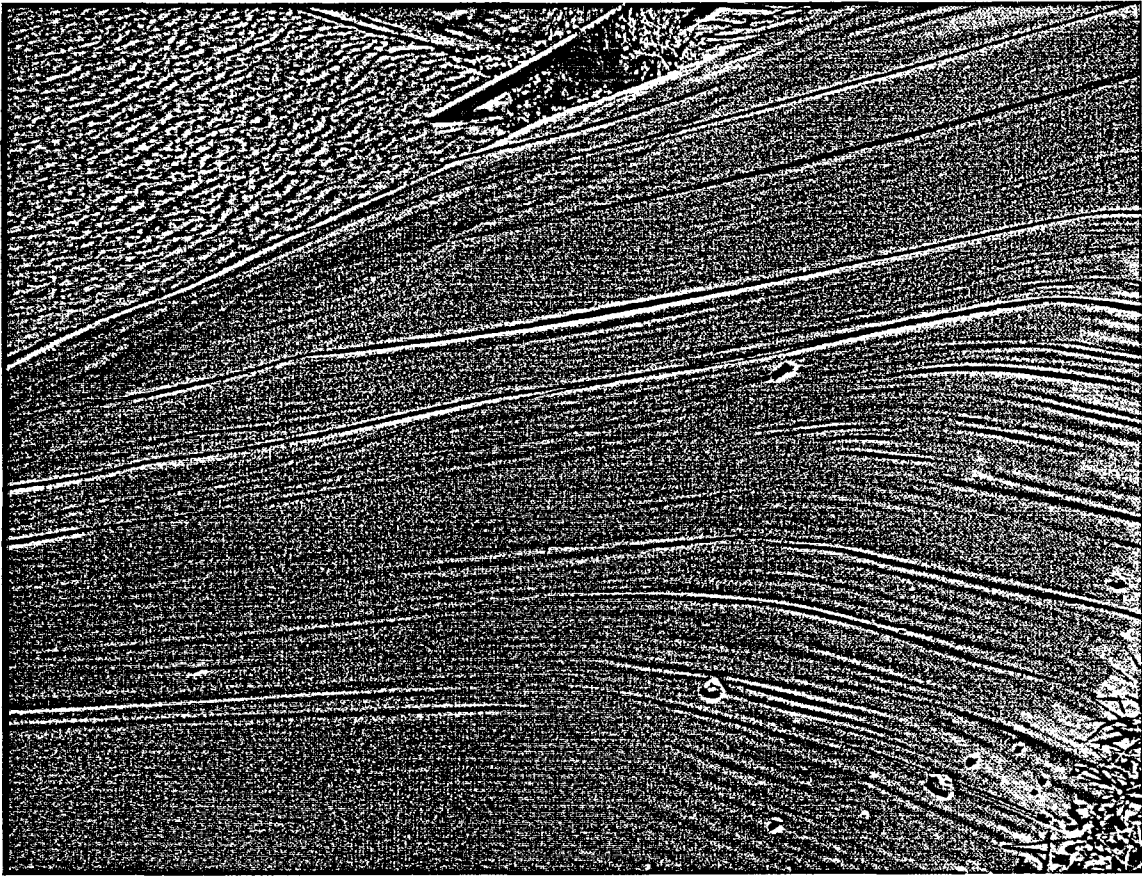
I noticed two puncher holes in the west cell pond liner. The holes were near the top of the pond embankment.

Two puncture holes in liner in Cell #1 (West): Date: 10/19/04
