**YUCCA MOUNTAIN**  
**April 1, 2004, Field Trip Report to**  
**Alcove 8 – Niche 3 Areas**

By M. (Sam) Nalluswami and Jack Parrott

U. S. Nuclear Regulatory Commission  
Washington, DC

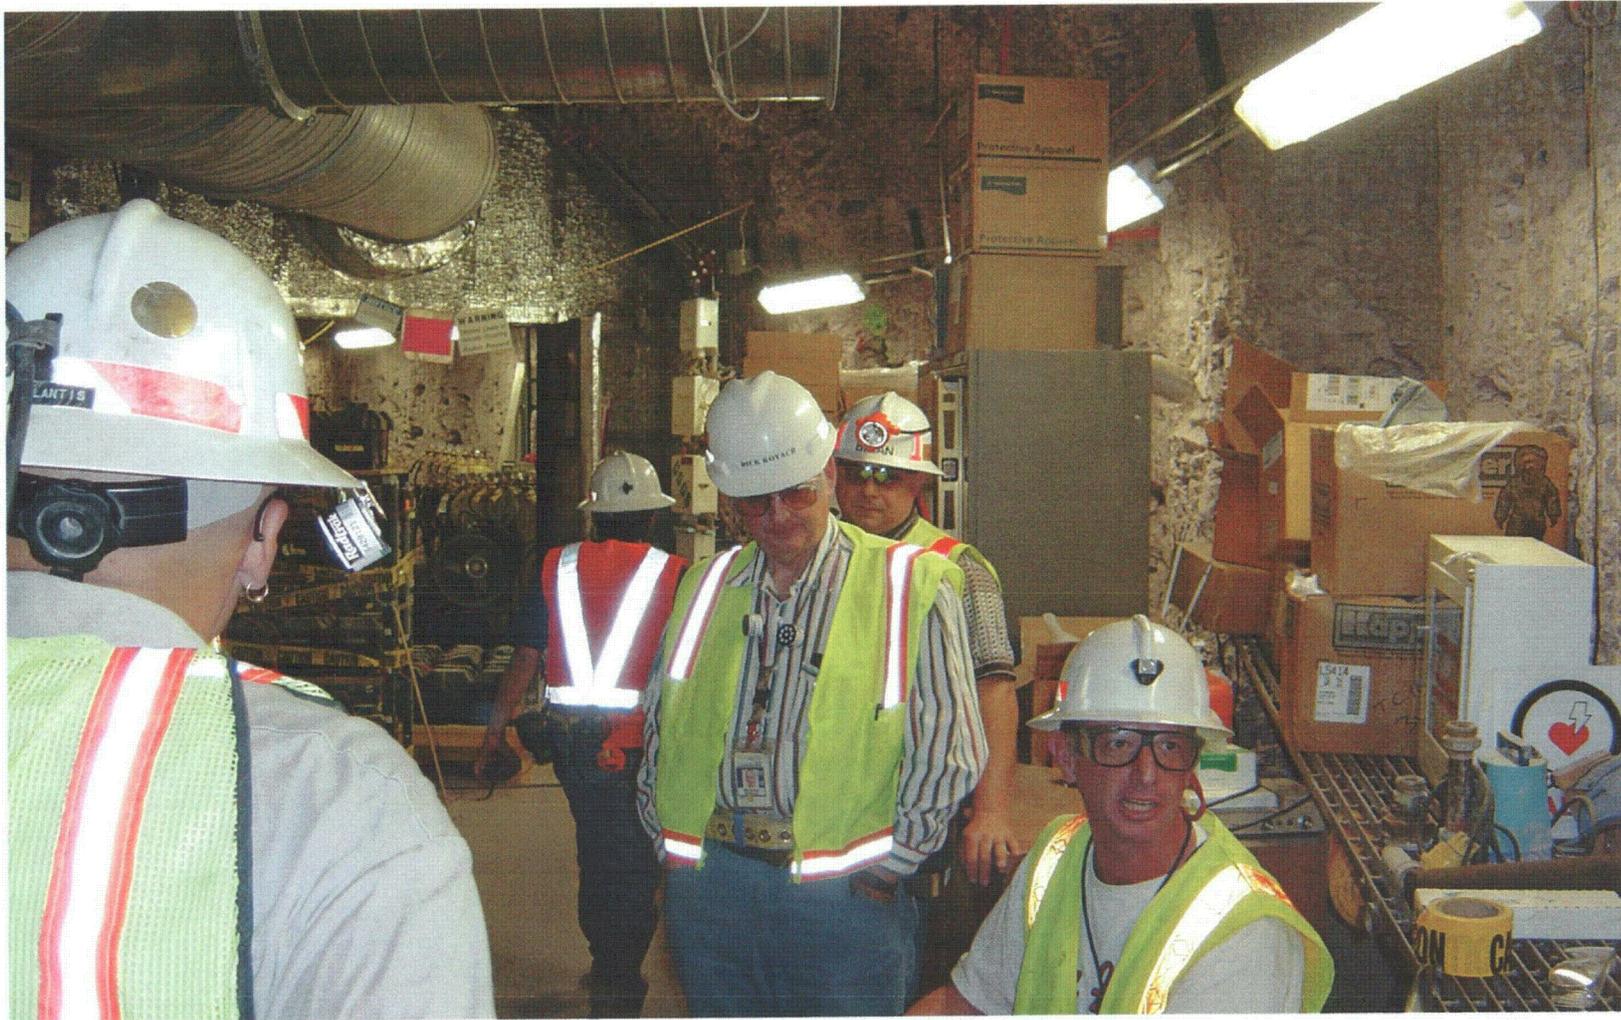
# Area in Front of Alcove 8 Test Area (4\_5\_04 018.jpg)

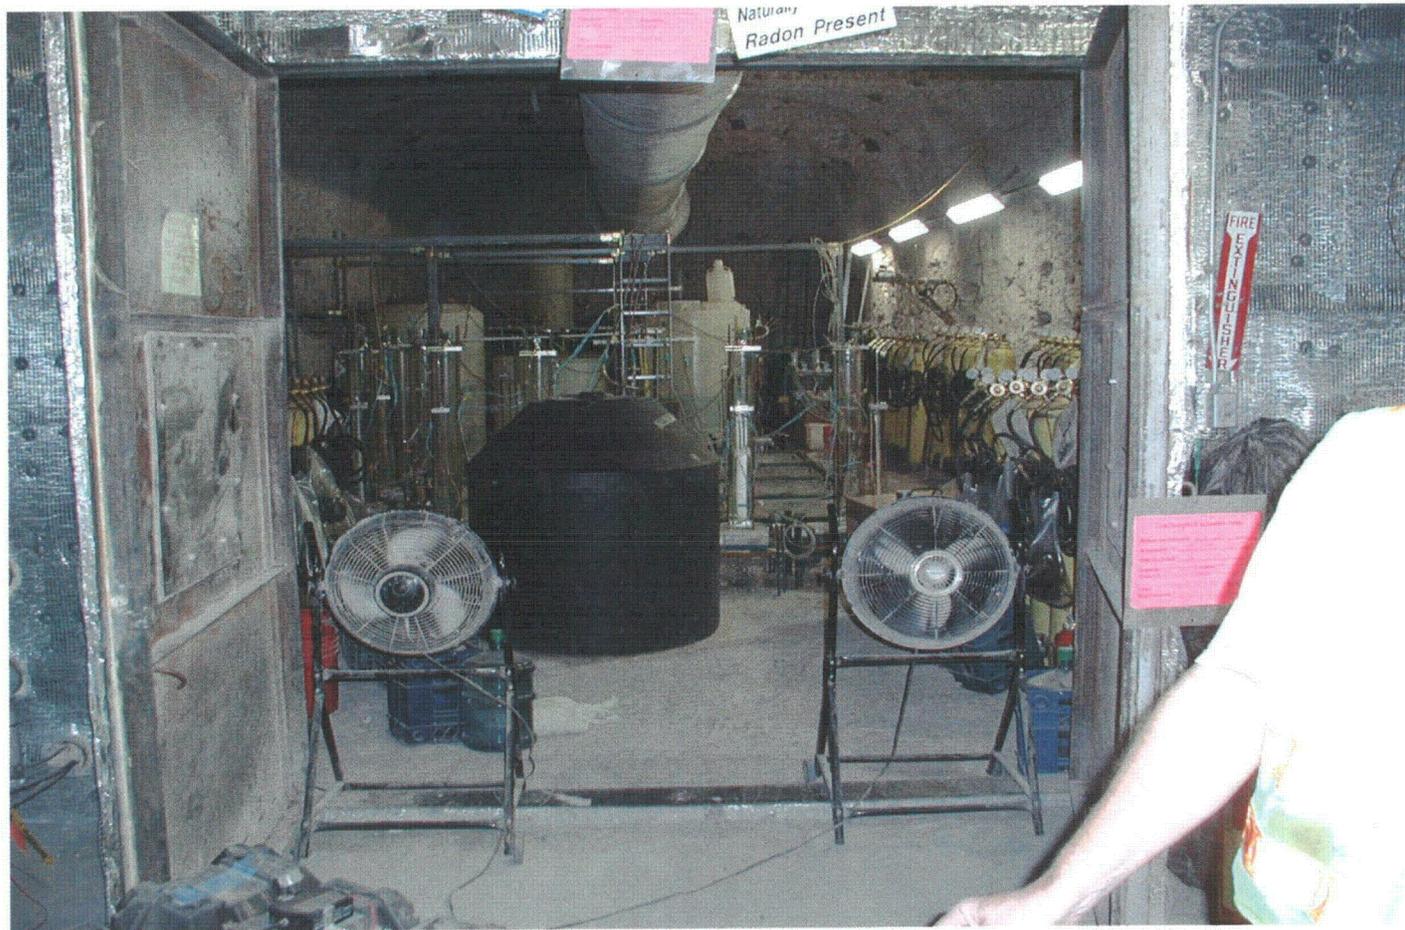
# Entrance to Alcove 8, ECRB (P4010011.jpg)

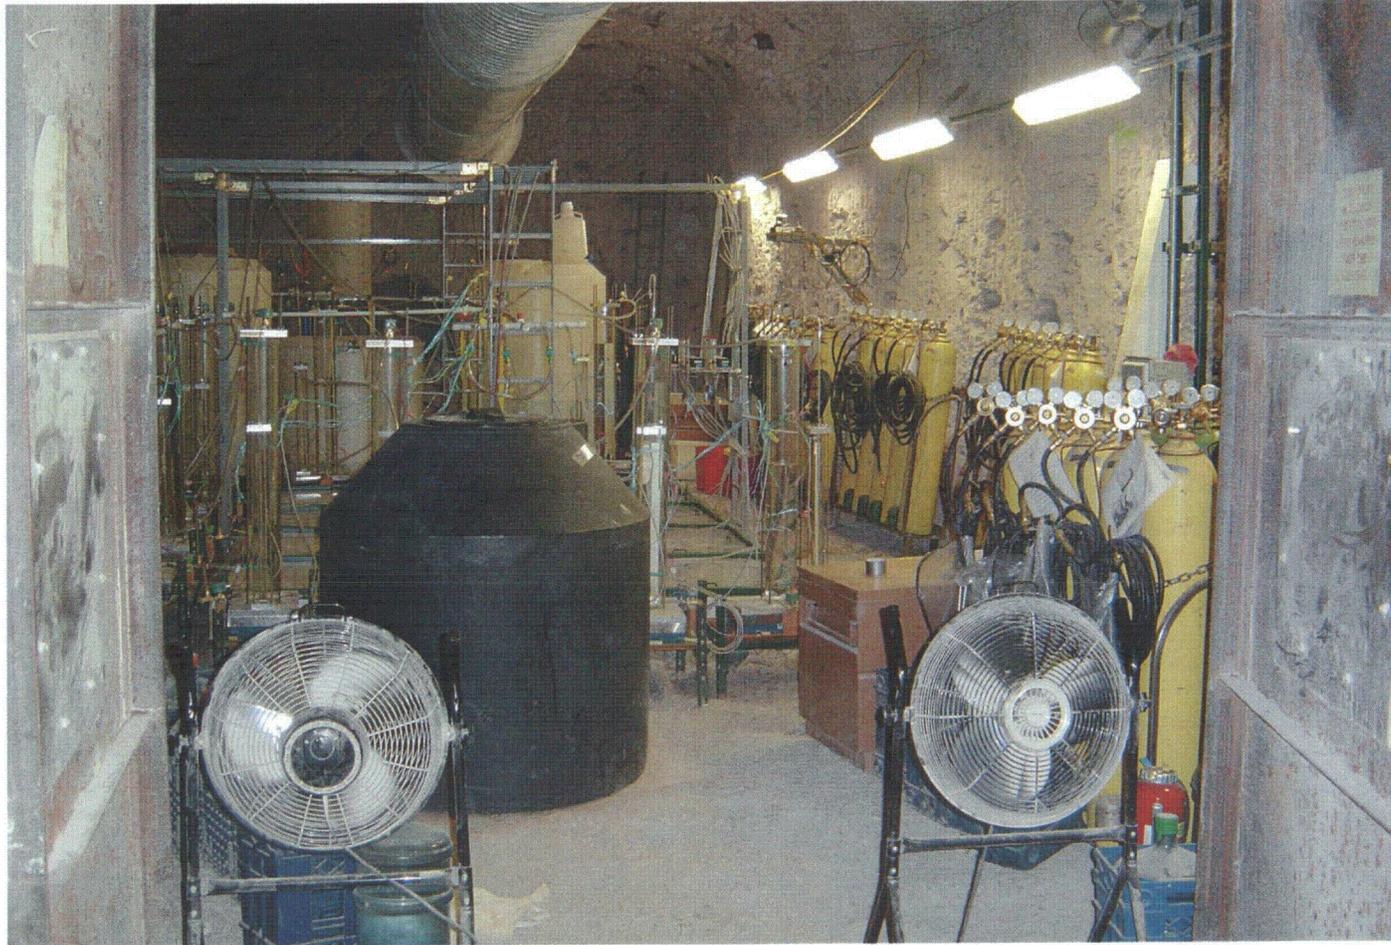
# View into Alcove 8 Test Area (4\_5\_04 019.jpg)

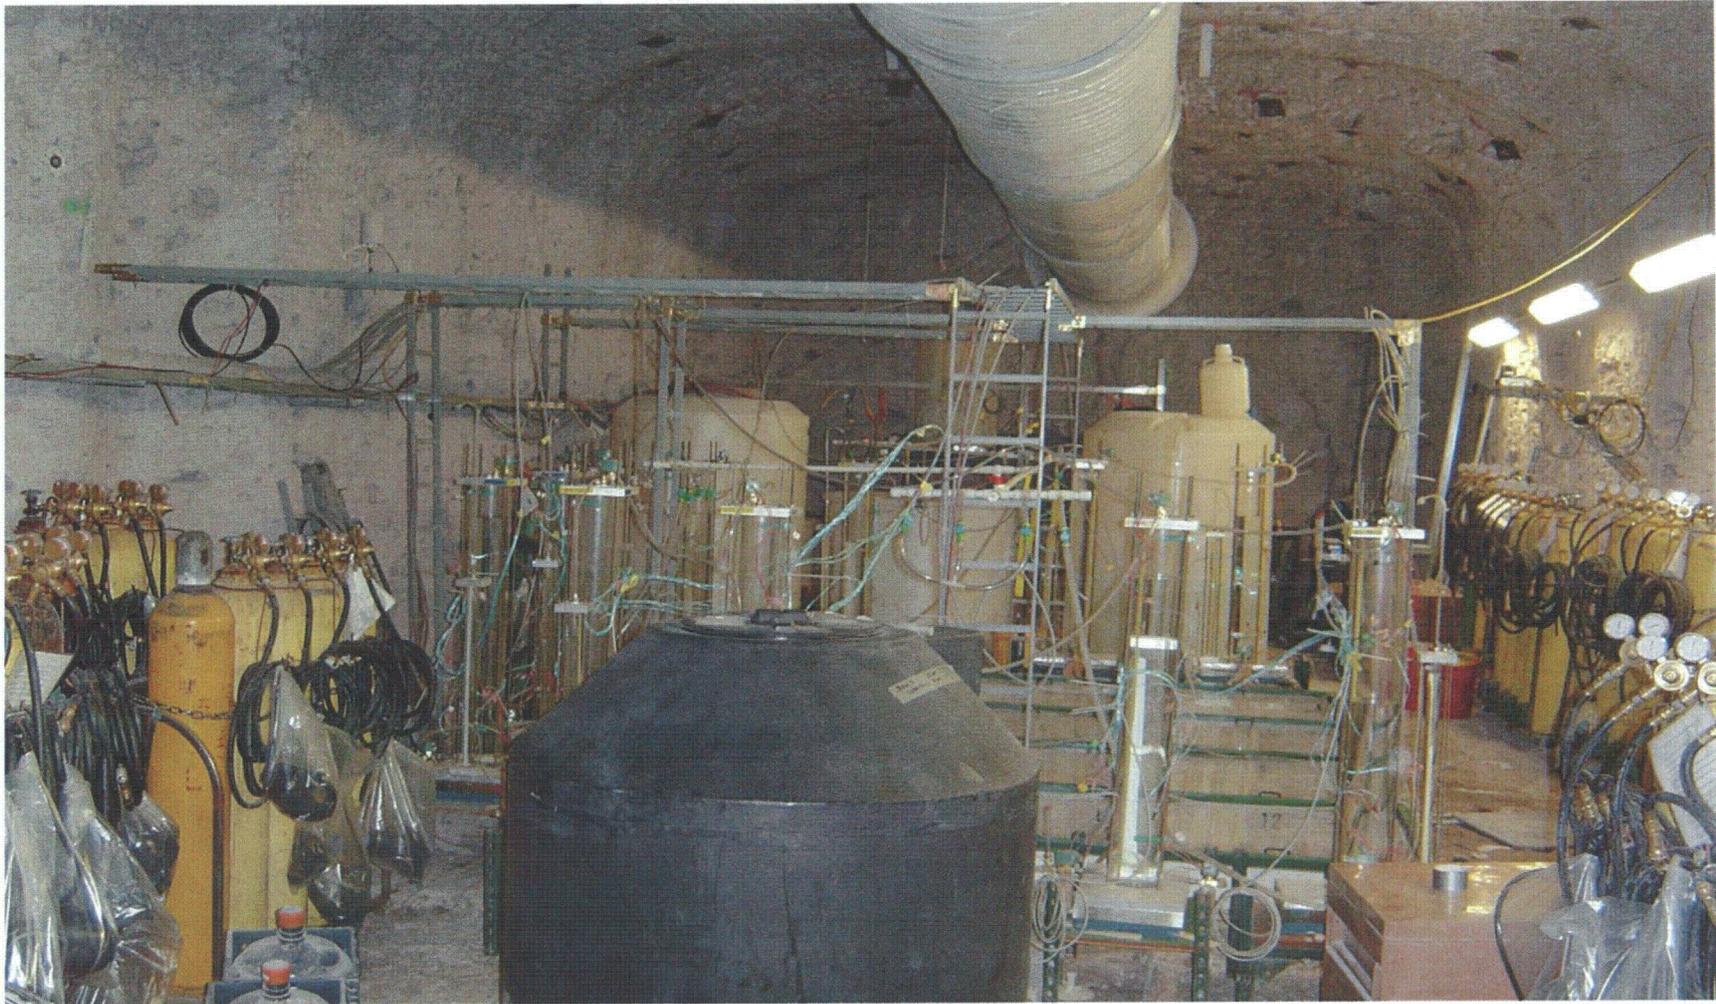
# View into Alcove 8 Test Area (4\_5\_04 020.jpg)

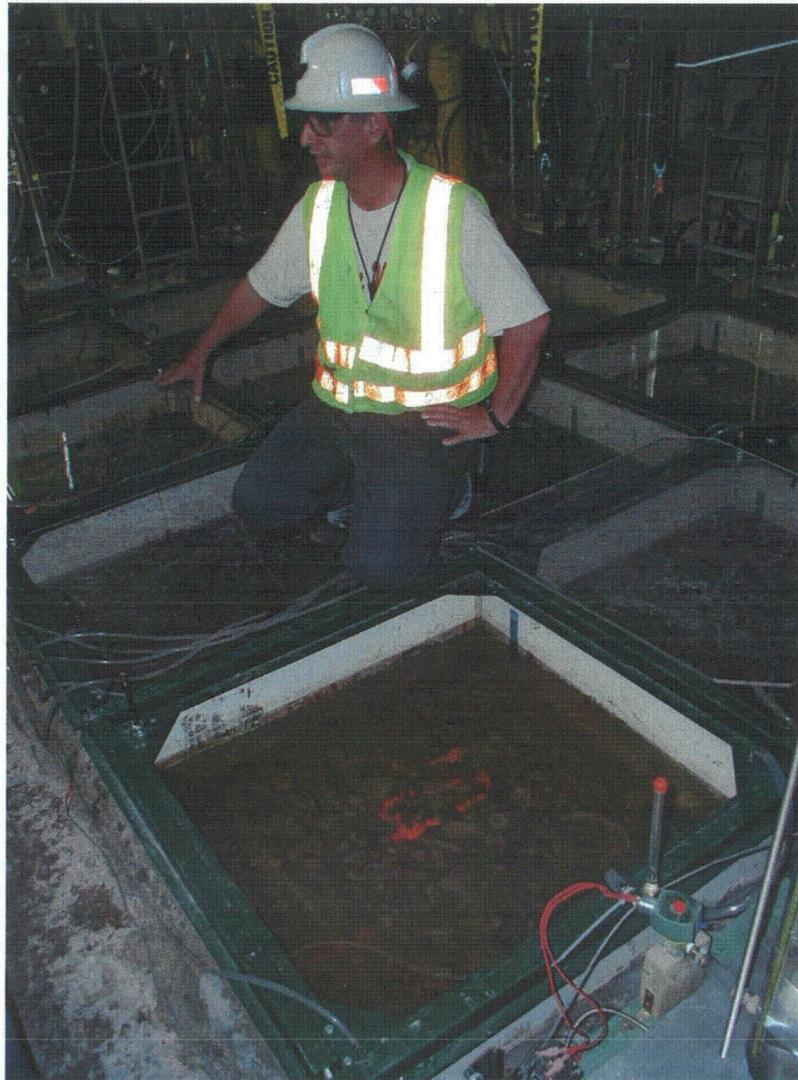
# Seepage Plot in Alcove 8, Dave Hudson, USGS (P4010012.jpg)

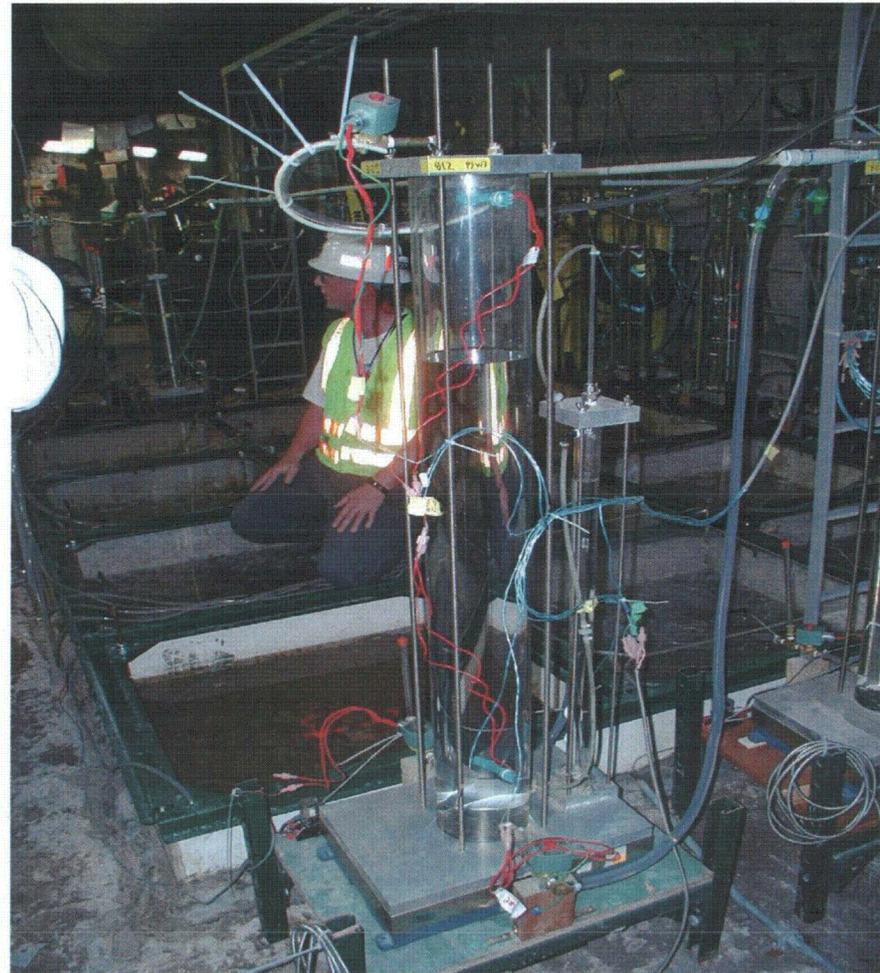
# Infiltration Water Apparatus in Alcove 8, Dave Hudson, USGS (P4010013.jpg)

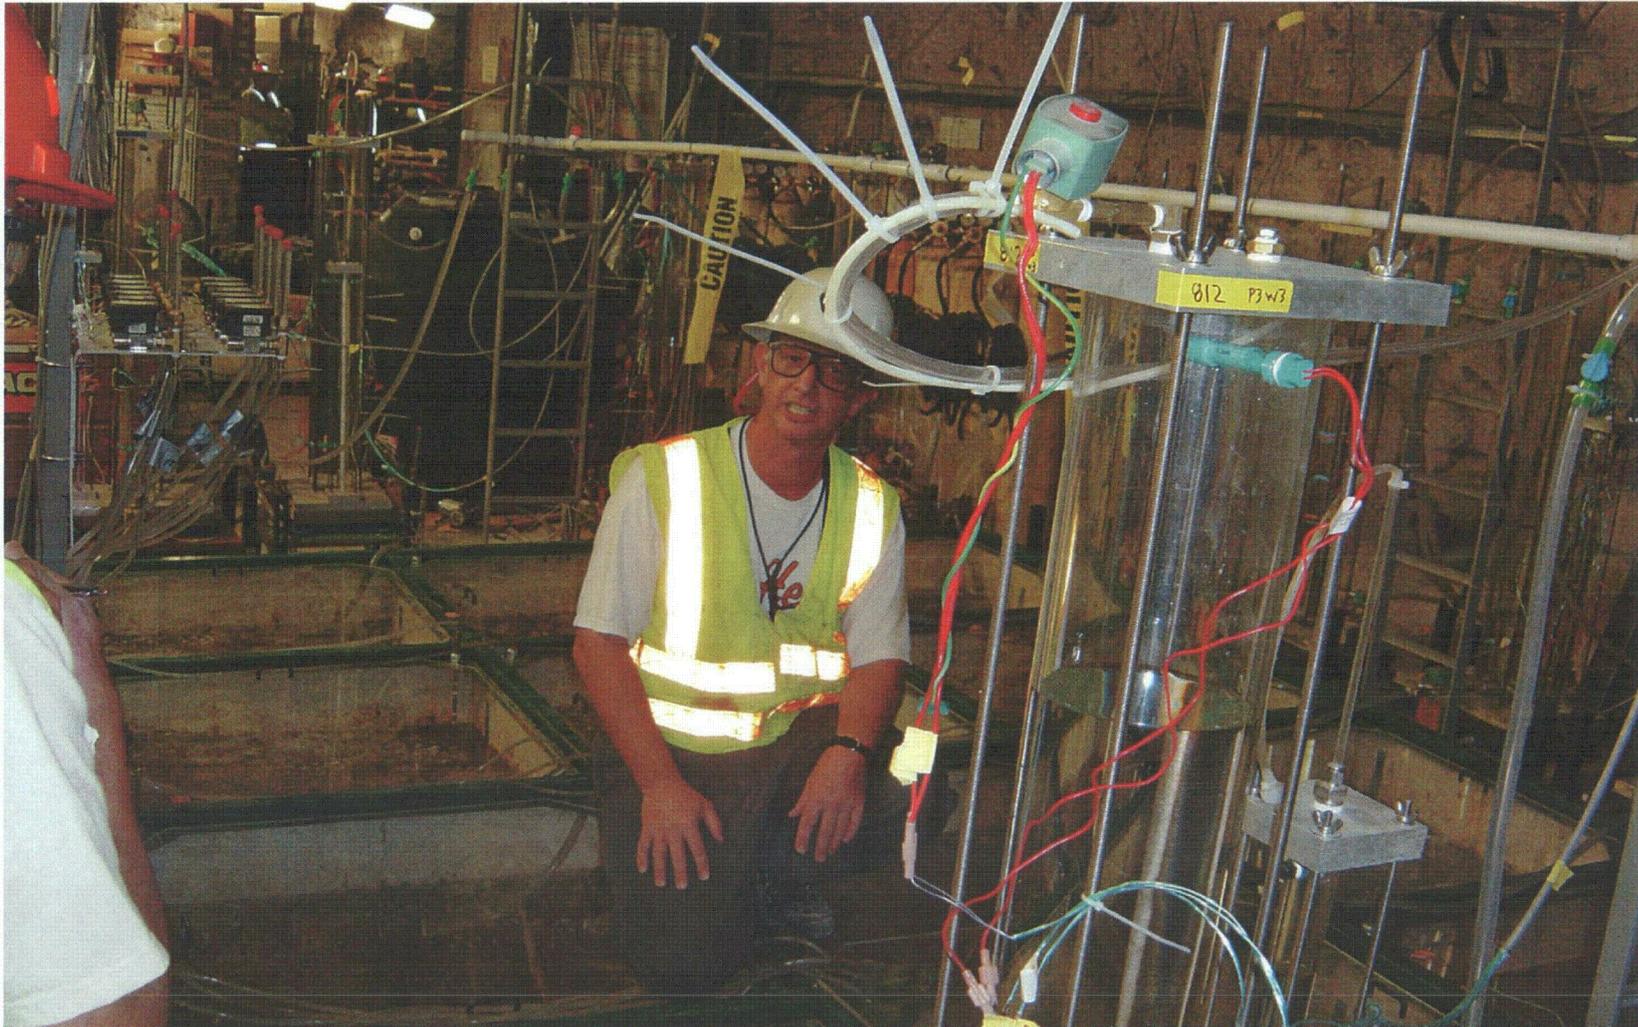
# Dave Hudson on Top of Seepage Plots in Alcove 8 (4\_5\_04 022.jpg)

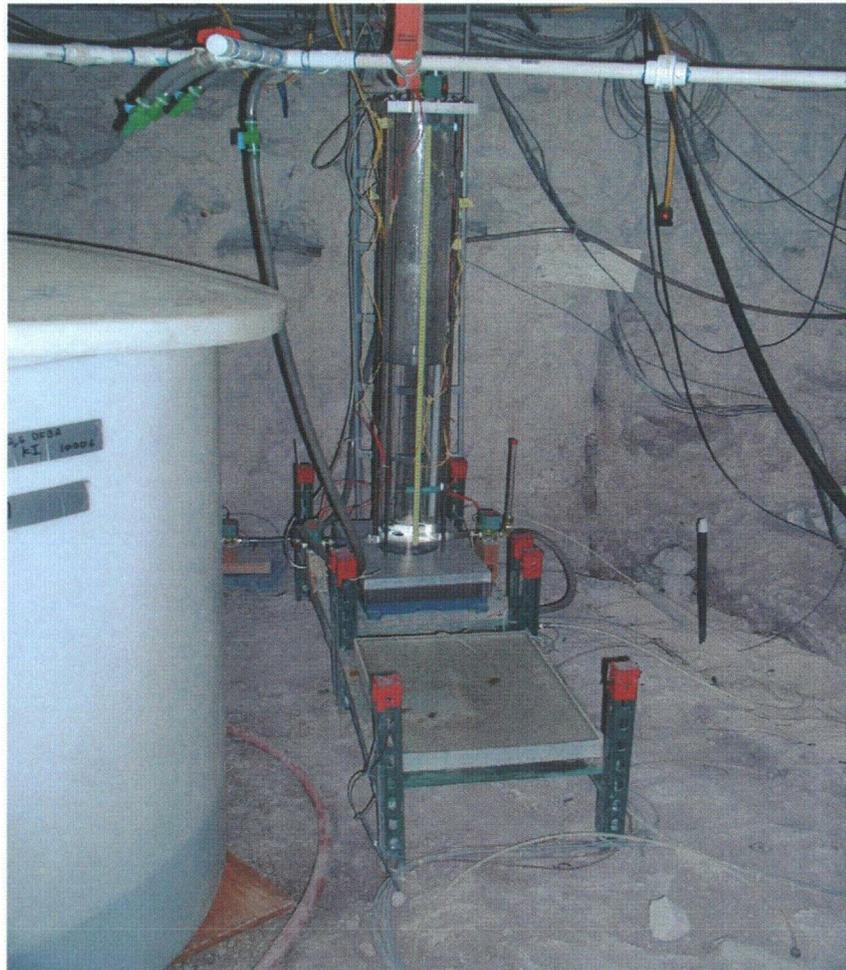
# Evaporation Measurement Apparatus in Alcove 8 (P4010014.jpg)

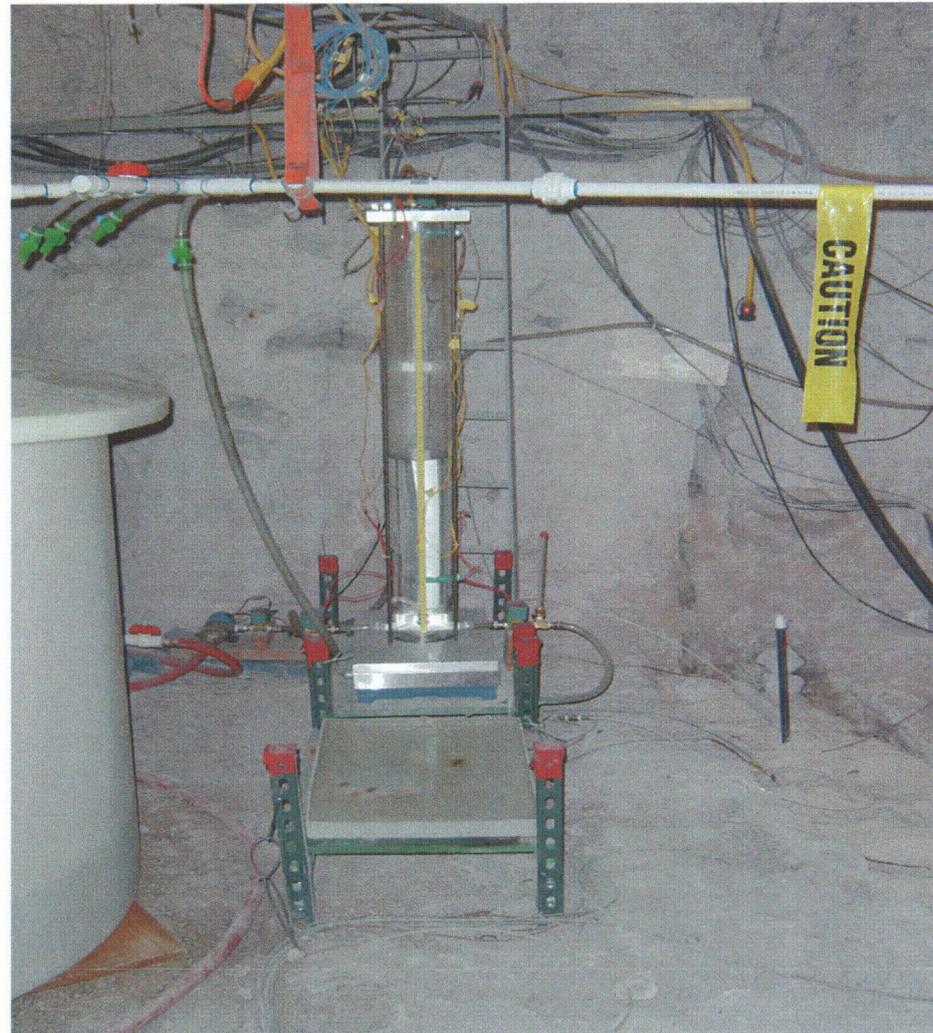
# Evaporation Monitoring System in Alcove 8 (4\_5\_04 023.jpg)

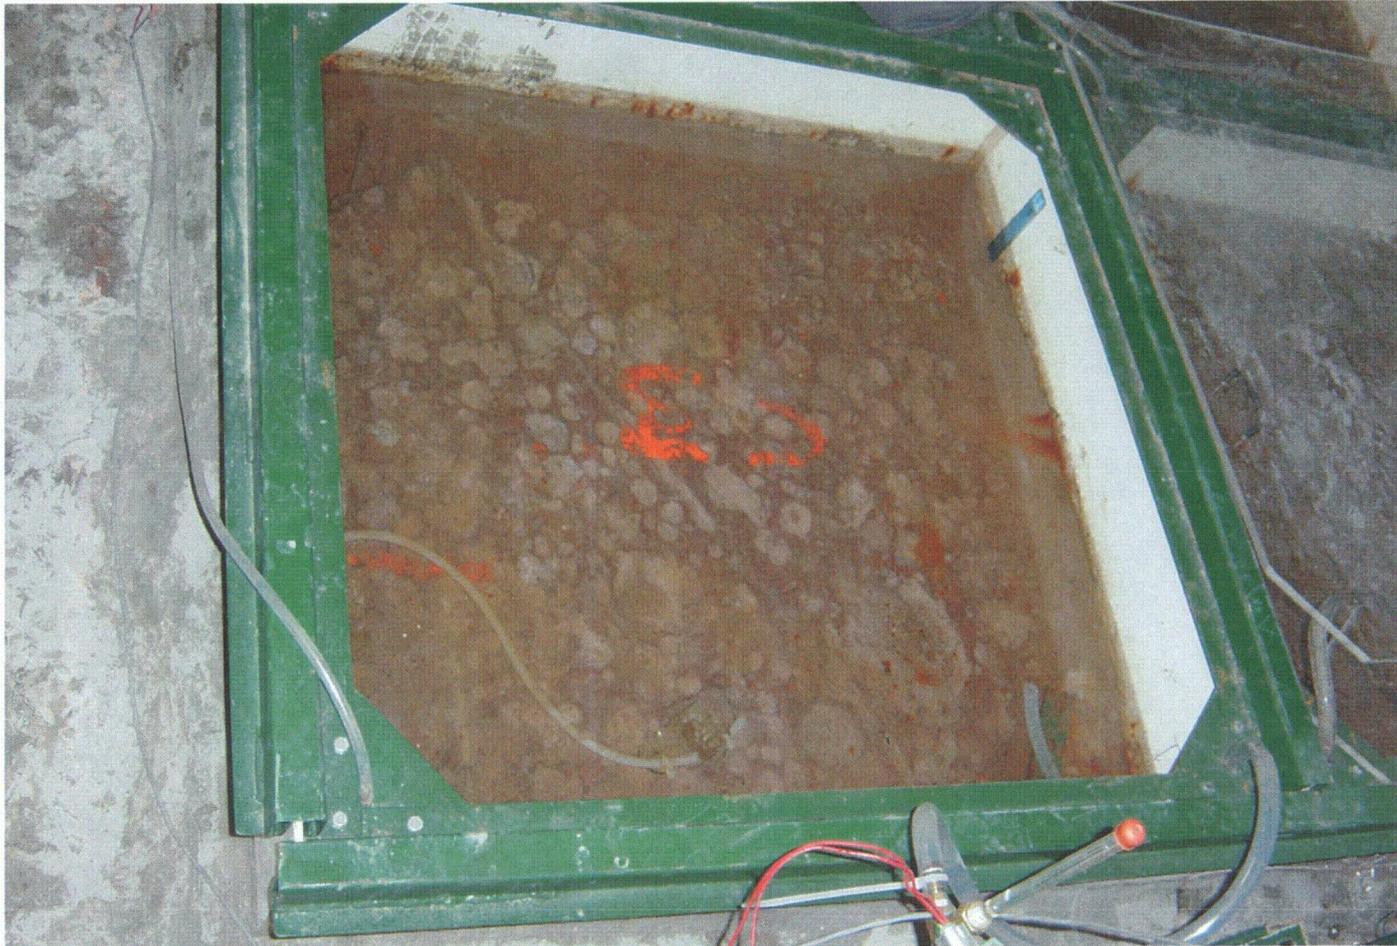
# View of One Seepage Plot in Alcove 8 (4\_5\_04 021.jpg)

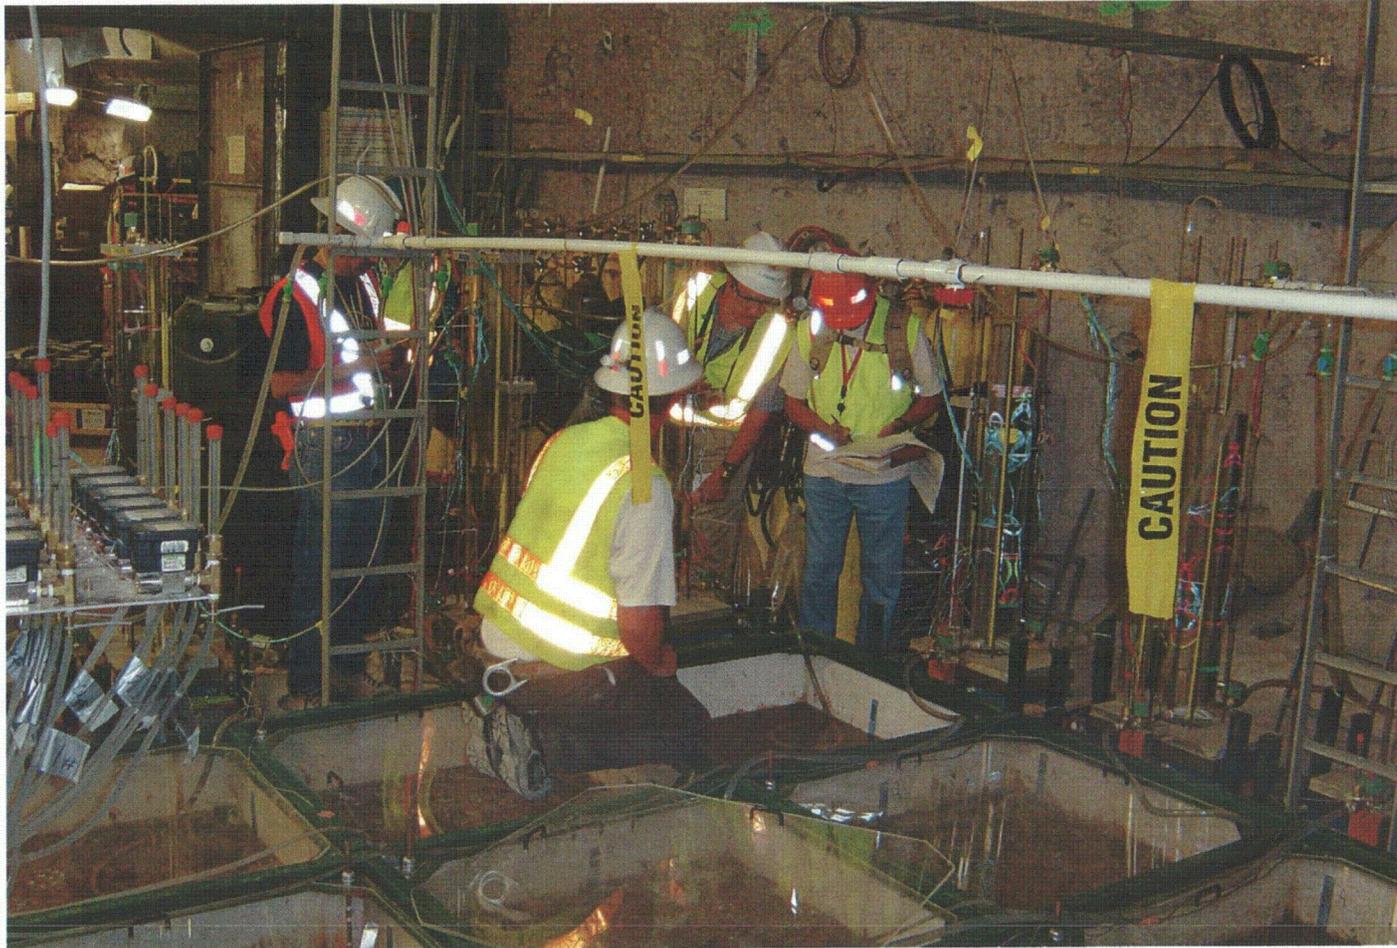
# Seepage Plot Area and Equipment in Alcove 8 (4\_5\_04 024.jpg)

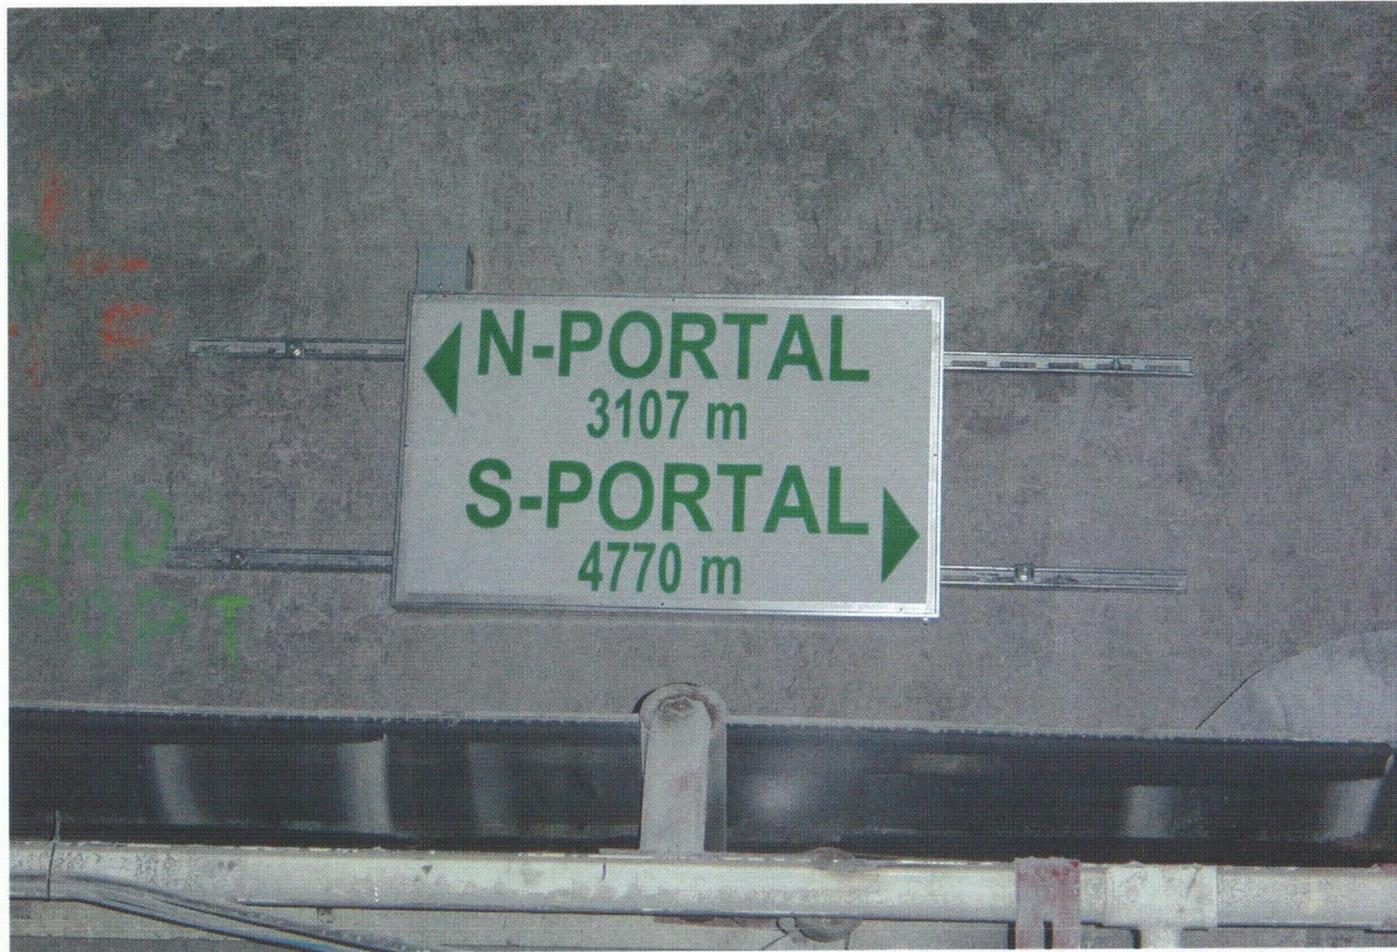
# Niche 3 Location (4\_5\_04 031.jpg)

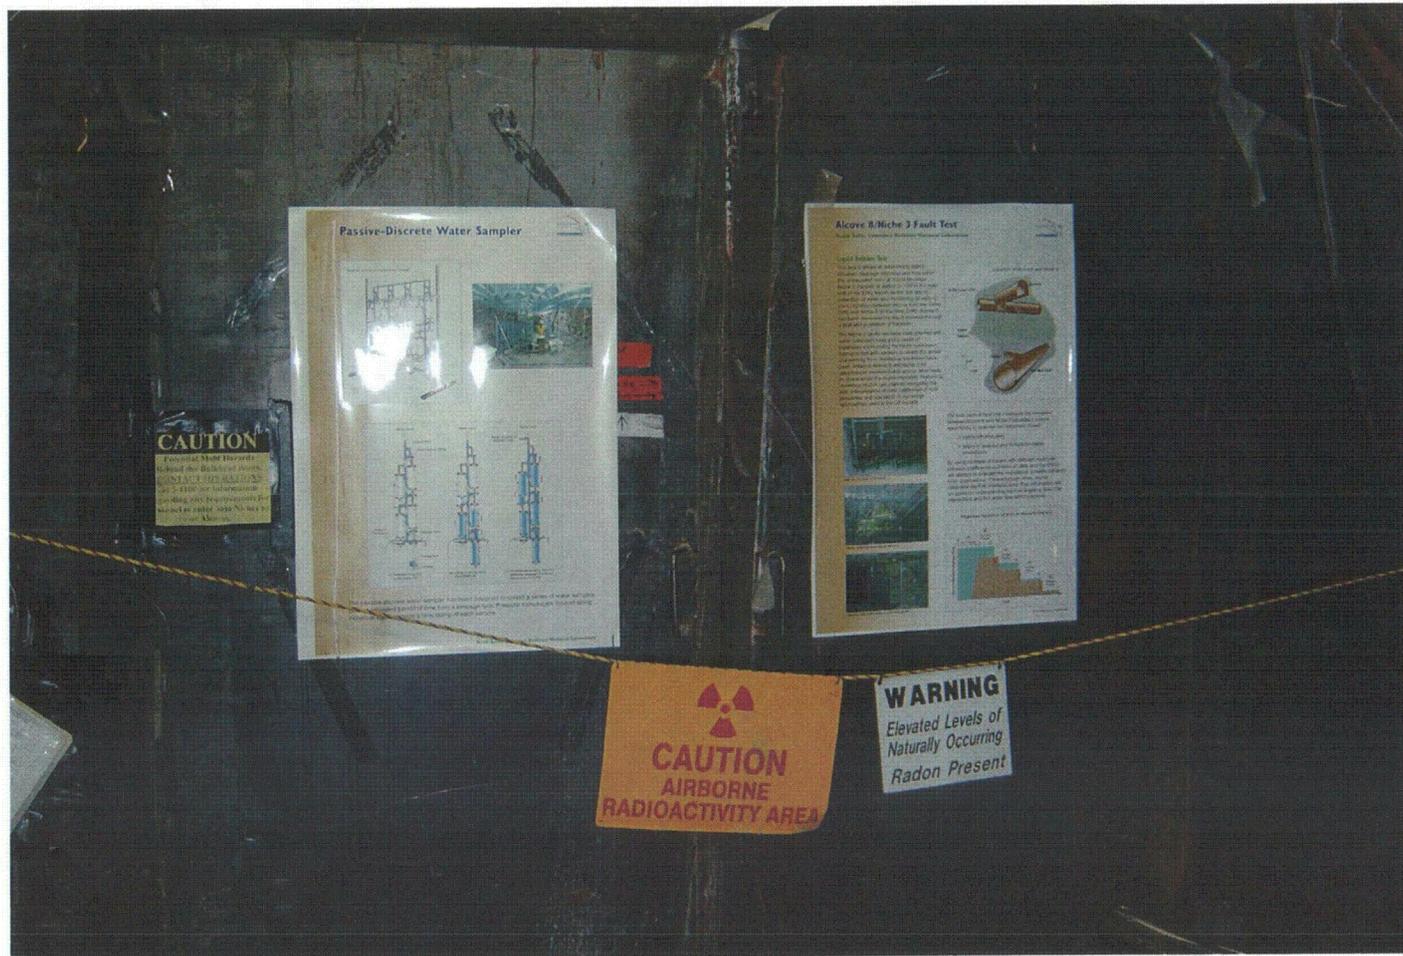
# Niche 3 Doorway (4\_5\_04 025.jpg)

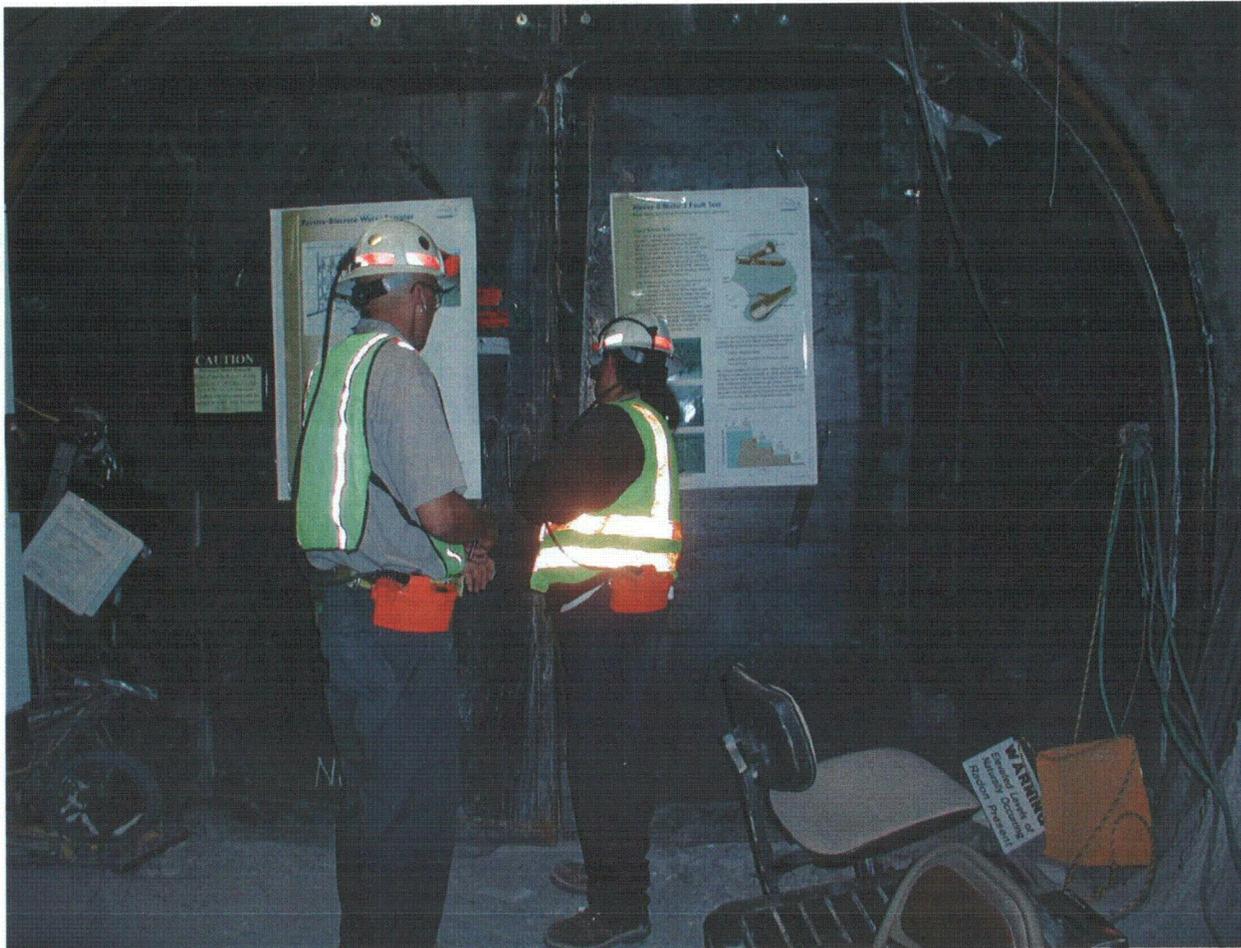
# Entrance to Niche 3 ESF, Radon Measurements being Taken (P4010016.jpg)

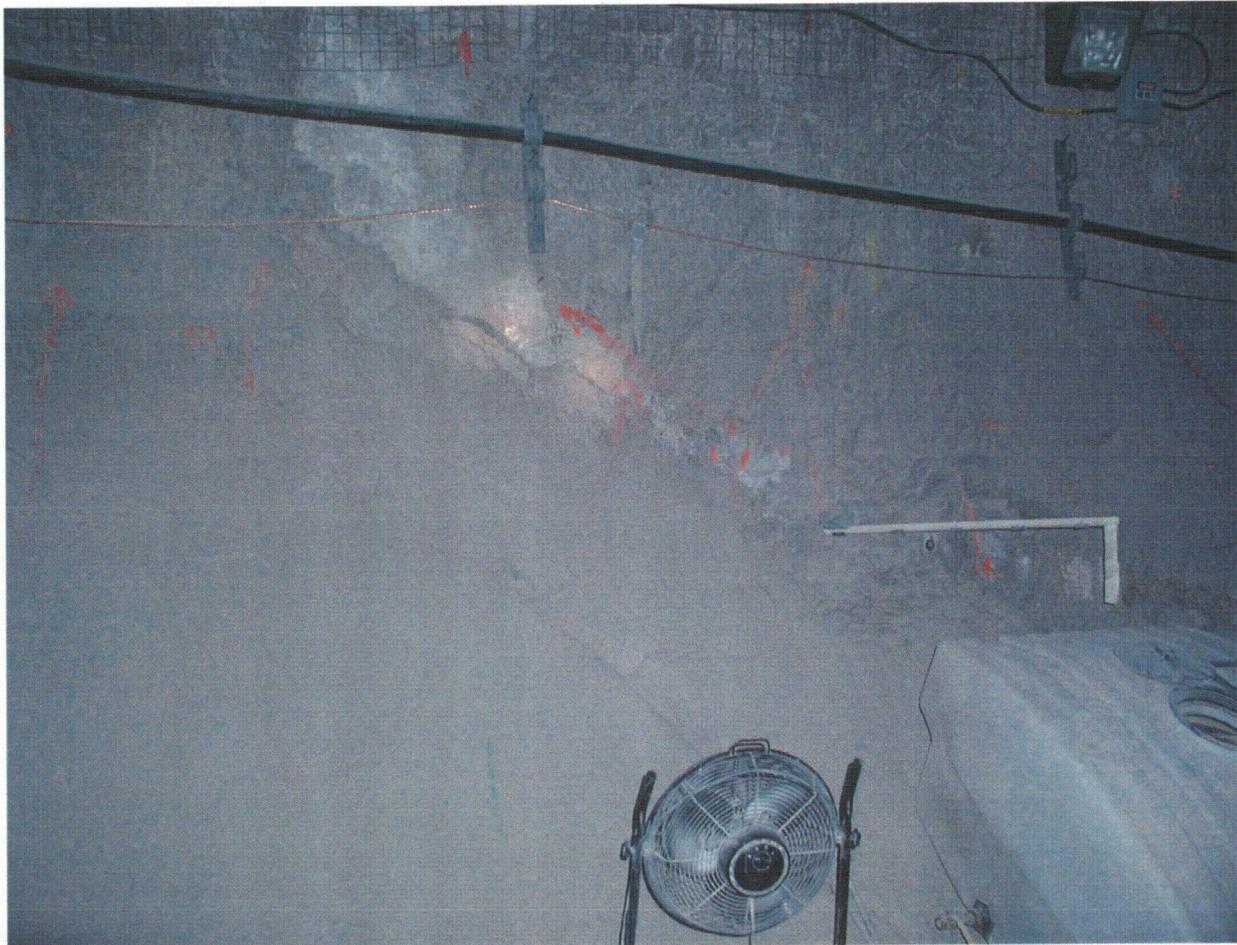
# Fault Outside of Niche 3 in the ESF (P4010017.jpg)

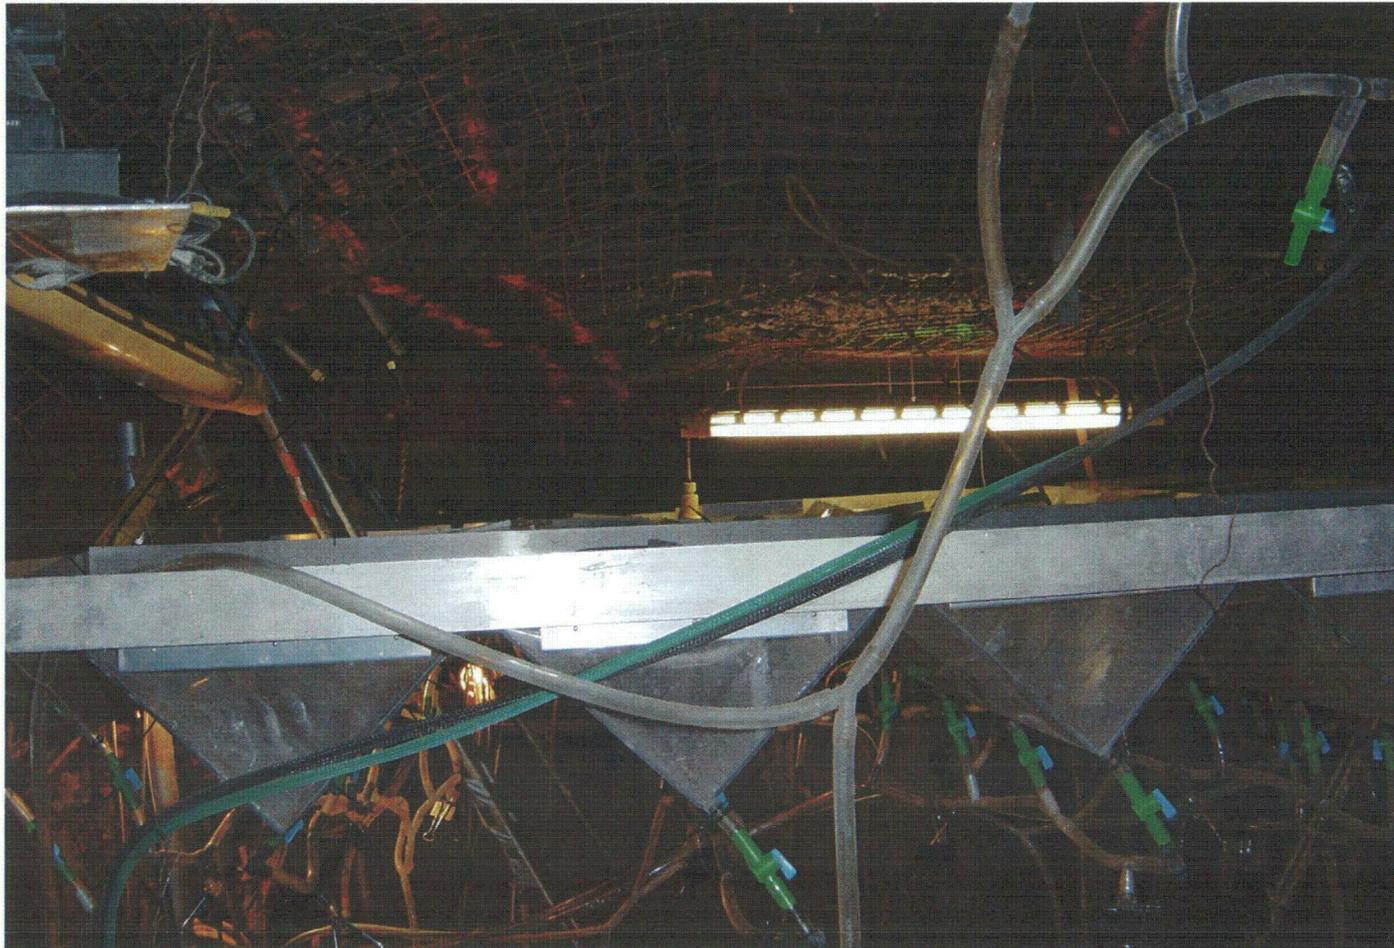
# Roof of Niche 3 and Seepage Collection Trays (4\_5\_04 027.jpg)

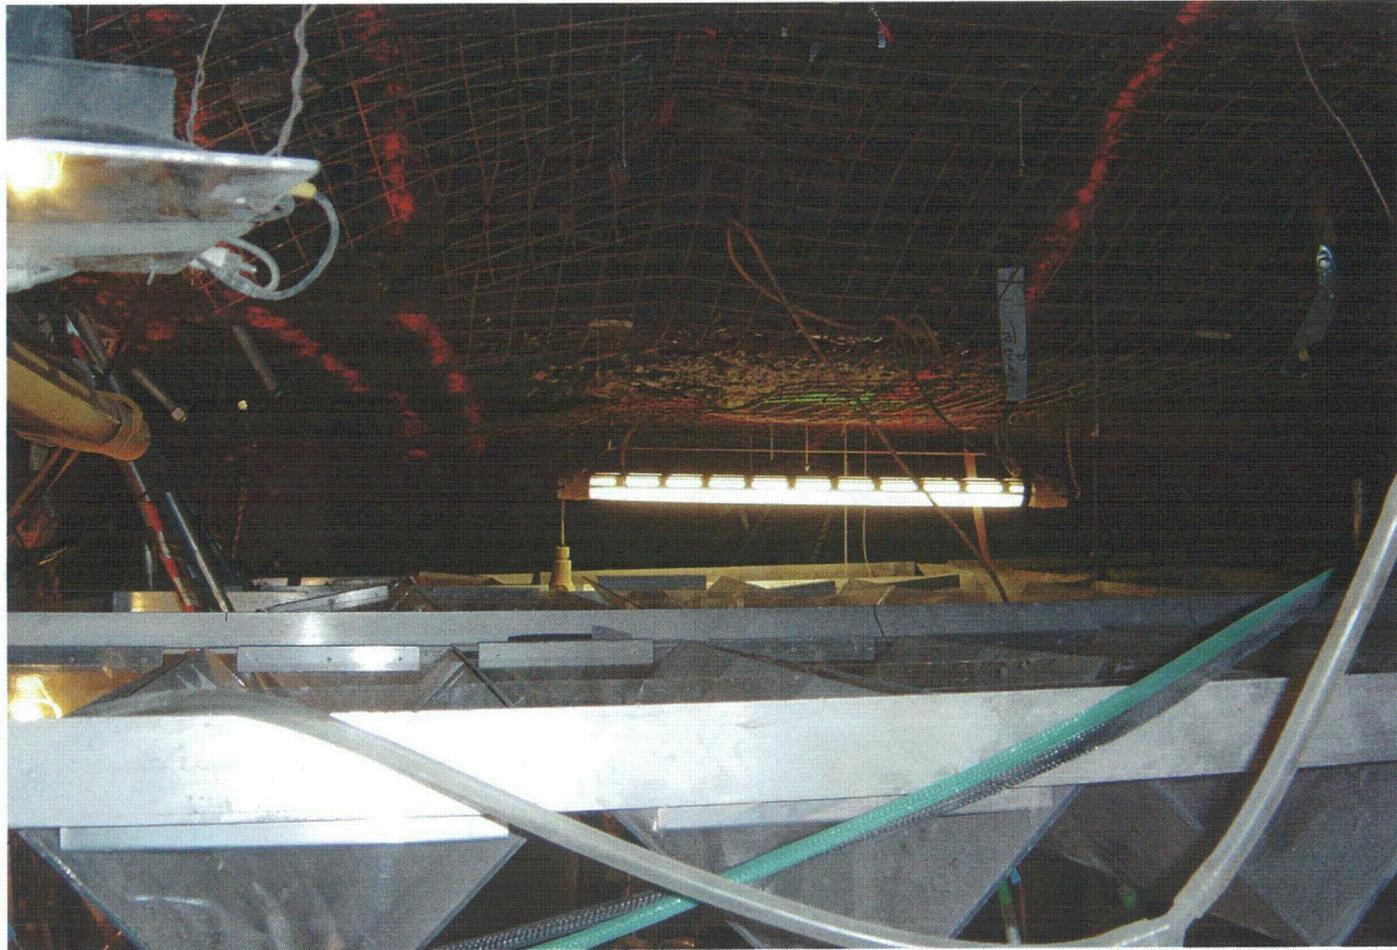
# Roof of Niche 3 (4\_5\_04 030.jpg)

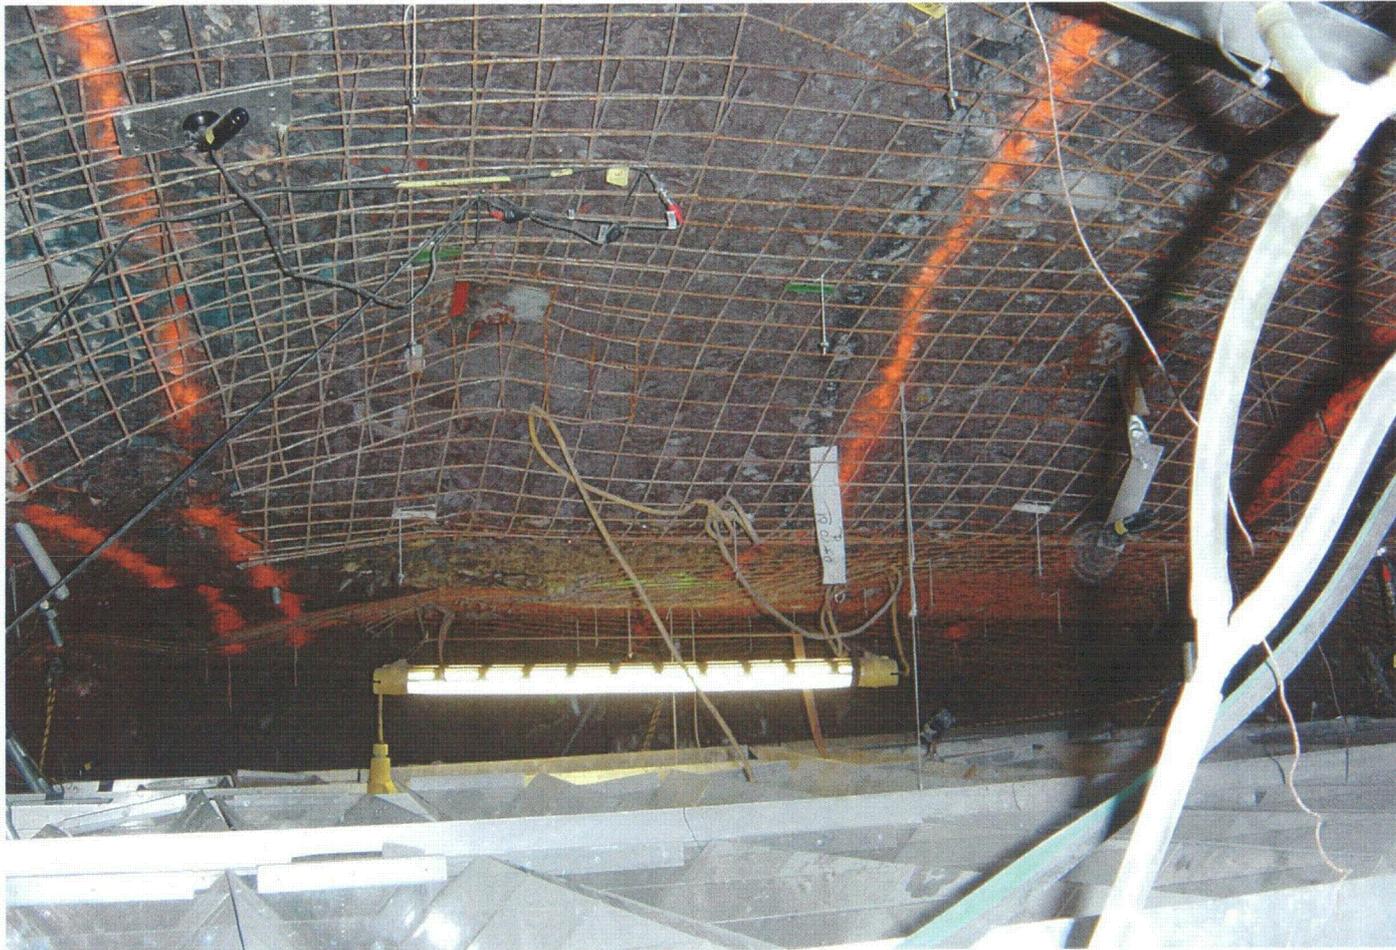
# Roof of Niche 3 (4\_5\_04 032.jpg)
