**YUCCA MOUNTAIN**  
**April 1, 2004, Field Trip Report to**  
**Alcove 8 – Niche 3 Areas**

By M. (Sam) Nalluswami and Jack Parrott

U. S. Nuclear Regulatory Commission  
Washington, DC

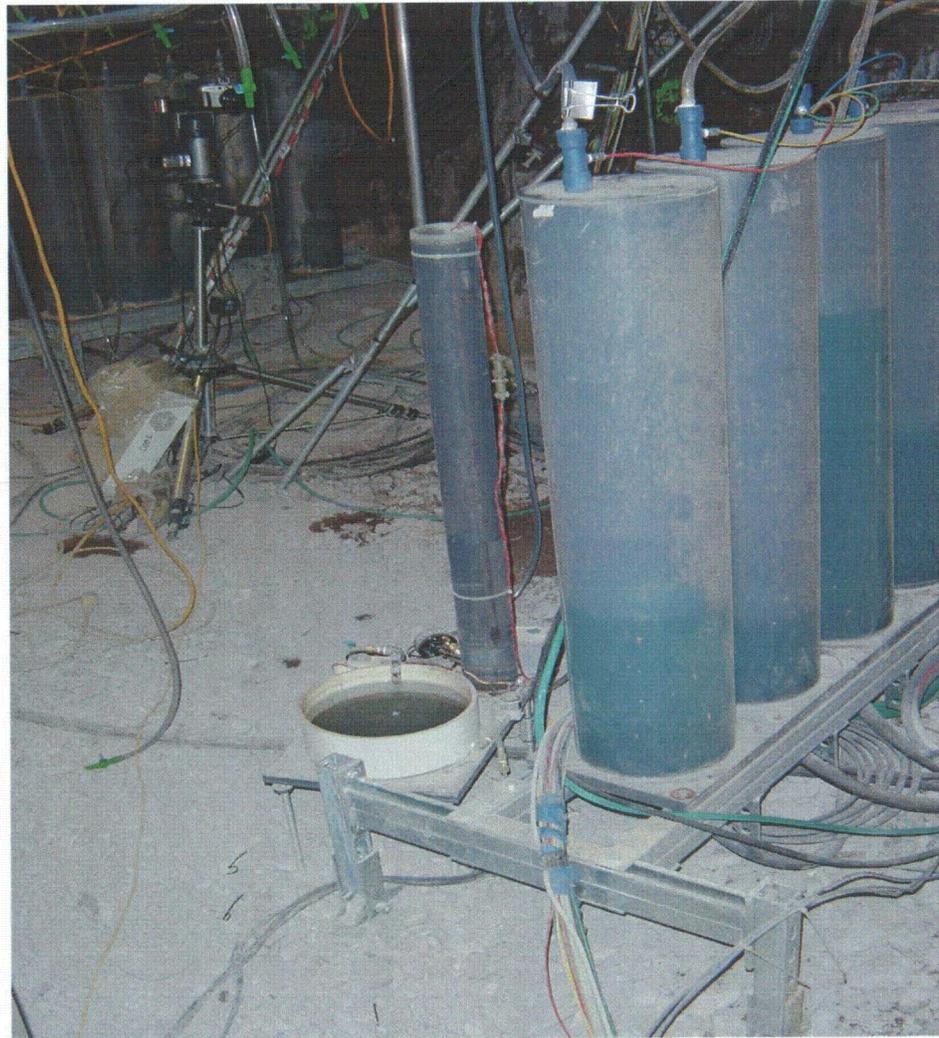
# Evaporation Measuring Device in Niche 3 (4\_5\_04 029.jpg)

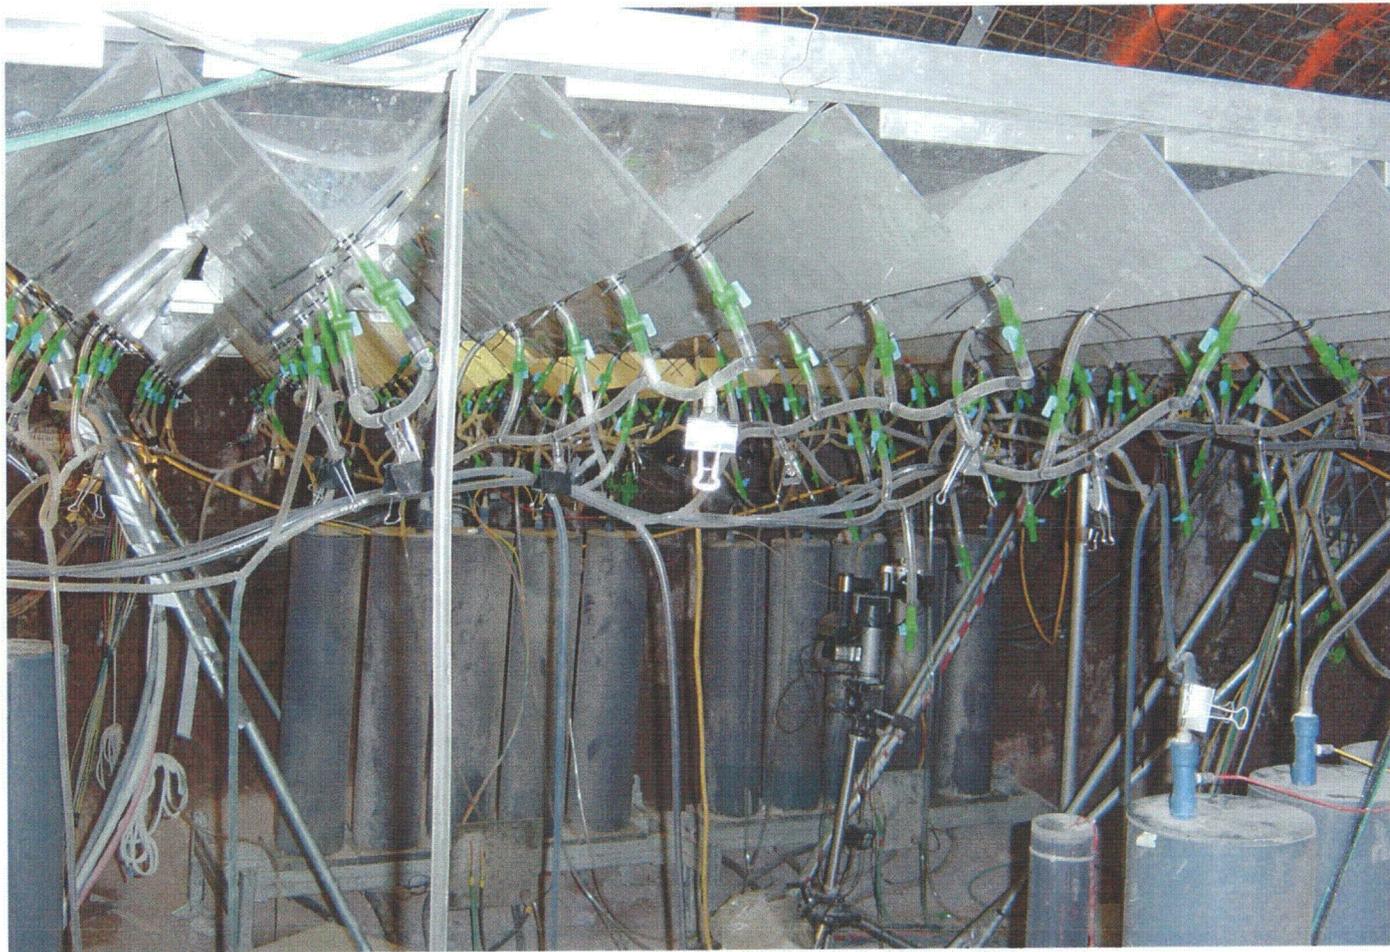
# Seepage Collection Trays and Seepage Collection System in Niche3 (4\_5\_04 028.jpg)

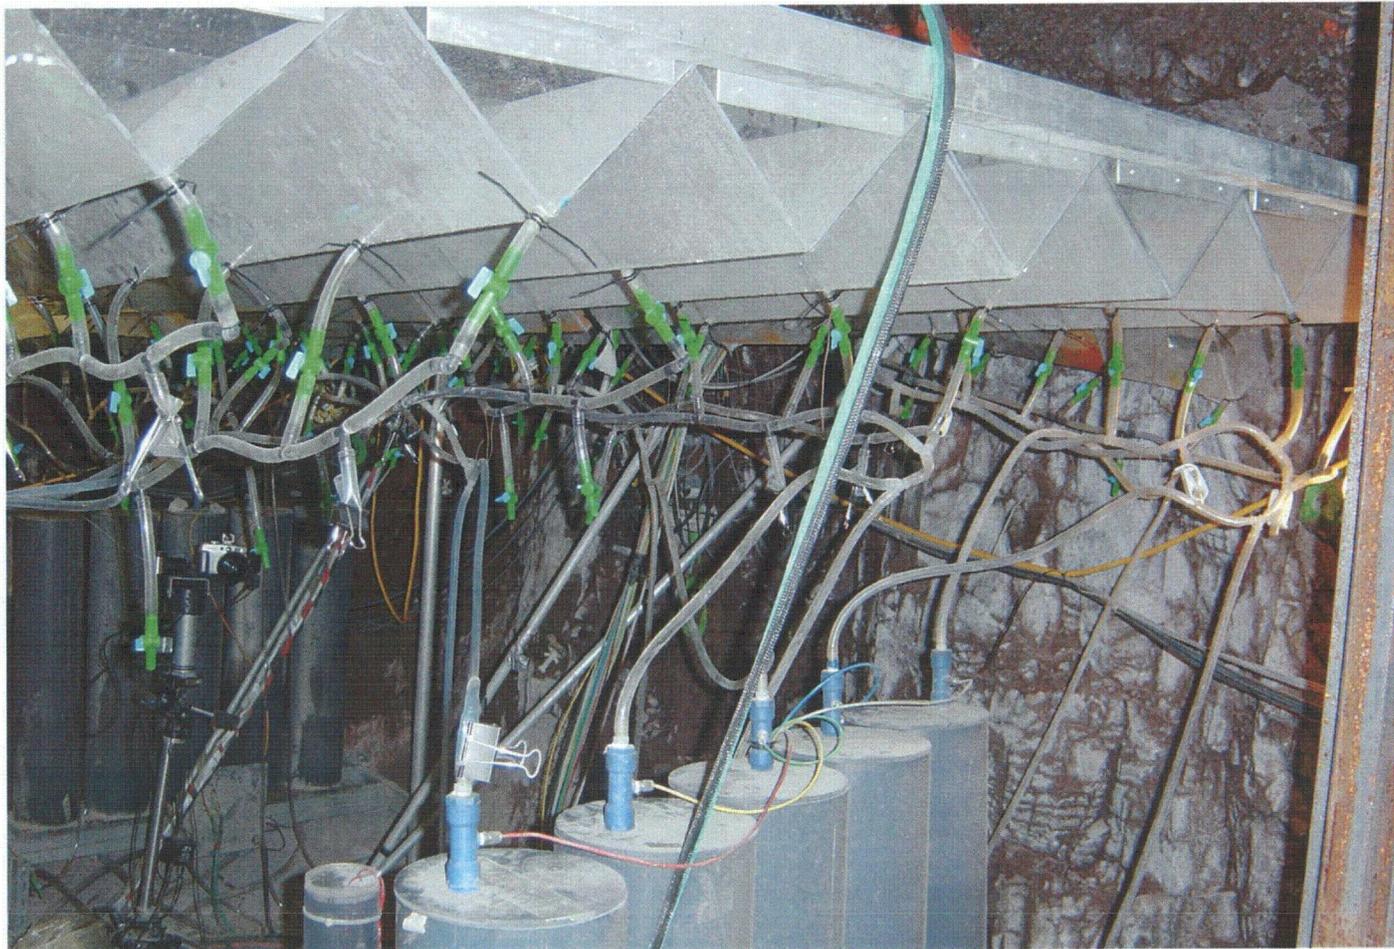
# Seepage Collection System in Niche 3 (4\_5\_04 033.jpg)

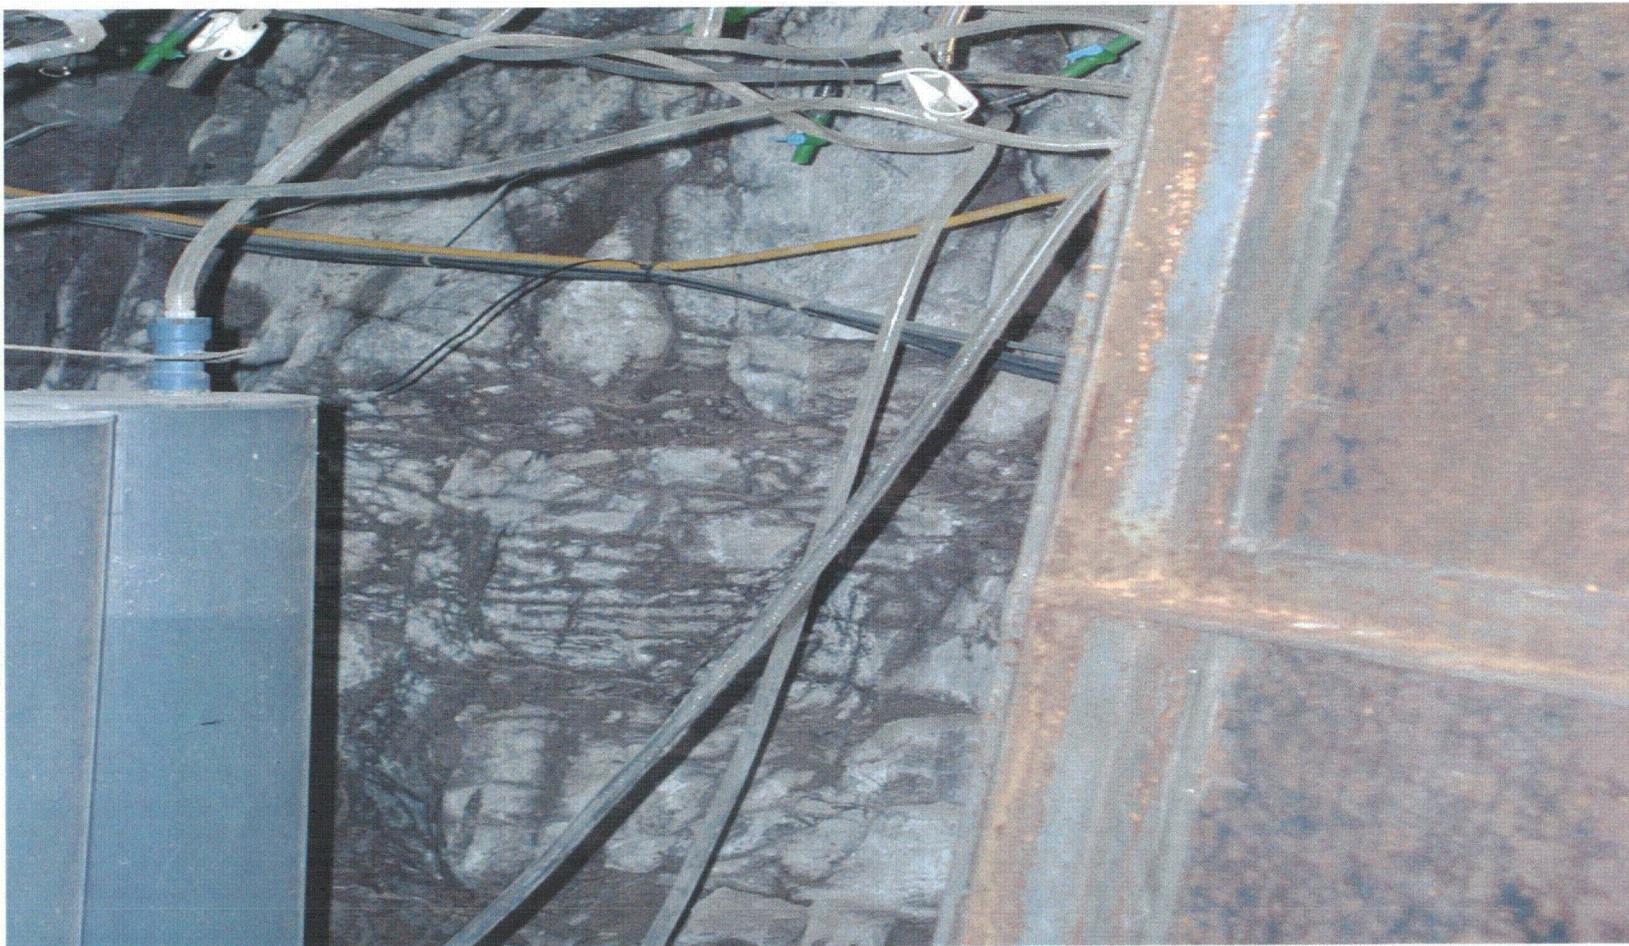
# Wetting Pattern on the Wall of Niche 3 to Left of Door Opening (P4010018.jpg)

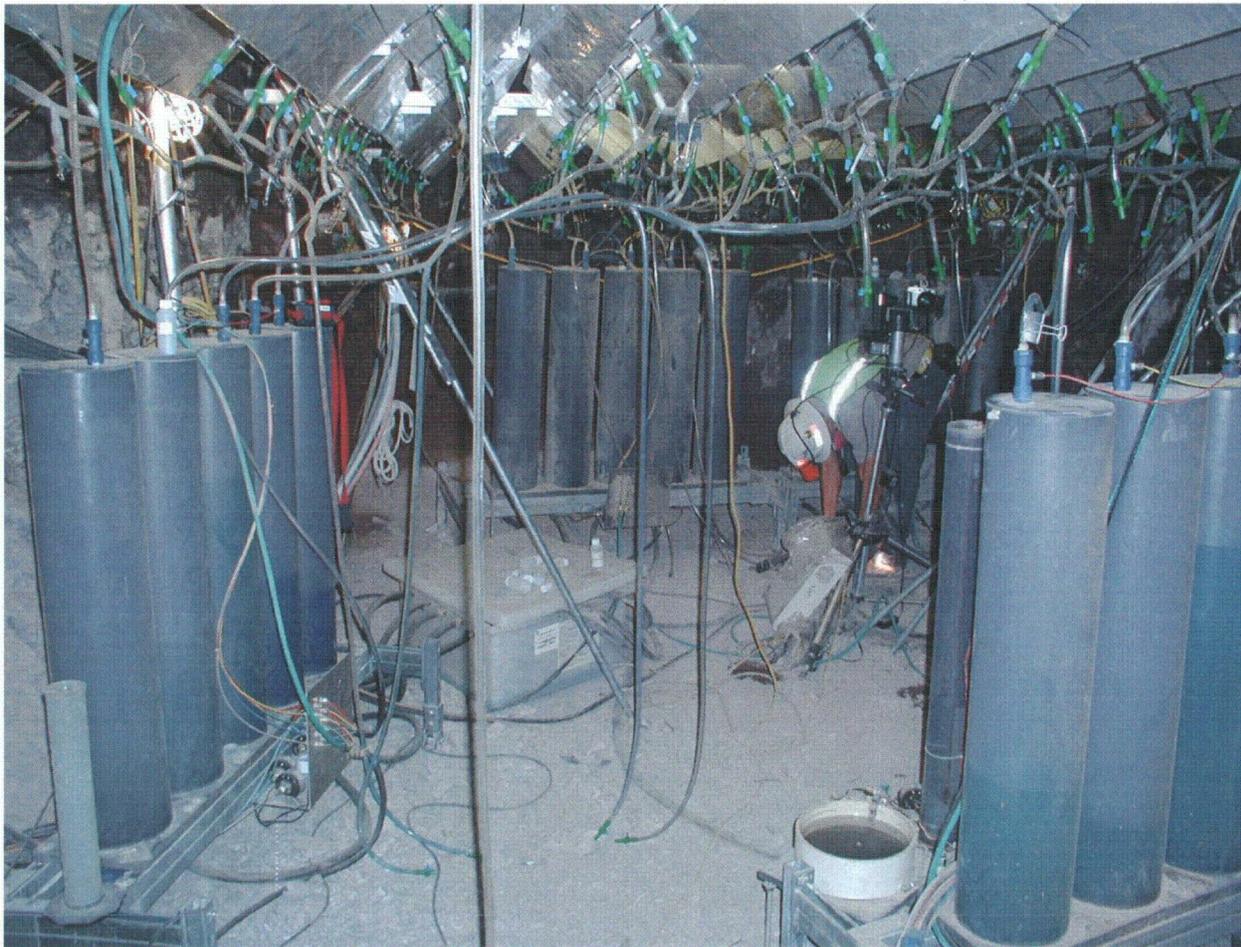
# Seepage Collection Apparatus in Niche 3 (P4010019)

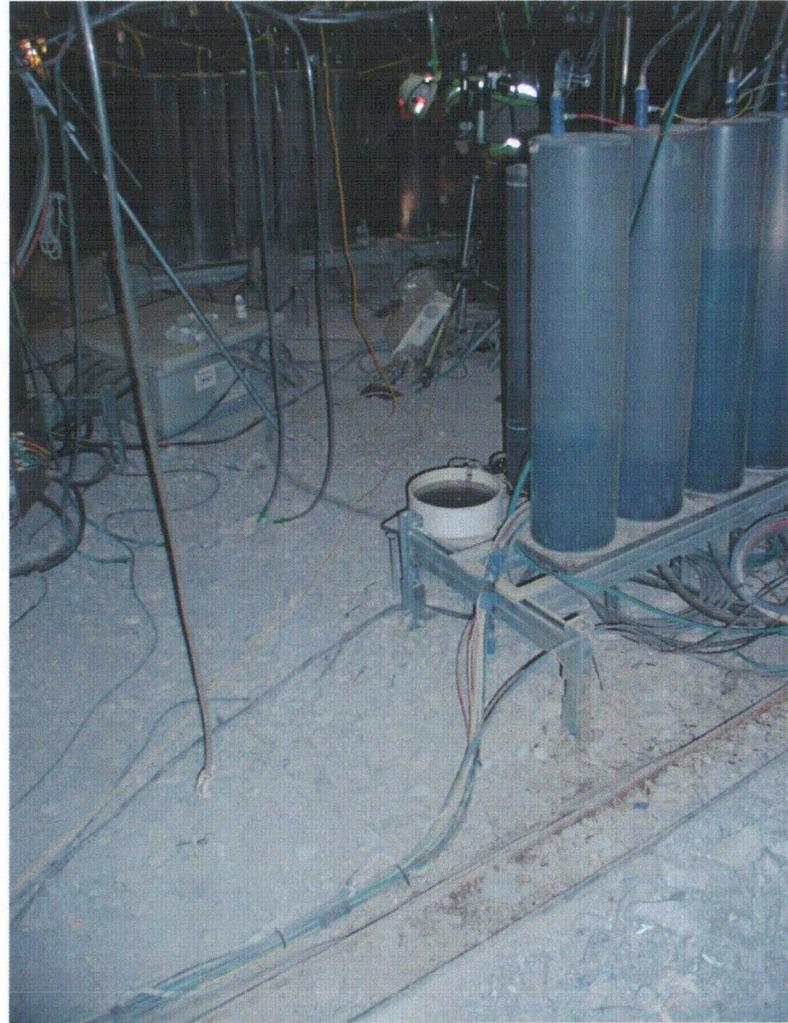
# Seepage Collection Apparatus in Niche 3 (P4010020.jpg)

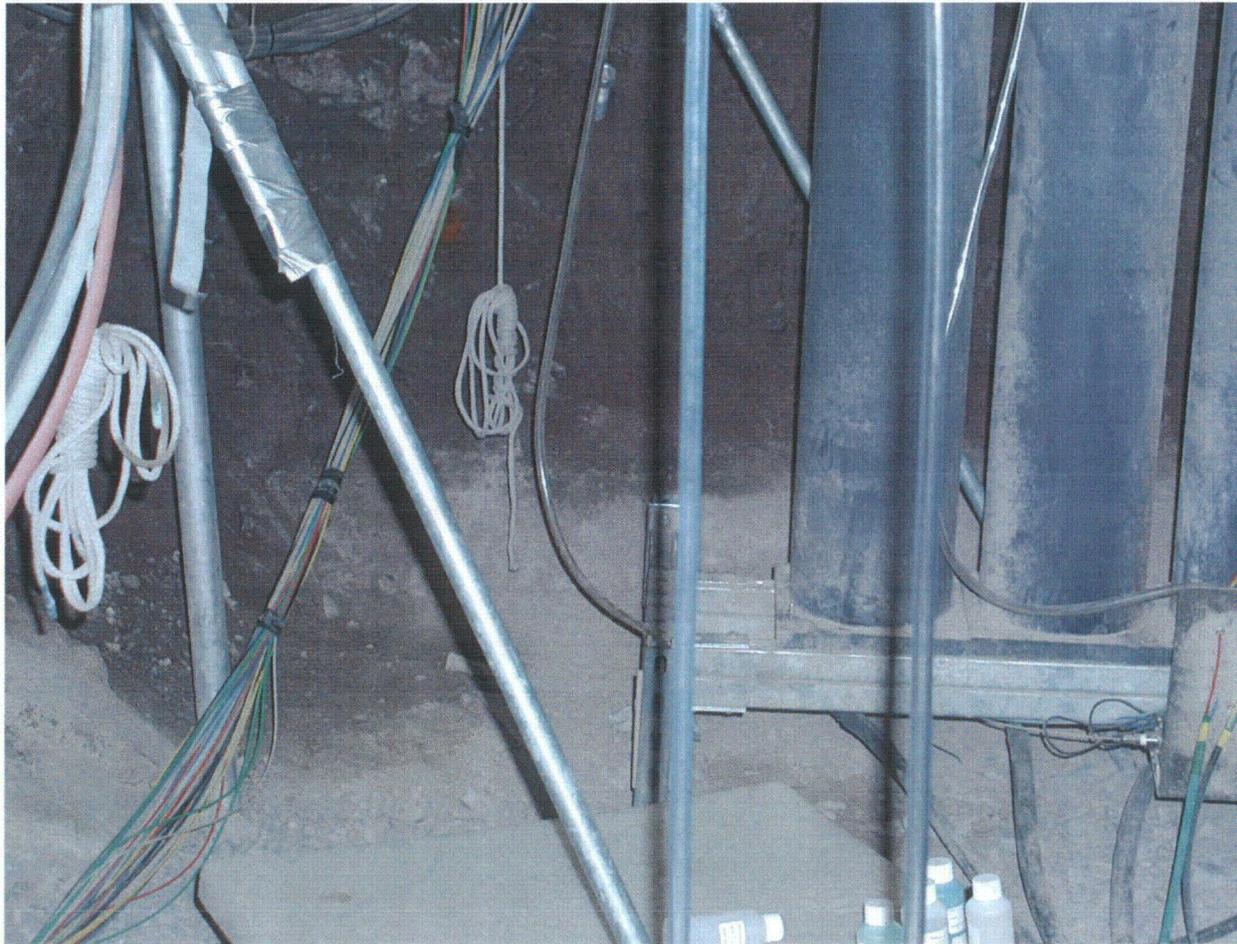
# Seepage Collection Apparatus and Seepage Down the Wall in Niche 3 (P4010021.jpg)

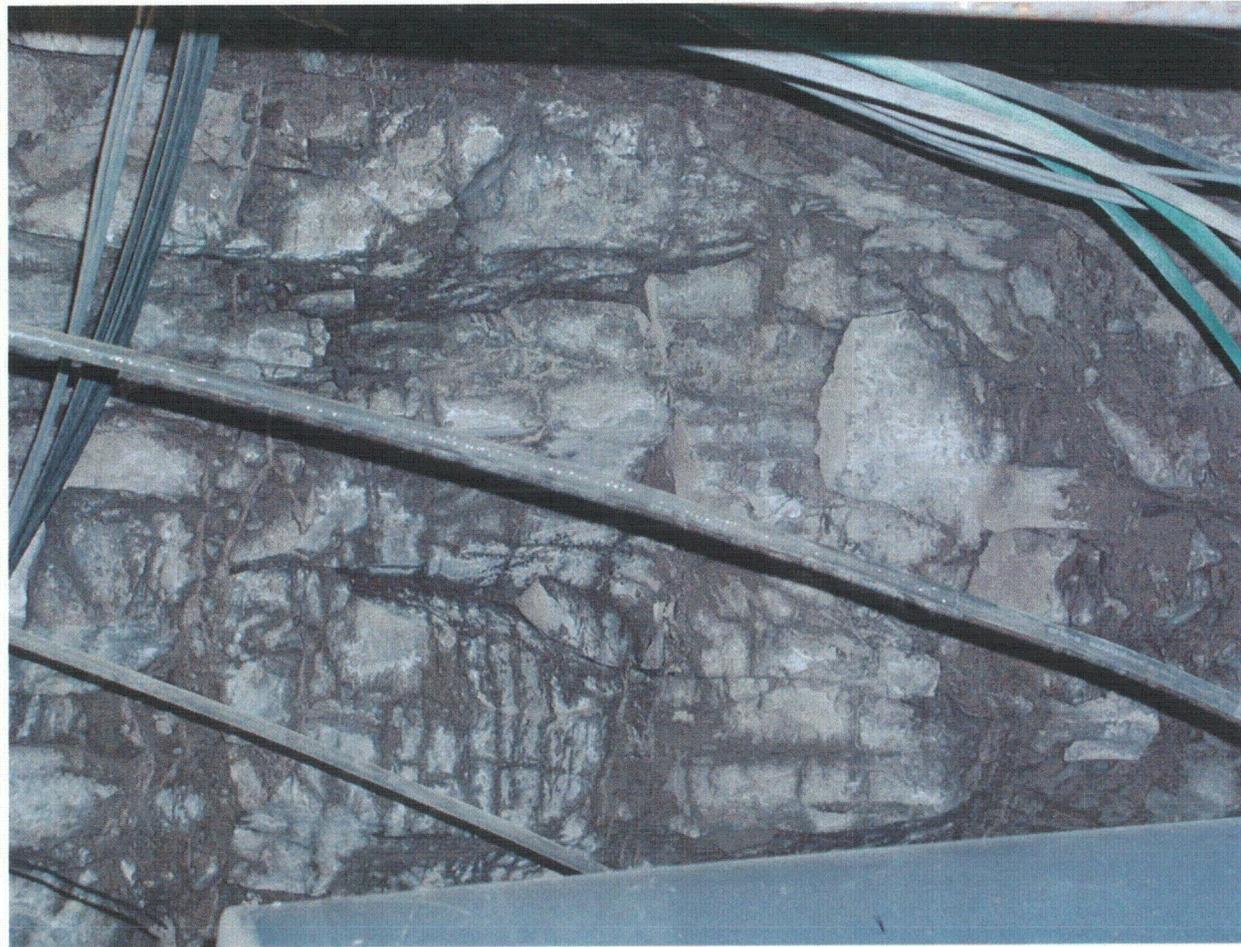
# Seepage Pattern in the Wall of Niche 3 (P4010022.jpg)

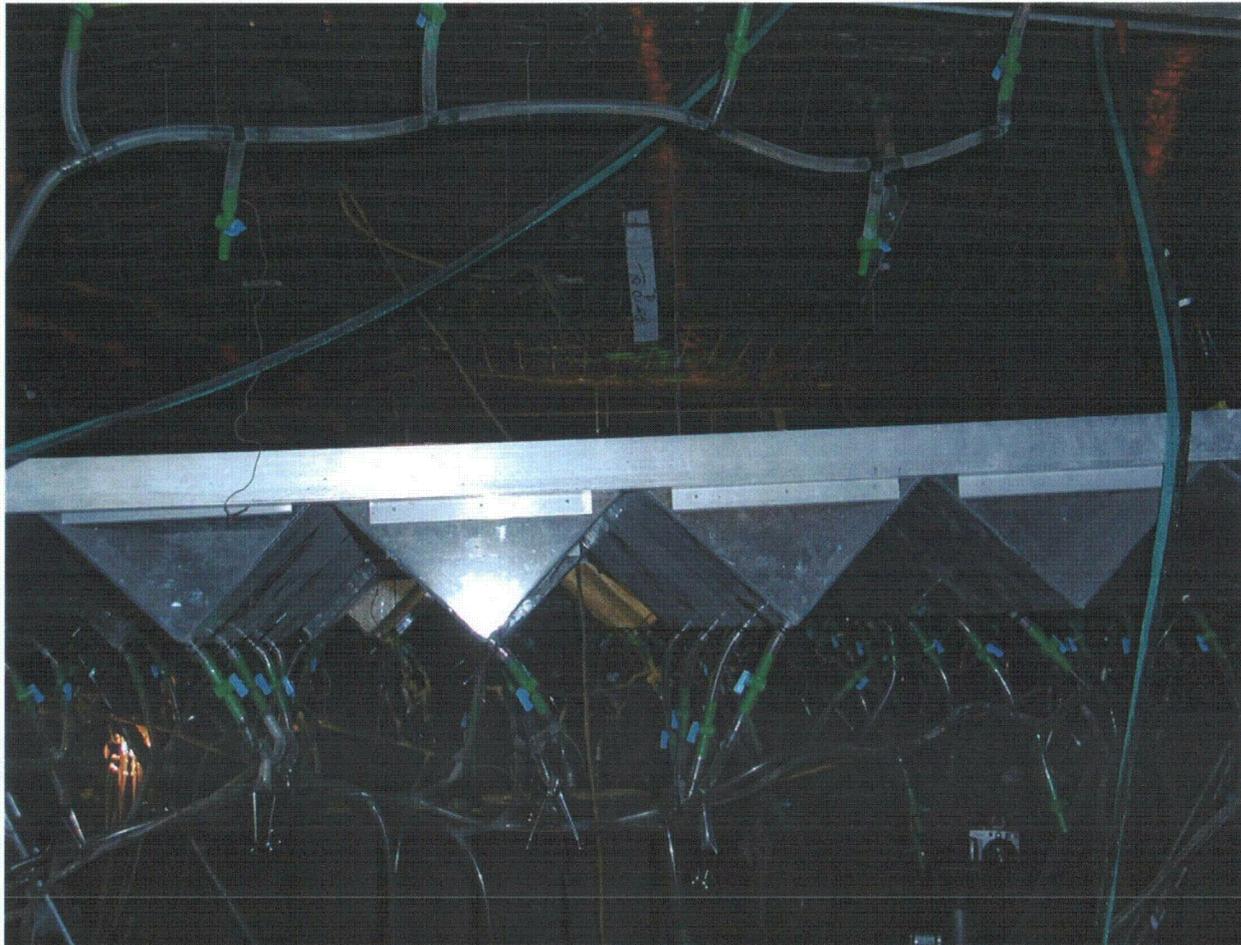
# Seepage Collection Devices in Niche 3 (P4010023.jpg)

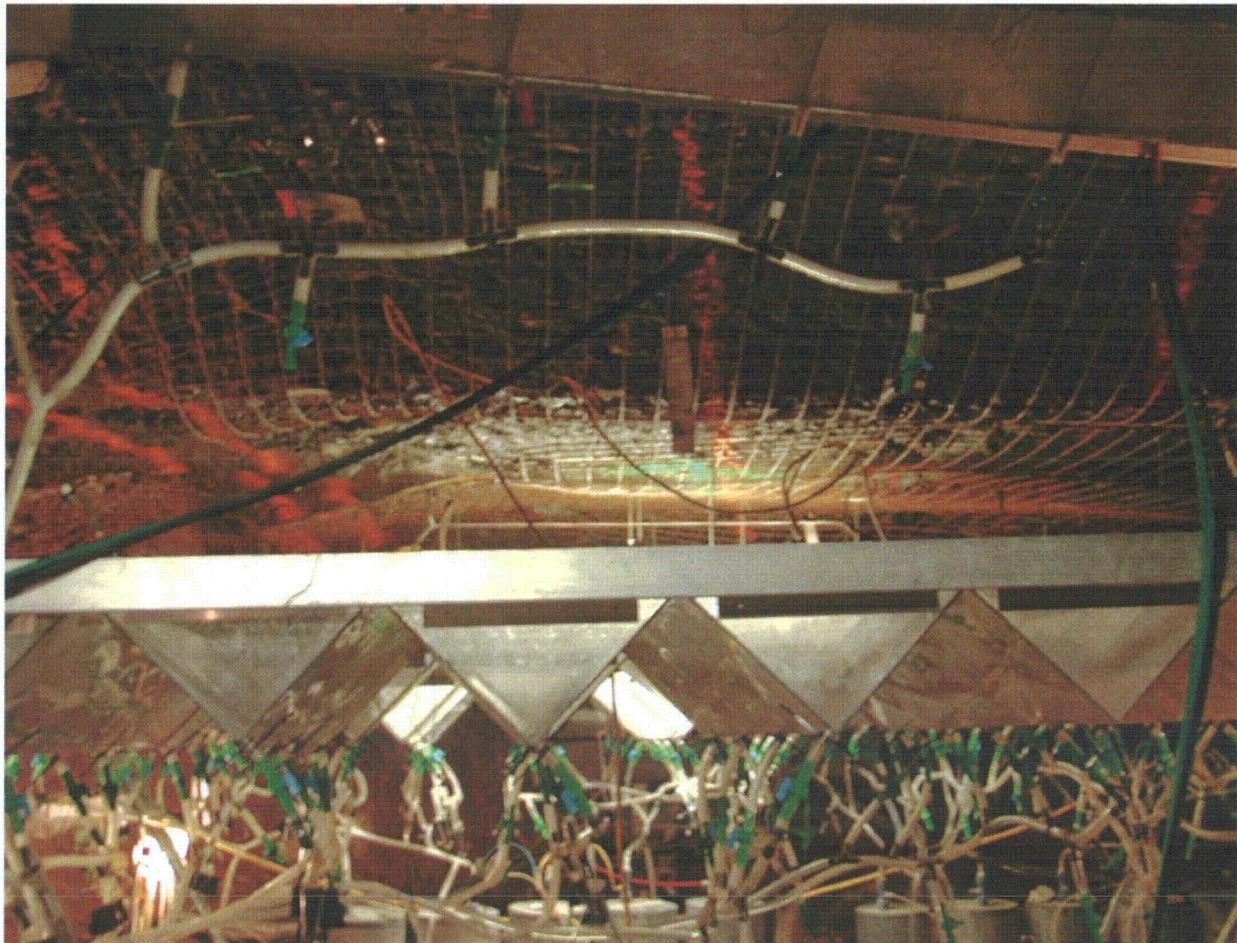
# Seepage Collection Devices and Roof of Niche 3 (P4010024.jpg)

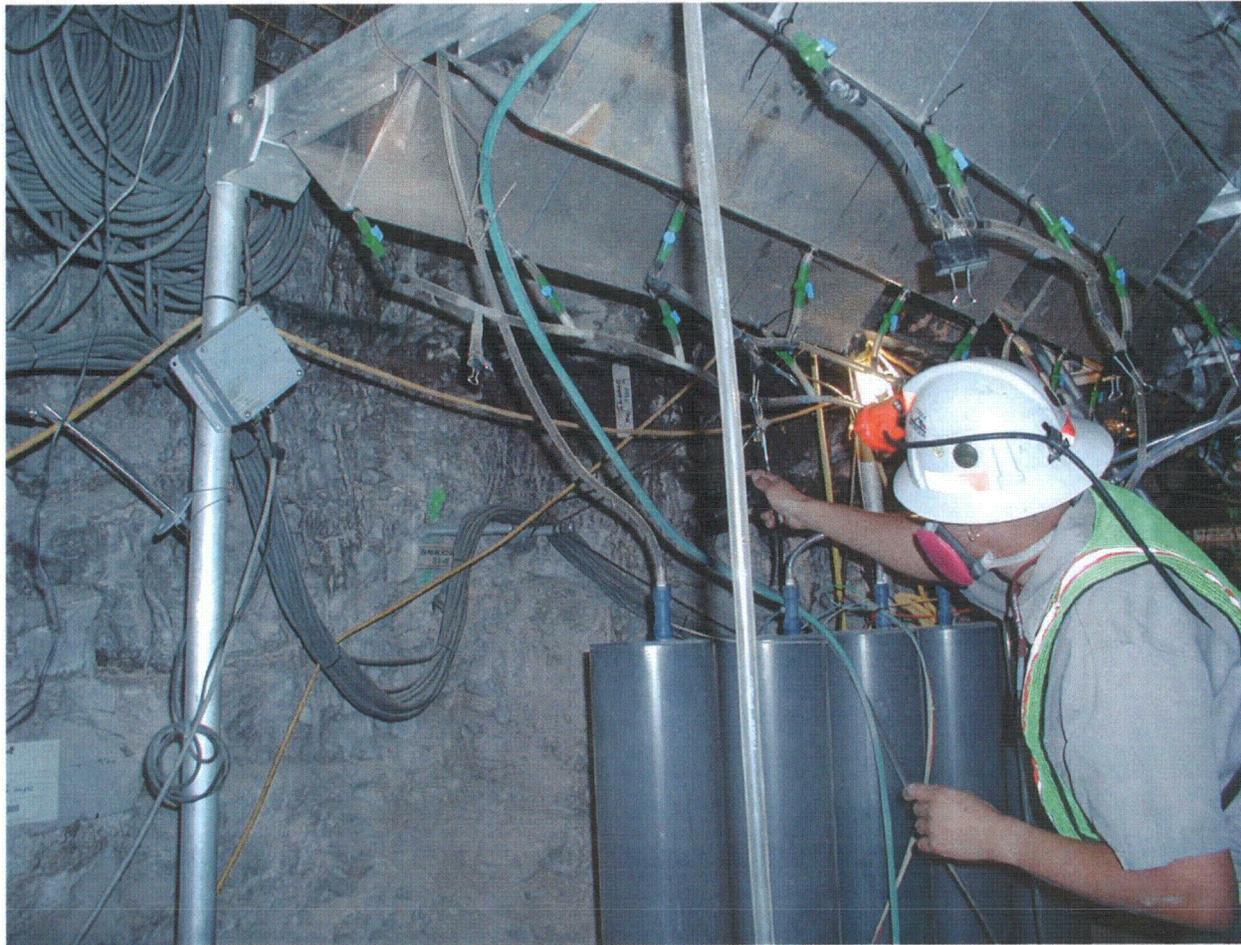
# Technician Checking Seepage Collection System, Niche 3 (P4010026)

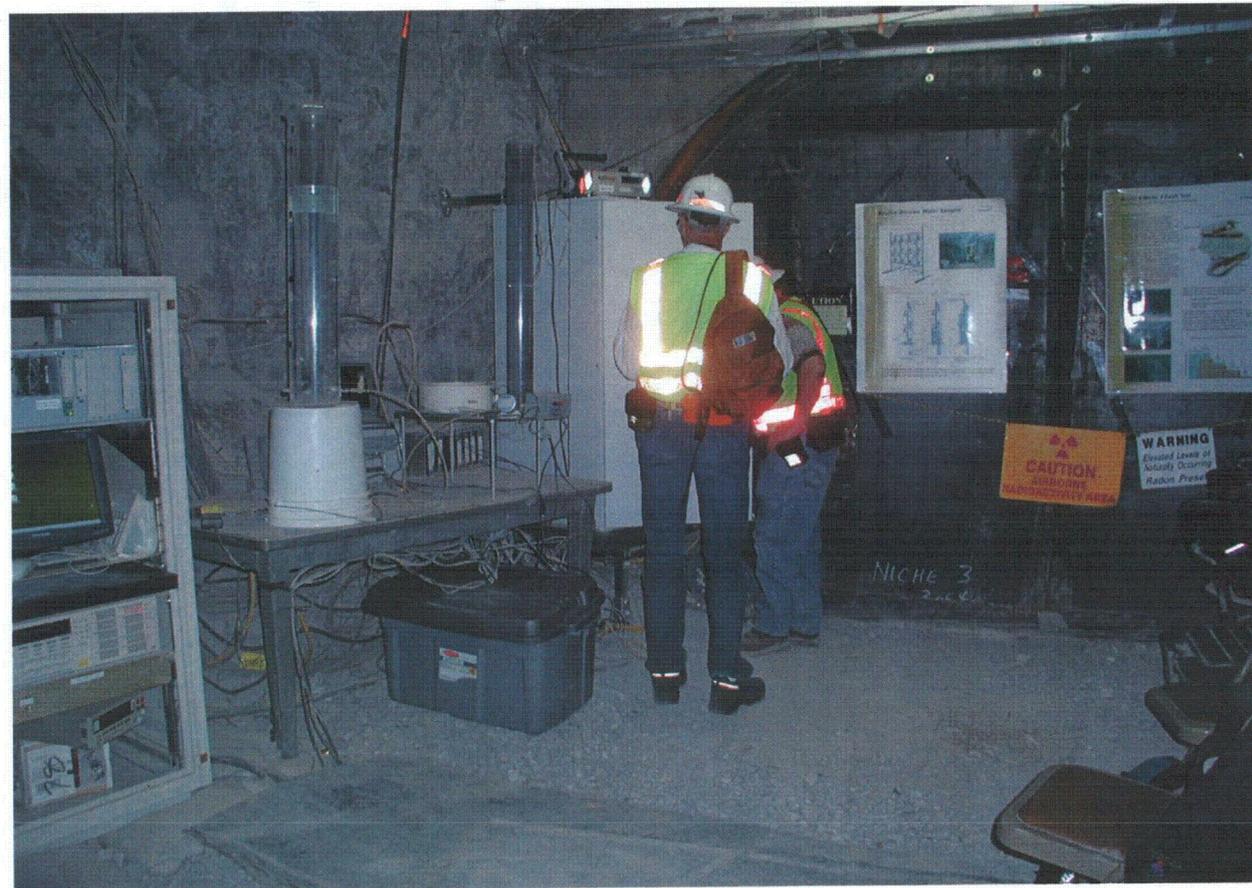
# From Left, Data Collection Instruments, Evaporation Measurement System and Door to Niche 3 (P4010027.jpg)
