Re: St. Lucie Unit 2
Docket No. 50-389
Order (EA-03-009)
Request for Additional Information Response
Relaxation Request No. 3

**RESPONSE TO NRC REQUESTS FOR ADDITIONAL INFORMATION
ST. LUCIE UNIT 2 RELAXATION REQUEST NO. 3
FROM THE FIRST REVISED NRC ORDER EA-03-009**

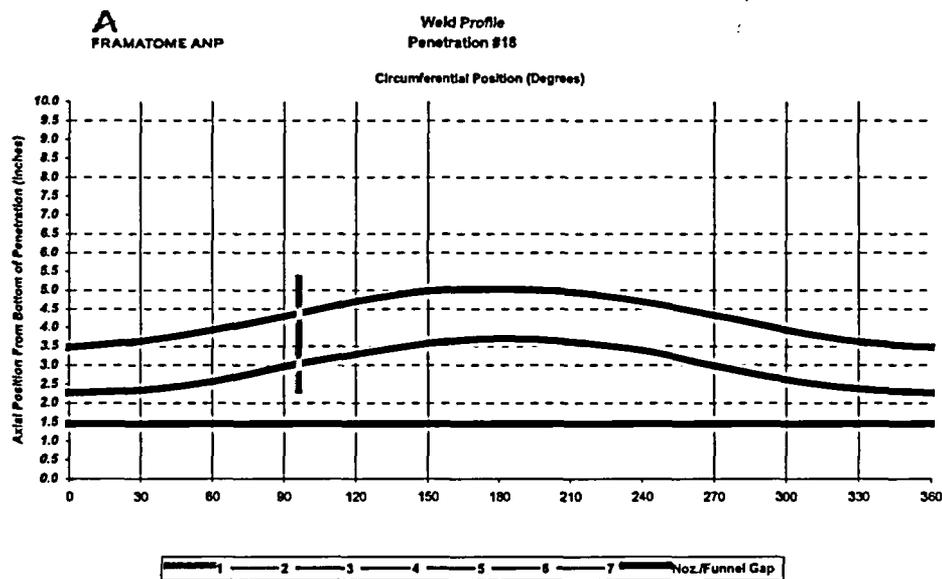
There was no traditional failure analysis since the flaw was destroyed during the repair. The sketch of the flaw in nozzle 18 was provided in Attachment 1, page 14 of FPL letter L-2003-129.

The phenomenon of PWSCC in alloy 600 RVHPs is well documented in industry reports and in the background sections of the NRC Bulletins and the Order. Failure analyses have been performed on earlier alloy 600 RVHPs with cracks such as Bugey and the retired North Anna head. The conclusions to date all point to PWSCC. The flaws detected at St. Lucie 2 during the spring 2003 inspection were characterized as PWSCC and typical of other cracks found in the industry. The cracks were contained completely within the inspection region proposed by this relaxation request.
