Re: St. Lucie Units 1 and 2
Docket Nos. 50-335 and 50-389
Reportable Event: 2004-004-00
Date of Event: September 25, 2004
Dual Unit Loss Of Offsite Power During Hurricane Jeanne

LICENSEE EVENT REPORT (LER)

4. TITLE
Dual Unit Loss Of Offsite Power During Hurricane Jeanne

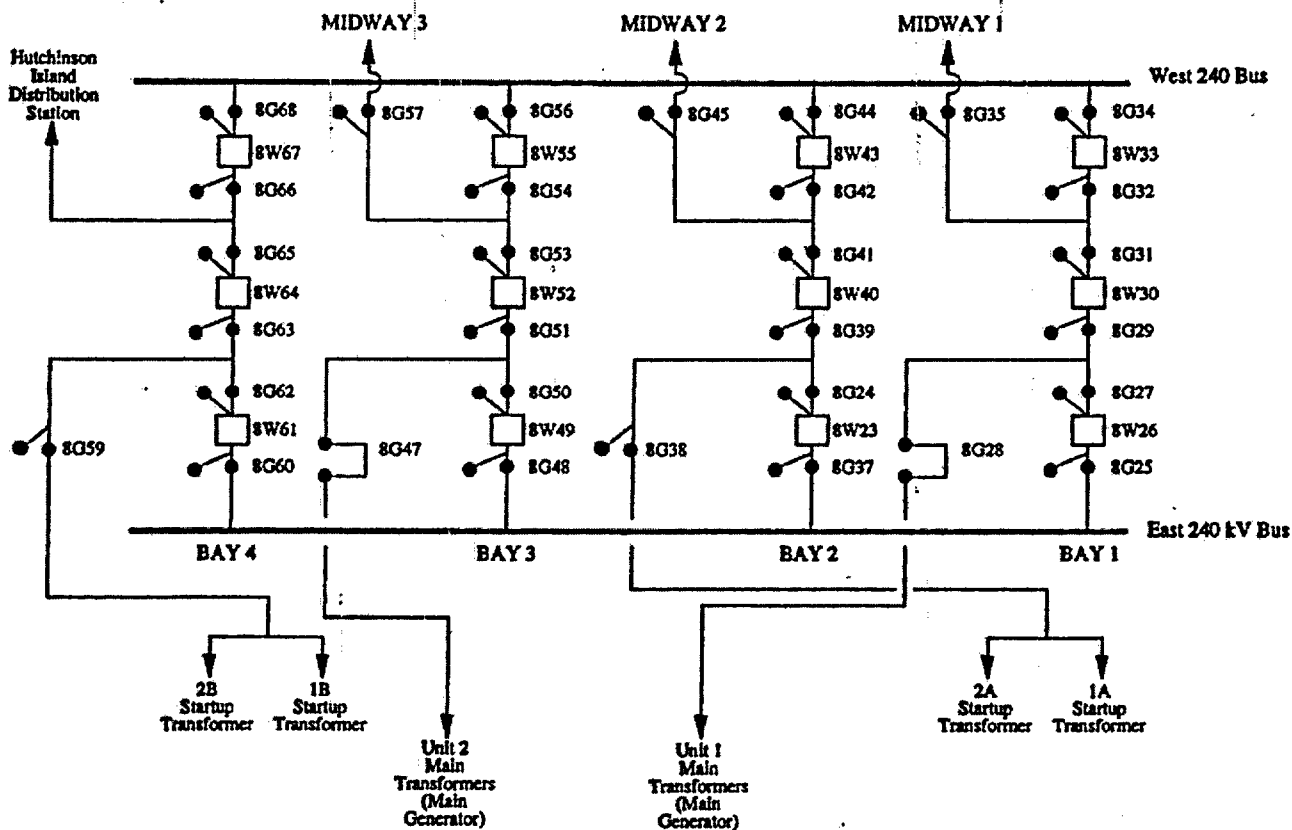
Figure 1 - St. Lucie Switchyard Arrangement

The arrangement of the St. Lucie switchyard [EIIS:FK] is presented in Figure 1. The four bay 230 kV (nominal) switchyard provides switching capability for two main generator outputs, four startup transformers, three outgoing transmission lines, and one distribution substation. The three outgoing transmission lines are identified as Midway 1, 2, and 3 and service switchyard Bays 1, 2, and 3, respectively. The Hutchinson Island distribution substation is serviced by Bay 4. The main generators for both St Lucie Units 1 and 2 produce power and that enters the switchyard in Bays 1 and 3, respectively.

Bay 2 (Midway 2) supplies power to startup transformers 1A and 2A, located in the St Lucie Unit 1 transformer yard. Bay 4 (Hutchinson Island distribution substation) supplies power to startup transformers 1B and 2B located in the St. Lucie Unit 2 transformer yard. During normal operation, either set of startup transformers can be fed from any one of the incoming transmission lines through all of the east-west switchyard bus cross-ties. However, when a unit is taken off-line, the switchyard design requires removal of the cross-tie between the east and west 230kV busses. To remove a unit from service, the generator breakers (8W30 and 8W26 in Bay 1 for Unit 1 or 8W52 and 8W49 in Bay 3 for Unit 2) must be opened and remain open to isolate the main transformer lines. Since both units are removed from service in anticipation of hurricane force winds, two bays between the east and west busses are lost such that the startup transformers are serviced by the two remaining east-west cross-ties in Bays 2 and 4.

At 1100 hours on September 25, 2004, Unit 1 was removed from service followed by Unit 2 at 1159 hours. Later the same day Unit 1 entered Mode 4 at 1840 hours followed by Unit 2 at 2036 hours. At 2221 hours, a fault in the Hutchinson Island distribution substation feed caused the west bus breaker 8W67 [EIIS:FK:BRK] and mid breaker 8W64 [EIIS:FK:BRK] to open in Bay 4. At this time, the 1A/2A startup transformers [EIIS:EA:XMFR] were still connected to the east and west switchyard busses in Bay 2, but in Bay 1 the 1B/2B startup transformers [EIIS:EA:XMFR] were only connected to the east switchyard bus. By 2349 hours, Unit 1 completed the transition to shutdown cooling as the decay heat removal mechanism, but Unit 2 was still removing decay heat by steaming to the steam generators. At 2356 hours, a fault on the Midway 2 feed to Bay 2 opened the west bus breaker 8W43 [EIIS:FK:BRK] and the mid breaker 8W40 [EIIS:FK:BRK], and power to the east switchyard bus was lost causing a complete loss of offsite power (LOOP) at both units (although Midway lines 1 and 3 remained energized, they were only capable of powering the west switchyard bus and the east-west cross-ties in Bays 2 and 4 were lost with the faults on the Hutchinson Island distribution substation and Midway 2 feeds). As described later, all four of the emergency diesel generators (EDGs) [EIIS:EK:DG] started in response the LOOP conditions and safe shutdown loads were sequenced onto each unit's safety busses. At 0004 hours on September 26, 2004, power to the Midway 2 line was restored. However, the decision was made to not restore power to the startup transformers until weather conditions improved enough to permit switchyard inspections.

The faults that resulted in the dual unit LOOP at the St. Lucie site were most likely caused by salt contamination on electrical components as a result of the extreme environmental conditions experienced during Hurricane Jeanne. The west side of the eye wall was heavily contaminated with salt spray, creating the potential for electrical faults. This salt spray contamination was removed by the east side of eye wall as it washed the salt away with cleaner water. This west eye wall salt spray contamination - east eye wall self cleaning phenomenon was also observed in substations throughout the FPL service territory.

An additional cause for the LOOP is that the switchyard design requires removal of each unit's east and west 230kV bus cross-tie when the unit is off-line. If the switchyard design had non-load interrupting disconnect switches (NLIDS) in the main transformer lines, Bays 1 and 3 would provide additional cross-ties between the east and west 230kV busses. This would allow re-closing the generator breakers (8W30 and 8W26 in Bay 1 for Unit 1 or 8W52 and 8W49 for Unit 2 in Bay 3) when a St. Lucie unit is off-line. This design would result in a more robust 230kV switchyard when challenged by extreme environmental conditions.

1. No immediate corrective action related to salt contamination was required since the post-storm testing demonstrated that the switchyard insulation was clean.
2. The 1B ICW pump load-sequencing relay was replaced under work order 34016797 and the 1B ICW pump control switch was replaced under work order 34016797.
3. The 2A EDG Day Tank RHH1 relay and the solid-state controller were replaced under work order 34016818.
4. St. Lucie is considering replacing the disconnect links between the switchyard and the main transformers of each St. Lucie unit with motor operated disconnect (MOD) switches or evaluate other means of improving switchyard reliability. This assessment will be completed by May 1, 2005.
