December 3, 2004

License SUA -1341
Docket 40-8502

RE: Christensen Ranch Pond 4 leak.

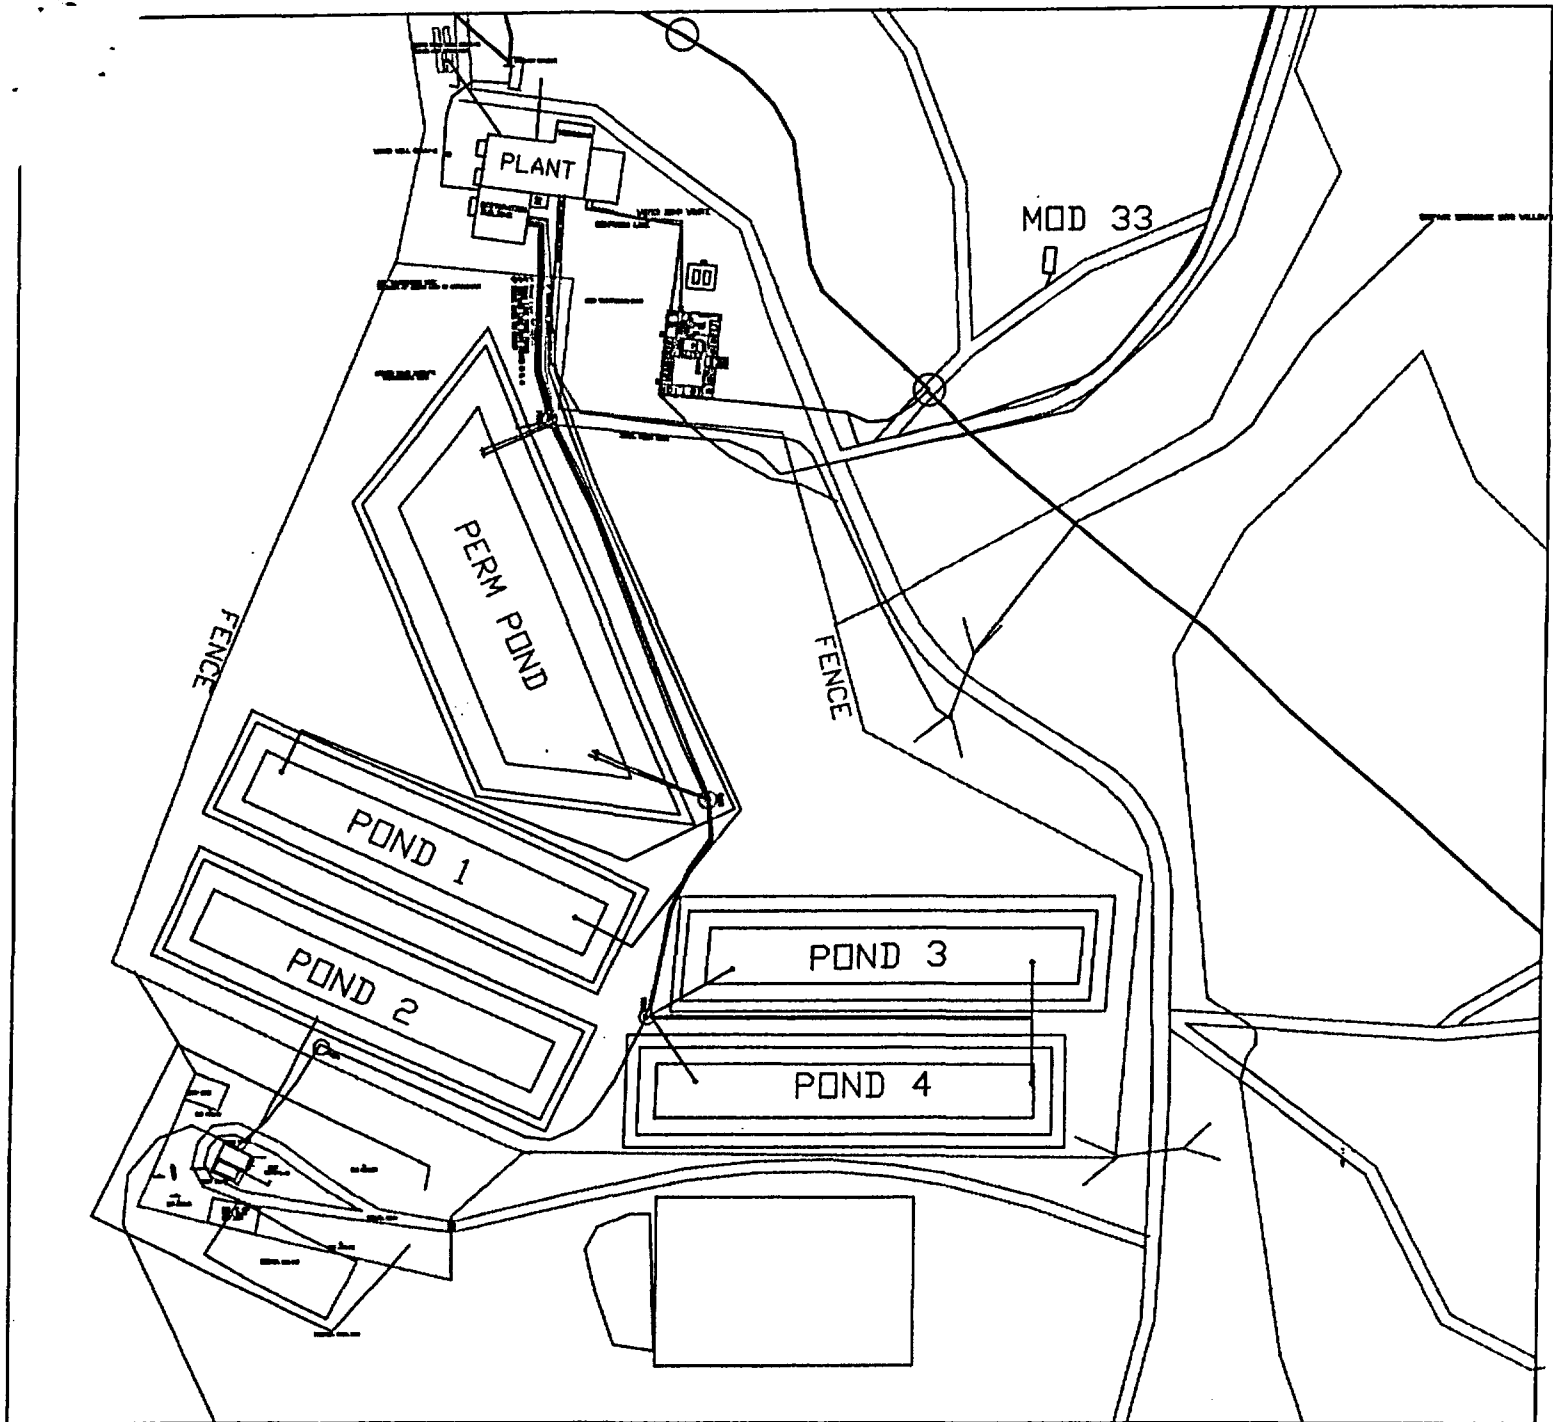
The Christensen evaporation ponds are constructed such that each pond contains six cells that are monitored individually by a leak detection system. As stated above, fluid was detected in only the northwest cell of Pond 4, (see attached map) indicating that the source of the leakage should be in that particular part of the pond.
