Generator Rotor and Steam Dryer Meeting

Dresden Nuclear Power Station
December 2, 2004

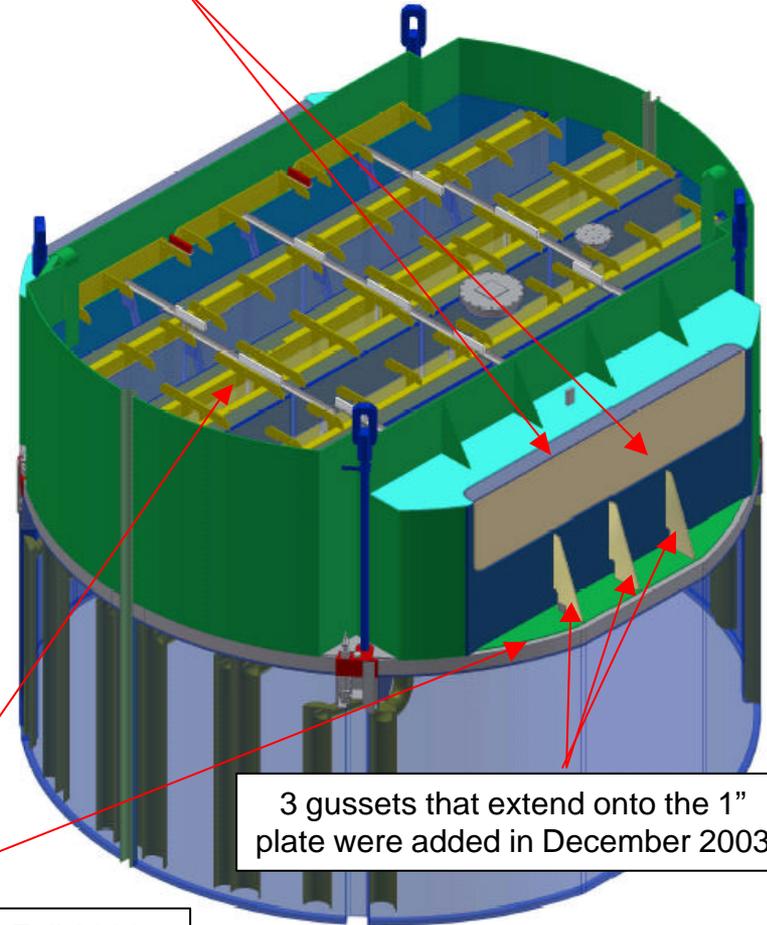
1" inserts added December 2003

3 gussets that extend onto the 1" plate were added in December 2003

Insert/cover plate size increased to 1/2" in Fall 2002

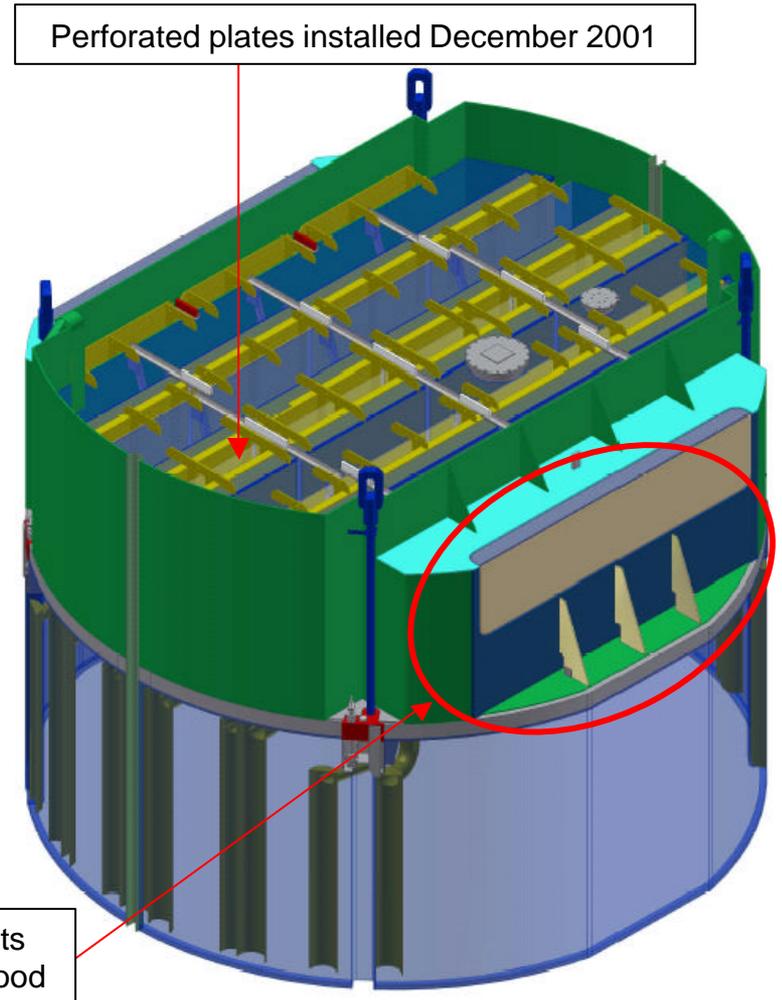
- Began EPU operation on December 26, 2001
 - During the Fall 2001 refueling outage, perforated plates were added to reduce moisture carryover
- Fall 2003 refueling outage (post 690 days continuous run at EPU power)
 - Added 1/2" cover plate
 - Added 1" partial height front hood face plate
 - Added 3 gussets on both 90° and 270° sides that did not extend to the 1" plate
 - Interior and exterior examinations performed in accordance with GE SIL 644

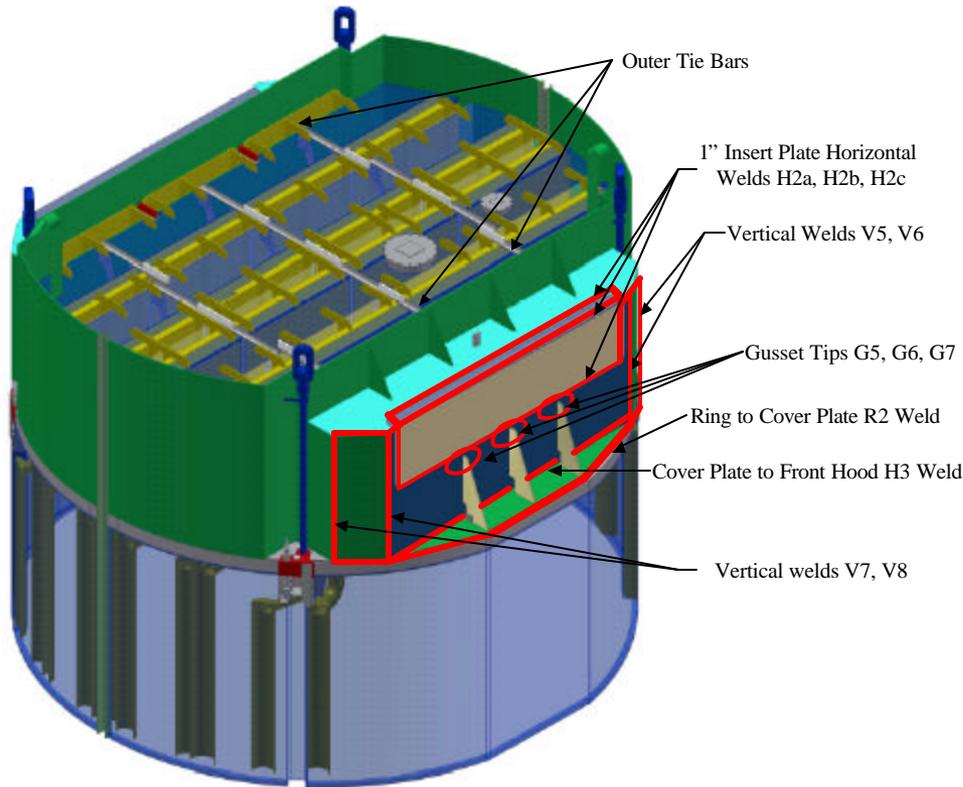
- Based on D3 inspection results, an inspection of D2 was performed
- Inspected areas where loose parts could be generated or the structural integrity of the dryer could be threatened
 - All high stress welds identified in GE SIL 644, Revision 1
 - Welds in areas modified in 2003
 - Outer tie bars
 - Startup instrumentation piping
 - Interior inspections of the illustrated welds
- One INR identified – cover plate to dryer support ring crack
