Subject: Duke Energy
Oconee Nuclear Station, Unit 2
Docket Nos. 50-270
Third Ten Year Inservice Inspection Interval
Requests for Relief No. 04-ON-002 and 003
Request for Additional Information

**REQUEST FOR ADDITIONAL INFORMATION
ON THIRD 10-YEAR INSERVICE INSPECTION INTERVAL
REQUESTS FOR RELIEF 04-ON-002 AND 04-ON-003**

Relief Request 04-ON-002

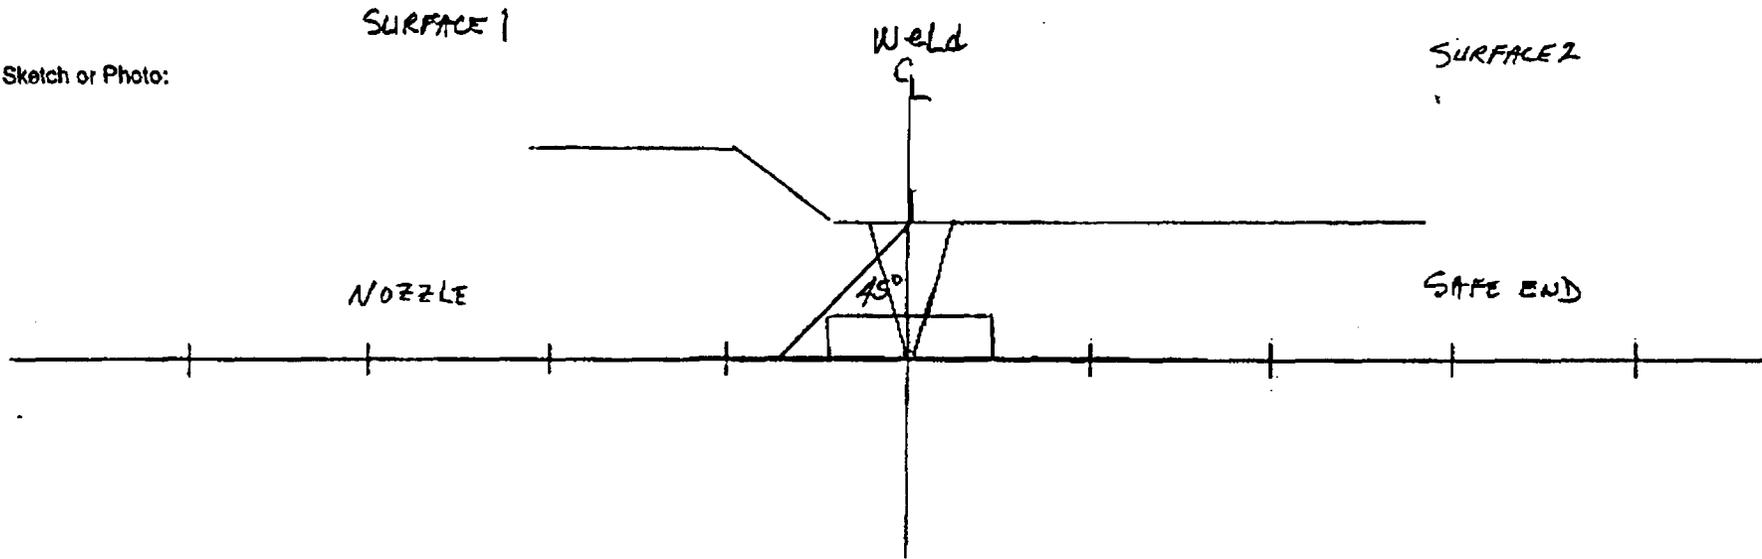
2-PZR-WP45 B05.040.002A

Attachment C, page 3 of 59, shows a UT profile/plot sheet for Weld 2-PZR-WP45. Please clarify what is depicted on this sheet; specifically, describe the relevance of the 60° notation in the sketch.

Answer: One hundred percent coverage was achieved scanning from the safe end side of the weld using 45 degree shear wave and longitudinal wave search units. An axial scan from the nozzle side of the weld could not be performed because of the nozzle taper. Circumferential scans were performed over 100% of the examination volume in two opposite directions. The 60 degree notation is an error. It should read 45 degrees. A revised drawing (page 3 of 59) is enclosed. A review of the nozzle detail drawings shows no buttering at this weld location.

During the ultrasonic examination of dissimilar metal weld 2-PZR-WP45, 75% coverage of the required examination volume was obtained. Scanning limitations were caused by the taper of the nozzle which prevented scanning from both sides of the weld. The percent coverage reported represents the aggregate coverage from all scans performed on the weld. The examination volume was scanned in two circumferential and one axial direction using 45° shear wave and longitudinal wave search units. In order to scan all of the required surfaces for the inspection of this weld, the nozzle would have to be redesigned to allow scanning from both sides of the weld, which is impractical. There were no recordable indications found during the inspection of this weld.
