UNITED STATES
NUCLEAR REGULATORY COMMISSION
OFFICE OF NUCLEAR REACTOR REGULATION
WASHINGTON, D.C. 20555

February 10, 2005

NRC INFORMATION NOTICE 2005-03: INADEQUATE DESIGN AND INSTALLATION OF
SEISMIC-GAP FIRE BARRIERS

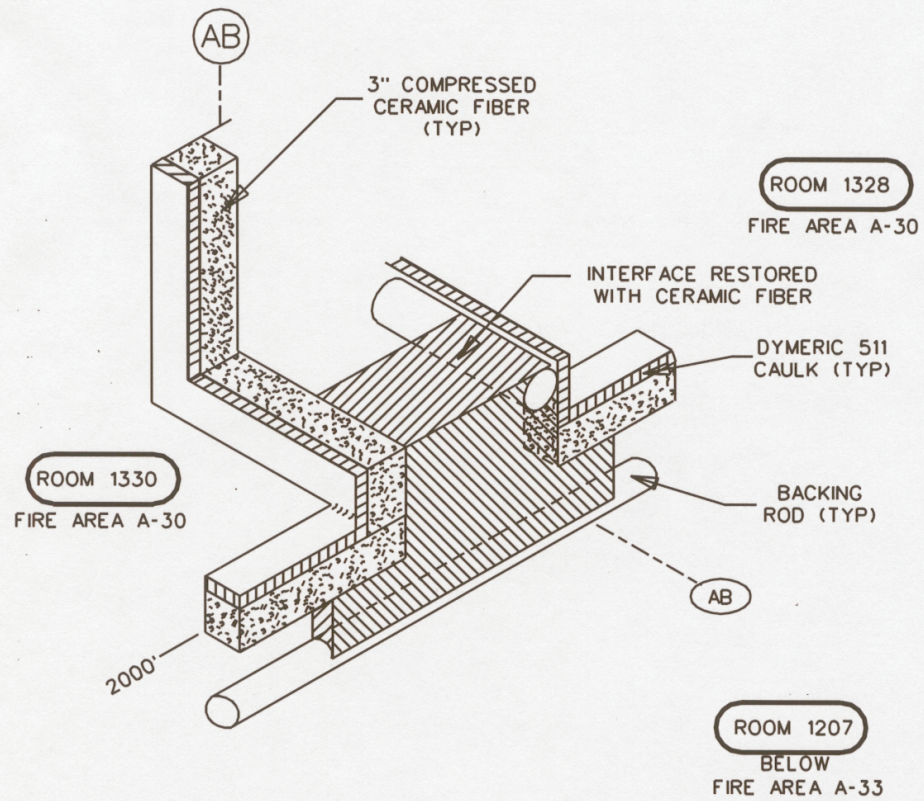
The licensee also found, during the course of resolving the missing fire barrier segment issue, that the original seismic-gap fire barrier design was deficient. The design only included the gaps between a single floor or wall of one building and a wall or floor of an adjacent building or fire area. The design did not include the fire barrier configuration where floors, walls, and/or ceilings of one building joined together, such as a corner of a room, at the seismic gap with an adjacent building or fire area. Since the design was deficient, the licensee implemented compensatory measures for all potentially affected fire areas. The licensee inspected 25 suspect configurations and determined that 14 were inadequate. The attached diagram represents a typical as-found deficient seal and the associated restoration configuration where multiple fire boundary seismic-gap seals interface.

Through intrusive inspection, it was determined that the original fire barriers were not installed per the design at many single-interface locations. Instead of installing fire barrier material on just one side of a gap, the installers placed barrier material in the gaps at both sides of a wall or floor and did not use the polyethylene backing. The polyethylene is provided for support of the caulking material. With fire barrier material on both sides, the polyethylene backing is not needed. Installing barrier material on both sides of the gap actually mitigated the potential consequences of the inadequate installations at some of the room corners. The licensee immediately corrected the deficiencies at the corner interfaces by adding fire barrier material.

1. CERAMIC FIBER INSTALLED TO CNT-MC-680 WITHIN CAVITY TO SATISFY 3-HR FIRE RESISTANCE AND OVERLAP REQUIREMENTS.
2. WALL AND FLOOR/CEILING NOT SHOWN FOR CLARITY.
