*Goulds Pumps
Vertical Products Operations*

**1) Corporate
Summary by ITT**

On May 21, 2004, at 0150 hours with the Perry Nuclear Power Plant ("PNPP") operating in MODE 1 at 100 percent power, the PNPP declared Emergency Service Water ("ESW") pump A "inoperable" due to a pump shaft coupling failure. Subsequent to that failure, First Energy Nuclear Operating Company ("FENOC") issued a Licensee Event Report ("LER") to the Nuclear Regulatory Commission ("NRC"), which stated in part that Goulds had provided pump shaft couplings to PNPP that were defective.¹

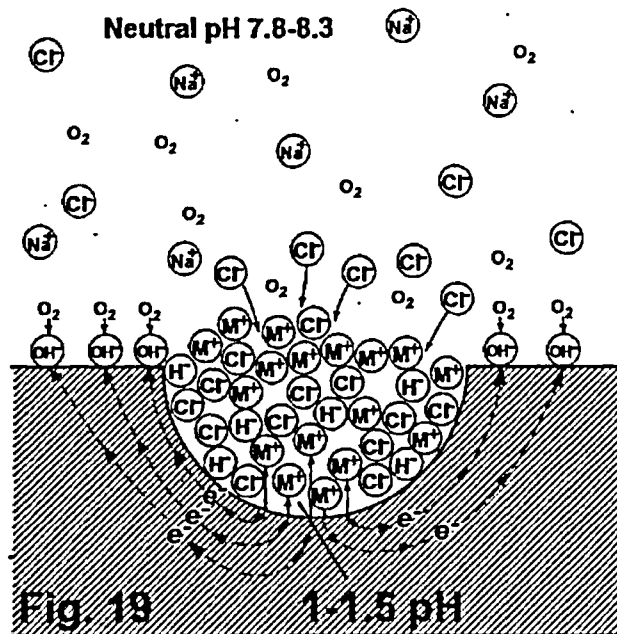
Fig. 19 Autocatalytic processes occurring in a corrosion pit. The metal, M, is being pitted by an aerated NaCl solution. Rapid dissolution occurs within the pit, while oxygen reduction takes place on the adjacent surfaces. [REI definition of stagnant pool corrosion.]

At the time of the first failure event, PNPP had not yet identified the standby environment involved when the couplings are not continuously immersed in a flowing stream. Furthermore, PNPP had not provided Goulds information during the design stage that would have placed it on notice that this potentially important factor would be present. As such, vapor likely was created within the pump column and corrosive tendencies significantly increased with no remedial actions identified nor an opportunity given to Goulds to assist PNPP to resolve potential corrosion related problems. The vapor within the pump column included free oxygen and chlorine ions that were inclined to condense on the top of the exposed line shaft where gravitational effects would concentrate corrosive ions at the top coupling sleeve after normal stagnant pool action in the pump column. This situation has been addressed in significant detail in Attachment 2, Section 5.0 *Forebay Environment Issues*. (See the discussion on page 25 regarding Fig. 19 provided above.)

In summary, while stagnant pool corrosion is not a desirable condition, based upon nineteen years of failure free operation regarding the couplings, the autocatalytic processes would have been acceptable were it not for the local stress concentration and ion attraction within surface flaws in the keyway of the coupling sleeve caused by improper machining. The normal "ion pumping" action of the trapped vapors in the pump column resulted in stress intensities at the corrosion pits reaching the Stage II Plateau Velocity Region for IGSCC within a matter of weeks of operation. Consequentially, stagnant pool corrosive degradation of the coupling sleeve led to IGSCC Stage III Terminal Fracture and then rupture of the sleeve under normal operating loads where extreme stress concentration factors tipped the scale in favor of intergranular stress corrosion cracking induced failure. The above conditions, while present throughout failures one (7/24/97-9/1/03) and two (9/5/03-5/21/04), were overshadowed during the analysis of failure one due to the acknowledged installation errors. However, for failure two, these environmental conditions had a direct impact. In both cases the subsequent analyses of IGSCC terminal fracture overshadowed the potential for corrosion during standby conditions. This led the PNPP to mistakenly identify IGSCC as the root cause of failure, for which the 416SS material was an essential participant.
